Our ref: 7407-R1 Rev2
8 March 2025

Proposed New Water & Sewer Services Installation, Lots 793, 794 & 795, Diggins Terrace, Thredbo Village NSW Geotechnical Assessment

This report presents the results of a geotechnical assessment for Proposed new Water and Sewer Services Installation for Lot 793 (Sashas Apartments) Lot 794 (Blackbear Lodge) and Lot 795 (Candlelight Lodge), Diggins Terrace, Thredbo Village NSW (the Site). The assessment was commissioned by Kyra O'Sullivan of Kosciuszko Thredbo Pty Ltd. Preliminary comments were provided in our memo dated 30 November 2023, ref: 7047-M1. This report is updated to reflect the revised sewer main plans.

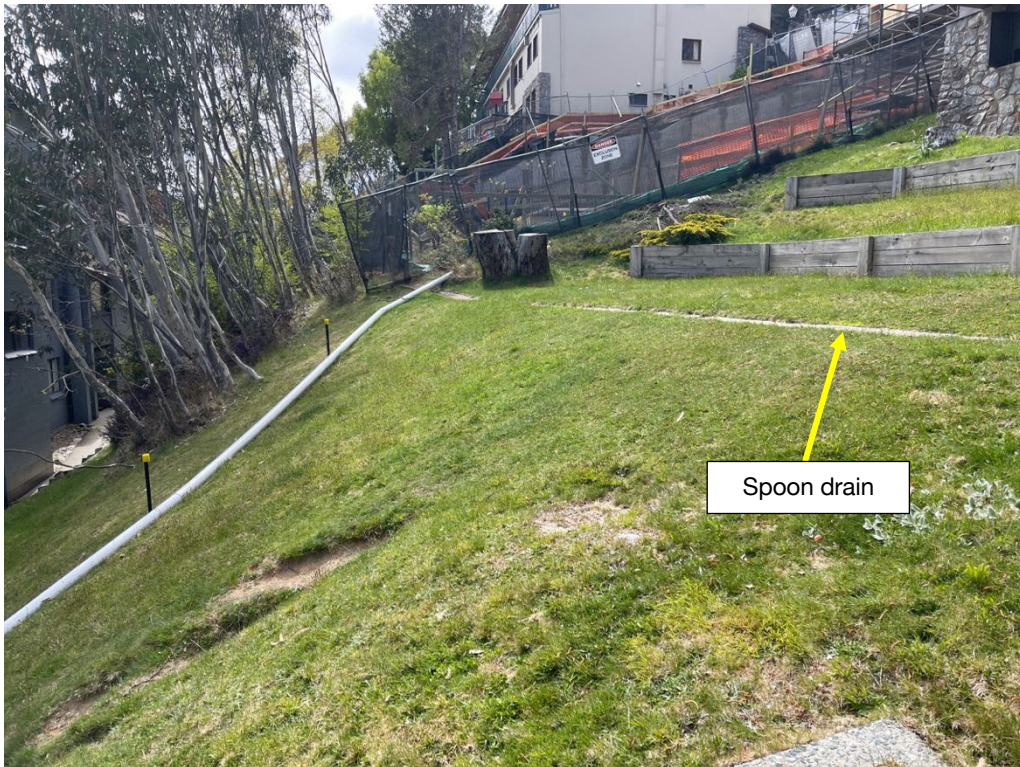
Photo 1 – View towards Blackbear Inn (being re-developed) – Sashas Apartments in foreground.

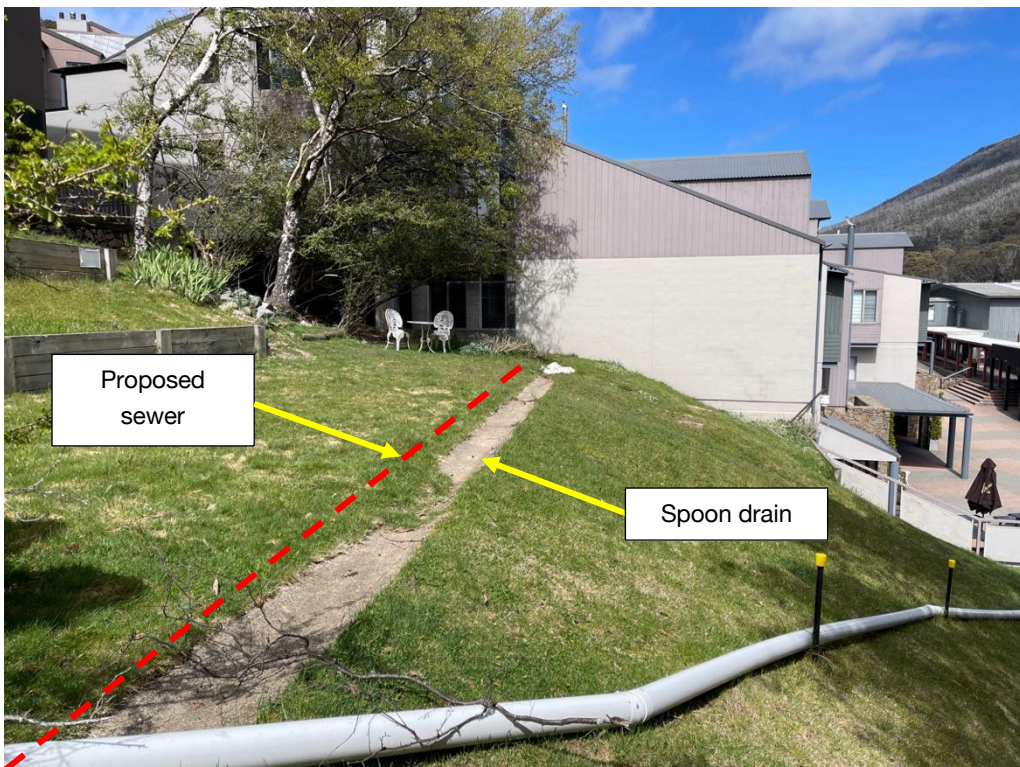
Photo 2 – View of rear of Sashas Apartments showing existing spoon drain and proposed sewer and stormwater.

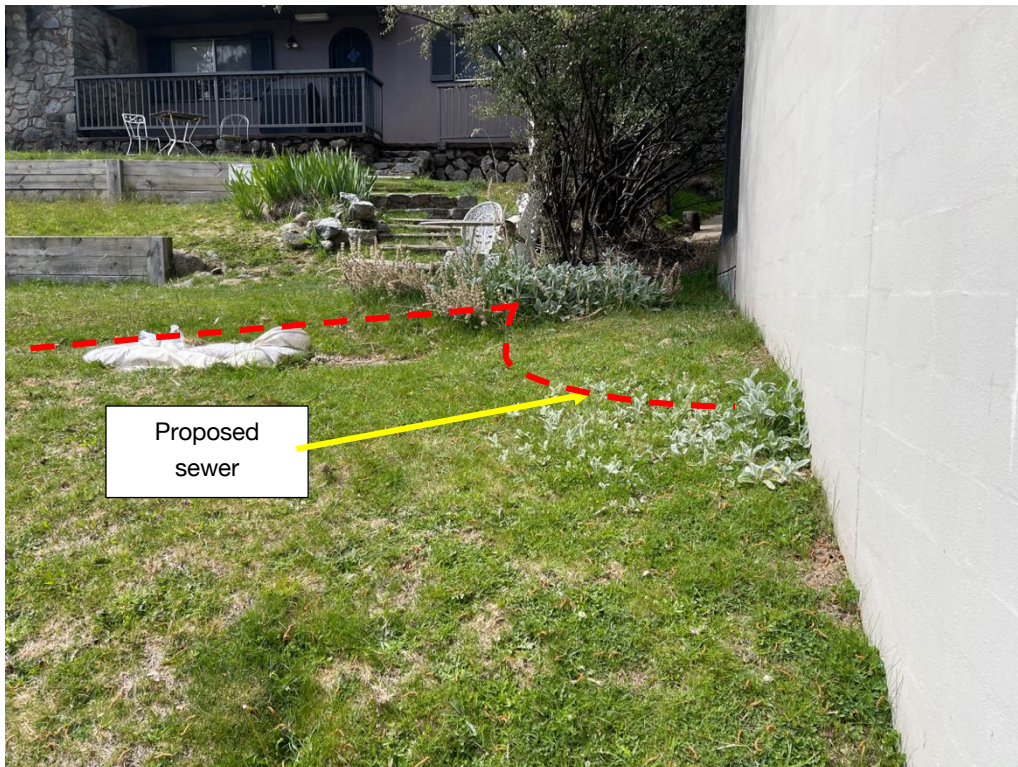
Photo 3 – View of rear of Sashas Apartments showing proposed sewer connection.

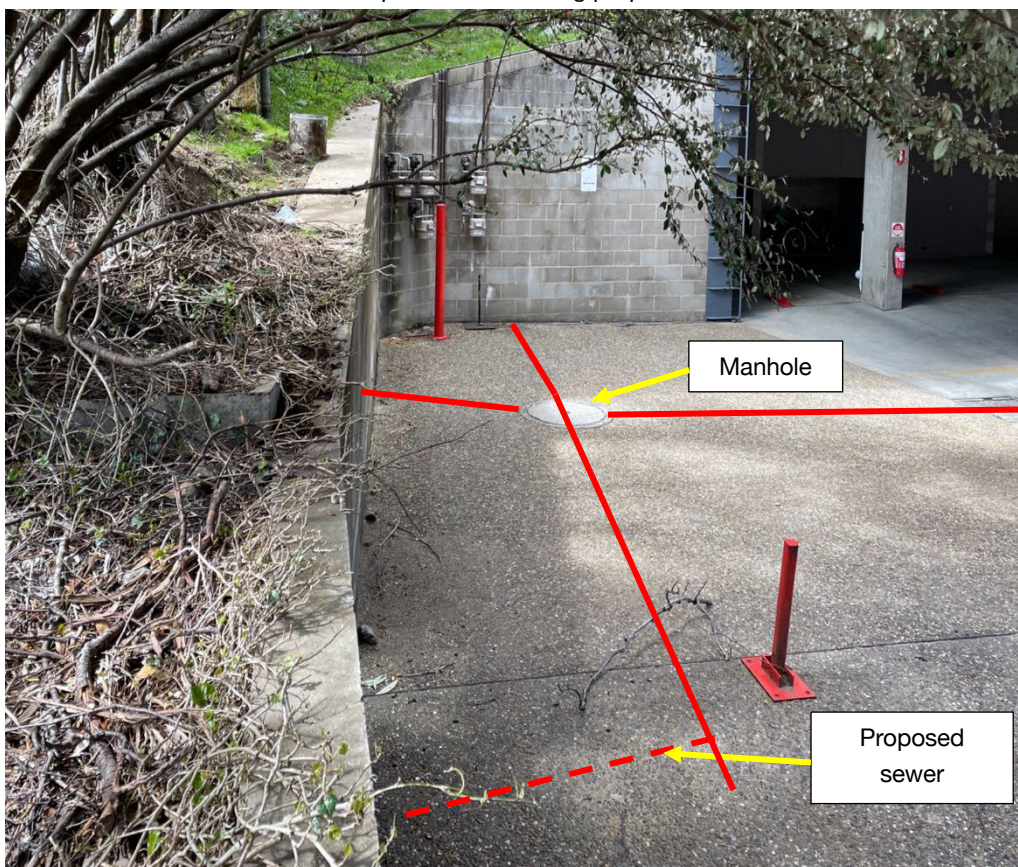
Photo 4 – View of rear of Squatters Run, showing possible sewer

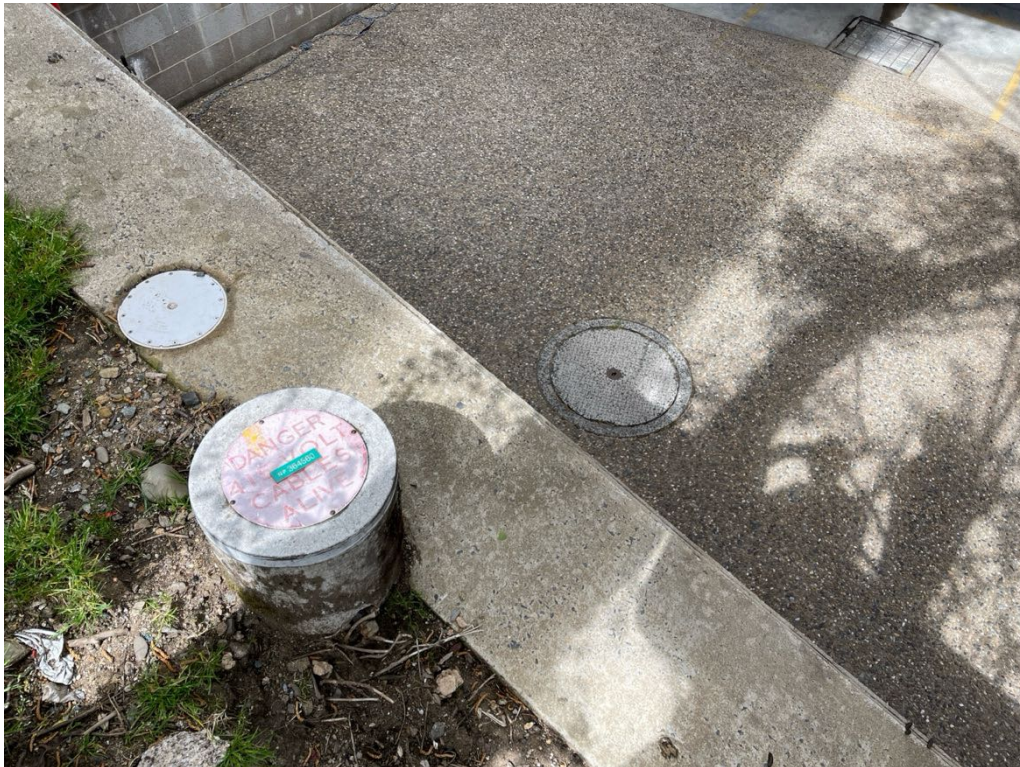
Photo 5 – Closeup view of riser and adjacent manhole.

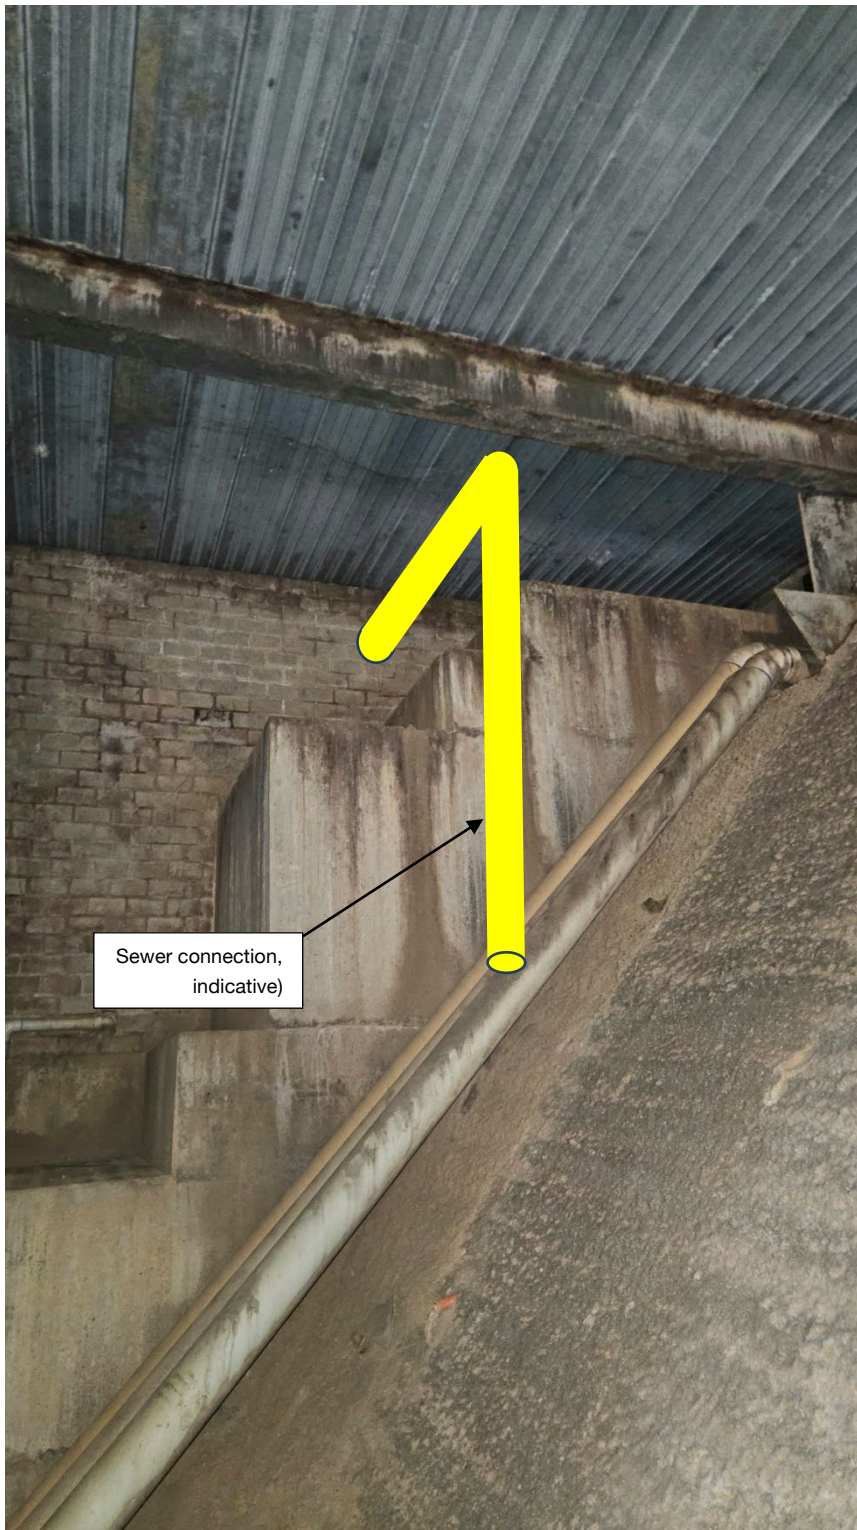
Photo 6 – View of void behind carpark where sewer will connect to existing (source: Kosciuszko Thredbo Pty Ltd).
