Arboricultural Impact Assessment report

Site address
20 Selwyn Street, Mayfield East NSW 2304

Prepared for property owners
JBC Family Nominees Pty Ltd

24 July 2024

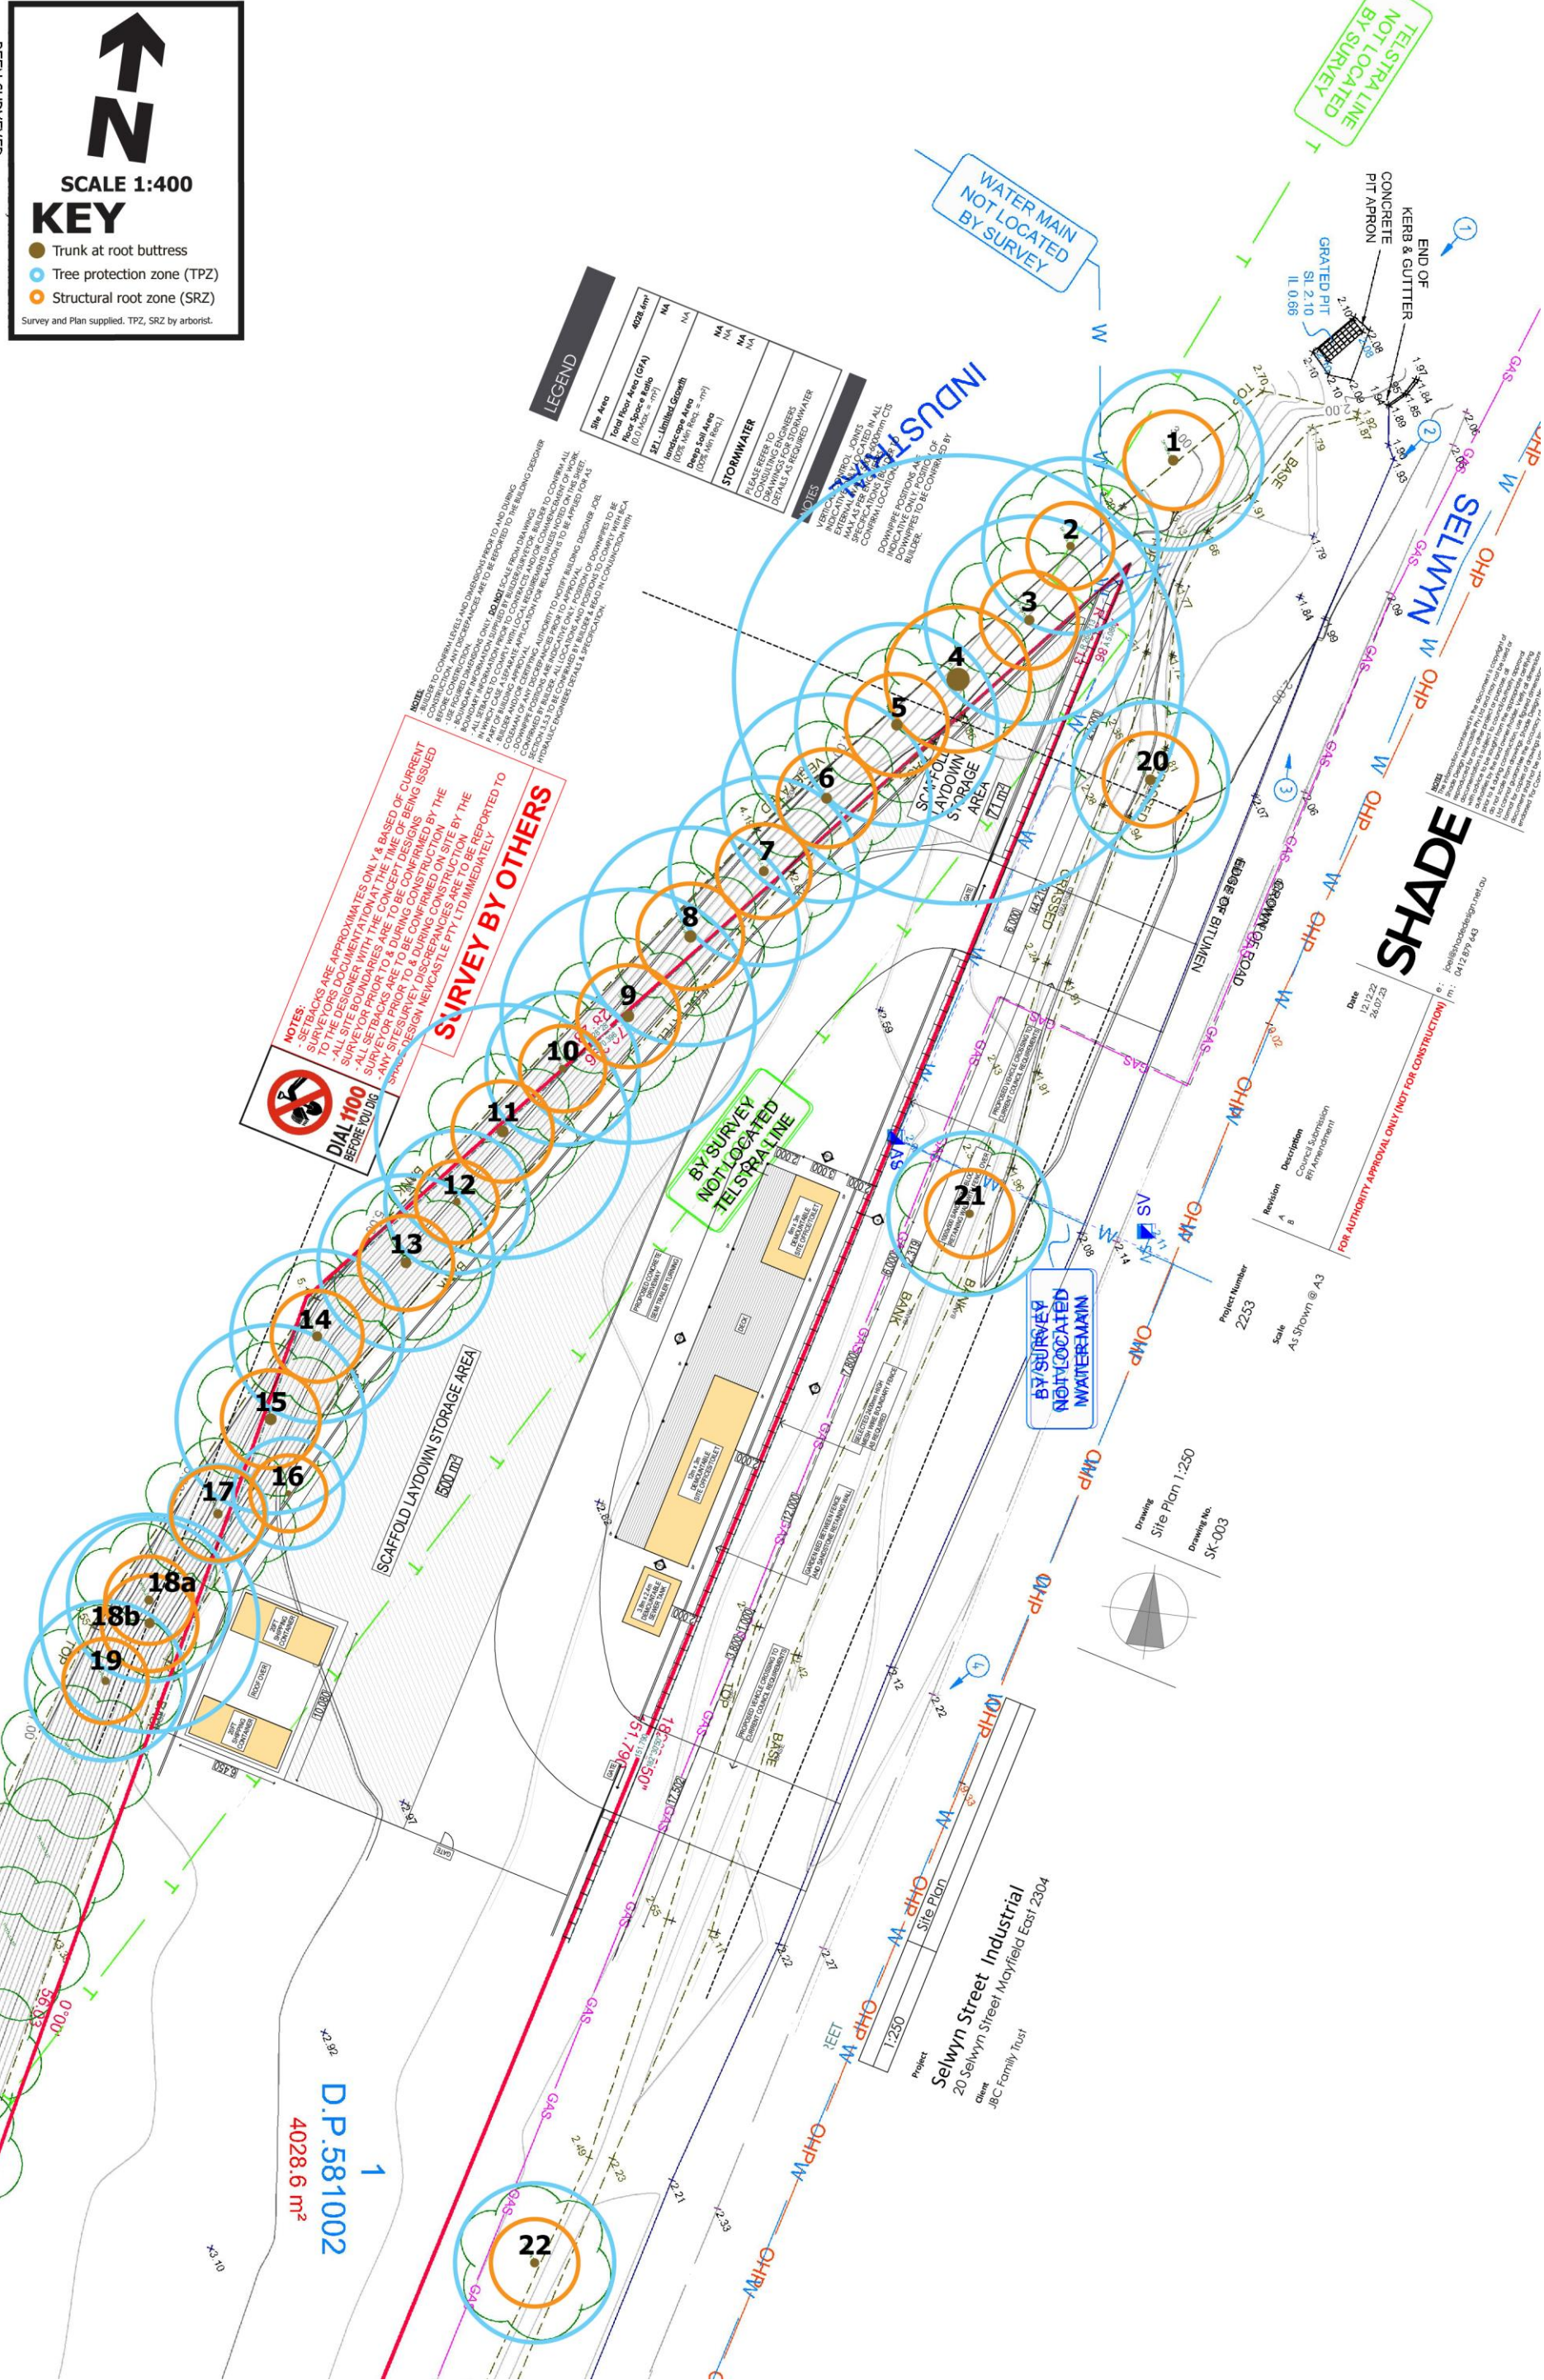
6. SITE PLAN WITH TPZ AND SRZ

- 5.2. Tree 1, 10, 17, 20 and 22 are the only tree to have no TPZ incursion. Minimal TPZ incursion would occur to all other trees except tree 4, 16 and 20. Tree 22 would not be affected at all by the proposal due to its displacement to the south-east of the proposed.

- 5.3. Tree 4, being the largest tree with subsequently the largest TPZ and SRZ would have incursion to both TPZ and SRZ. However, as it resides on top a slope in the landform the TPZ and SRZ are along the face of the embankment and may not be as far to the east because of the one-dimension of the site layout as seen on paper.

- 5.4. SRZ incursion would occur to most other trees. This results from fencing to the west of the site (east of the trees) along the flat of the landform. This fencing should be of chain wire to reduce impact to the trees.

- 5.5. Tree 16 and 21 may not be retainable because of the location of the proposed chain wire fencing. Fencing could accommodate retention of the trees by placement around them rather than through the SRZ of the tree.

- 5.6. Trees 18a, 18b and 19 would have minimal TPZ incursion from the placement of the shipping containers. Their branch spread would not be affected by height of the shipping containers.

- 4.1. It is suggested that the chain wire fence to the east and west of the site accommodate trees 16, 20, 21 and 22.
- 4.2. As much of the tree population resides at a high point in the landform and are at a distance from construction of buildings and the driveway, they do not require temporary fencing.
