STRUCTURAL INSPECTION BUILDING REPORT

Client Details - Project: A.A.C - **Perisher Huette**

Date: **17/09/2024, 11:38 AM** | Australia/Sydney (+10:00)

Meeting Address: **35 Wheatley Rd, Perisher Valley NSW 2624, Australia**

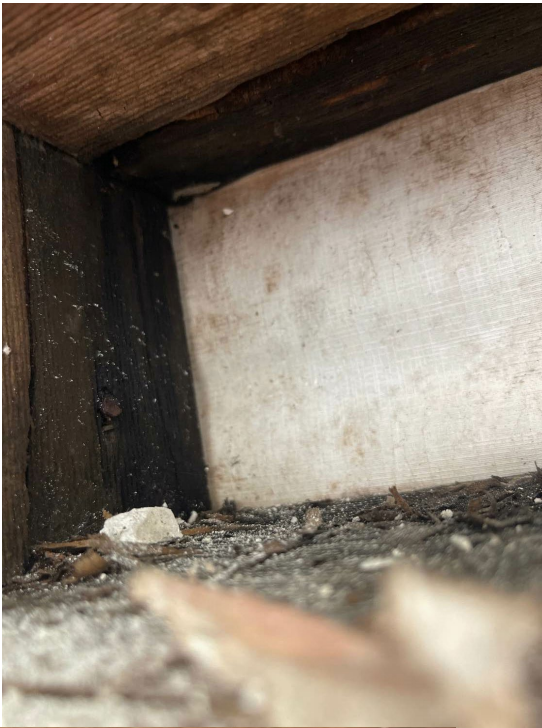
A portion of plasterboard approximatly 1m x 500mm was removed in an already damaged area. Inspection of the timber frame reveiled severe rot, and was slighty damp to the touch. A screwdriver was easily pushed through the external side of the framing member. The sarking was also damp.

There was also no insulation in some area's. Insulation in another area had set hard from being in contact with moisture. White mould was also noticed on the timber.

The frame to the wall has no lateral bracing due to no full length studs, the wall is built in 2 separate sections above the lintil height.

The timber frame is 140 x 45 pine and the lvl lintil above the large window is possibly undersized.

The structural integrity of the wall has been greatly compromised by water ingress and consistent moisture causing the timber to rot and deteriorate.

In my opinion, the movement of the wall during high winds is caused by the 2 sections of wall 'kinking' at the lintel height due to no lateral strength.

The north west face of the building receives winds of over 120km/h, the deterioration of the structural members will possibly not withhold these forces. It is recommended to replace the structural members and install moisture barriers with a cavity to reduce the chance of water ingress.

This should be taken as an immediate action.

A simple engineered steel portal frame that extends above the windows to the underside of the centre window would be suffice. Basic timber framing can be installed between the portal steel beam and existing structural members for the roof.
