# STRUCTURAL INSPECTION BUILDING REPORT

Client Details - Project: A.A.C - **Perisher Huette**

Date: **17/09/2024, 11:38 AM** | Australia/Sydney ( +10:00 )

Meeting Address: **35 Wheatley Rd, Perisher Valley NSW 2624, Australia**

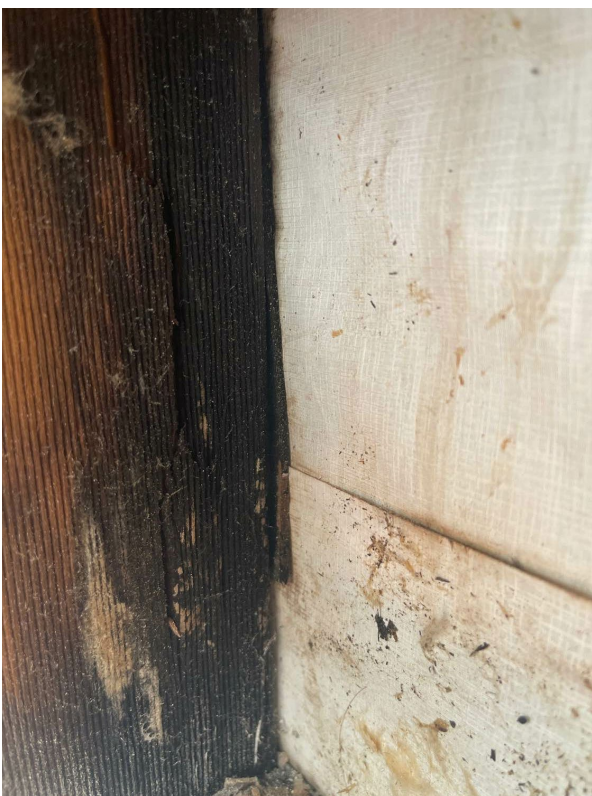
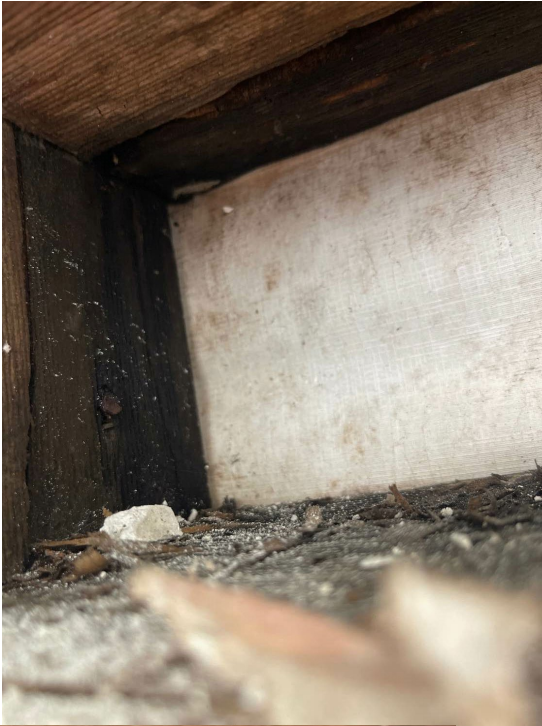
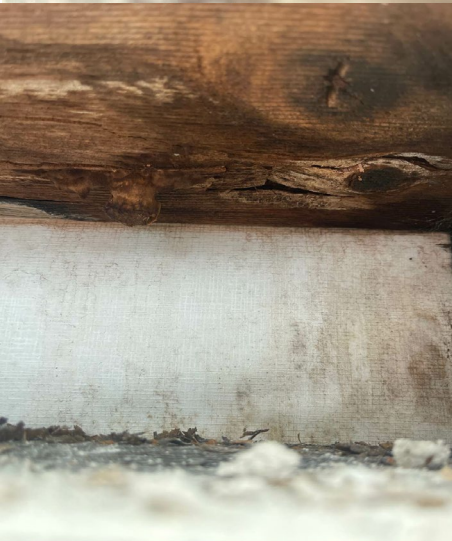
Upon first visual inspection, the plasterboard was seen to have major cracks in the area of concern.

A portion of plasterboard approximatly 1m x 500mm was removed in an already damaged area. Inspection of the timber frame reveiled severe rot, and was slighty damp to the touch. A screwdriver was easily pushed through the external side of the framing member. The sarking was also damp.

There was also no insulation in some area's. Insulation in another area had set hard from being in contact with moisture. White mould was also noticed on the timber.

The north west face of the building receives winds of over 120km/h, the deterioration of the structural members will possibly not withhold these forces. It is recommended to replace the structural members and install moisture barriers with a cavity to reduce the chance of water ingress.

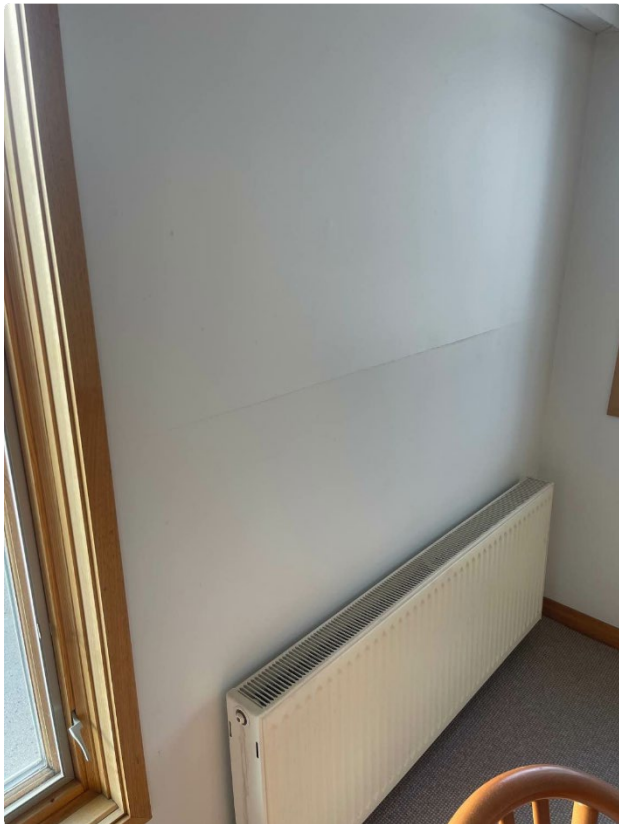
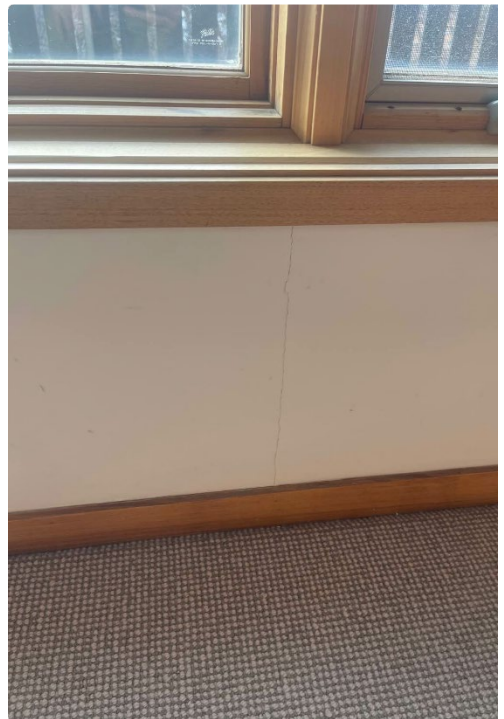
The cladding is constructed from hardboard fixed directly to the timber frame with membrane but no cavity or batten. There are 2 apron flashings at sheet heights, see photo. There is no internal vapour membrane or internal batten. The plasterboard appeared to be a single layer of 13mm 'Fyrcek'.

The Hardwood cladding is deteriorated.

A simple engineered steel portal frame that extends above the windows to the underside of the centre window would be suffice. Basic timber framing can be installed between the portal steel beam and existing structural members for the roof.
