Proposed Bike/Ski Storage Area and New Entry Ramp

**Hi Noon Ski Lodge, 12 Banjo Drive,
Thredbo NSW**

Geotechnical Investigation

Our ref: 7404-R1 Rev2
18 January 2025

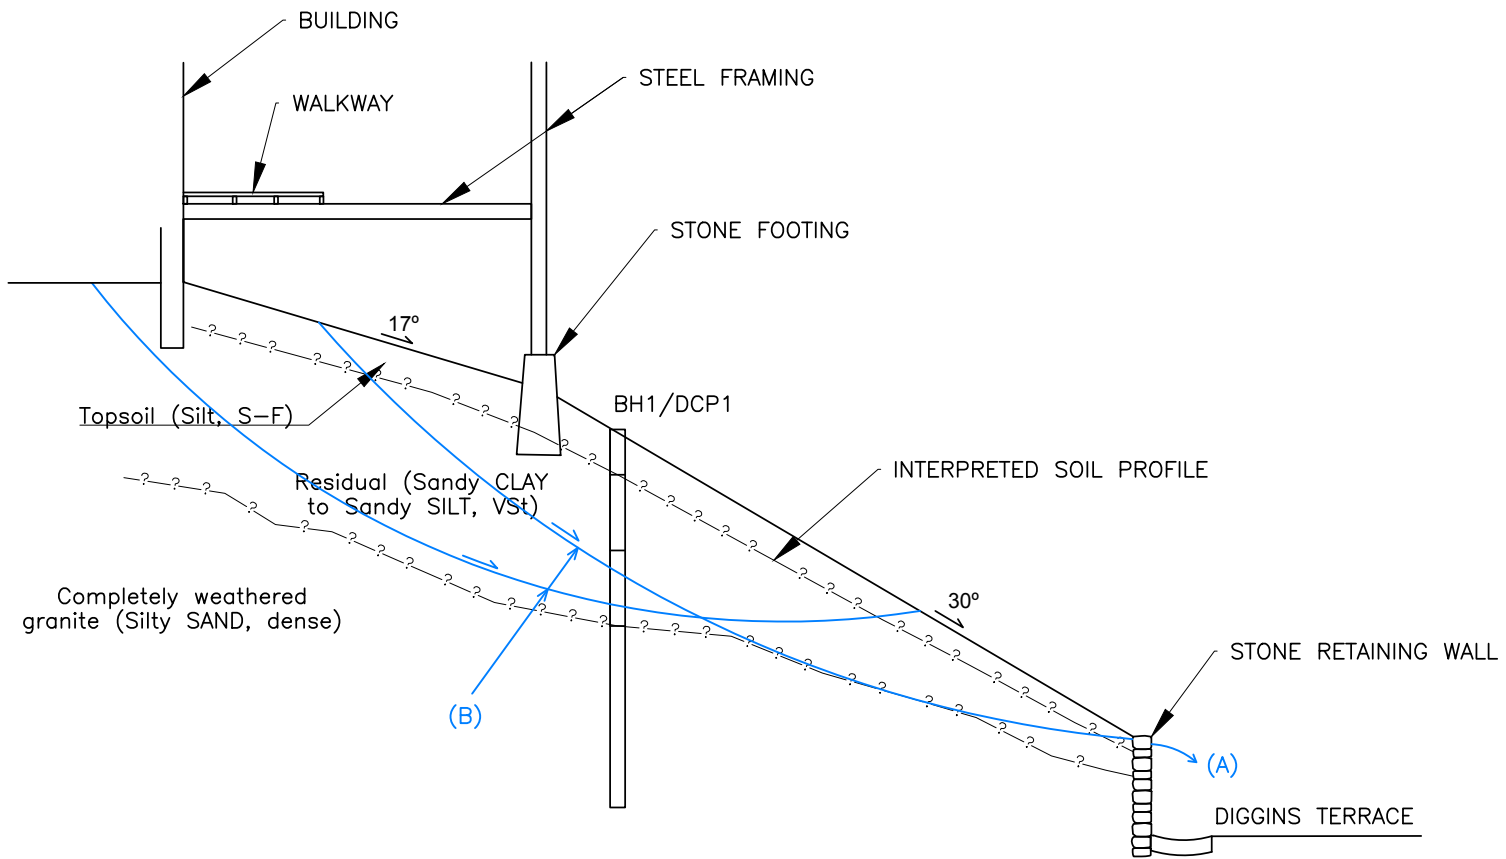
Figure 3 – Interpreted Section A - A

(B) POSSIBLE FAILURE MECHANISM

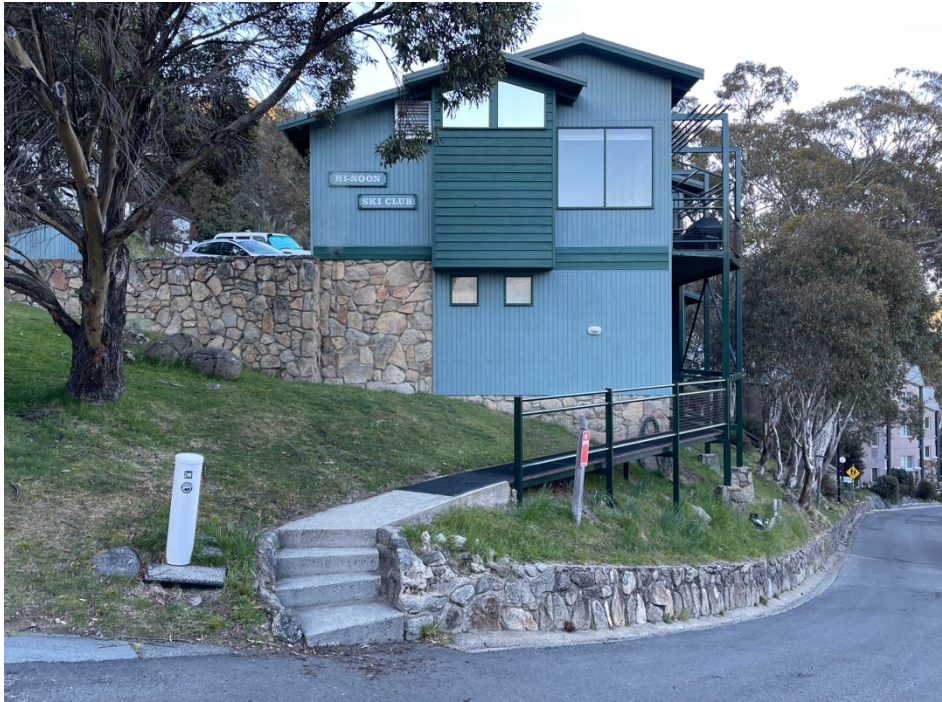
Photo 1
View of Hi-Noon Ski Club looking southwest

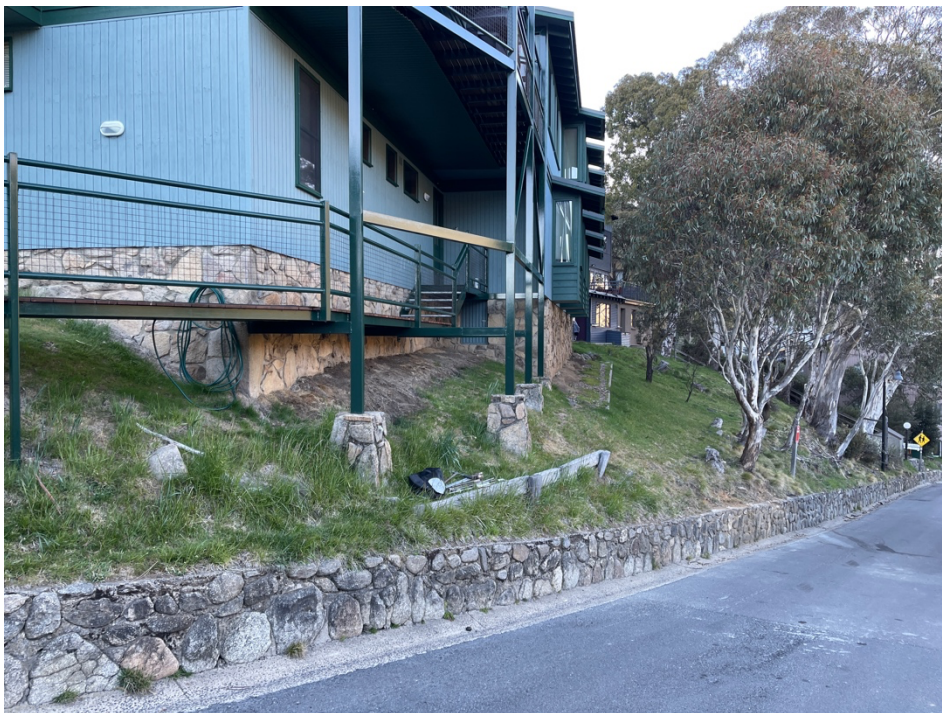
Photo 2
View of existing ramp and walkway

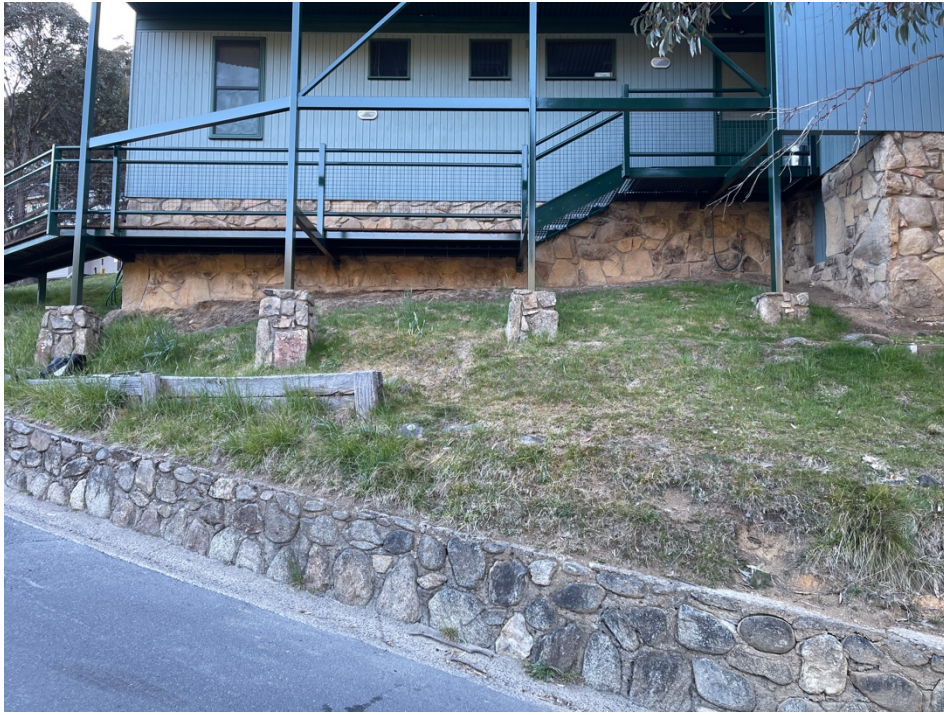
Photo 3

View of existing
ramp and walkway
at rear of ski club
and downhill slope
