Proposed Bike/Ski Storage Area and New Entry Ramp

**Hi Noon Ski Lodge, 12 Banjo Drive,
Thredbo NSW**

Geotechnical Investigation

Our ref: 7404-R1 Rev2
18 January 2025

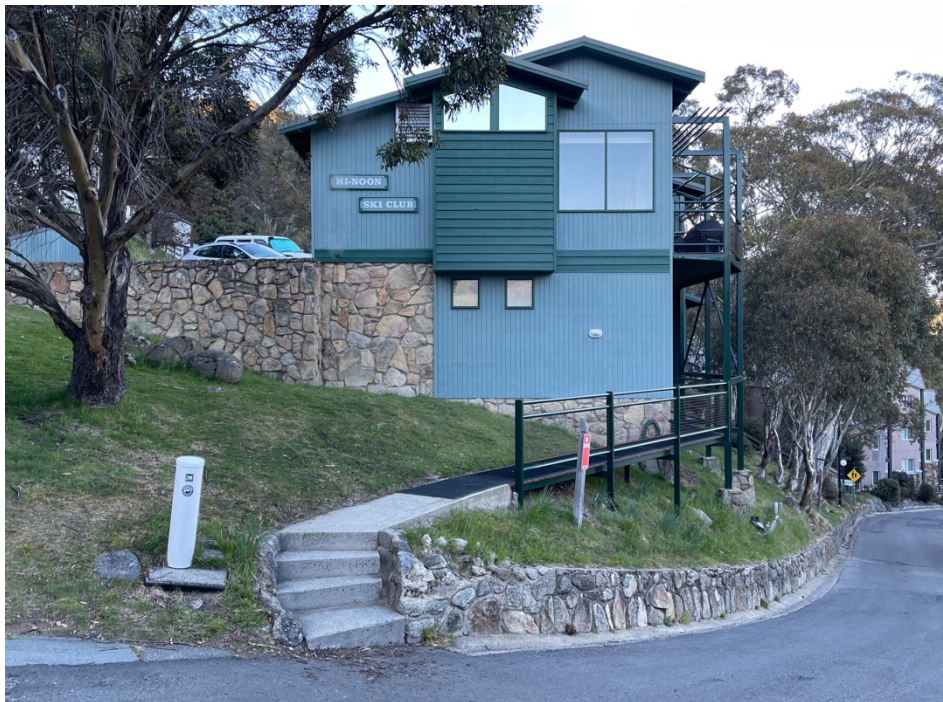
Photo 1
View of Hi-Noon Ski
Club looking
southwest

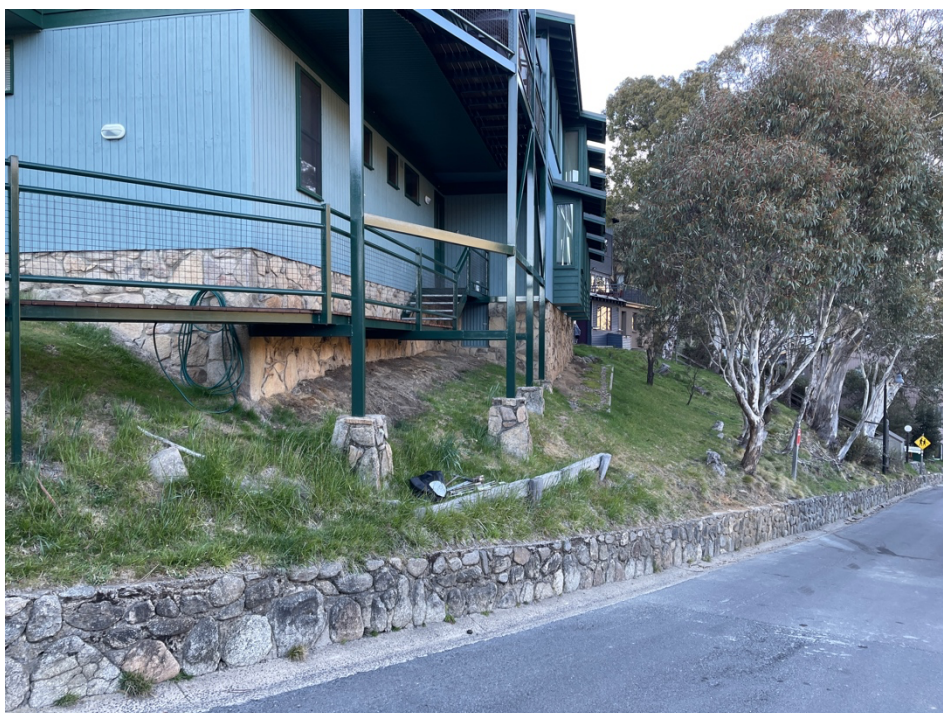
Photo 2
View of existing
ramp and walkway

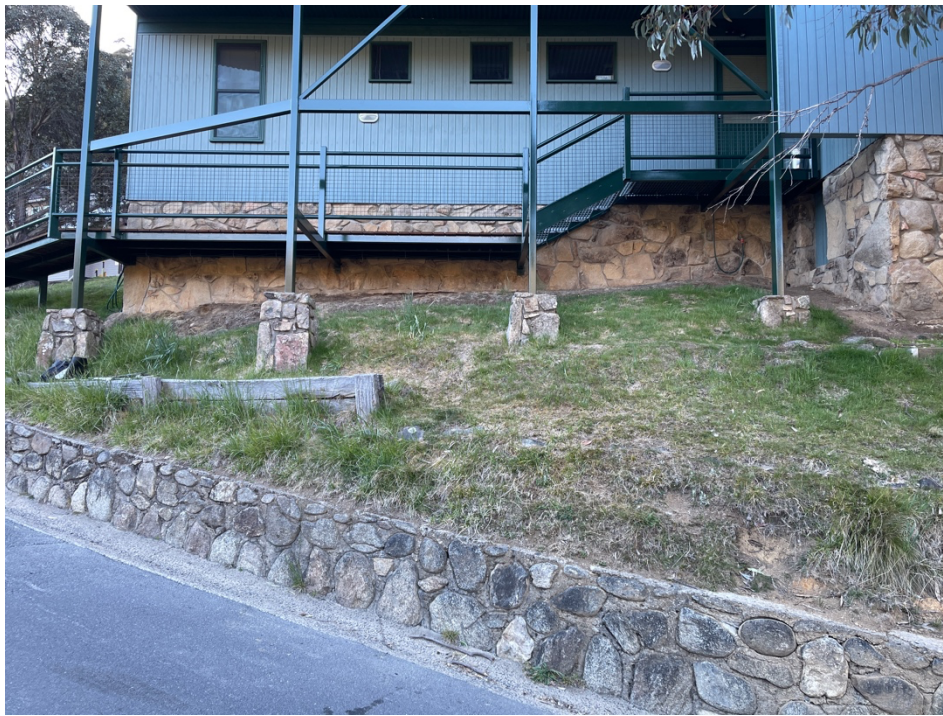
Photo 3

View of existing
ramp and walkway
at rear of ski club
and downhill slope
