Proposed Bike/Ski Storage Area and New Entry Ramp

**Hi Noon Ski Lodge, 12 Banjo Drive,
Thredbo NSW**

Geotechnical Investigation

Our ref: 7404-R1 Rev2
18 January 2025

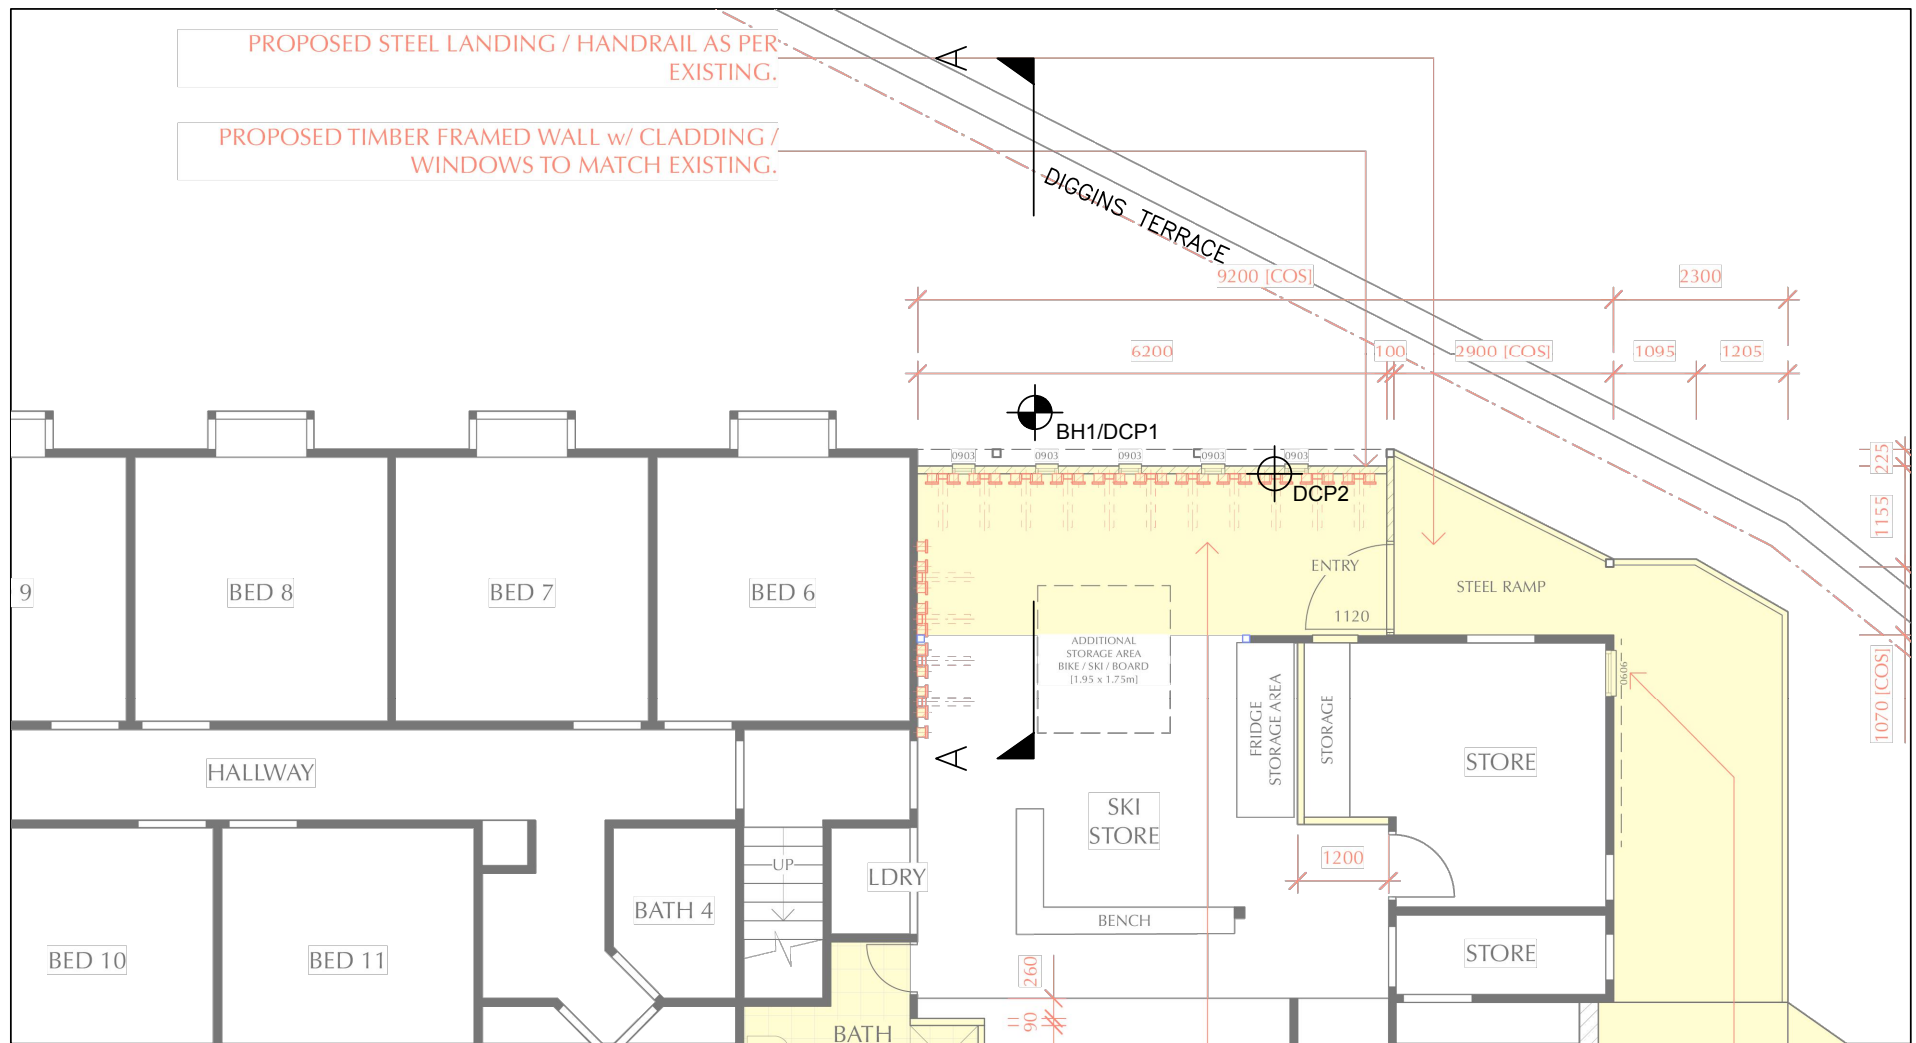
job no.:
7404
fig: 2
issue: C

Figure 2 – Test Locations

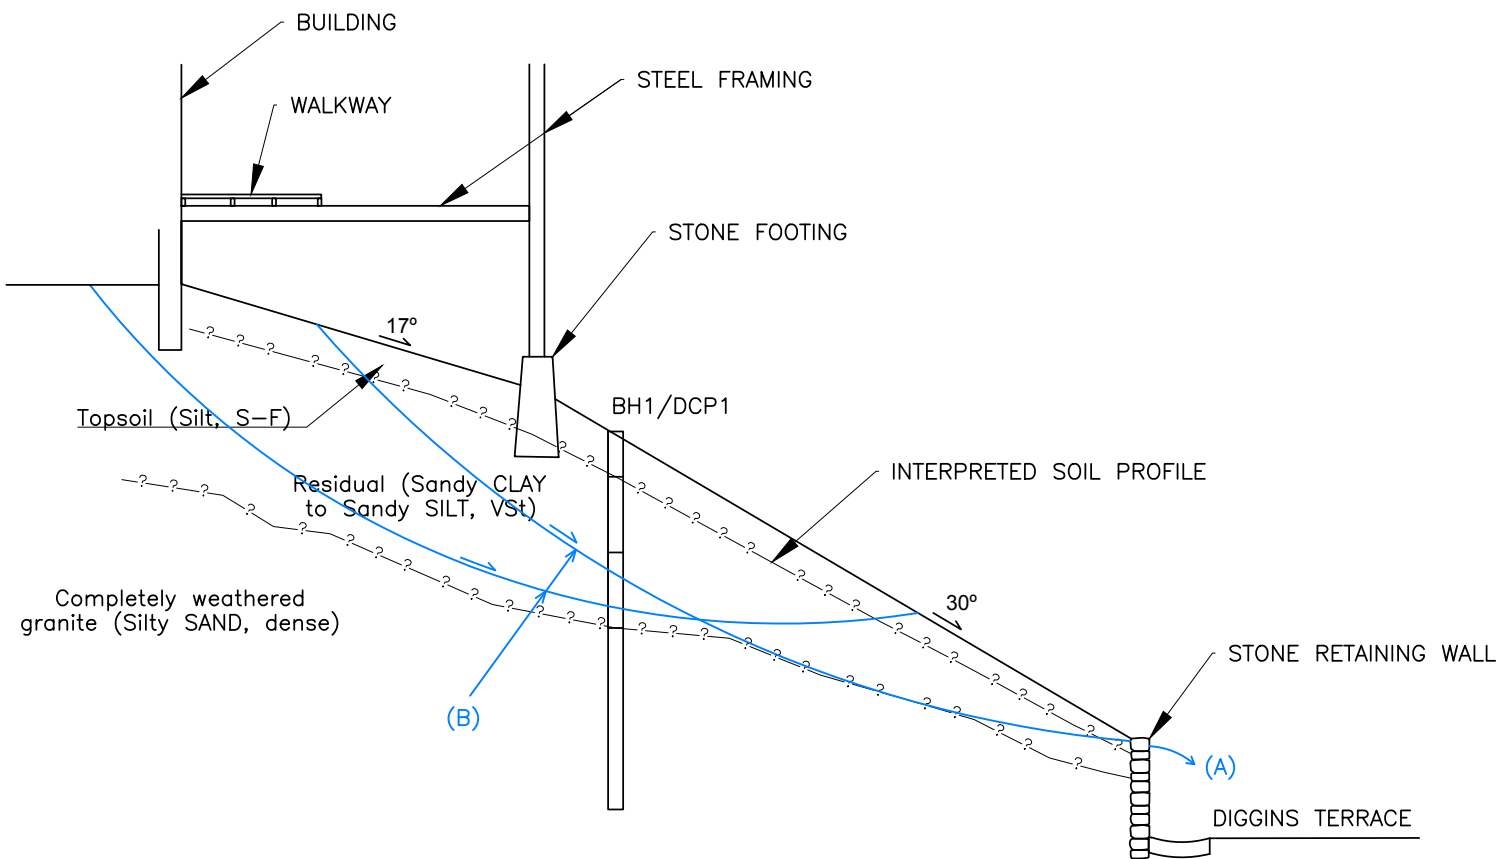
Figure 3 – Interpreted Section A - A

(B) POSSIBLE FAILURE MECHANISM

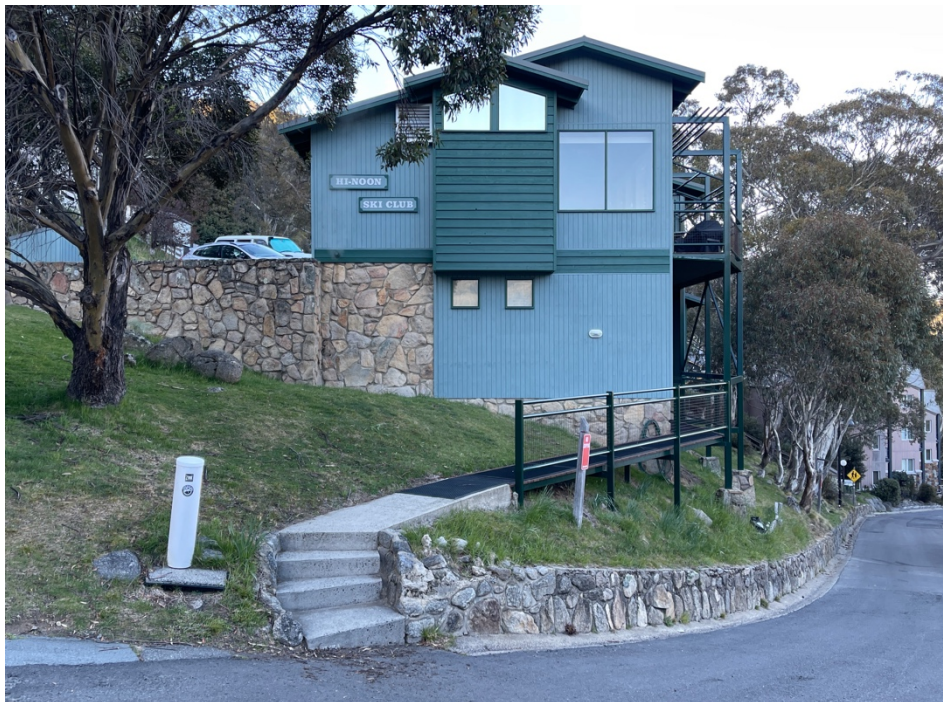
The existing lodge including the mortared stone walls and piers appears to be in overall good condition with no obvious signs of movement or cracking. The mortared stone retaining wall along the side of Diggins Terrace also appears to be in good condition with no sign of movement or cracking.

Photo 1
View of Hi-Noon Ski
Club looking
southwest

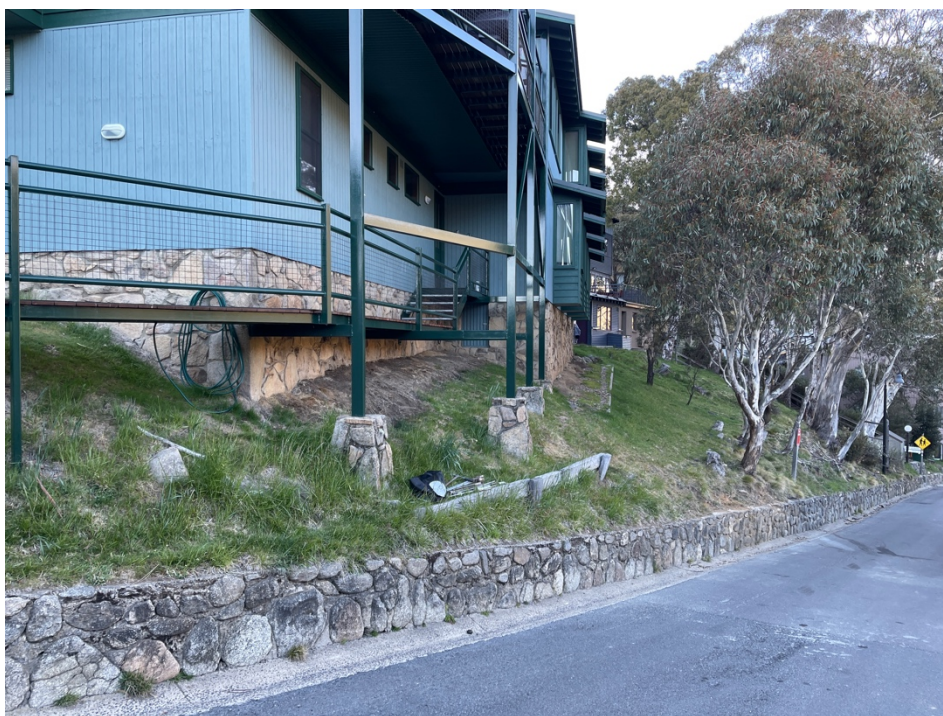
Photo 2
View of existing
ramp and walkway

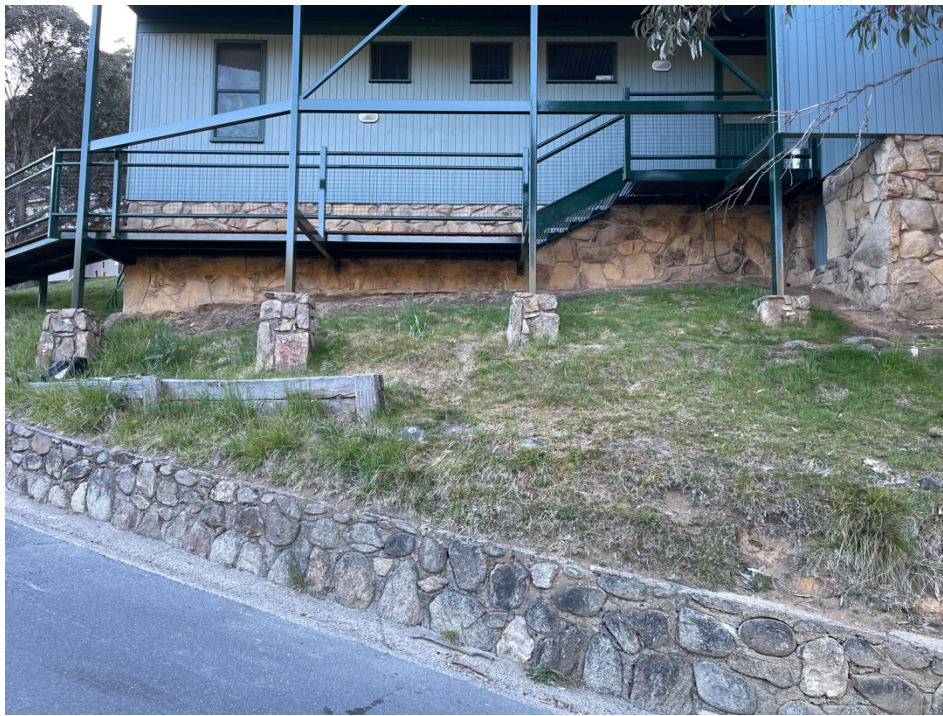
Photo 3

View of existing
ramp and walkway
at rear of ski club
and downhill slope
