ARBORICULTURAL IMPACT ASSESSMENT

98 Mackenzie Street,,
Revesby
NSW

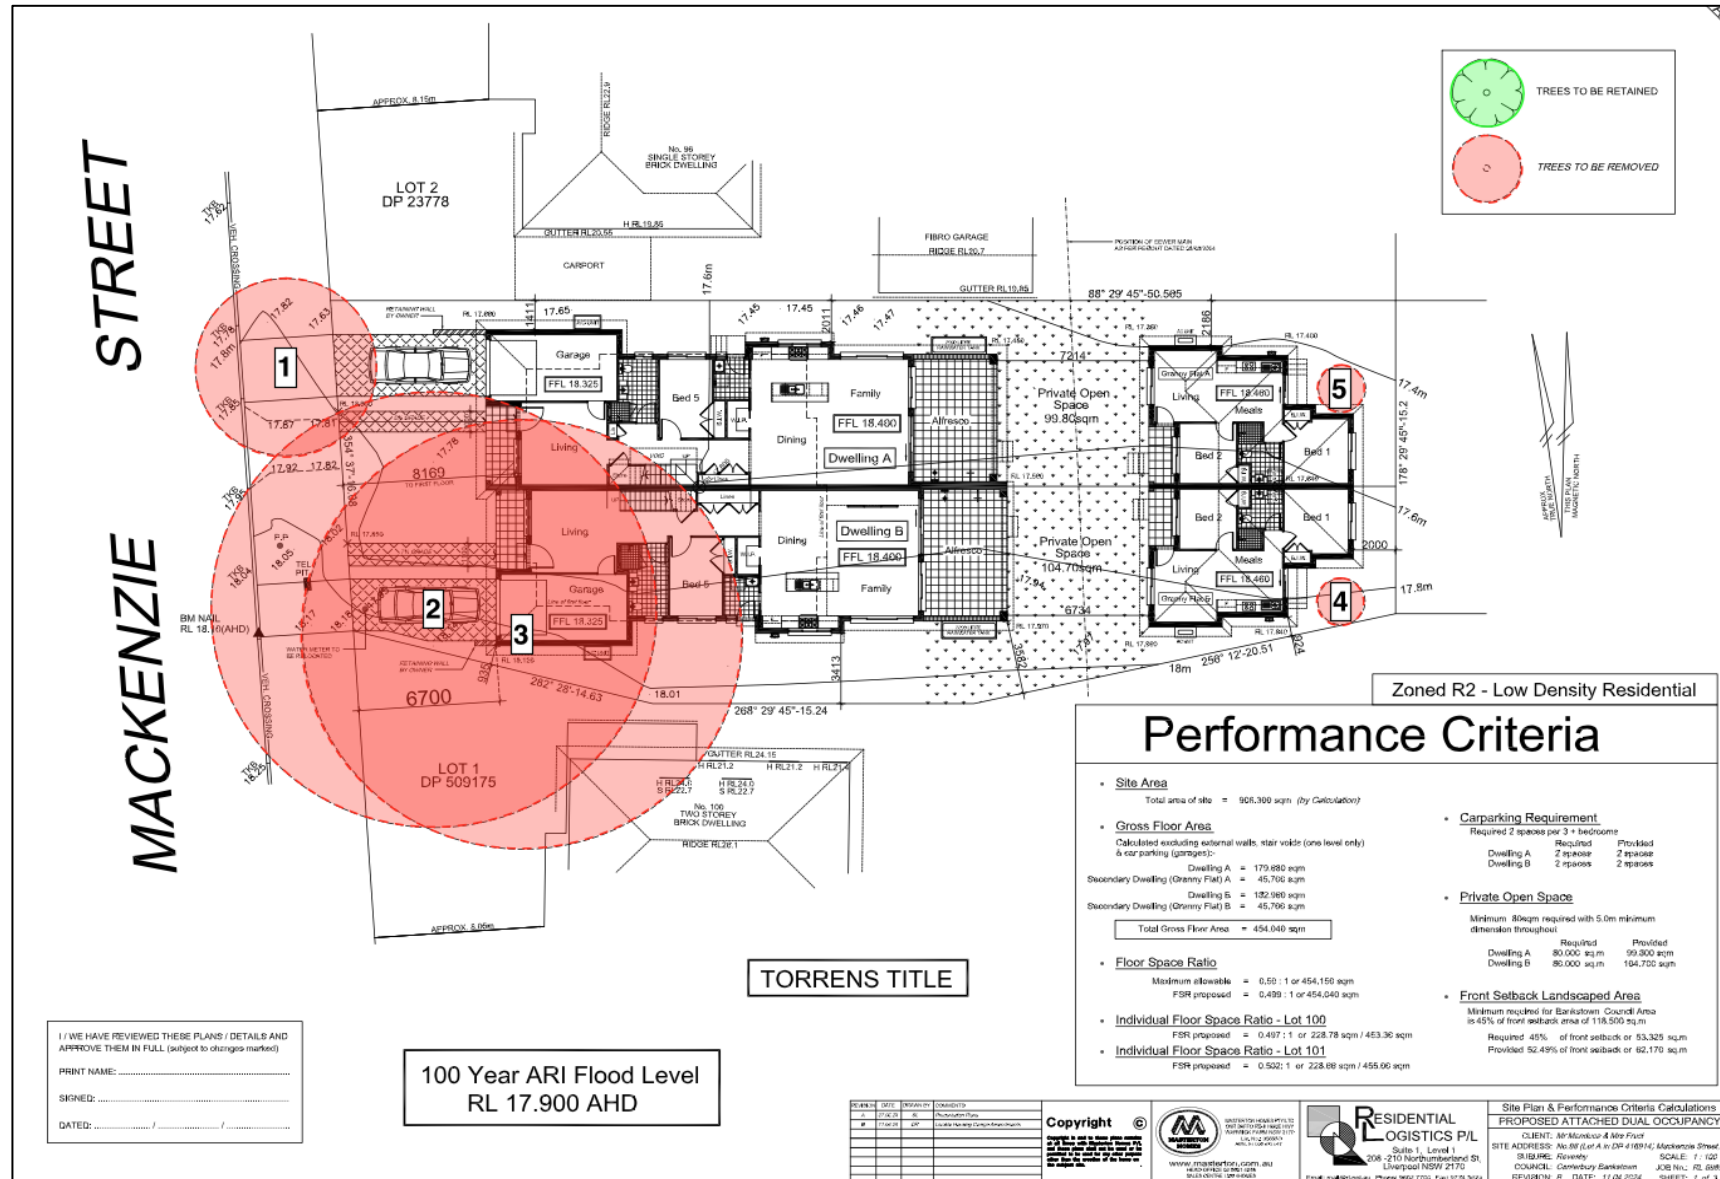
PLAN 2: Site Plan indicating proposed tree removal (Plan supplied by client May 2024).

The proposed development of this site is a 'Torrens Title Sub-division' which includes the demolition of existing structures, the removal of all site trees, and one council street tree. This is to be followed by the construction of a new two storey 'Attached Dual Occupancy' with new separate 'Driveways' and new separate 'Driveway Crossovers'.

- The proposed removal of Tree 1, Tree 2, Tree 3, Tree 4, and Tree 5 will require consent from local Council. These trees are to be assessed for removal by Council as part of the site DA process.
- It is recommended that all trees removed as part of this sites' development be adequately replenished using replacement species that are encouraged by Local Council.
- In order to maintain high arboricultural standards and high site safety standards any tree work performed on this site must comply with AS:4373-2007 Pruning of Amenity Trees.
- It is recommended that contractors undertaking tree works on this site must have appropriate qualifications and expertise in relation to removing or pruning of trees.

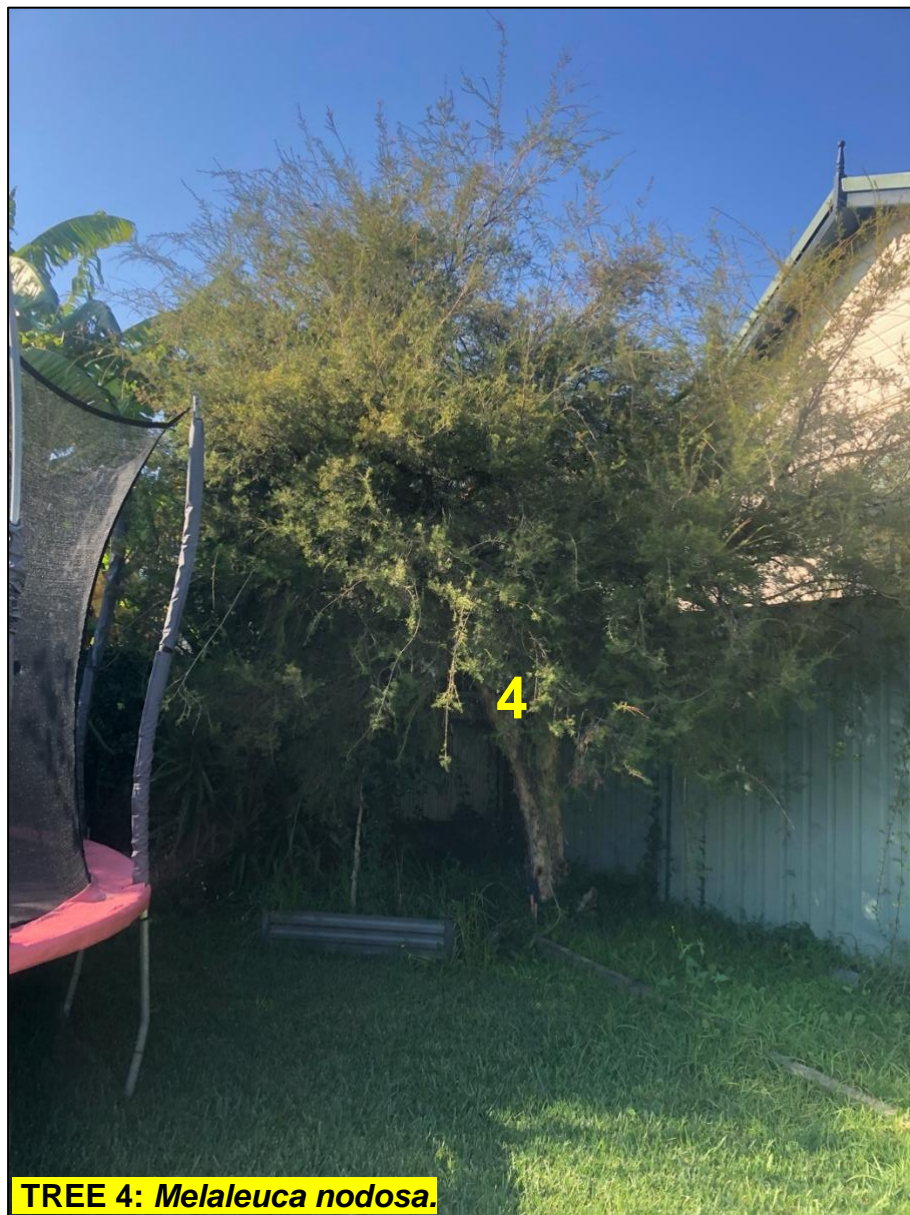
TREE 4: *Melaleuca nodosa*.

Tree 4: Prickly-leaved Paperbark (*Melaleuca nodosa*)

Tree 4 is a semi-mature site tree growing in the south-east corner of the subject sites rear yard.

Tree 4 has been awarded a 'Low' retention value.

Tree 4 has been proposed for removal to facilitate the proposed 'Granny Flat B Landscape Design'.

Tree 4 will require consent from Local Council before it can be removed. Tree 4 is to be assessed for removal by council as part of the sites DA.

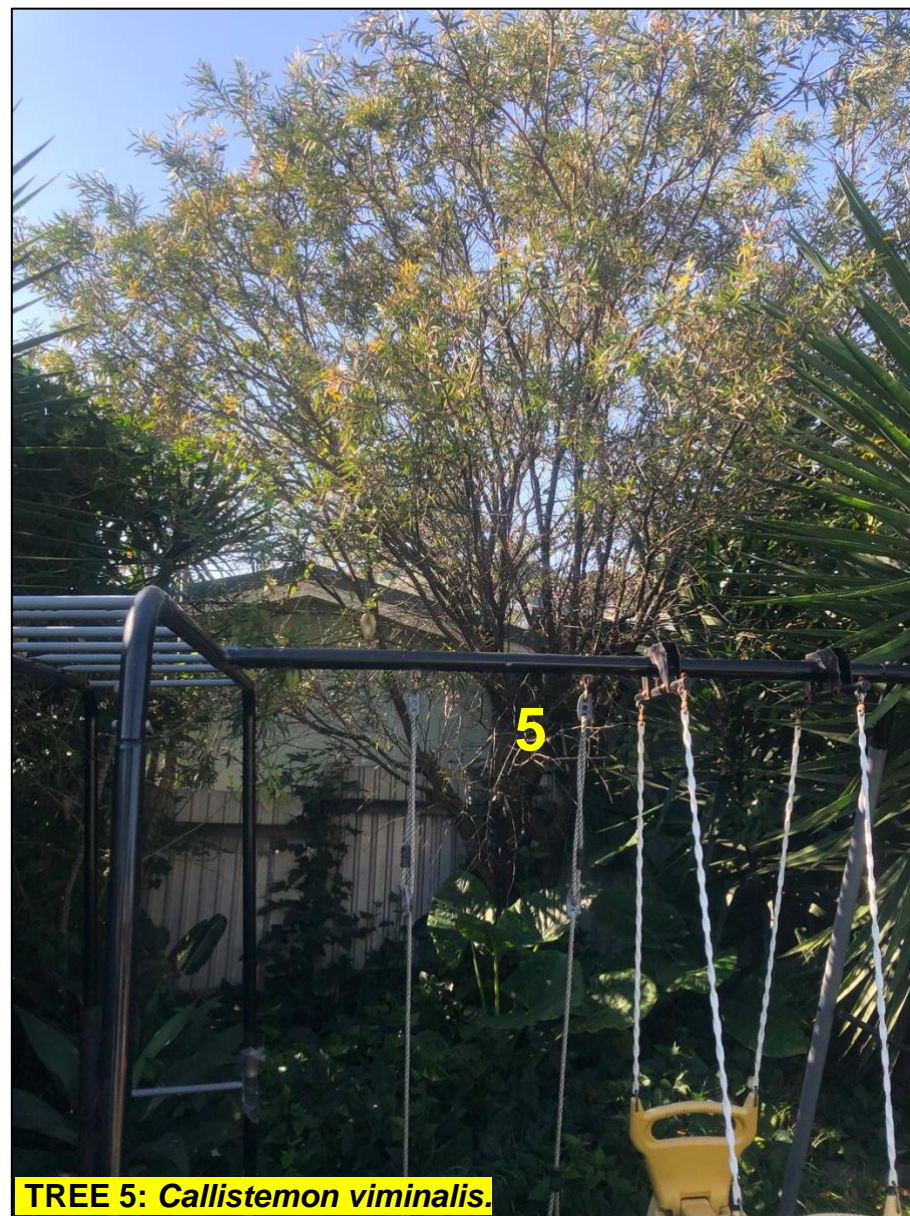
TREE 5: *Callistemon viminalis*.

Tree 5: Weeping Bottlebrush (*Callistemon viminalis*)

Tree 5 is a semi-mature site tree growing in the south-east corner of the subject sites rear yard.

Tree 5 has been awarded a 'Low' retention value.

Tree 5 has been proposed for removal to facilitate the proposed 'Granny Flat A Landscape Design'.

Tree 5 will require consent from Local Council before it can be removed. Tree 5 is to be assessed for removal by council as part of the sites DA.
