Our ref: 7665-R1 Rev1
4 December 2024

Kosciuszko Thredbo Pty Ltd
1 Friday Drive
Thredbo NSW 2625

Proposed Sewer Main Rehabilitation, Thredbo Village NSW Geotechnical Assessment

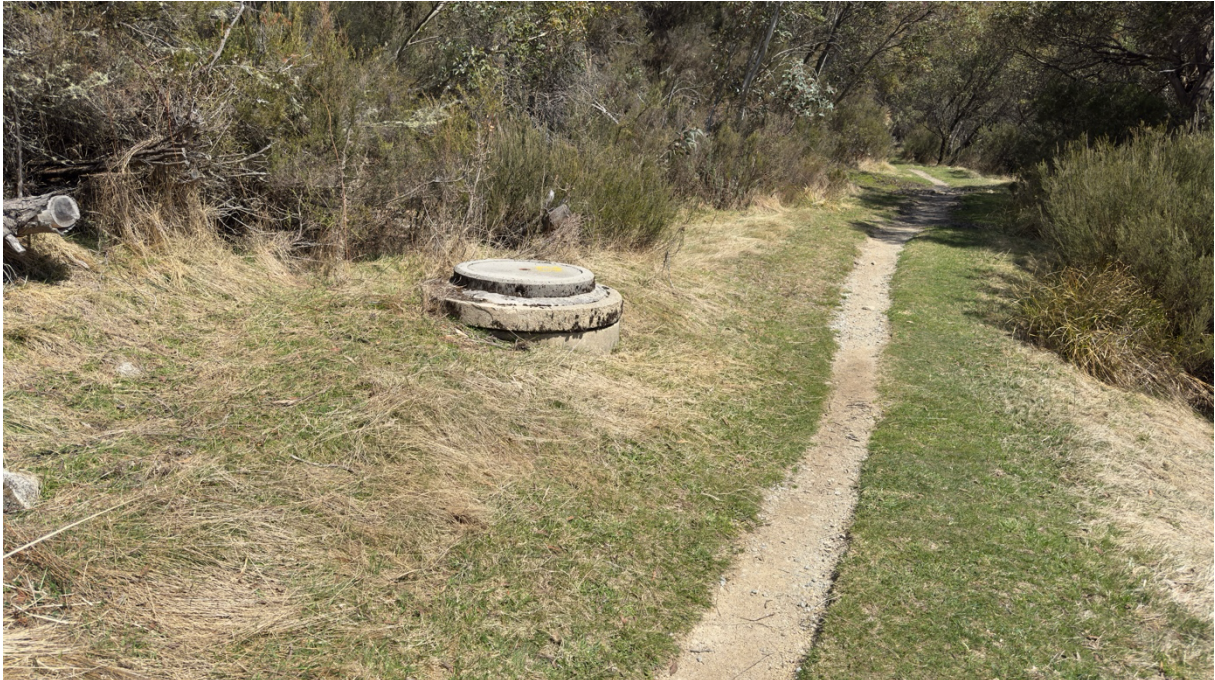
Photo 1 – view of manhole at start of sewer section to be repaired.

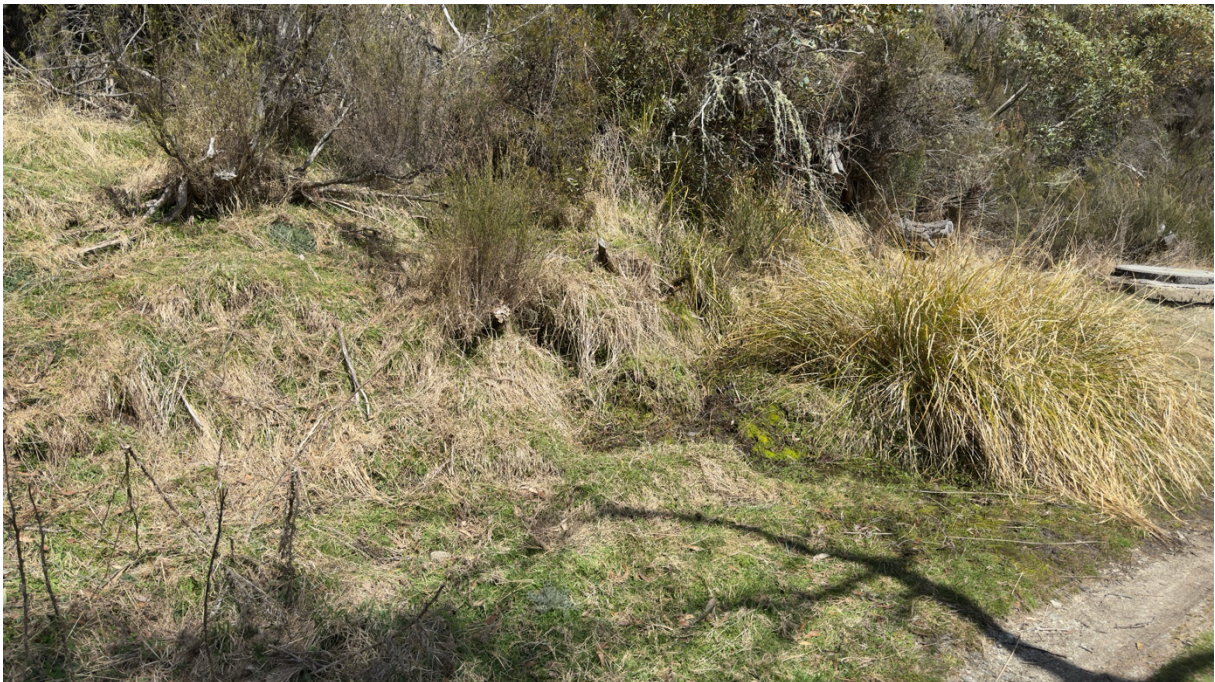
Photo 2 – view of second manhole where sewer section is to be repaired.
