# PRELIMINARY SITE INVESTIGATION

## PROPOSED DEVELOPMENT

1 HYNES STREET,  
BROKEN HILL, NSW

**January 30<sup>th</sup> - 2023**

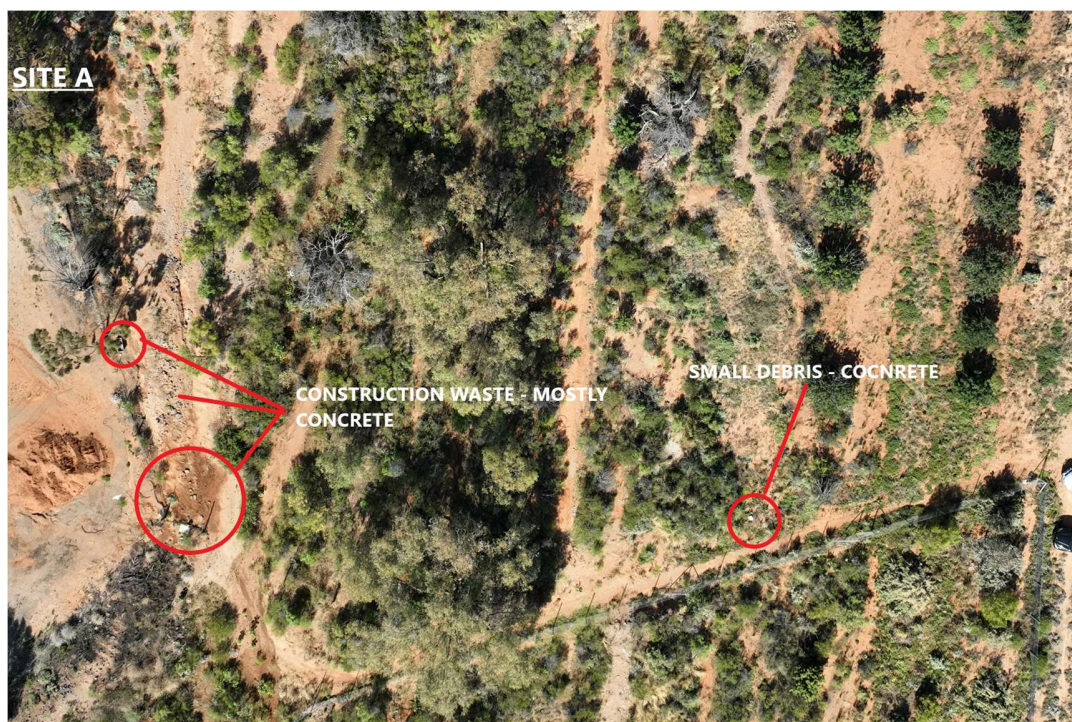
**Photo 1: Contaminants found Site A:**

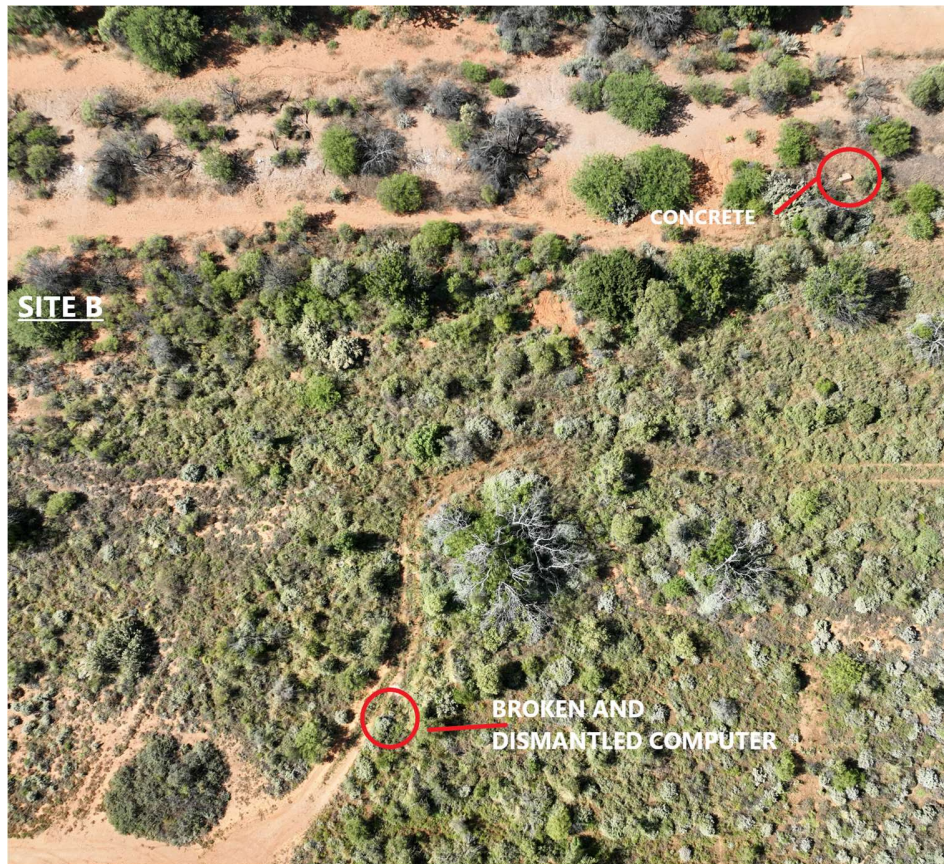
**Photo 2: Contaminants found Site B:**

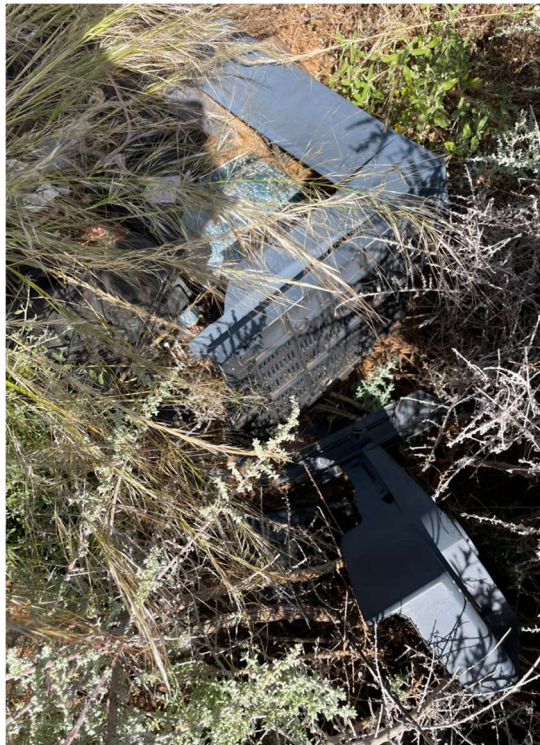
Computer

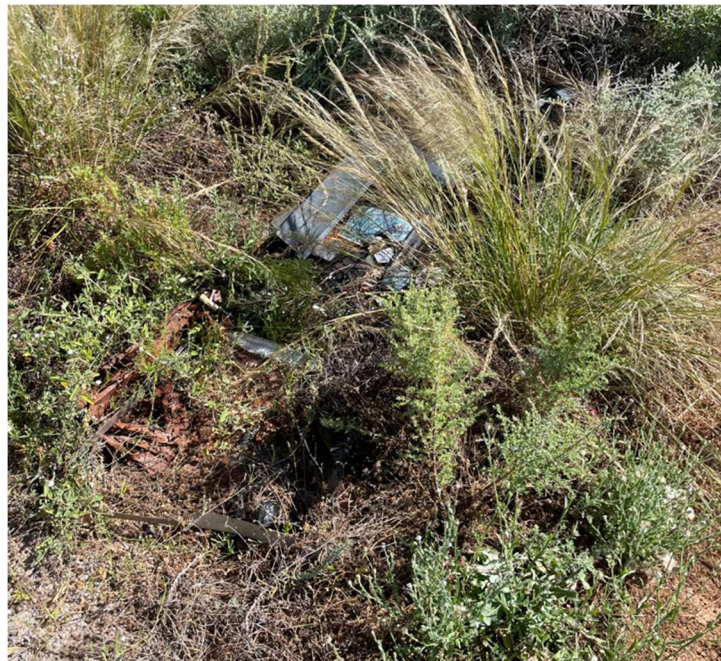
Sheet Metal and Broken Glass

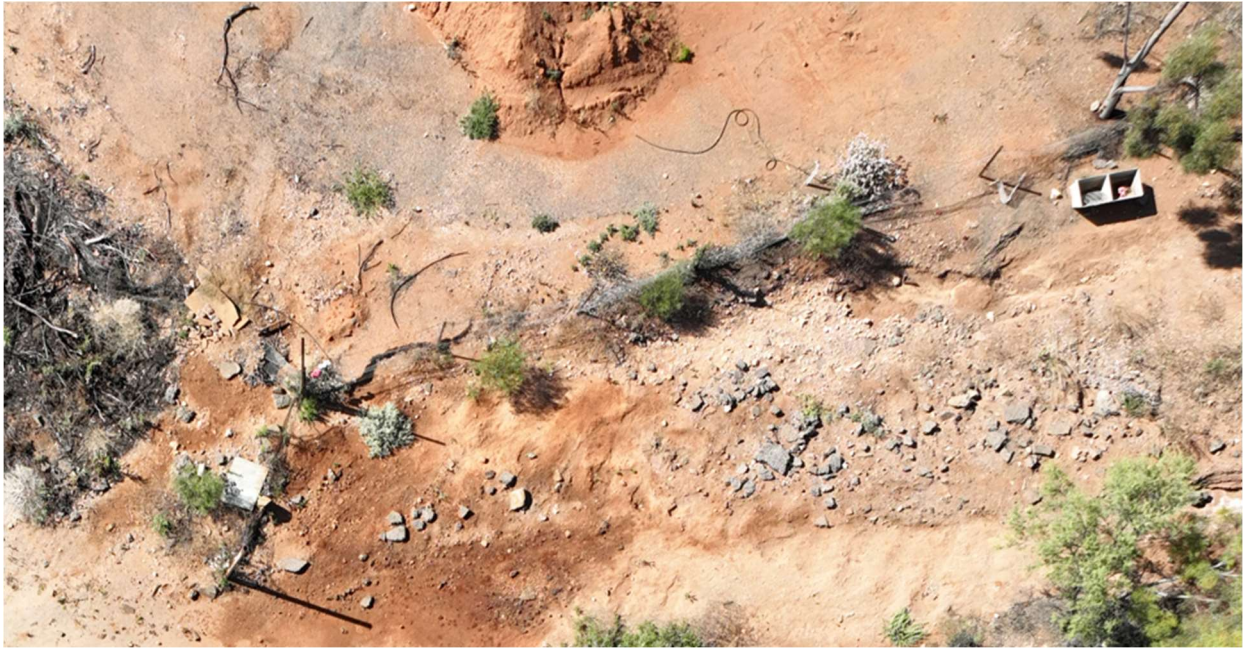
Some Construction waste, mostly Concrete  
(may fall outside of property)
