RGS03137.1-AE

**RE: Proposed Manufactured Home Estate – 40-80 Chapmans Road, Tuncurry
Addendum to Detailed Site Investigation – Contamination Assessment**

Asbestos Clearance Report

Report No. A1148_CLR Report_151123

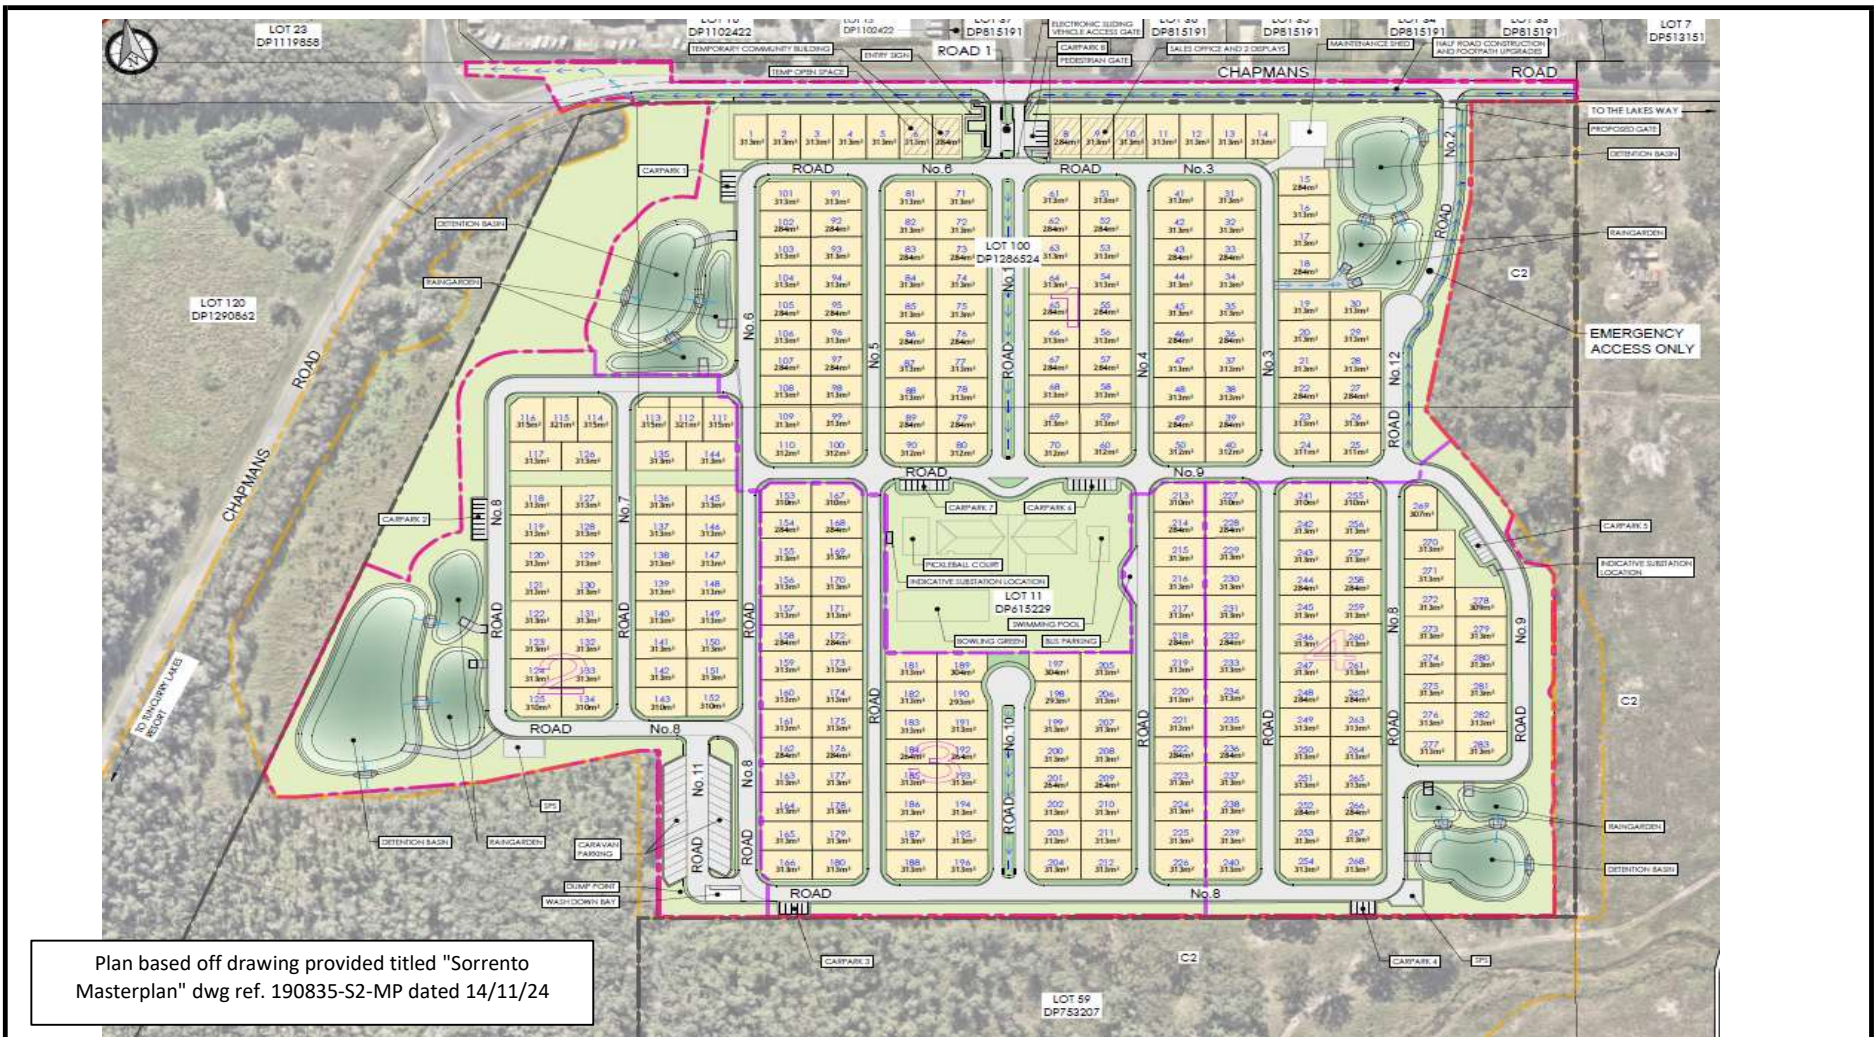
Client:	Allam Property Group	Job No.	RGS03137.1
	Project:	Proposed Manufactured Home Estate 40-80 Chapmans Road, Tuncurry	Drawn By:	APH
	Title:	Site Layout Plan	Scale:	As Shown
			Date:	20-Nov-24
			Drawing No.	Figure 1

Regional Geotechnical Solutions (RGS) has prepared this addendum to the Detailed Site Investigation contamination assessment (DSI) report (Ref.RGS03137.1-AC, dated 14 November 2022) in response to asbestos removal and asbestos clearance work that has been undertaken since the preparation of the DSI report. A summary of the works undertaken is provided below and the asbestos clearance report is attached. In addition, the proposed layout plan has been updated since the preparation of the DSI report. As such, Figure 2 contained in the DSI report has been superseded. The updated layout plan is attached as Figure 1.

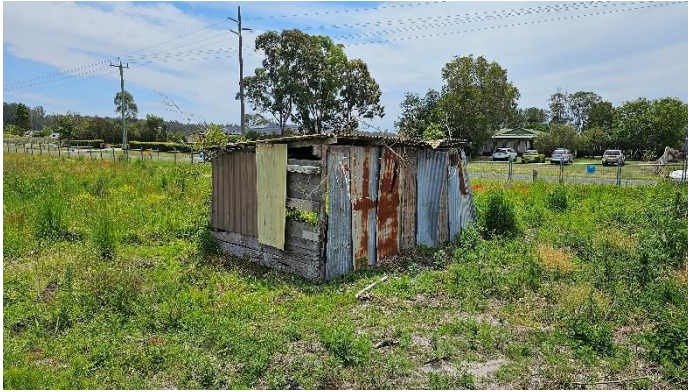
Photo 1

Removal of asbestos cement sheet debris to the ground surface in the vicinity of the dilapidated structures to the central northern portion of the site.

As inspected on the 15th November 2023 at the completion of works.
