Asbestos Clearance Report

40 Chapmans Road, Tuncurry NSW

Report No. A1148_CLR Report_151123

Date: 15 November 2023

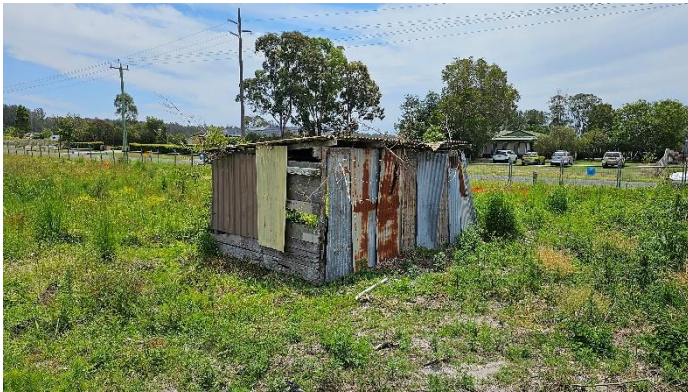
Photo 1

Removal of asbestos cement sheet debris to the ground surface in the vicinity of the dilapidated structures to the central northern portion of the site.

As inspected on the 15th November 2023 at the completion of works.

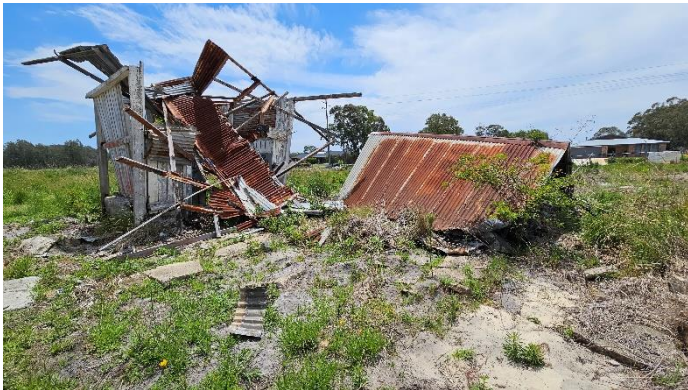
Photo 2

Removal of asbestos cement sheet debris to the ground surface in the vicinity of the dilapidated structures to the central northern portion of the site.

As inspected on the 15th November 2023 at the completion of works.

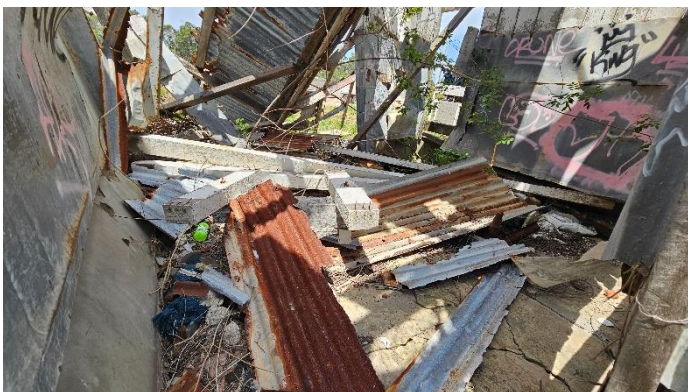
Photo 3

Asbestos containing materials may be obscured beneath the structures concrete slab floors.

As inspected on the 15th November 2023.

It is recommended that a final visual clearance inspection is conducted of the site upon completion of demolition and removal of the dilapidated structures, as asbestos containing materials may be obscured beneath the structures concrete slab floors and surrounding vegetation.
