Re: Visual inspection for bank stability of a large dam. Lot 6 DP841293 Reno Rd, Reno NSW 2722

REPORT 7065

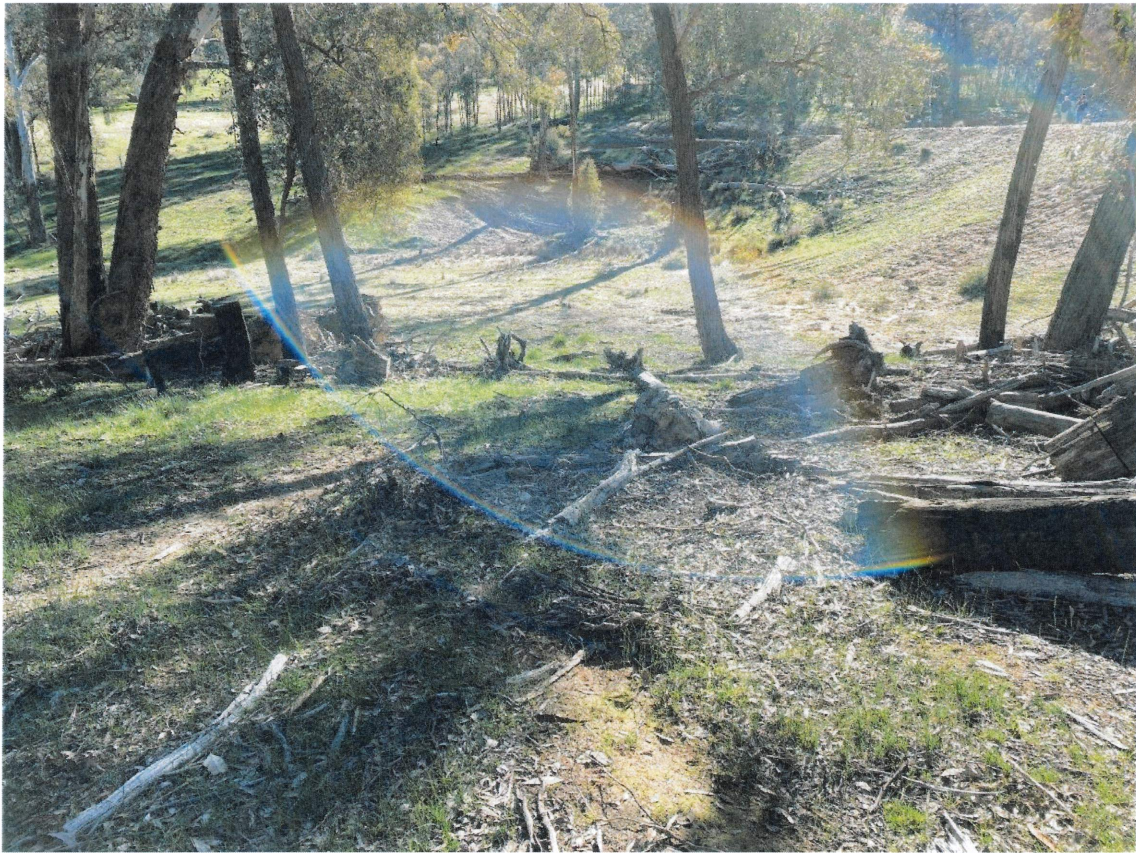
Evidence of overtopping was not observed, however there was minor erosional evidence within spillways that suggest bank full conditions have been observed between 2010 and the time of inspection.

Photograph 4: Minor erosion evident from overland flow of southern spillway. Facing North.

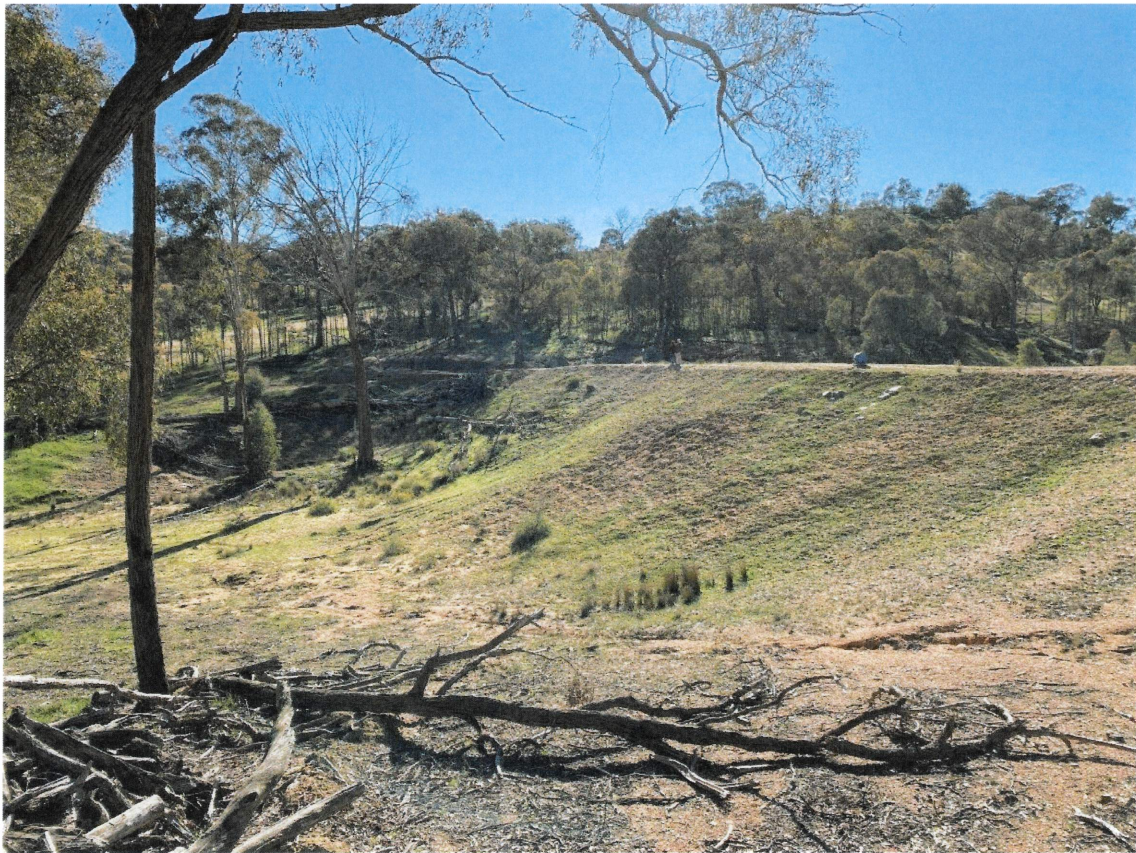
Photograph 5: Dam embankment. Facing North. Minor erosion evident in foreground due to overland flow from southern spillway.

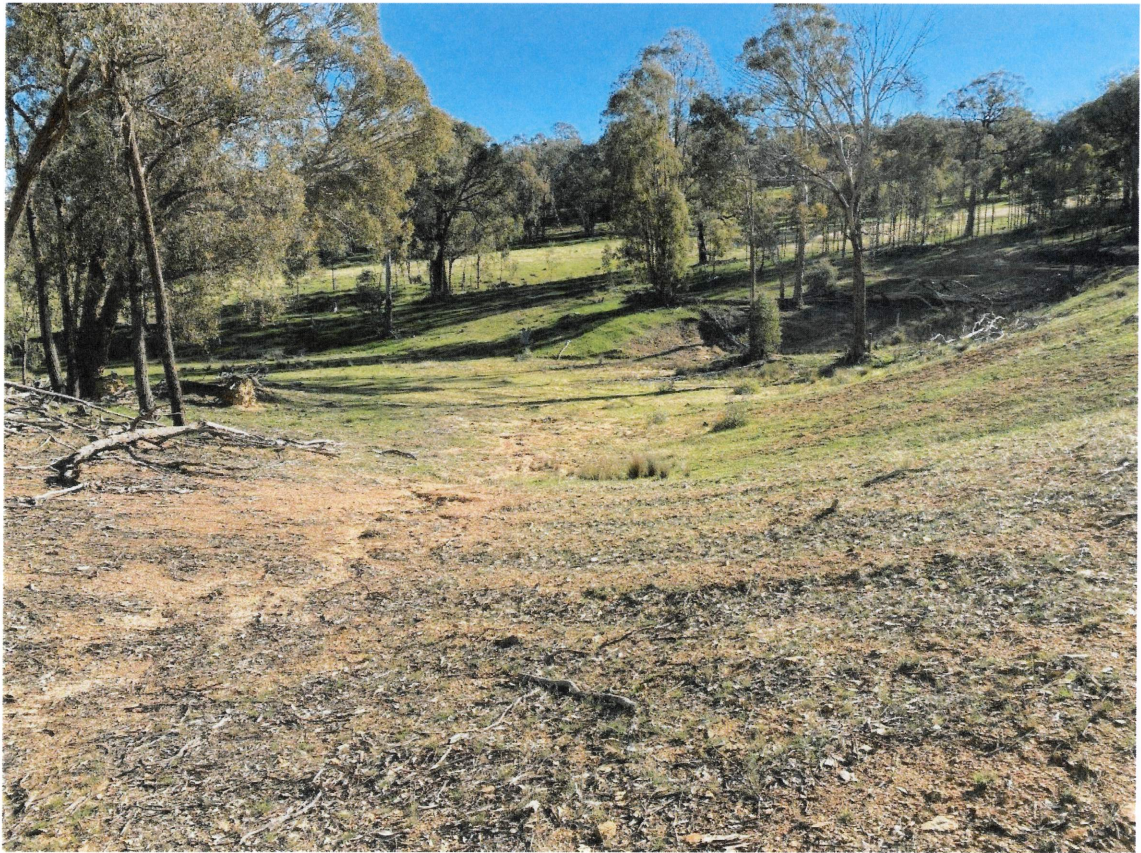
Photograph 6: Minor erosion due to overland flow from southern spillway. Facing West.

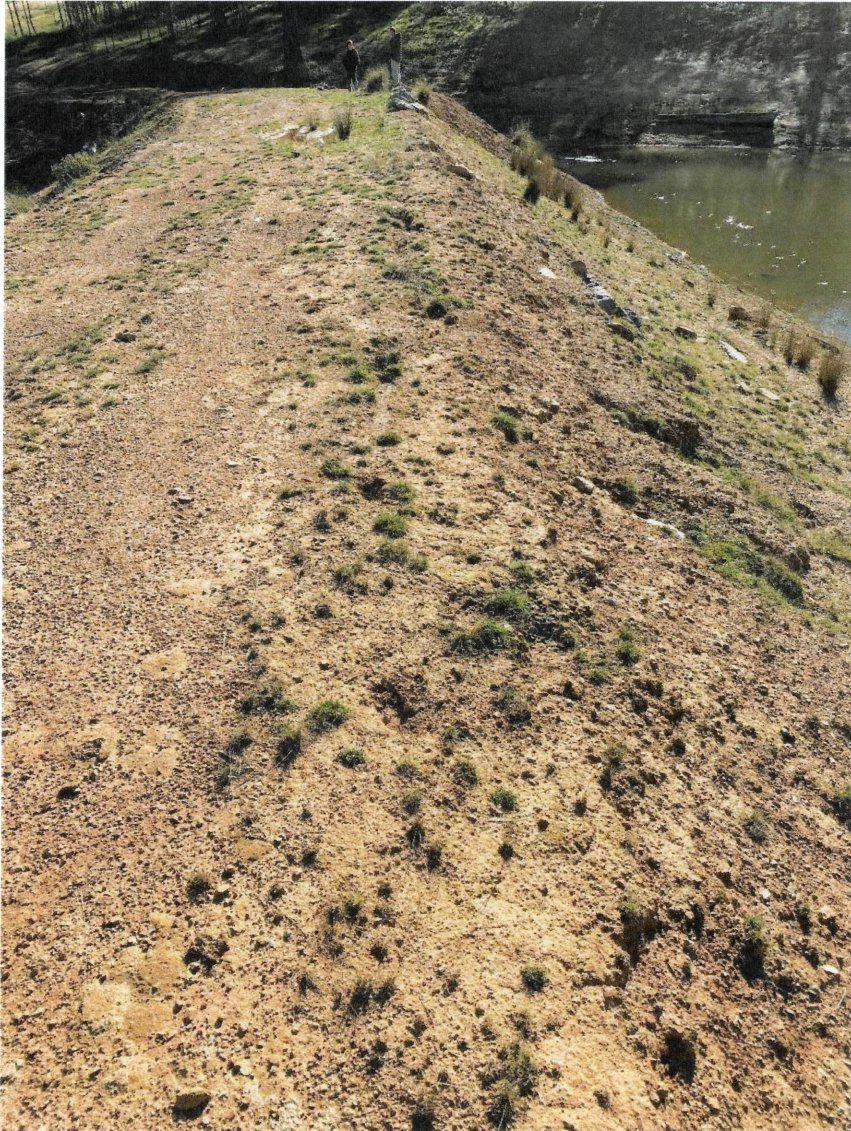
Tension cracking was observed at the top of the embankment. Tension cracks were evident in one section of the dam embankment and extended approximately 3m in length, with a surface crack distance of up to 20mm. The most likely mechanism for tension cracking as observed is drawdown of the dam water level from bank full storage.

Photograph 8: Evidence of tension cracking along eastern side of top of dam embankment. Facing North.

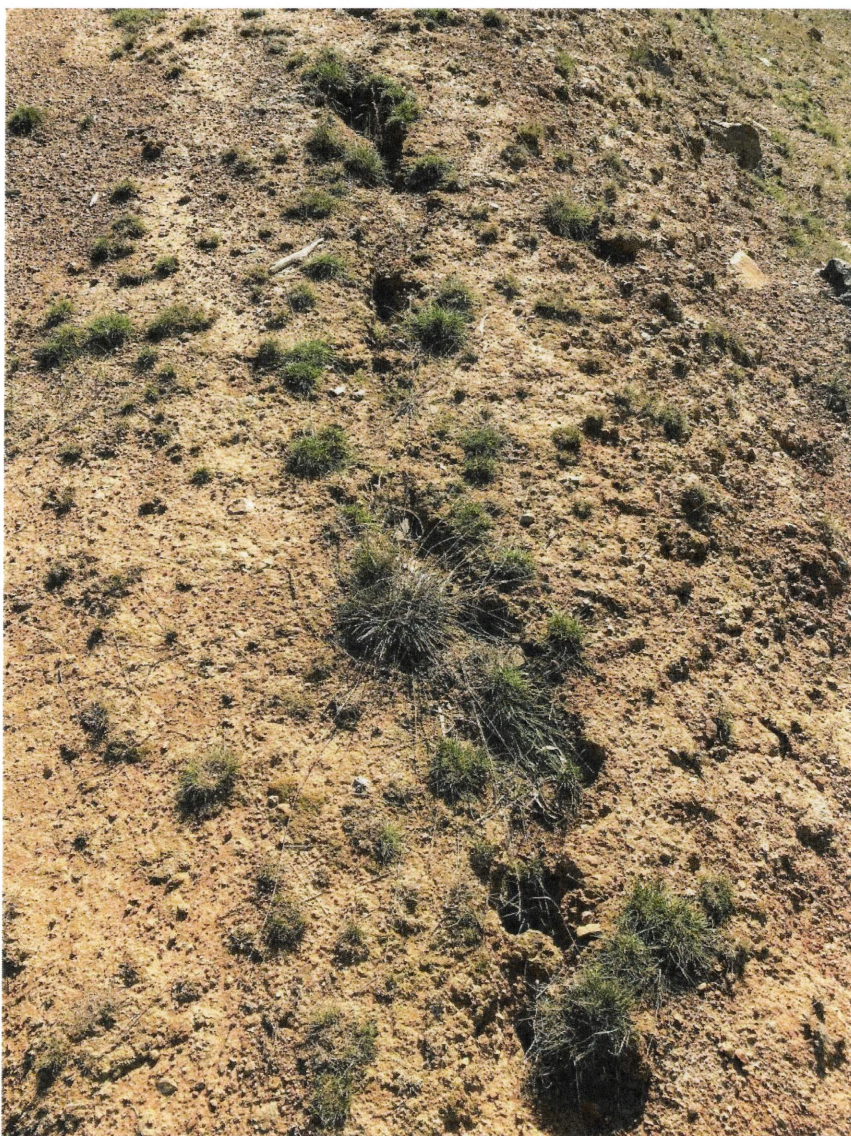
Photograph 9: Close up of tension cracking evident in Photograph 10.

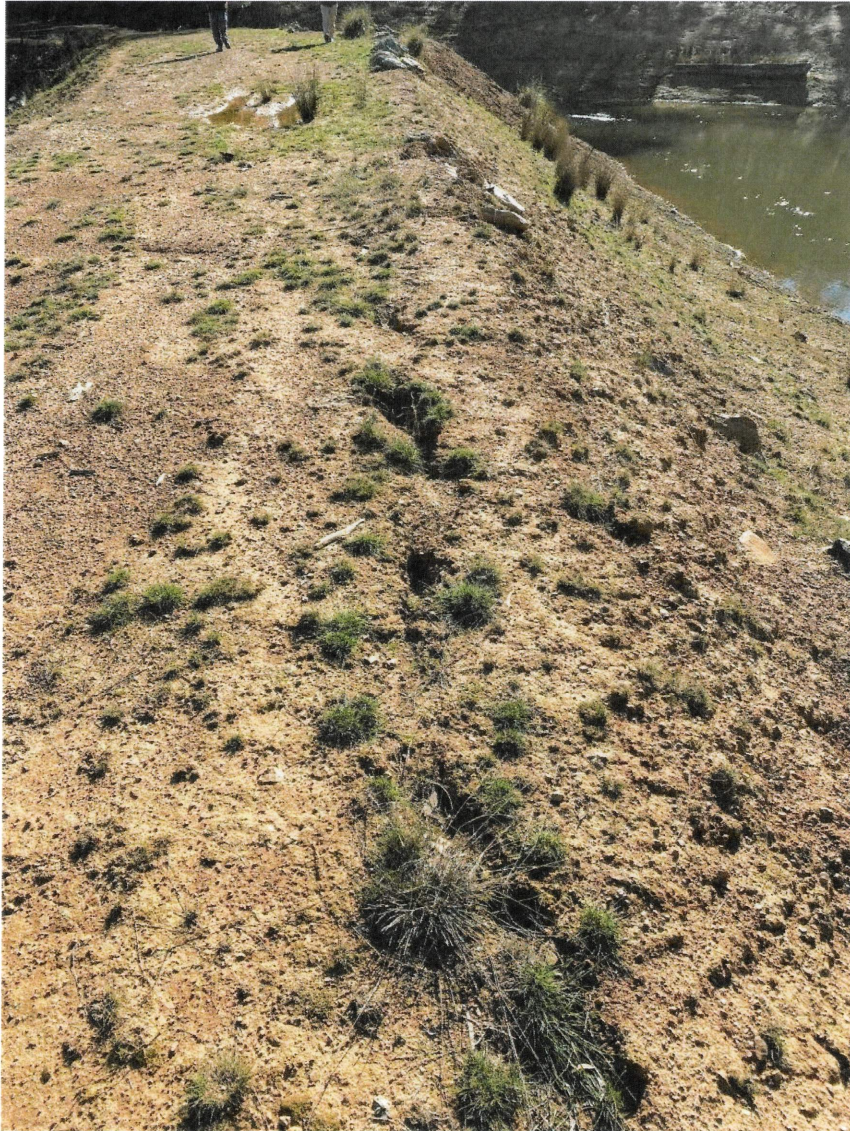
Photograph 10: Tension cracking of eastern side of top of embankment. Facing North.

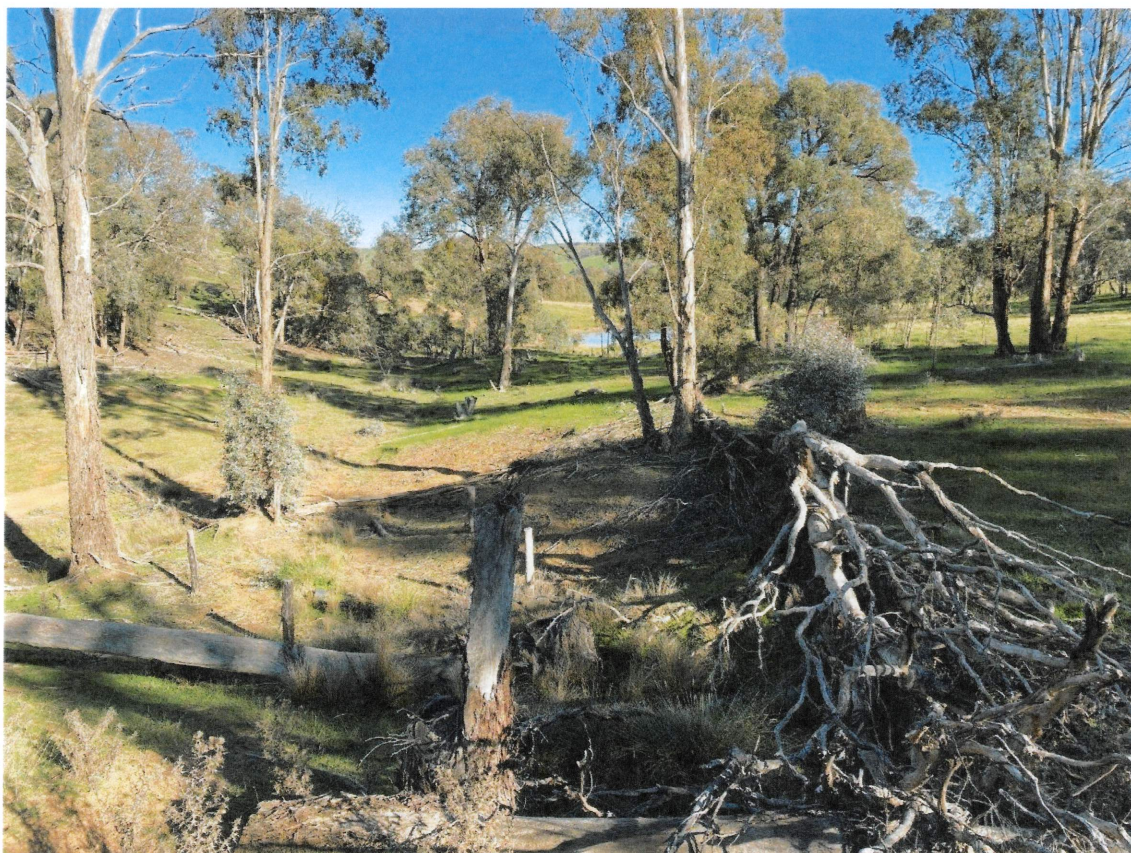
Throughflow or seepage was evident at the northern toe of the dam embankment from the presence of sedge and tussock grasses generally indicating soils that are predominantly wet throughout the majority of the year. Sedge grasses and wet soils were particularly evident in the initial drainage channel prior to the reconstructed northern spillway sometime between 2011 and 2013.

Photograph 13: Downslope of dam embankment. Facing west. Sedge grass evident in foreground, likely through seepage underneath dam embankment.

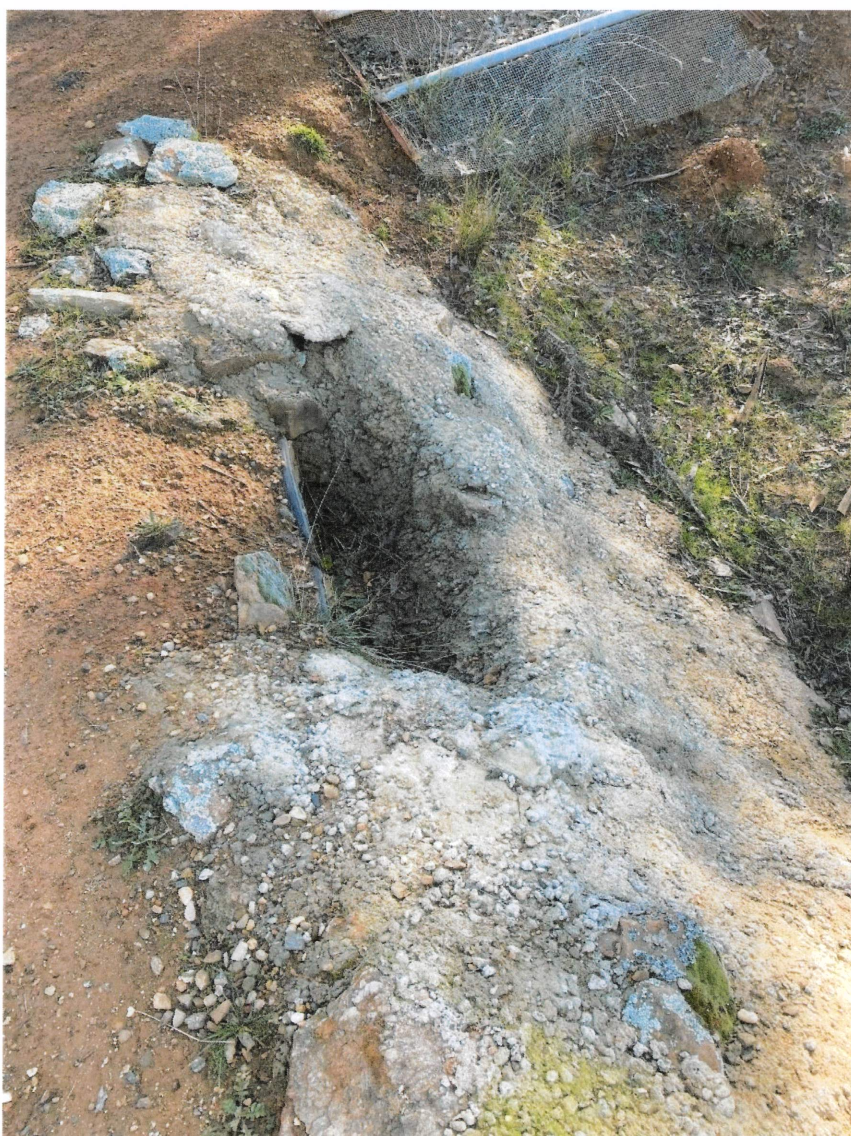
Photograph 19: Spillway with concrete surrounding outflow pipe. Concrete height approximately level with midsection of outflow pipe.

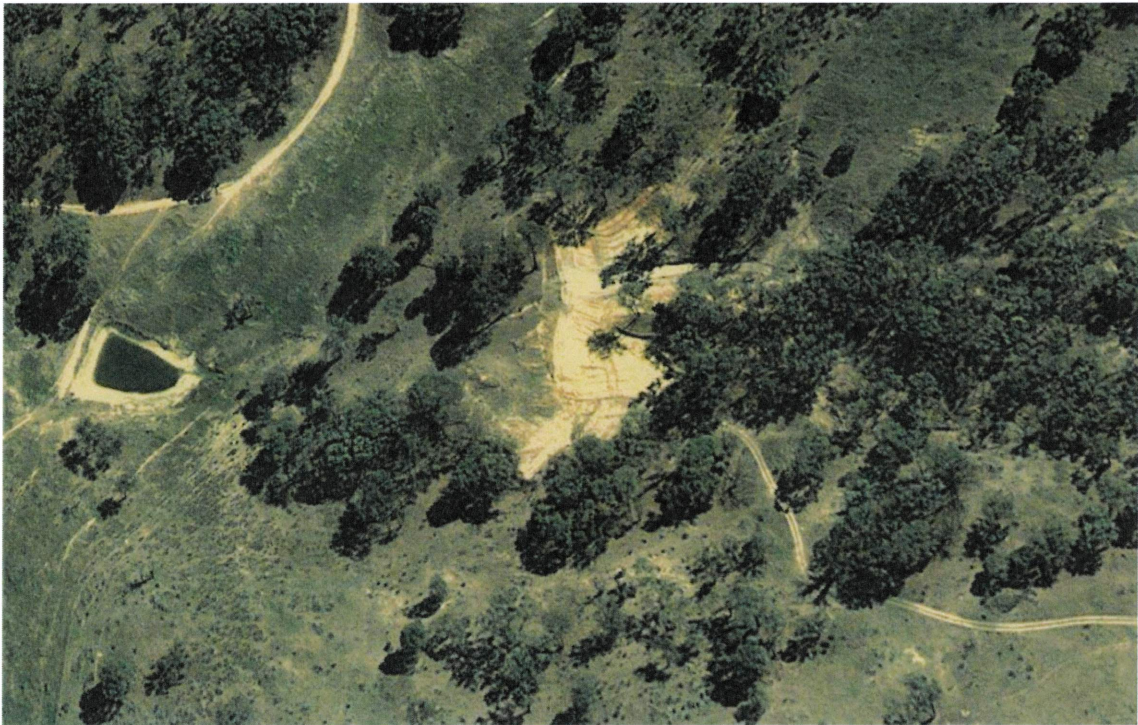
2010 (March) – Evidence of dam during construction.

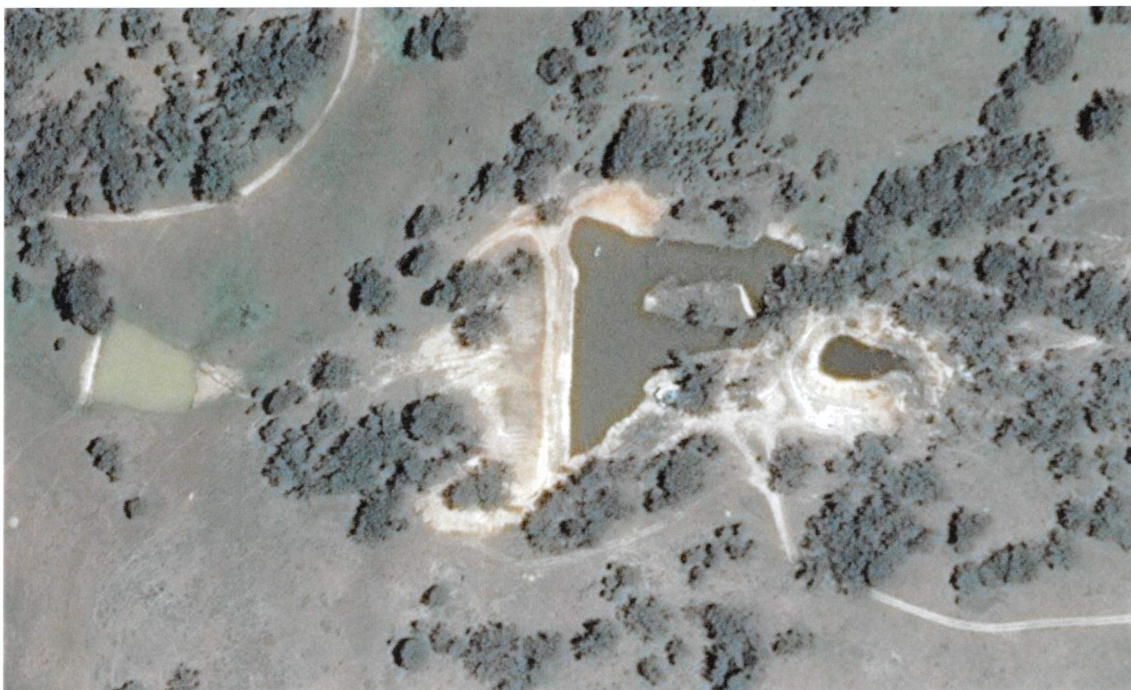
2013 (November) – Dam at near bank full condition.
