# Preliminary Arboricultural Assessment

Riverlands Development  
56 Prescott Parade, Milperra  
Community Facility  
DA-4/2020  
LEC No: 2020/267229  
20/08/2024

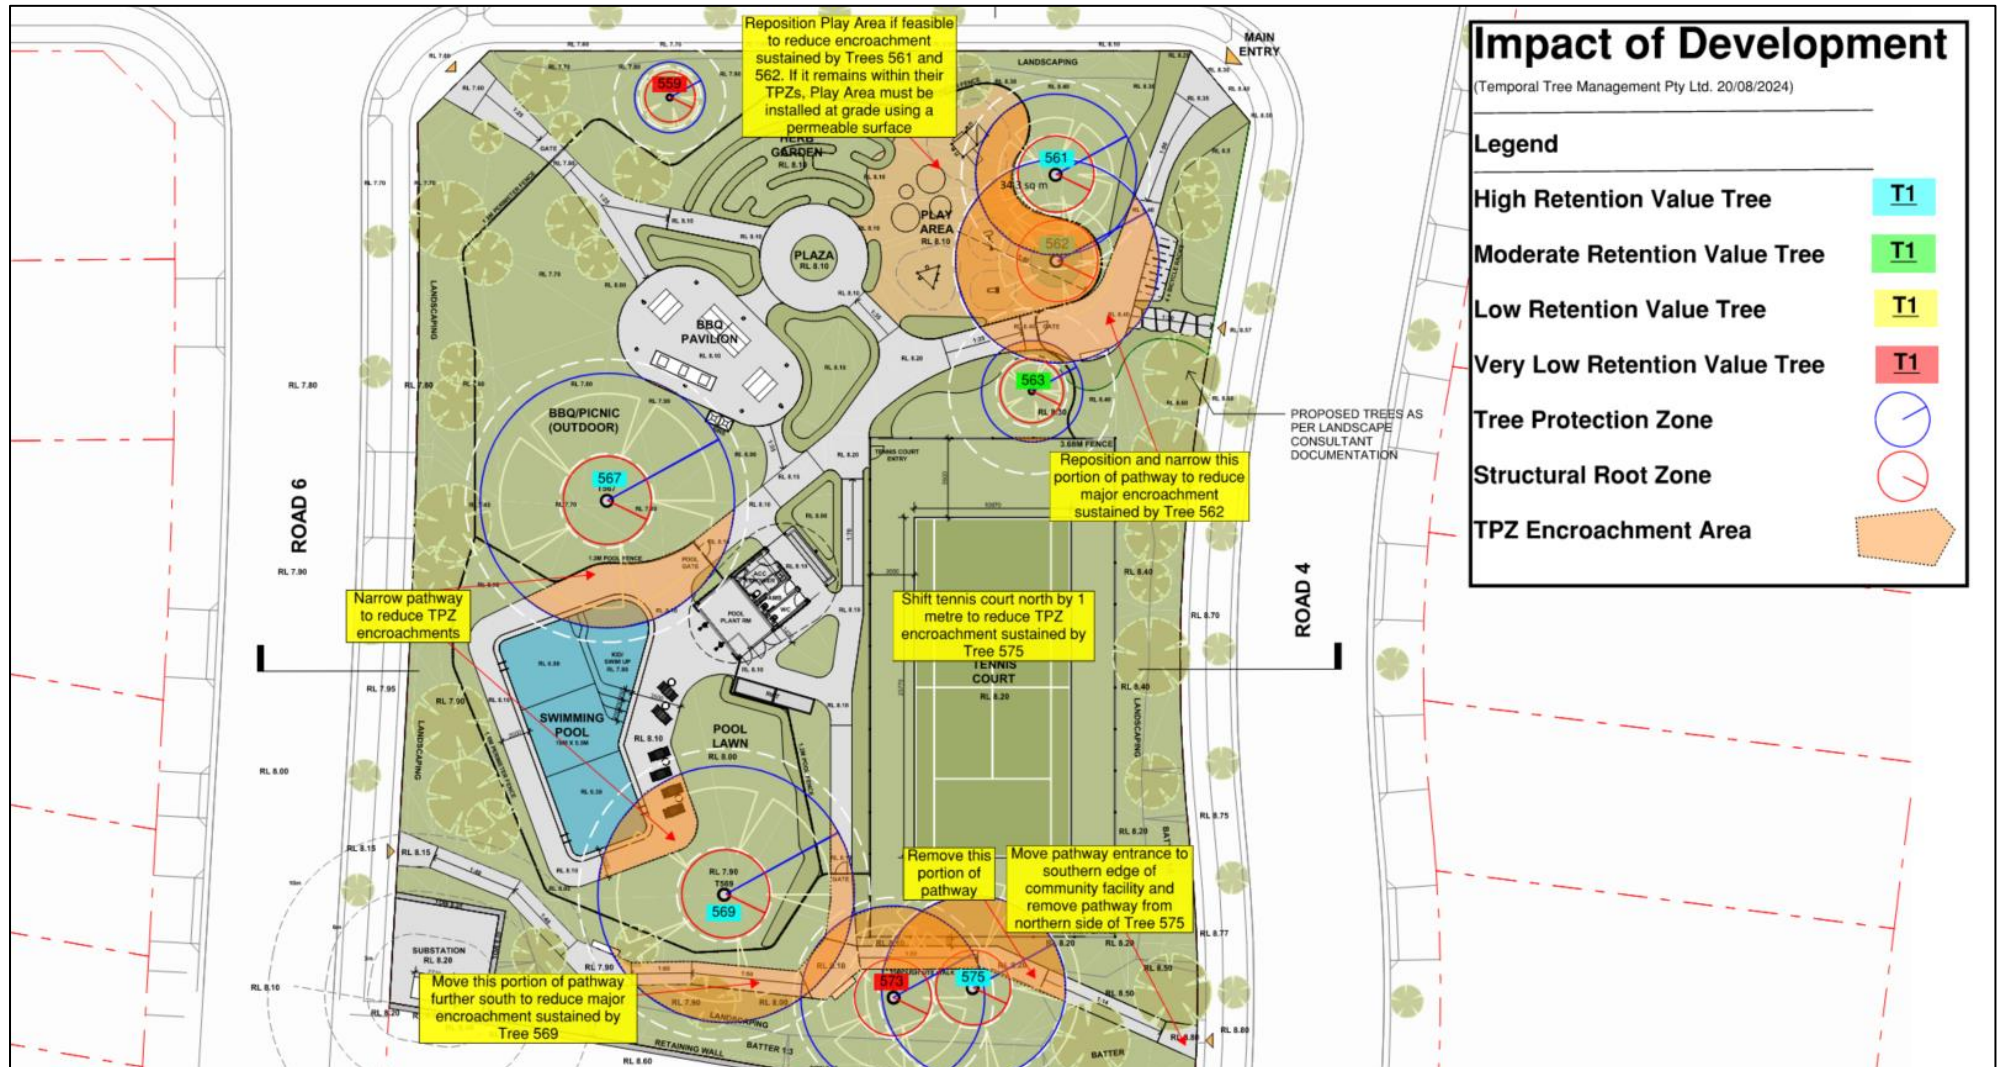
Figure 6. Retention values, TPZs, SRZs and Encroachments for eight assessed trees. Riverlands Community Facility - Site Plan & Sediment Control Plan, prepared by Mirvac Design (Job No: MB-10243, Rev: B, drawn: 19/06/2024). Annotated by Temporal Tree Management Pty Ltd. (13/08/2024)

| Tree | SRZ Encroachment | Encroachment (%) | Impact | Mitigation | Proposed Management |
|---|---|---|---|---|---|
| 561 | Yes | 34 | Severe | Tree will sustain major encroachment within western portion of TPZ during installation of Play Area. Level of encroachment is likely to impact viability within landscape. | <b>Retain.</b> Reposition Play Area to reduce TPZ encroachment. Ensure Play Area surface is permeable and is installed at grade or requires minimal excavation (max depth 50mm) for installation. Install tree protection measures compliant with Section 4 of AS4970 (2009). |
| 562 | Yes | 79 | Severe | Tree will sustain major encroachment within western portion of TPZ during installation of Play Area and within southern portion of TPZ during installation of pathway. Level of encroachment is likely to impact viability within landscape. | <b>Retain.</b> Reposition Play Area and narrow pathway to reduce TPZ encroachment. Ensure Play Area surface is permeable. Ensure play area and pathway are installed at grade or require minimal excavation (max depth 50mm) for installation. Install tree protection measures compliant with Section 4 of AS4970 (2009). |
| 563 | No | 8 | Low | Tree with smaller DBH and TPZ than initially assessed. Will sustain a minor encroachment within the southern portion of its TPZ. Tree will suitably tolerate this minor encroachment without any design mitigation. Trees smaller size, good health and Moderate retention value render it suitable for a greater encroachment if required. | <b>Retain.</b> Install tree protection measures compliant with Section 4 of AS4970 (2009). Tennis court should be moved closer to this tree to reduce the encroachment sustained by Tree 575. |

| Tree | SRZ Encroachment | Encroachment (%) | Impact | Mitigation | Proposed Management |
|---|---|---|---|---|---|
| 567 | No | 20 | High | Tree with smaller DBH and TPZ than initially assessed. Will sustain a major encroachment within the southern portion of its TPZ during installation of pool and surrounding pathway. | <b>Retain.</b> Narrow pathway on northern side of pool to reduce TPZ encroachment. If feasible, ensure installation of pathway surrounding pool requires minimal excavation (max depth 150mm) for installation. Install tree protection measures compliant with Section 4 of AS4970 (2009). |
| 569 | No | 34 | Severe | Tree with smaller DBH and TPZ than initially assessed. Will sustain a major encroachment within the TPZ during installation of pool and pathways. | <b>Retain.</b> Narrow pathway on south-eastern side of pool to reduce TPZ encroachment. If feasible, ensure installation of pathway surrounding pool requires minimal excavation (max depth 150mm) for installation. Reposition footpath on southern and eastern sides of stem to minimise encroachment. Ensure pathways are installed at grade or require minimal excavation (max depth 50mm) for installation. Install tree protection measures compliant with Section 4 of AS4970 (2009). |
| 573 | Yes | 36 | Severe | Tree will sustain major encroachment within the northern portion of its TPZ during installation of proposed pathway. | <b>Remove.</b> Larger dead tree must be removed and replaced. |
| 575 | Yes | 41 | Severe | Tree will sustain major encroachment within the northern portion of its TPZ during excavation for the proposed tennis court and pathway. | <b>Retain.</b> Reposition pathway entrance to southern edge of communal facility to reduce TPZ encroachment. Entrance and pathway may be positioned to pass through Tree 573, which will be removed. Tennis court should be moved in the northern direction to minimise the encroachment sustained by Tree 575. Install tree protection measures compliant with Section 4 of AS4970 (2009). |

- Trees 561, 562, 567, 569 and 575 will sustain major encroachments of 20% or more that are likely to negatively impact their viability within the landscape. Amendments to the proposed design are required to mitigate the impact of these major TPZ encroachments.

- The Play Area should be repositioned to reduce the encroachment within the TPZs of Trees 561 and 562. If it remains within the TPZs of these two trees, the Play area surface must be permeable and installed at grade or with minimal excavation (max depth 50mm).

- The widest portions of the pathways on the northern and south-eastern sides of the proposed pool should be narrowed to reduce to encroachment within the TPZs of Trees 567 and 569.

- The shared pathways within the TPZs of Trees 562, 569, 575 should be repositioned if feasible to reduce the TPZ encroachments.
- The pathway entrance within the south-eastern corner of the Community Facility should be moved to the southern edge to reduce the major TPZ encroachment sustained by Tree 575.

- Pathways should be installed at grade or require minimal excavation (max depth 150mm) for installation.
- If feasible, the proposed tennis court should be moved 1 metre in the northern direction to minimise the encroachment sustained by Tree 575. Tree 563, which is a smaller tree that was observed to be in good health, will sustain an acceptable increase in the encroachment within the southern portion of its TPZ under this proposed modification.
