Cushman and Wakefield on behalf of Property and Development NSW **Hazardous Materials Assessment** **56-58 Knox Street, Goulburn** **NSW**

Reinspection to assess the condition, extent and risk associated with suspected hazardous materials

S-05772.HMA.024_56-58 Knox Street, Goulburn_June 2023

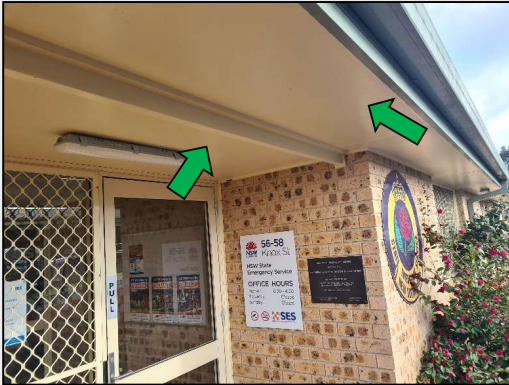
Photo 1: Ground floor, external, eaves linings all sides and entrance awning - presumed negative fibre cement sheeting

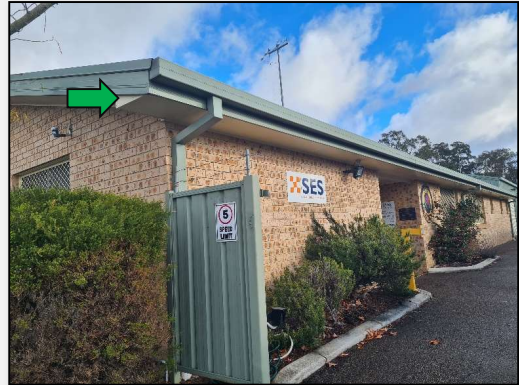
Photo 2: Ground floor, internal, gable ends at eaves end - non-asbestos fibre cement sheeting

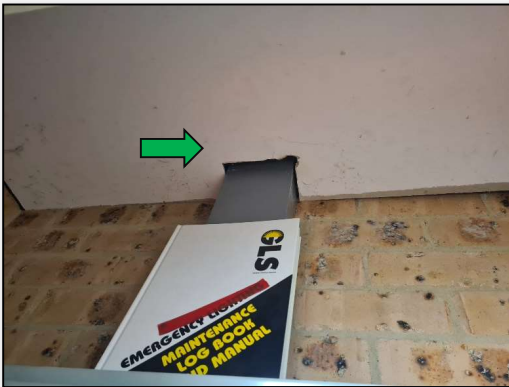
Photo 3: Ground floor, internal, electrical board ceiling - non-asbestos fibre cement sheeting

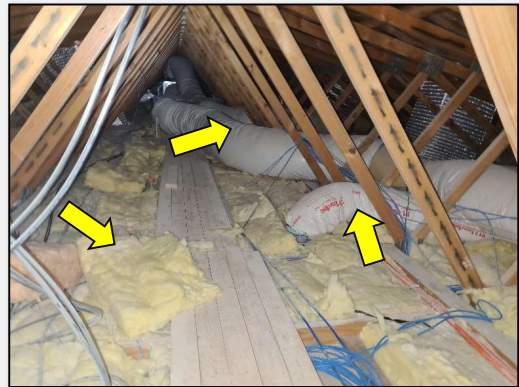
Photo 4: Ground floor, internal, ceiling cavity - SMF-containing insulation batts and insulation to ducting

- Engage a suitable contractor to remove all bonded and unbonded SMF materials within the site prior to planned refurbishment or demolition works under controlled condition in accordance with NOHSC: 2006 (1990).

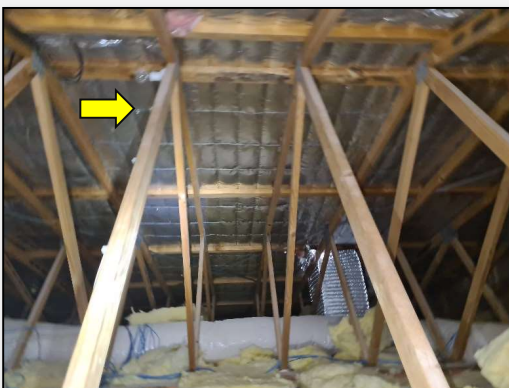
Photo 5: Ground floor, internal, ceiling cavity - SMF-containing sarking insulation

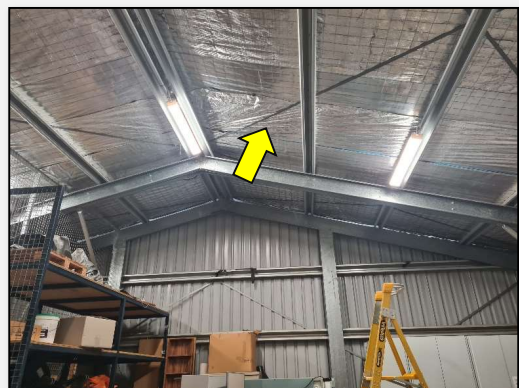
Ground floor, internal, garage ceiling cavity, sarking insulation	6	Yes	-	Positive	SMF-containing	Bonded	120	m sq	Good	Unlikely	Low	Maintain in current condition if to remain in-situ. Remove under controlled SMF conditions as per guidance materials.

Photo 6: Ground floor, internal, garage ceiling cavity - SMF-containing sarking insulation
