**PRELIMINARY SITE INVESTIGATION  
PREPARED FOR  
WINTERGREEN FARM PTY LTD  
3,329 OXLEY HWY SOMERTON NSW 2340**

**Report No:** 251021\_PSI\_Rev3  
June 2025  
(Released: 27 June 2025)

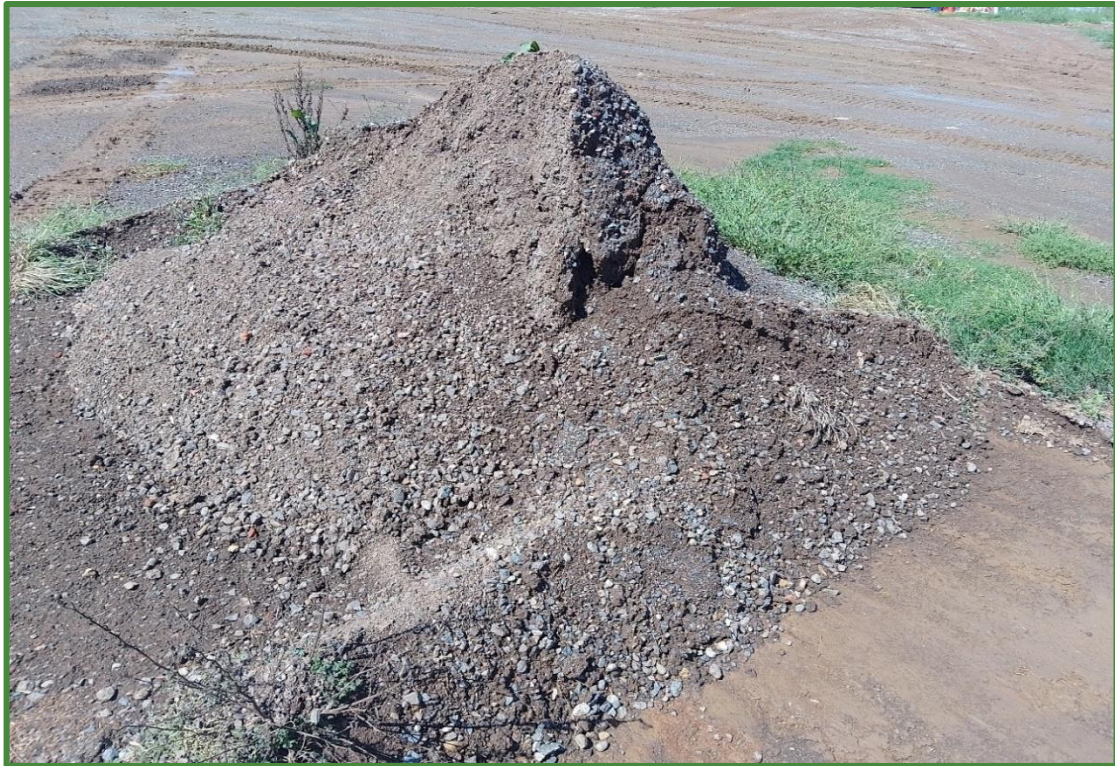
**Photograph 3:** Closeup of small road base stockpile (location in photograph 2 above)

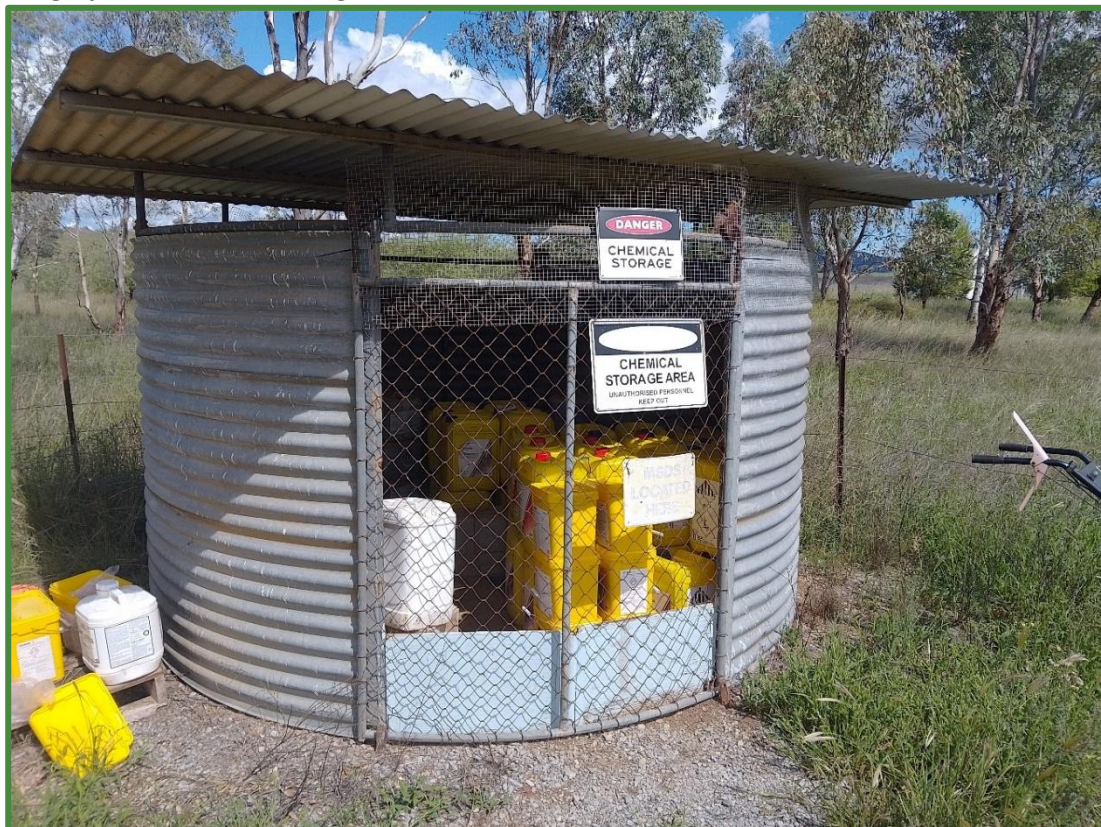
**Photograph 6:** Chemical Storage

All chemicals are stored securely in designated, clearly labelled storage areas that comply with relevant safety standards and regulations. Usage is strictly controlled and only carried out by trained personnel following manufacturer guidelines and accompanying safety data sheets (SDS). These practices ensure that the risk of environmental contamination through improper use, handling, or disposal is low. The farm maintains detailed records of chemical usage and conducts regular inspections to ensure ongoing compliance and environmental responsibility.

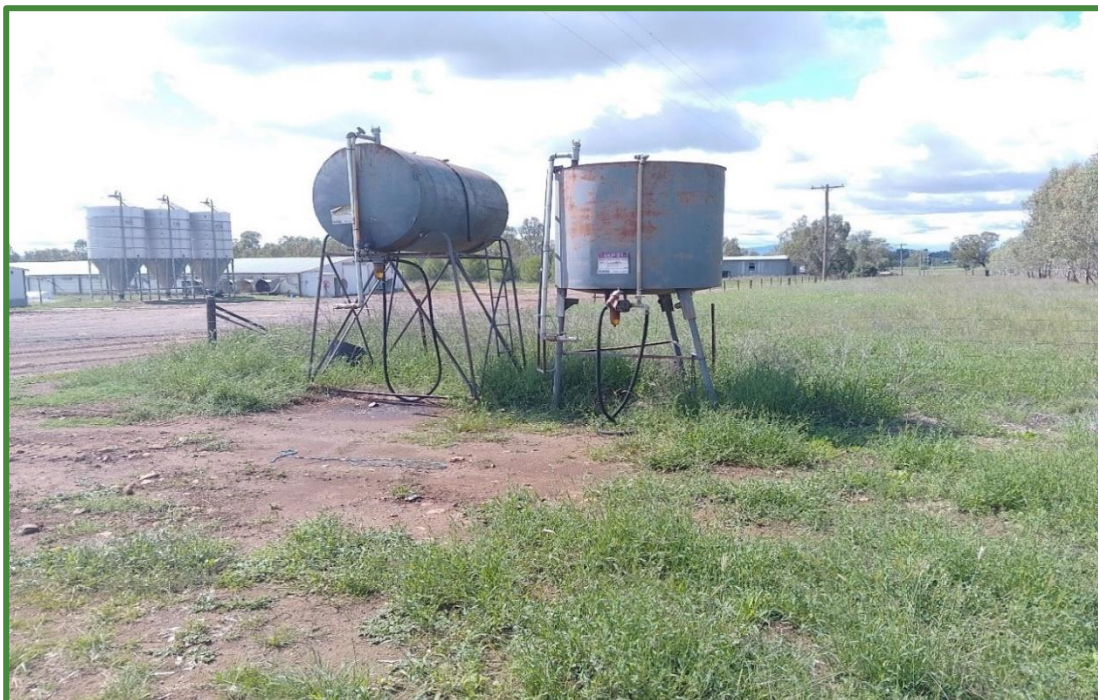
**Photograph 8:** Diesel/Petrol Tanks (superficial surface contamination beneath bowser)

Minor soil staining from fuels spills was observed beneath the bowser at the existing fuel storage area. This consists of two above ground storage tanks (of approximately of 2 – 3,000 litre storage capacity). Small patches of dead grass surrounding two unsecured Intermediate Bulk Container (IBCs) containing corrosive solutions (likely bleach and an acidic chemical), indicate superficial contamination of surface soils. It is understood these IBCs are to be removed. Furthermore, the fuel tanks are to be replaced by self-bunded tanks. It is recommended the top 0.5 m of surface soil beneath the two fuel tanks be retained elsewhere on site and treated with BioSolve® Hydrovent™ as per the manufacturer's instructions.

- Minor fuel staining was observed beneath the bowser at the existing fuel storage area, and localised vegetation dieback was noted near corrosive liquids stored in IBCs. Both suggest superficial soil contamination;

The small area believed impacted from diesel and petrol spills beneath the current aboveground fuel tanks, are recommended to be excavated with treated with BioSolve® Hydrovent™ as per the manufacturer's instructions.

- It is understood that the IBCs will be removed, and the existing aboveground fuel tanks will be replaced with self-bunded units, thereby mitigating any further potential for soil contamination;

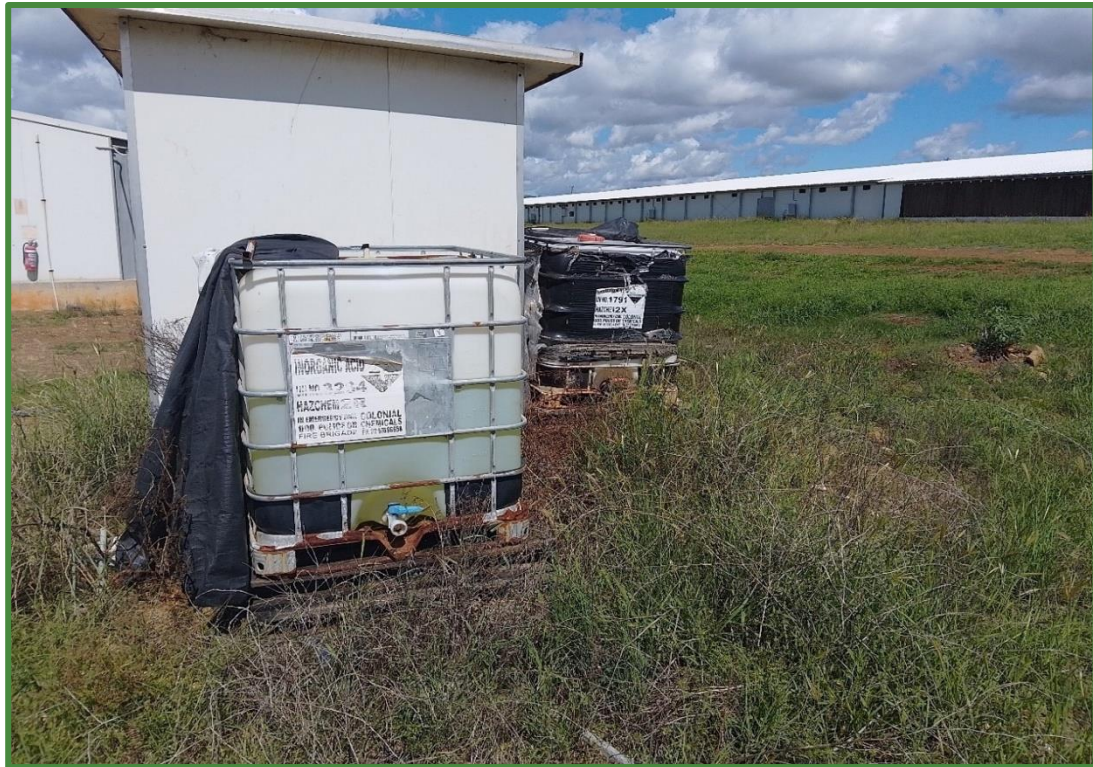
**Photograph 9:** IBC Corrosive Chemicals

Based on discussion with the client, it is understood that IBCs will be removed, and the aboveground fuel tanks will be replaced with safer, self-bunded tanks.
