RGS03414.1-AB

14 August 2024

**RE: Proposed Dwelling – 27 Maslin Close, Red Head  
Geotechnical Assessment**

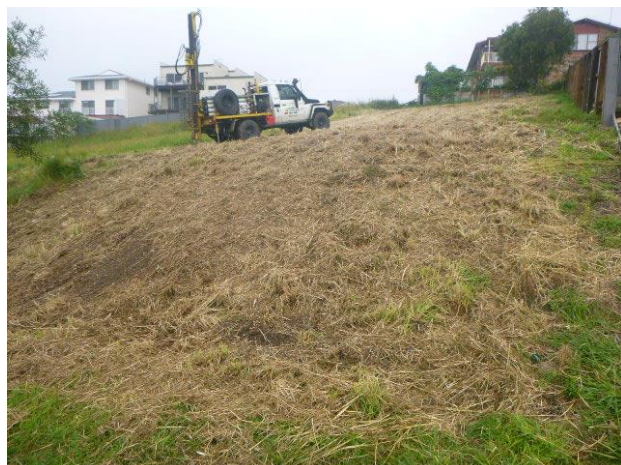
*Looking upslope to the south over the lot showing typical vegetation and slopes.*

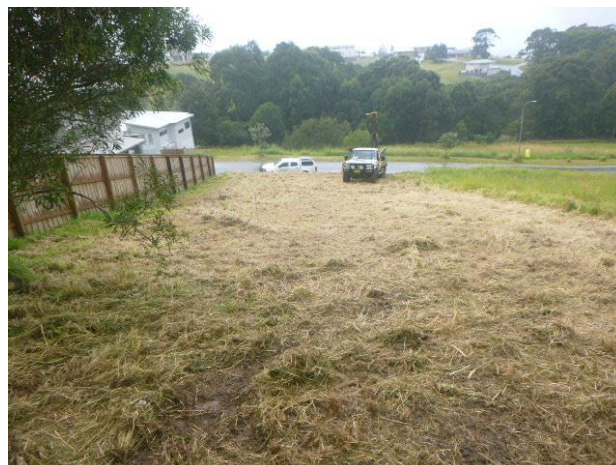
*Looking downslope to north over lot showing typical vegetation and slope angles.*

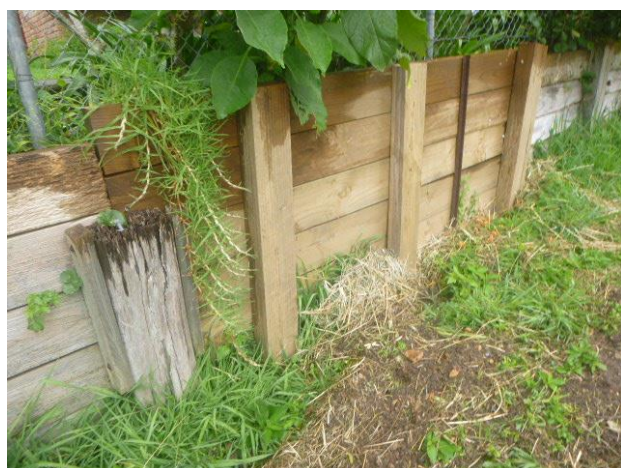
*Section of timber retaining wall located along southern boundary.*

Maintenance of retaining structures is recommended including reduction of vegetation growing within retaining walls, and regular maintenance of groundwater weep structures.

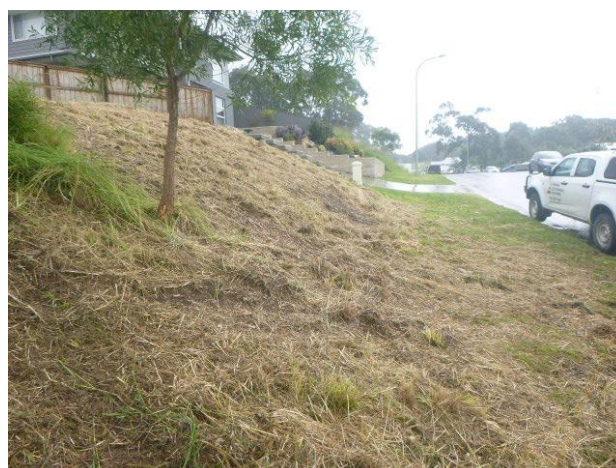
*Looking to west along steep batter on northern end of lot.*

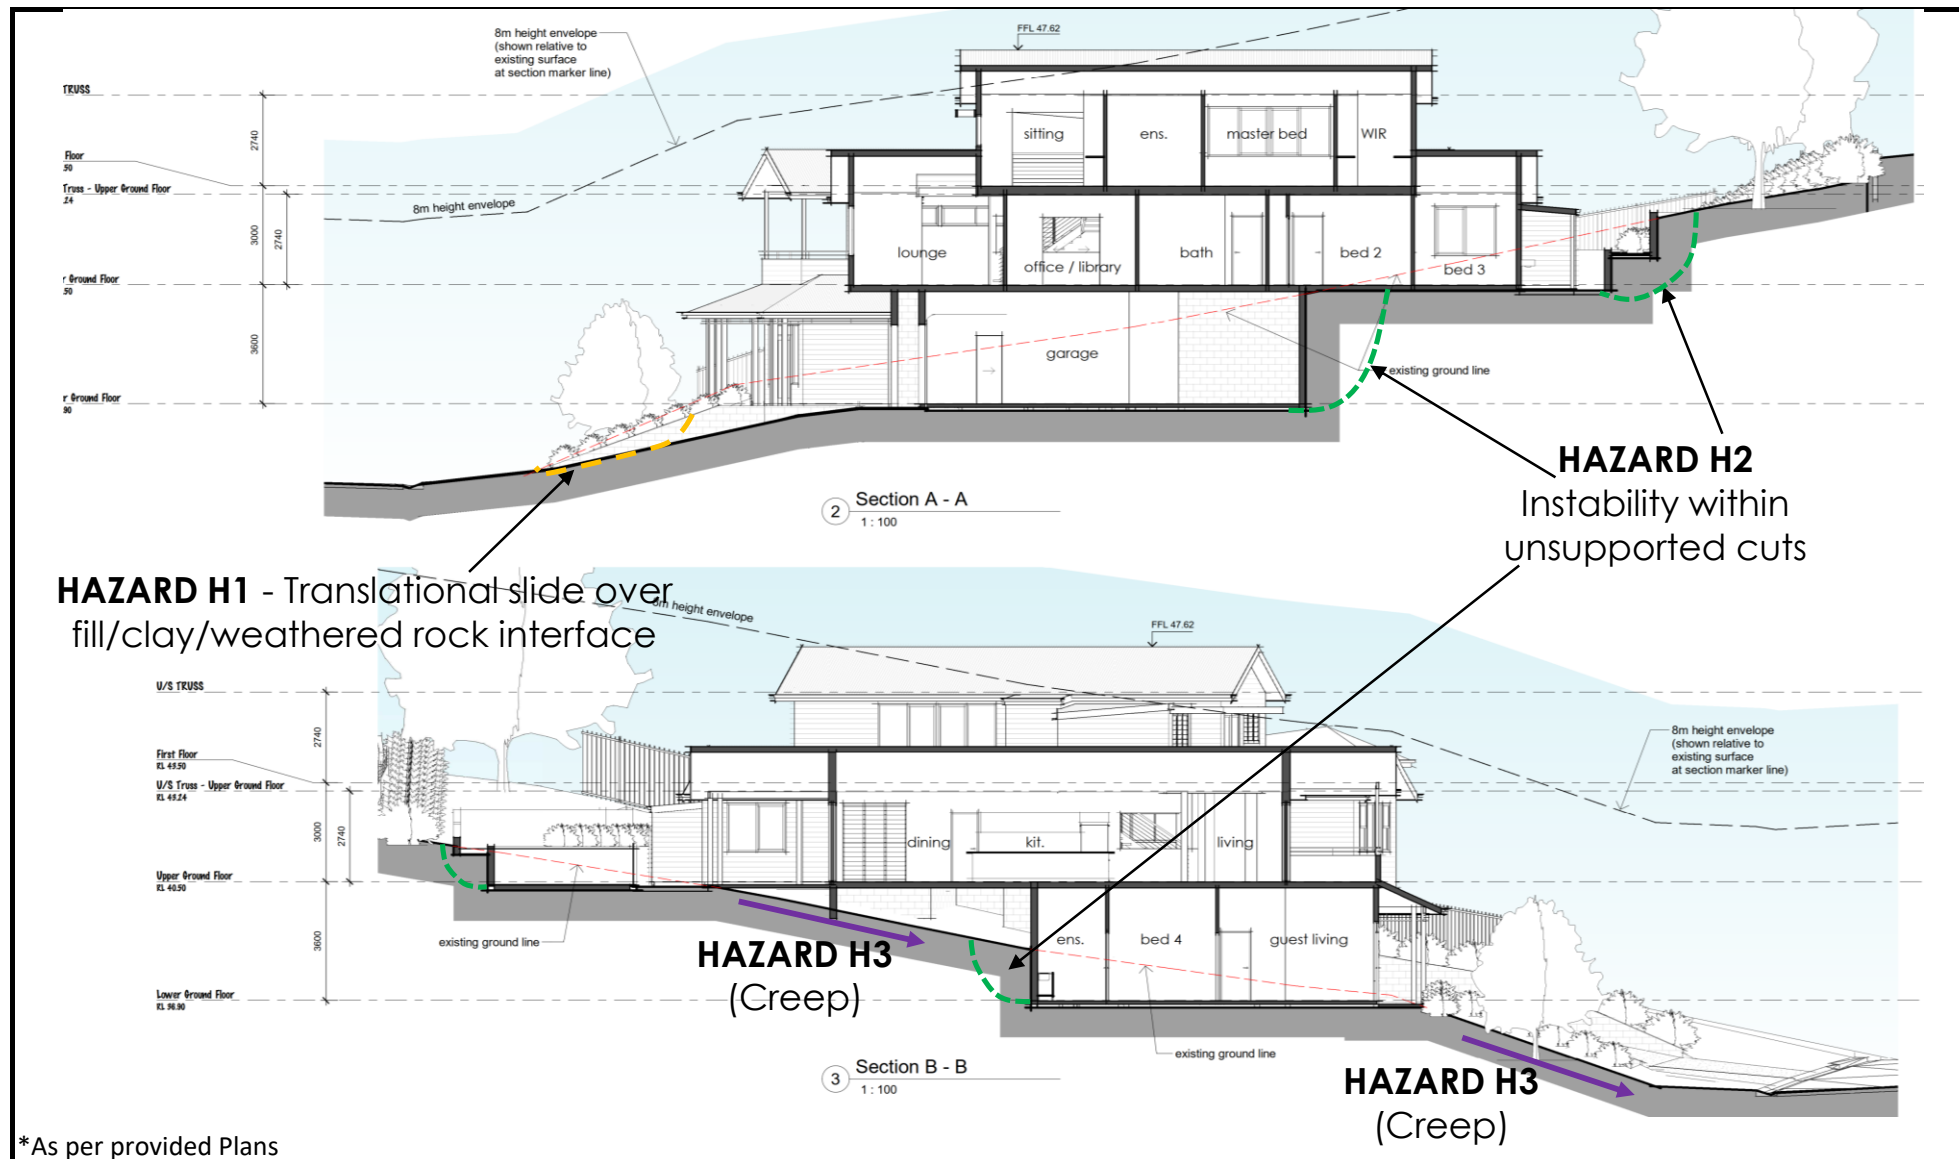
<b>REGIONAL GEOTECHNICAL SOLUTIONS</b>	<b>Client:</b>	Keith & Philippa Hogan	Job No.	RG03414.1
	<b>Project:</b>	Proposed Dwelling	Drawn By:	JD
		27 Maslin Close, Redhead	Scale:	NTS
			Date:	14-Aug-24
	<b>Title:</b>	Cross section with examples of identified hazards	Drawing No.	<b>Figure 2</b>

**Hazard 1** – Translational failure caused by sliding of the soil or rock profile over a plane of weakness such as a clay seam, zone of water concentration within the exposed rock mass, or on the soil-rock/soil – fill interface. Should such a failure occur it could potentially cause moderate structural damage;

**Hazard 2** – Rotational failure or toppling failure within unsupported excavations or fill batters. If such a failure was to occur it could potentially cause moderate structural damage to a structure. It is noted structural retaining walls are proposed.

**Hazard 3** – Soil creep. Creep is an imperceptibly slow movement that takes place on sloping soil sites. It is an ongoing, natural slope process involving the progressive downslope migration of soils over the underlying rock profile;

The identified hazards are shown in Figure 2.

The assessment presented in Table 2 indicates that there is a **Low** risk of slope instability for the site provided the development is undertaken in accordance with general good hillside practice (refer to attachment) and by adopting the recommendations of this report regarding maximum unsupported cut heights, batter angles, and retaining wall design.

All cuts and fills must be appropriately benched and battered, supported by temporary shoring or by an engineered retaining wall. All retaining walls should include an allowance for adequate drainage behind the wall in accordance with AS4678-2002 that either discharges into the site stormwater system or further downslope from the proposed dwelling.
