# UNIVERSAL DRILLING Pty Ltd

GJ Gardner Homes -Taree

| <b>Our reference</b> | 22120241ELLUISACL-01 |
| <b>Site Address</b> | No.1 Elluisa Close, Forster 2428 |

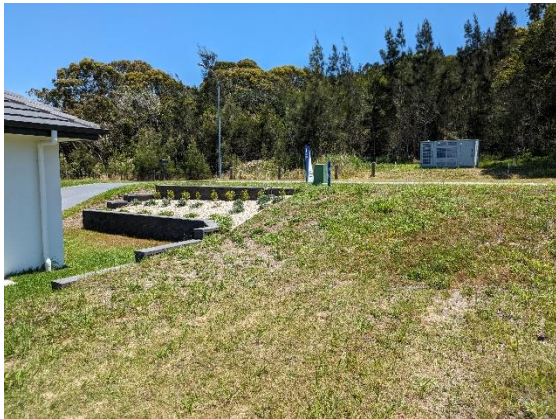
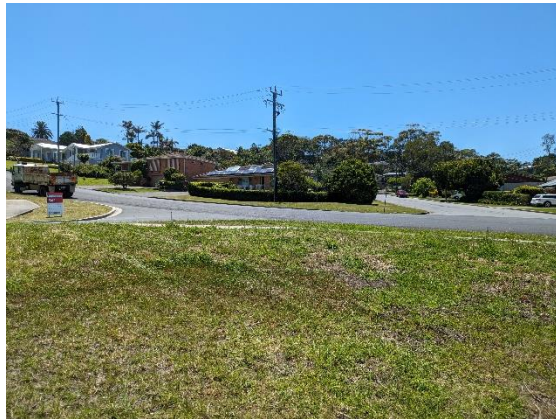
| <b>Trees &amp; other impediments</b> | No trees or gardens however drainage from the street level and adjacent properties is poor, a complete stripping and inspection of the site is required before construction. |

Notes: Some soft soils becoming firm over extremely weathered rock, a complete stripping of the site will reveal any further soft soils.

Notes: Some surface soft soils inside the first 1.0m profile appears to be stormwater and trapped water, this will become apparent when stripping the site of all topsoil.

If the site requires filling a complete stripping and foundation inspection should be carried out prior to placement of fill identifying all foundation issues, then all works should be conducted in accordance with AS 3798. Relative compaction and oversize material of the selected fill must be controlled (refer AS3798 clause 4.3 a to d). Typically, this will be obtained by a minimum STD MDD Ratio of 95% (AS3798 - Table 5.1) and moisture variation of +/-2% of optimum per 200mm layer or uniform thickness (AS3798 6.2.2 & Table 8.1).
