## STRUCTURAL INSPECTION REPORT

Property address: 78 George St,  
Grenfell NSW 2810

Type of inspection report: Structural Inspection Report

Our Reference: JN 24-2023

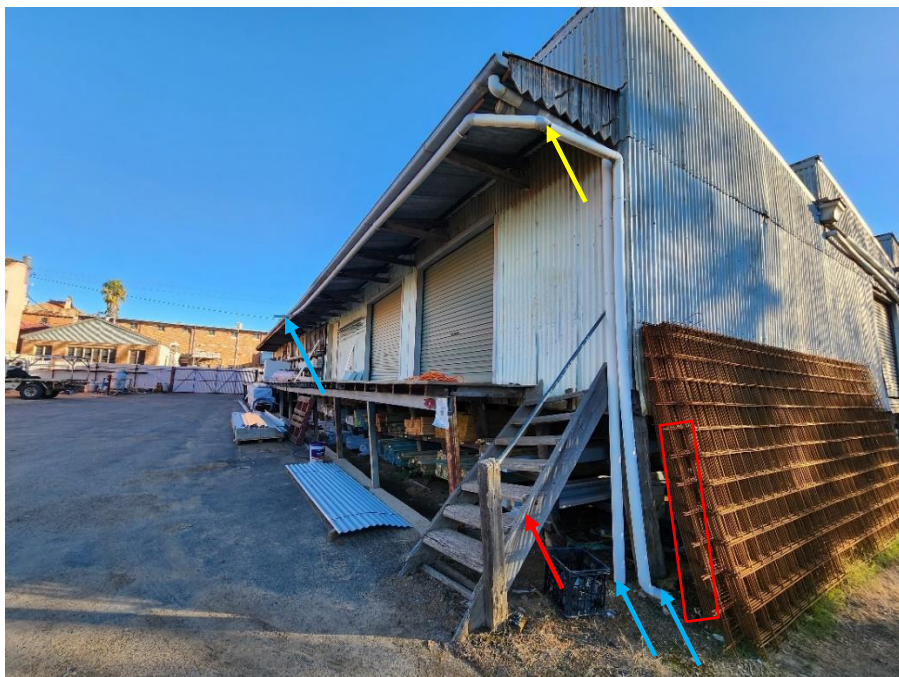
Photo 1: Main Building - A split and rotted timber stump shown boxed in red. Rotted timber stairs shown arrowed in red. Assessment type: Poor. A defective downpipe shown arrowed in yellow. The downpipes that have not been connected to a stormwater system shown arrowed in blue.

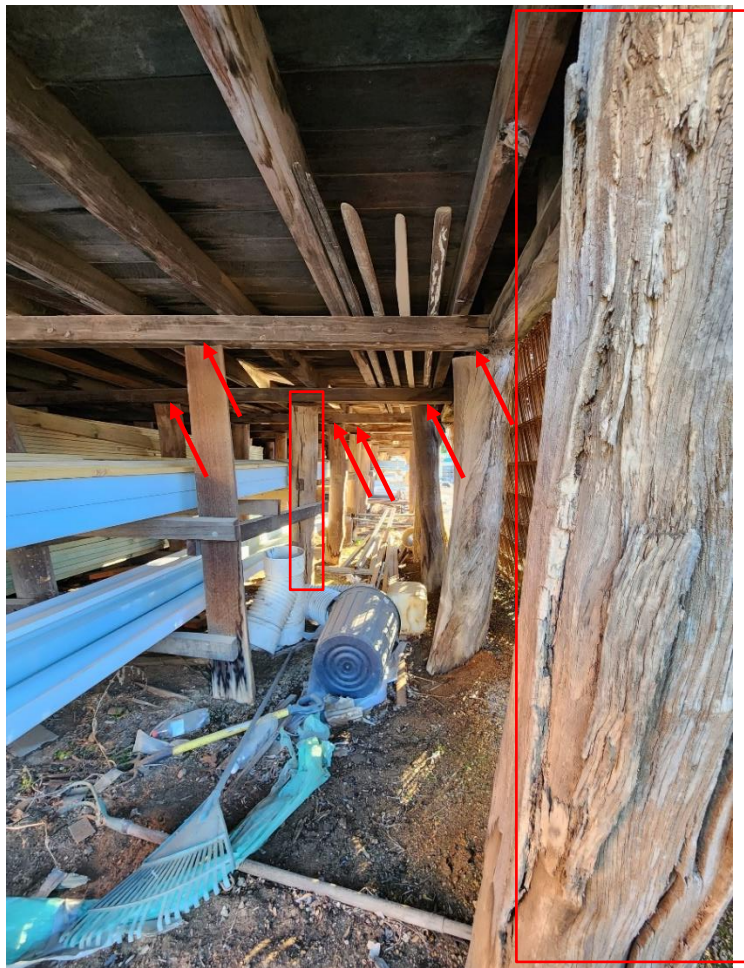
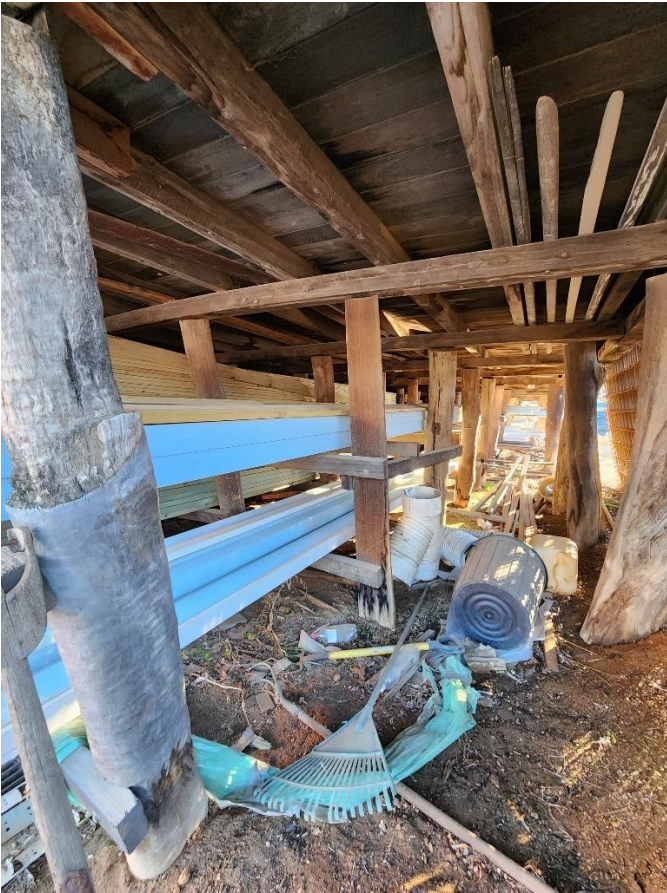
Photo 2: Main Building - Rotted/split timber stumps shown boxed in red. Gaps formed between bearers and tops of the timber stumps due to inclination of the stumps shown arrowed in red. Assessment type: Poor.

Photo 3: Another view of the defects shown in photo 2 above.

- The majority of the timber stumps in the subfloor have dislocated and inclined up to 16 degrees vertically, thus not supporting the bearers and lost the structural ability to carry the loadings above (photos 2, 3, 4, 5, 6, 7, 8, 9, 22, 23, 24, 28, 29, 30, 34 and 35).
- A significant number of timber stumps in the subfloor space have cracked, split and rotted, thus have lost the structural ability to carry the loadings from above (photos 1, 2, 11, 12, 13, 14, 15, 18, 20, 23, 25, 26, 27, 28, 30, 31, 32, 33, 34, 35, 36 and 37).
- Termite attack found on an internal wall member (photo 49).
- A few downpipes have not been connected to the stormwater system (photos 1 and 27).
- No structural braces have been provided for the roofs, walls and the subfloor.
- Roof leaks at a few locations.

Considering the structural instability of both buildings, it is strongly recommended that both the main building and shed 1 shall be completely demolished as soon as practicable. If any parts of the buildings are to be retained, they can be completely removed during the demolition, redesigned to conform current Australian Standards and NCC and reused if suitable.

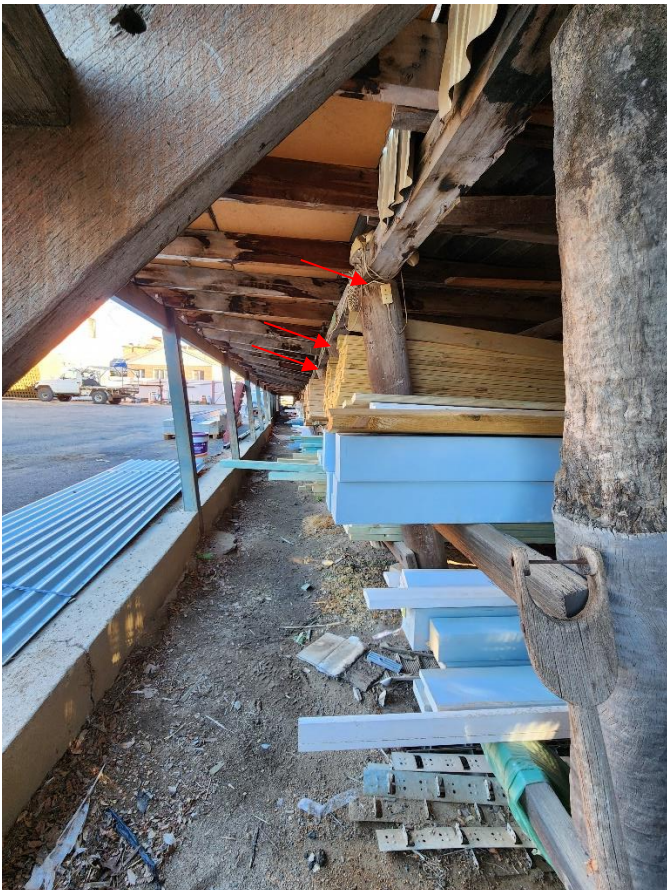
Photo 4: Main Building - Gaps formed between bearers and tops of the timber stumps due to inclination of the stumps shown arrowed in red. Assessment type: Poor.

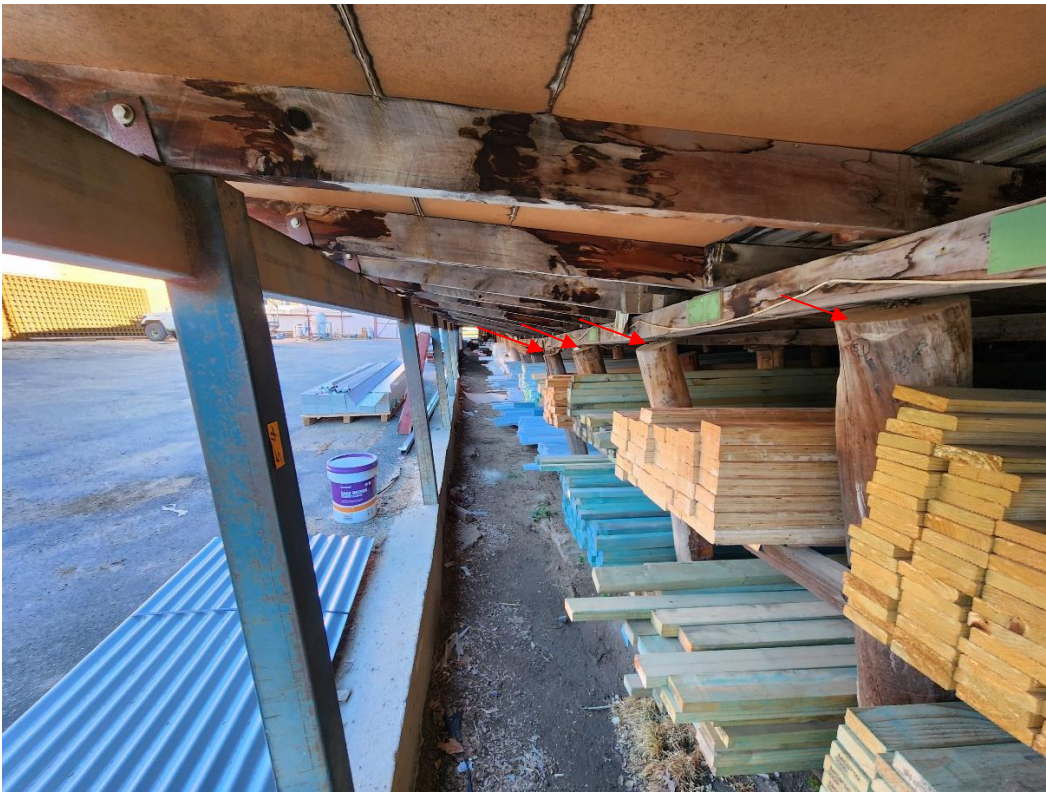
Photo 5: Main Building - Gaps formed between bearers and tops of the timber stumps due to inclination of the stumps shown arrowed in red. Assessment type: Poor.

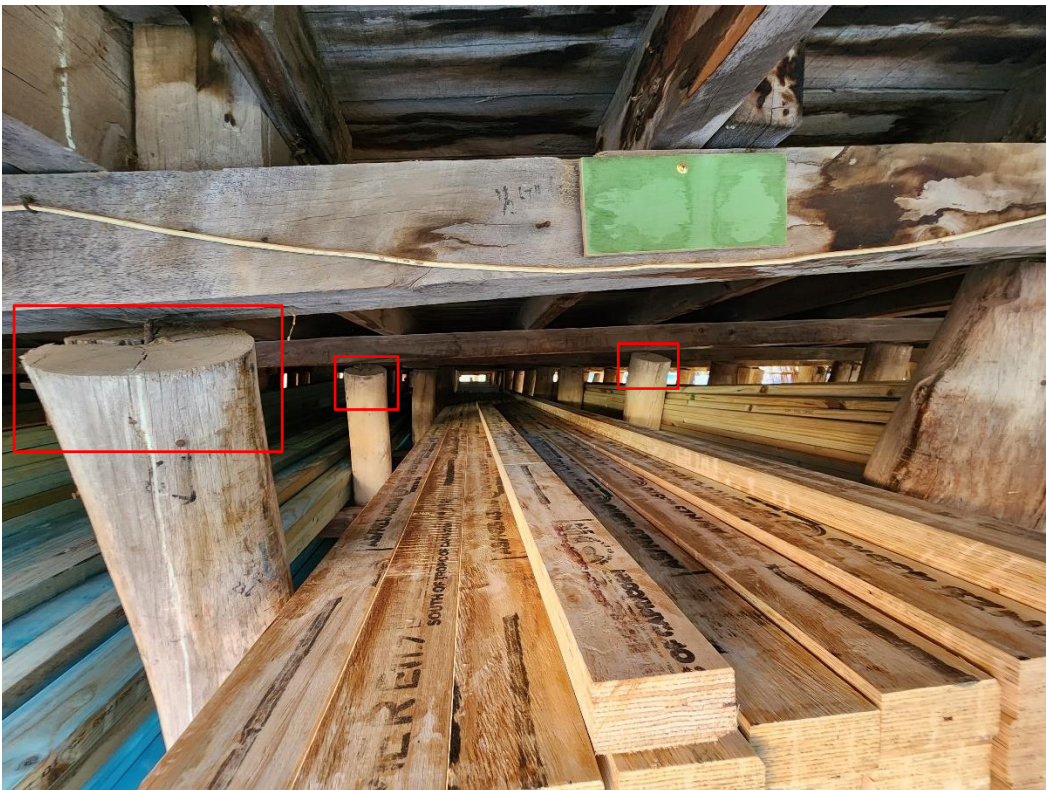
Photo 6: Main Building - Gaps formed between bearers and tops of the timber stumps due to inclination of the stumps shown boxed in red. Assessment type: Poor.

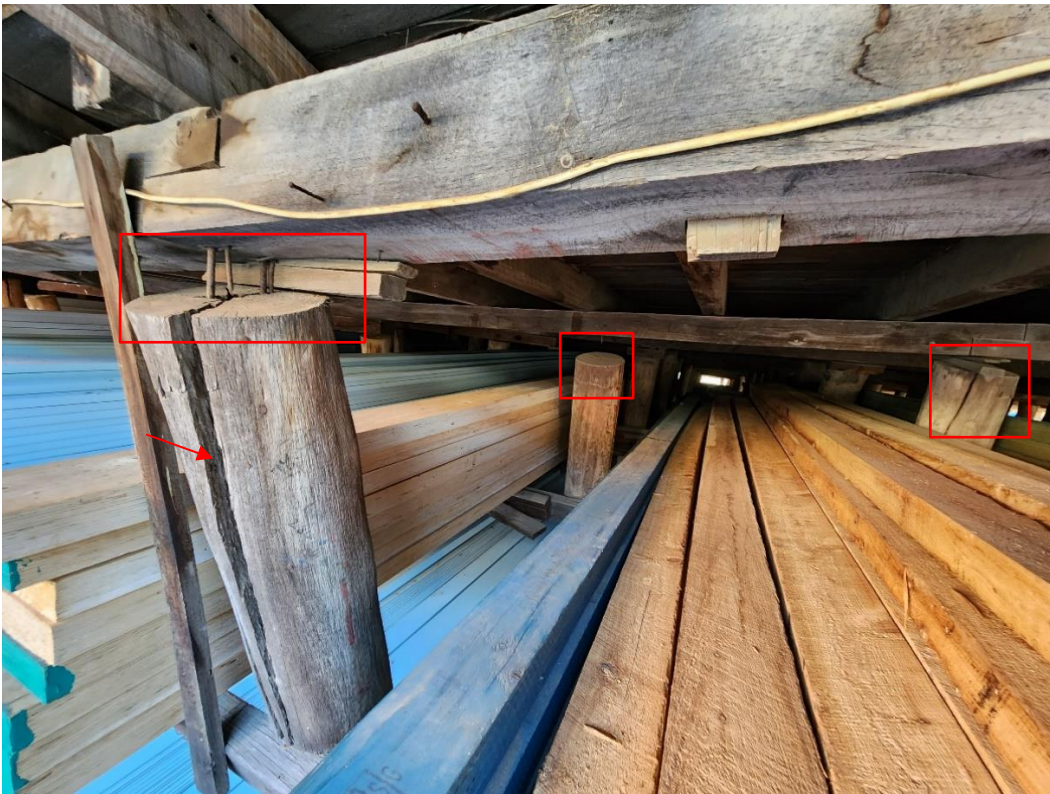
Photo 7: Main Building - Gaps formed between bearers and tops of the timber stumps due to inclination of the stumps shown boxed in red. A large split on the stump shown arrowed in red. Assessment type: Poor.

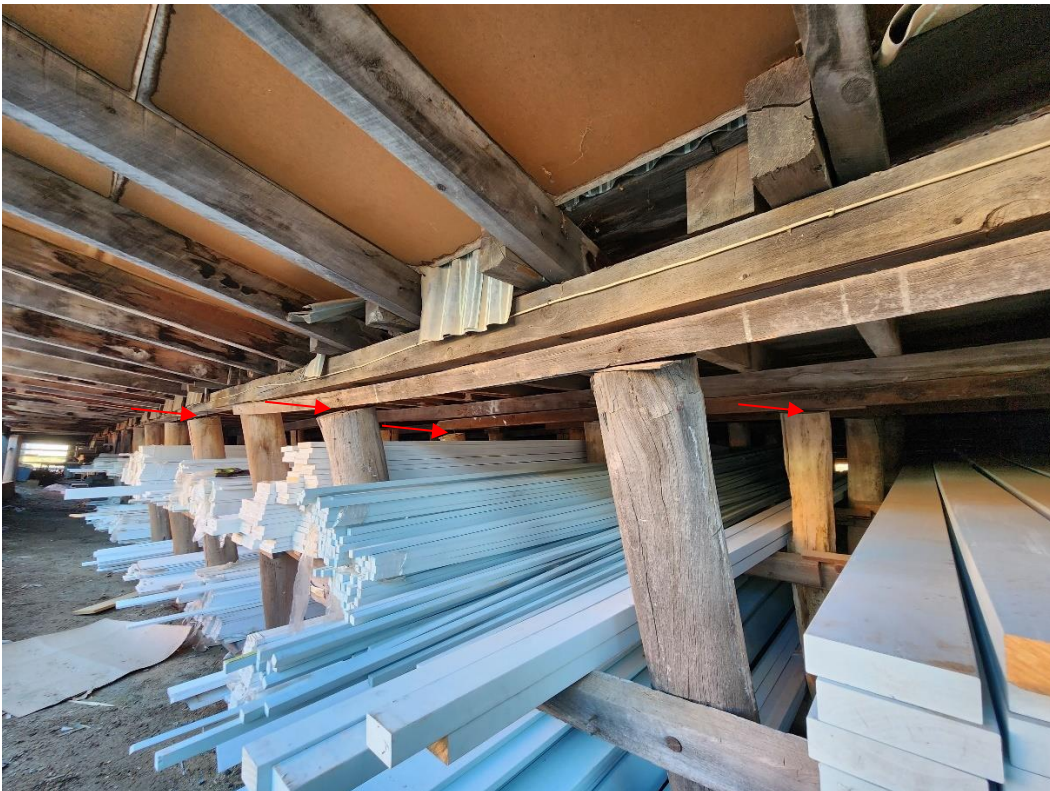
Photo 8: Main Building - Gaps formed between bearers and tops of the timber stumps due to inclination of the stumps shown arrowed in red. Assessment type: Poor.

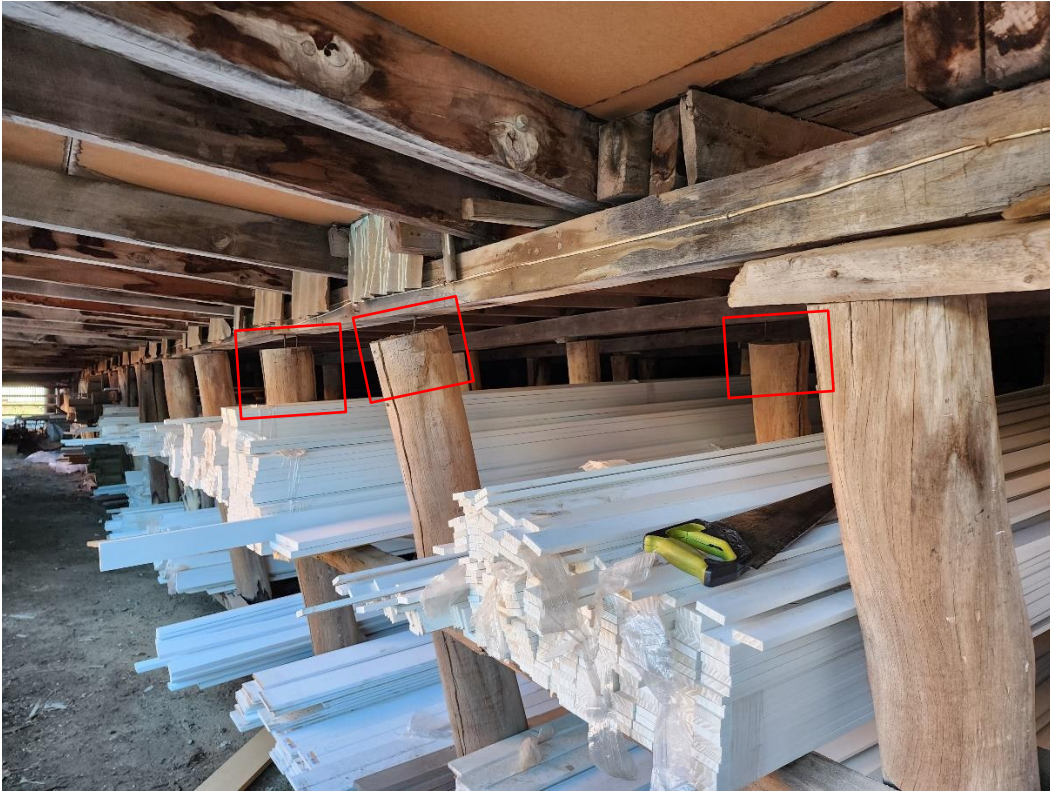
Photo 9: Main Building - Gaps formed between bearers and tops of the timber stumps due to inclination of the stumps shown boxed in red. Assessment type: Poor.

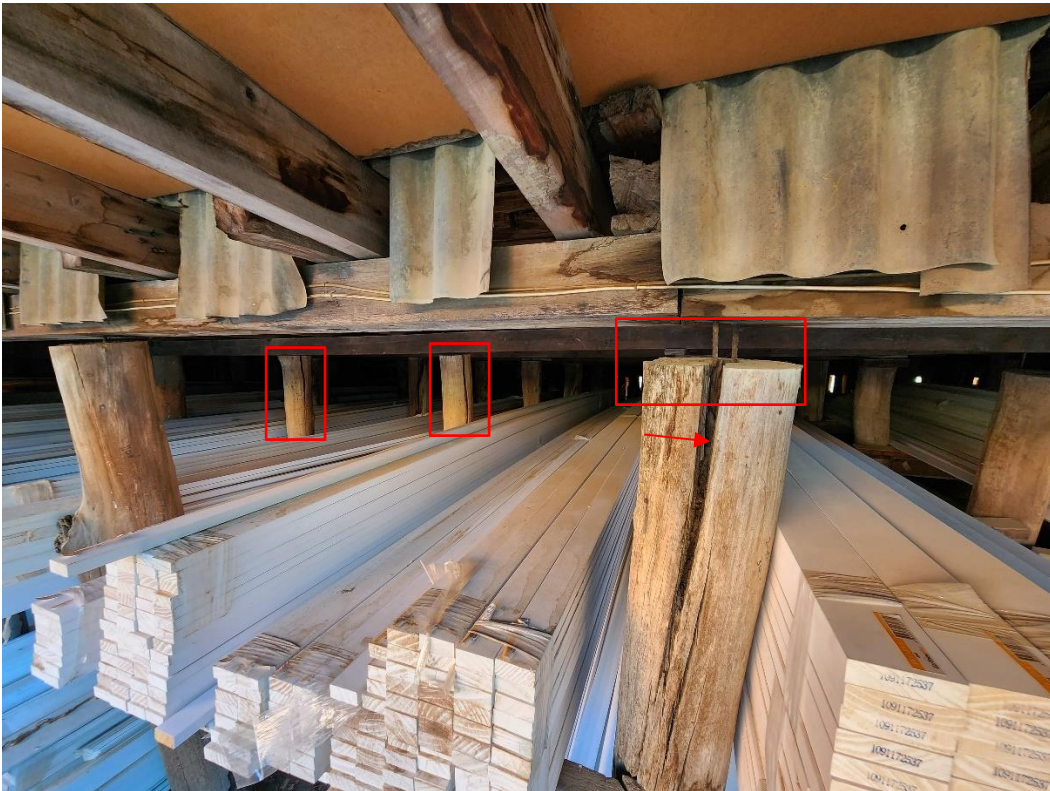
Photo 10: Main Building - Gaps formed between bearers and tops of the timber stumps due to inclination of the stumps shown boxed in red. A large split on the stump shown arrowed in red. Assessment type: Poor.

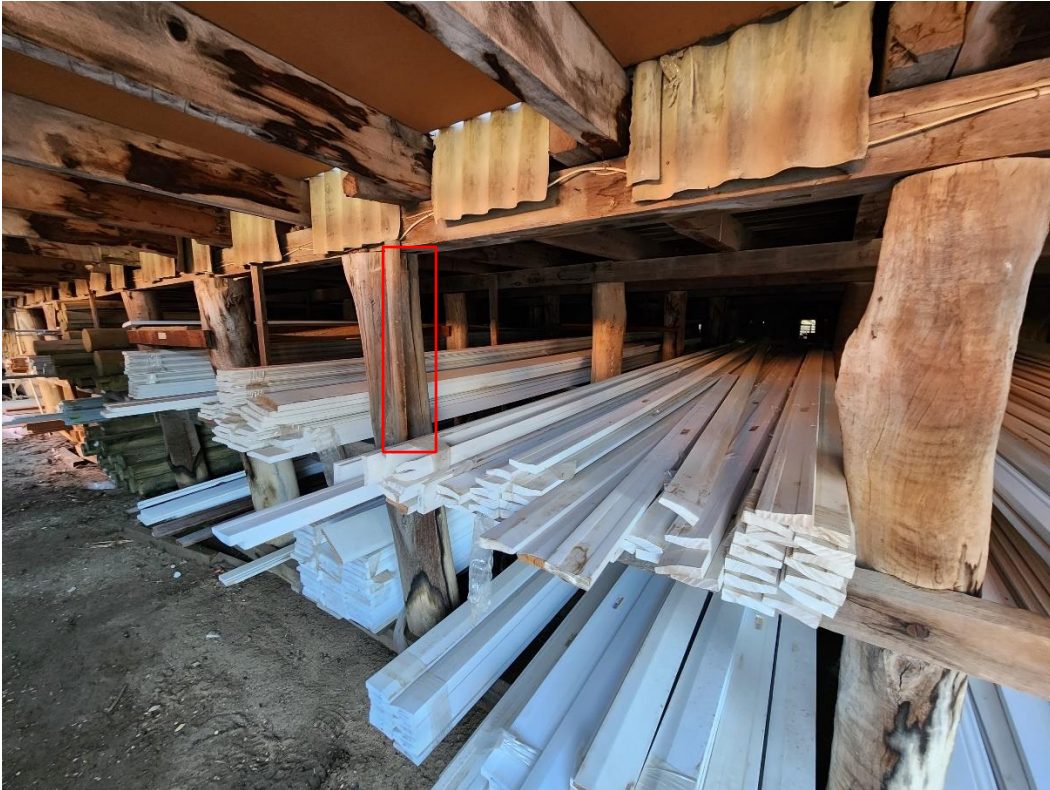
Photo 11: Main Building - Split on a stump shown boxed in red. Assessment type: Fair to poor.

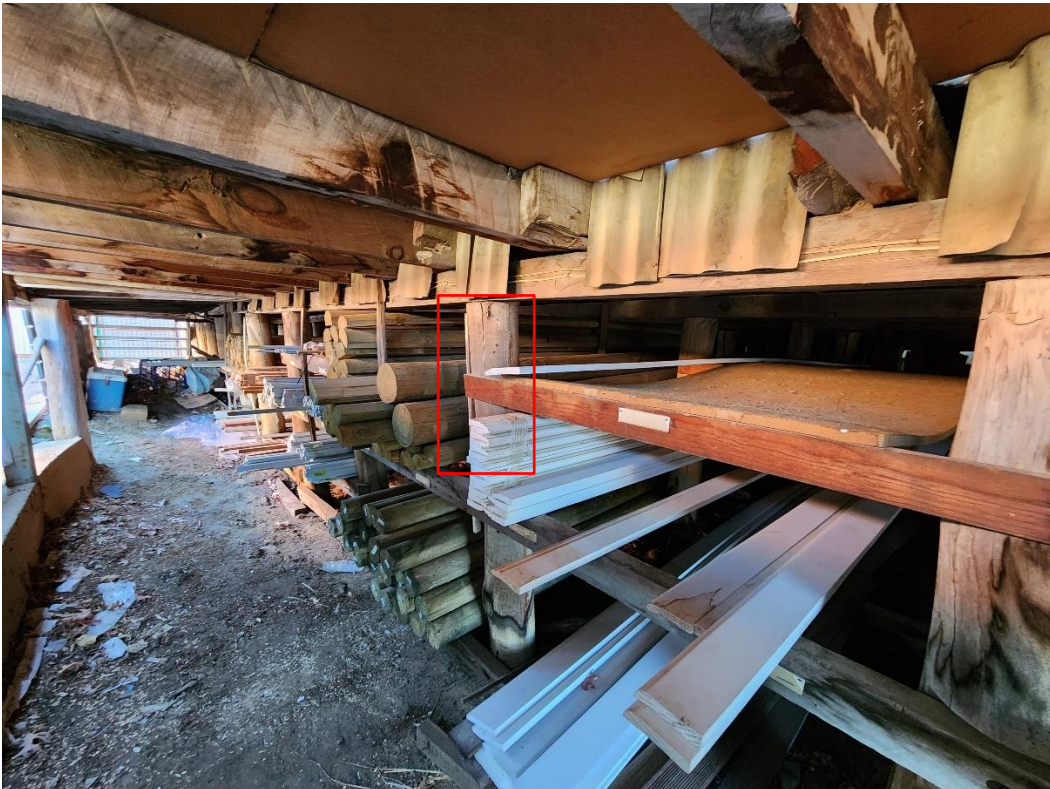
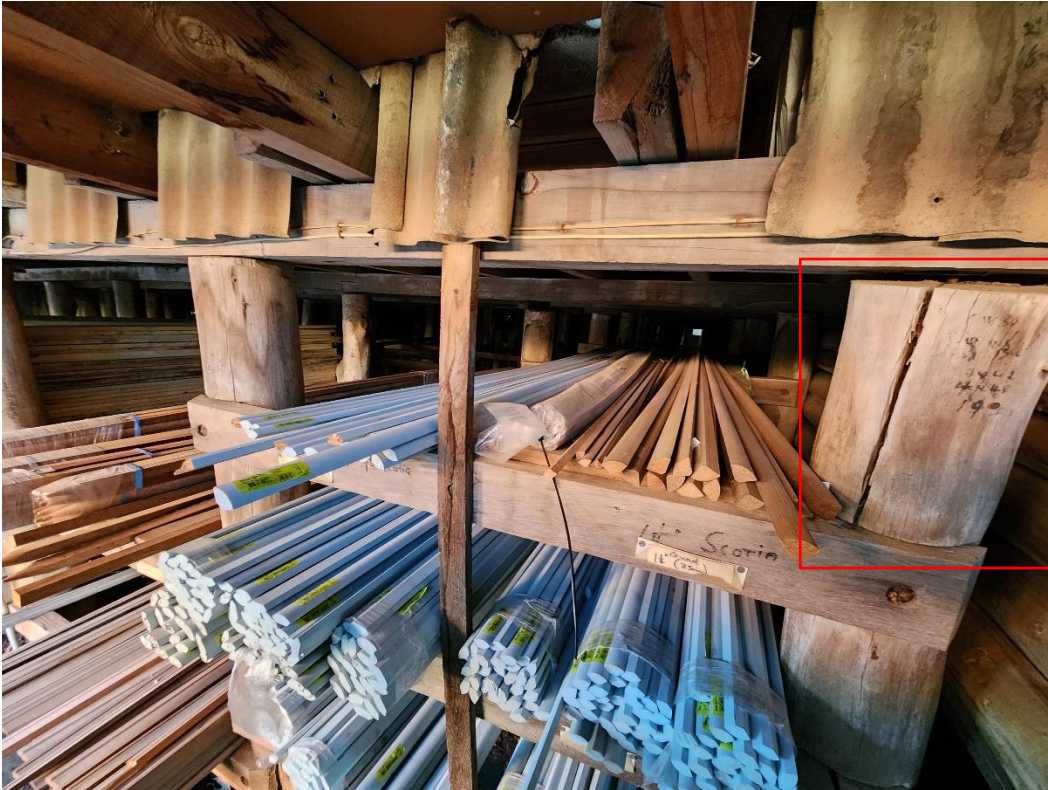
Photo 12: Main Building - Split on a stump shown boxed in red. Assessment type: Fair to poor.

Photo 13: A close-up view of the defect shown in photo 12 above.

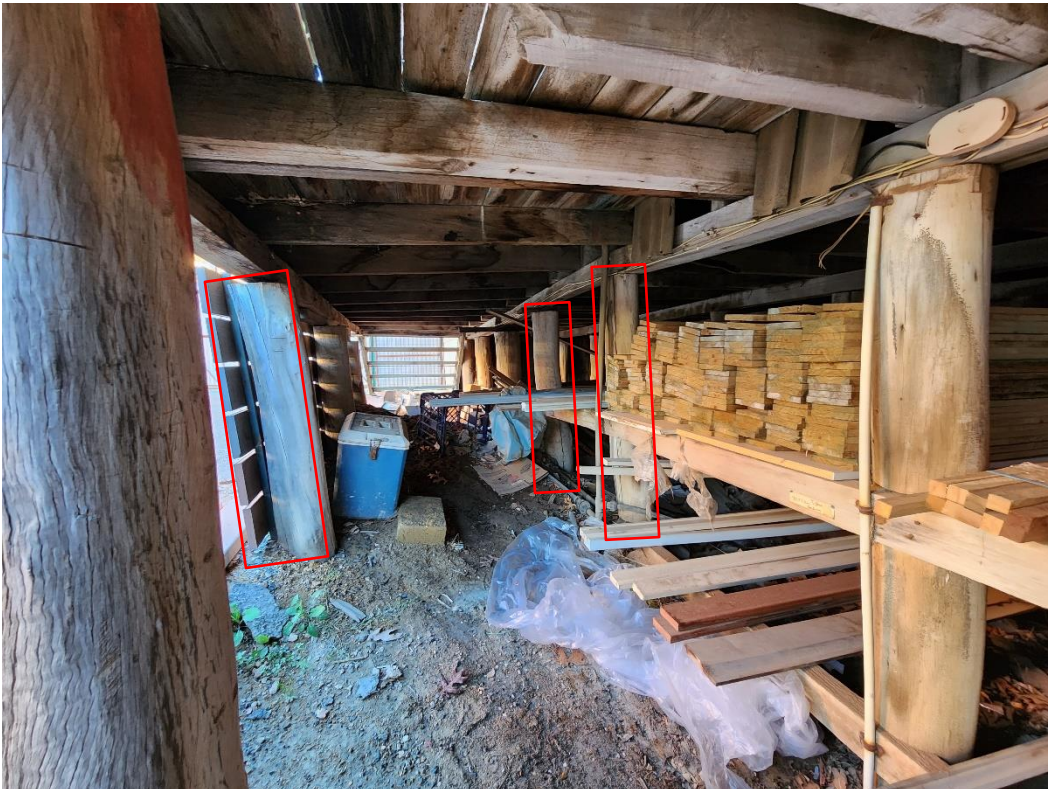
Photo 14: Main Building - Cracked stumps shown boxed in red. Assessment type: Fair to poor.

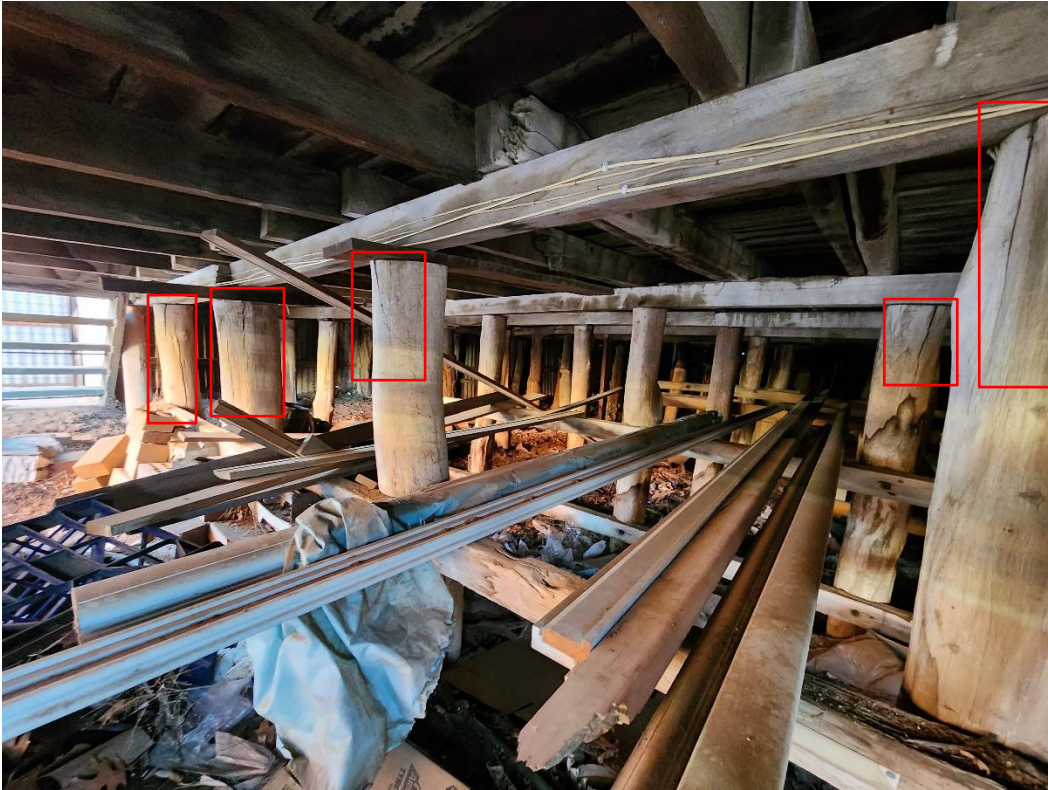
Photo 15: Main Building - Cracked timber stumps shown boxed in red. Assessment type: Fair to poor.

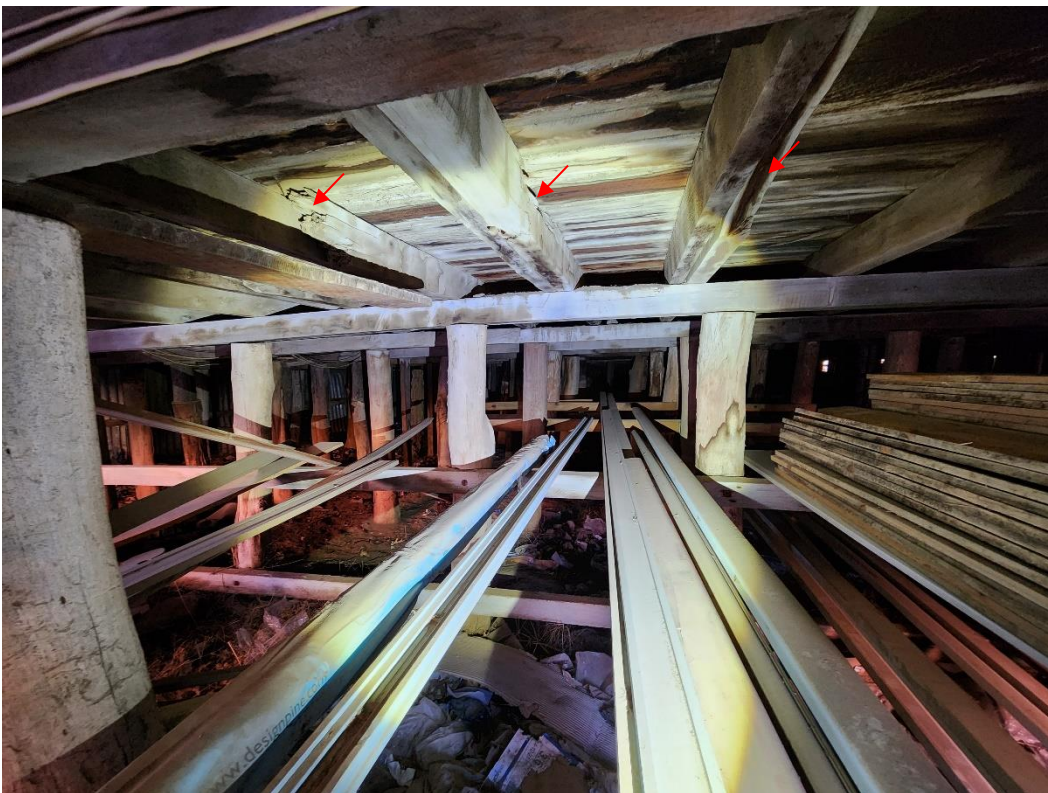
Photo 16: Main Building - Defective bearers shown arrowed in red. However, they have been overlapped with non-defective bearers.

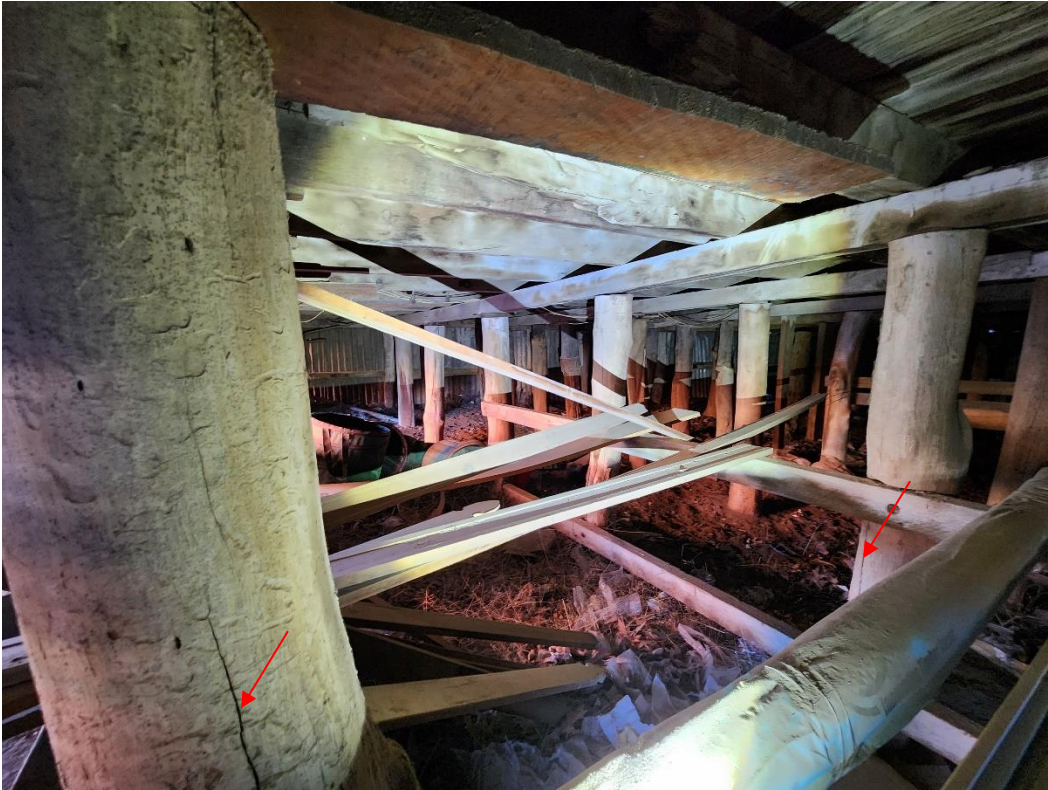
Photo 17: Main Building - Cracks on timber stumps shown arrowed in red. Assessment type: Fair.

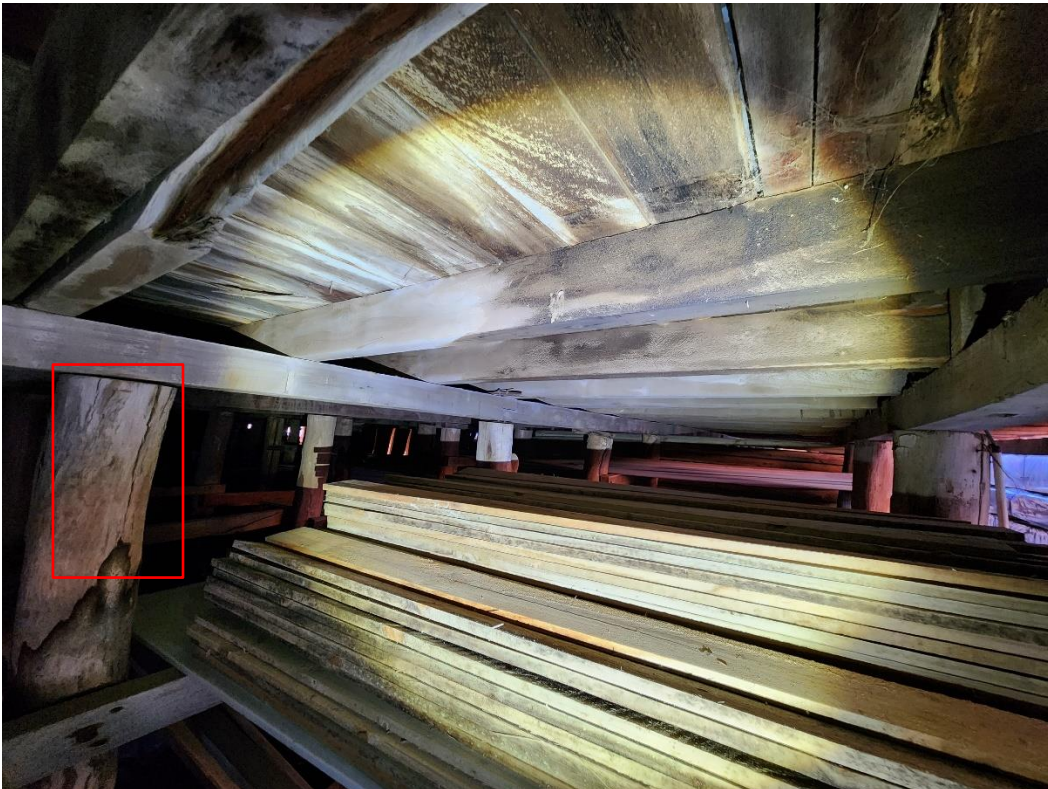
Photo 18: Main Building - A cracked timber stump shown boxed in red. Assessment type: Fair to poor.

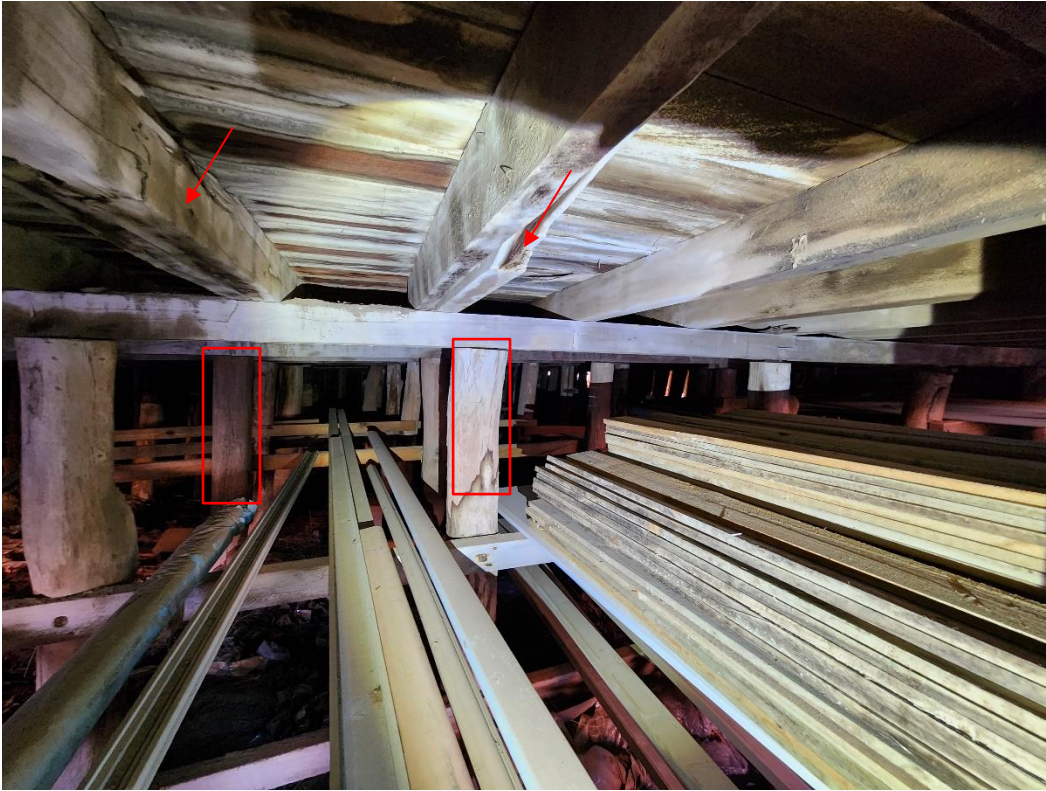
Photo 19: Main Building - Defective bearers shown arrowed in red. However, they have been overlapped with non-defective bearers.

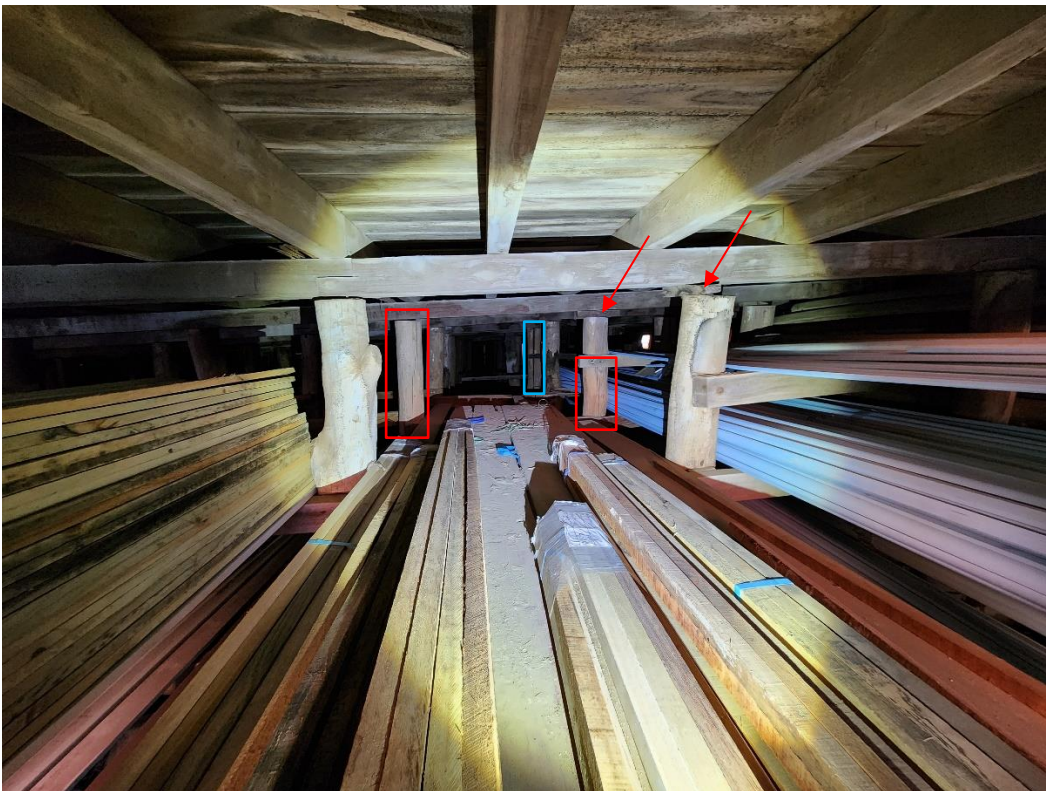
Photo 20: Main Building - Split on a timber stump shown boxed in blue. Assessment type: Poor. Cracked timber stumps shown boxed in red. Assessment type: Fair to poor. Timber packers have been added to fill the gaps between the stumps and bearers (arrowed red).

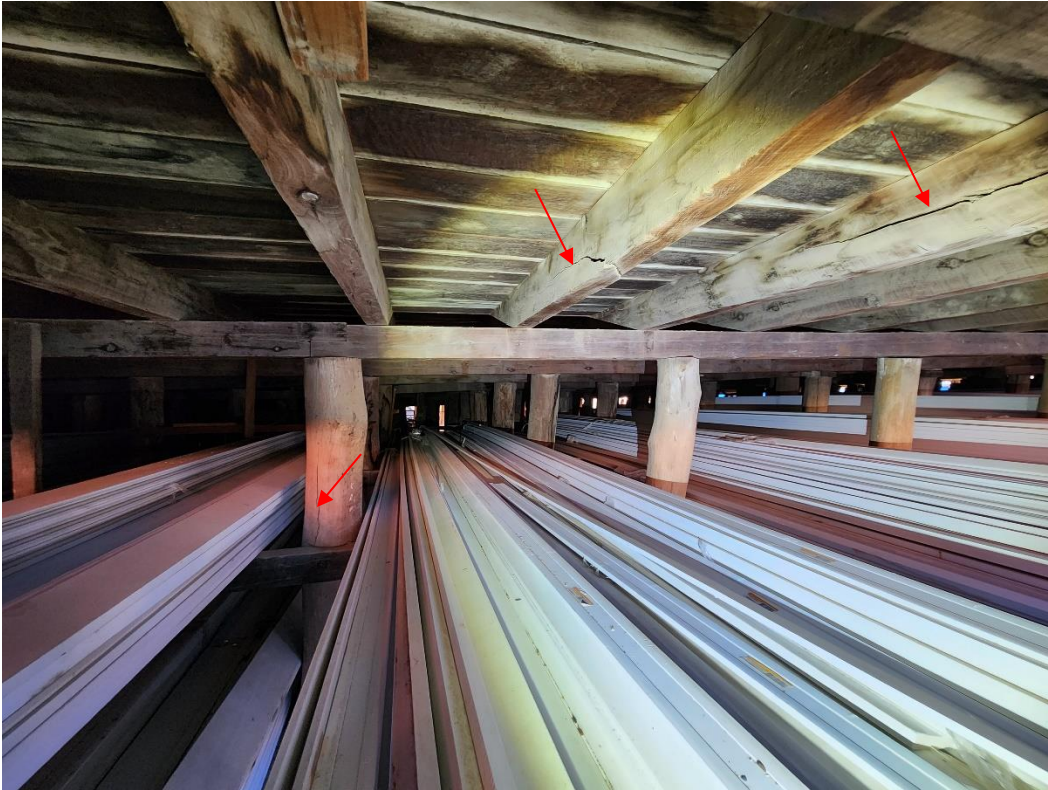
Photo 21: Main Building - A cracked timber stump and bearers shown arrowed in red. Assessment type: Fair to poor.

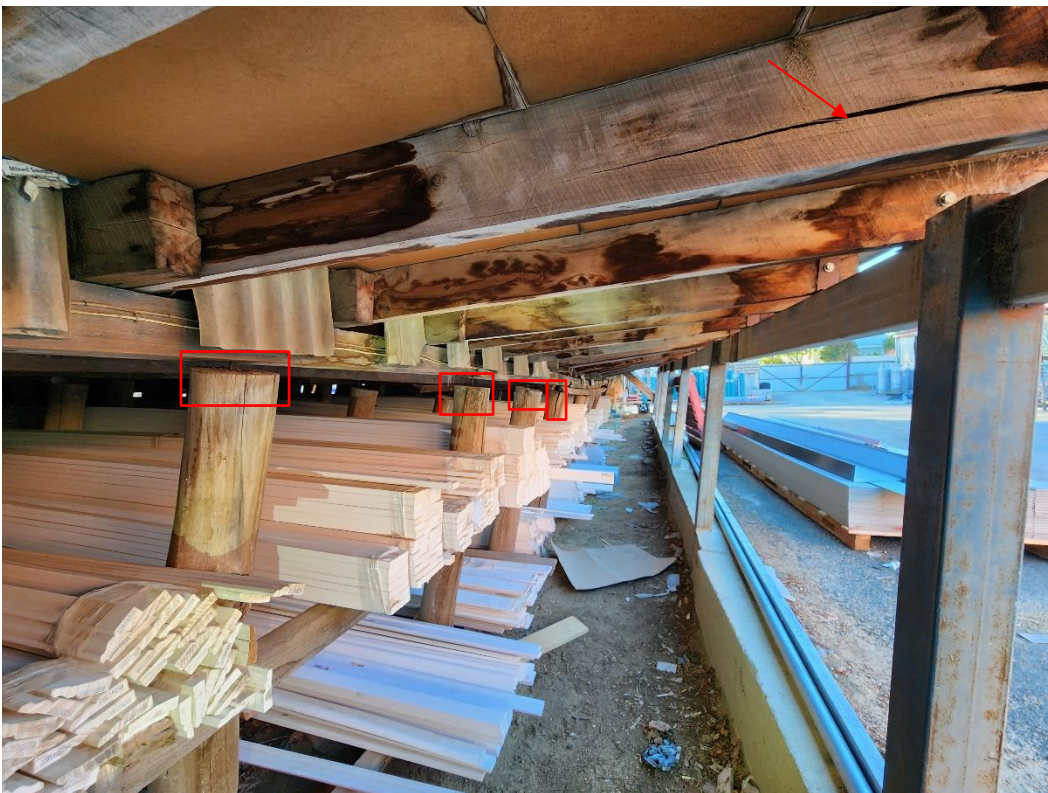
Photo 22: Main Building - Gaps formed between bearers and tops of the timber stumps due to inclination of the stumps shown boxed in red. A large split on a timber bearer shown arrowed in red. Assessment type: Poor.

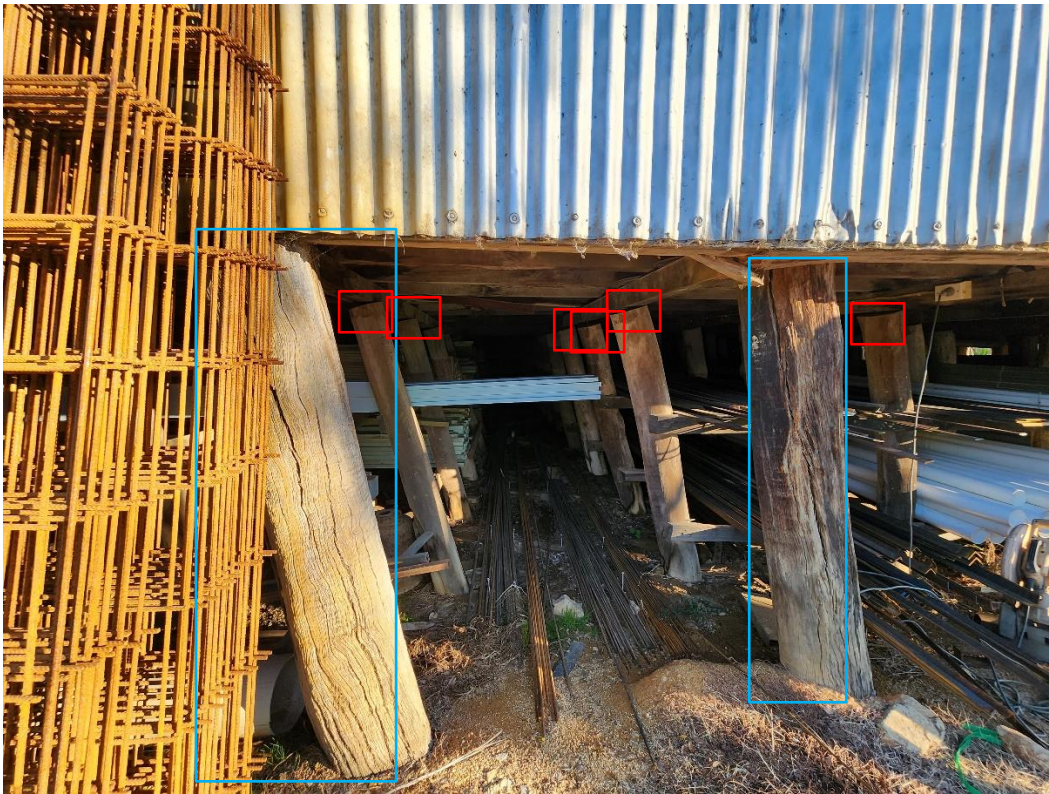
Photo 23: Main Building - Gaps formed between bearers and tops of the timber stumps due to inclination of the stumps shown boxed in red. A large split on timber stumps shown boxed in blue. Assessment type: Poor.

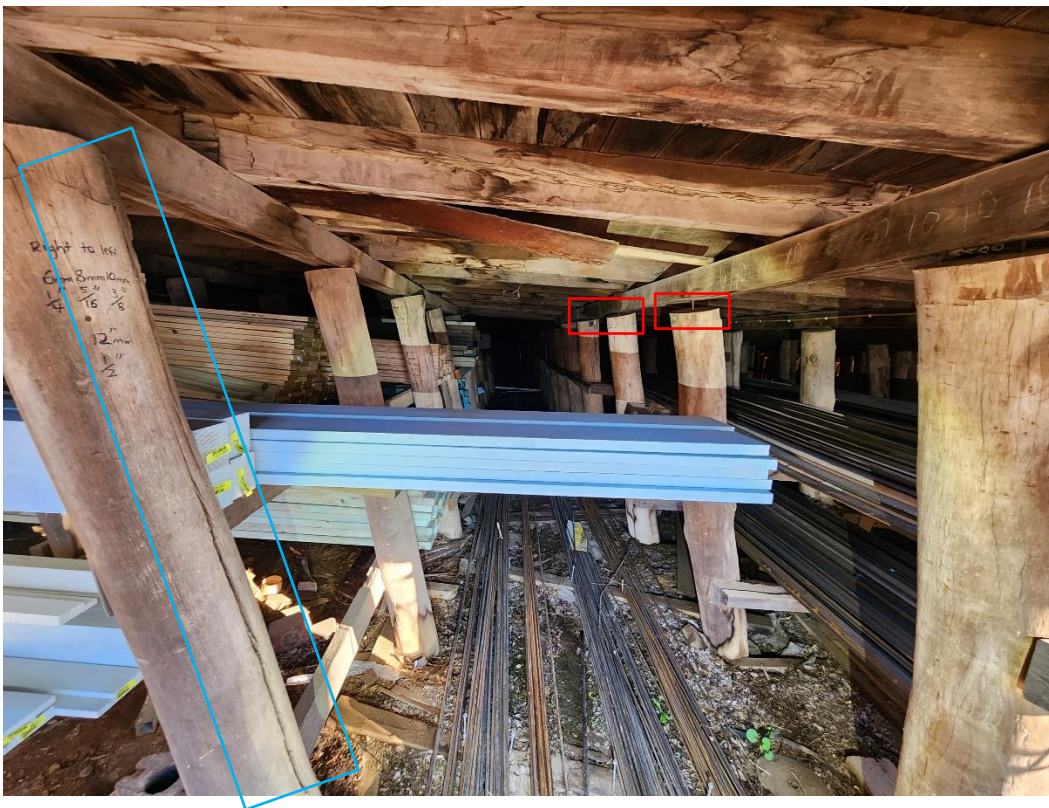
Photo 24: Main Building - Gaps formed between bearers and tops of the timber stumps due to inclination of the stumps shown boxed in red. A cracked timber stump shown boxed in blue. Assessment type: Poor.

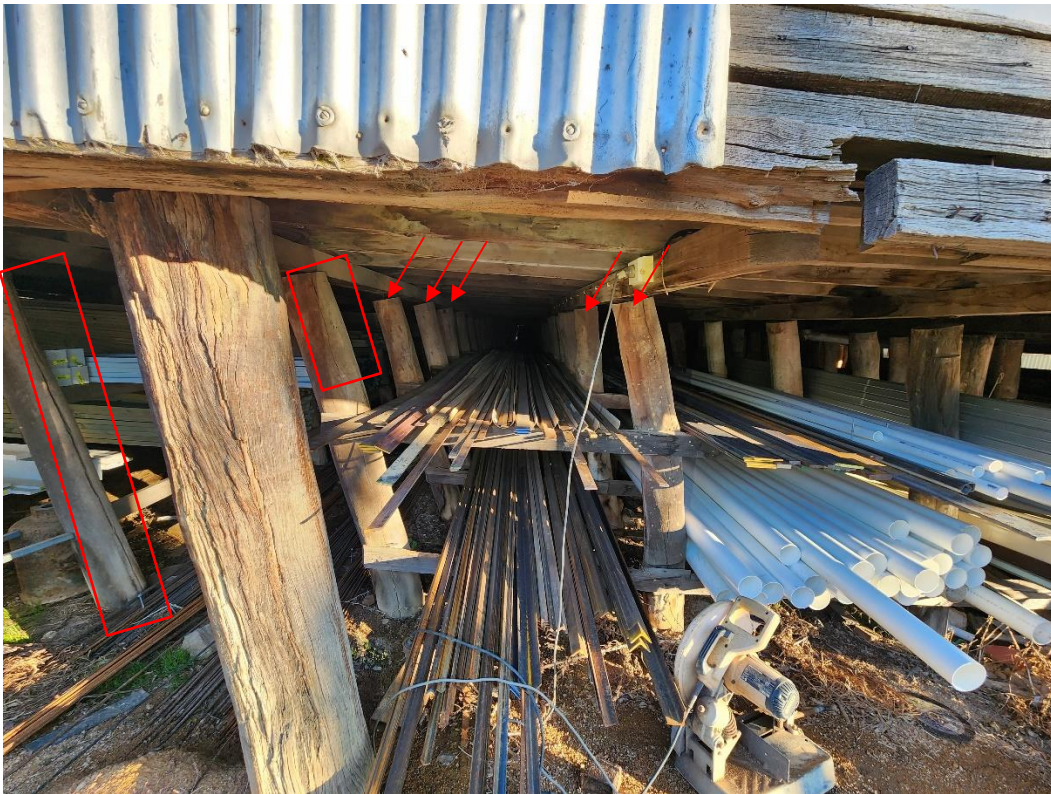
Photo 25: Main Building - Gaps formed between bearers and tops of the timber stumps due to inclination of the stumps shown arrowed in red. Assessment type: Poor. Cracked timber stumps shown boxed in red. Assessment type: Fair to Poor.

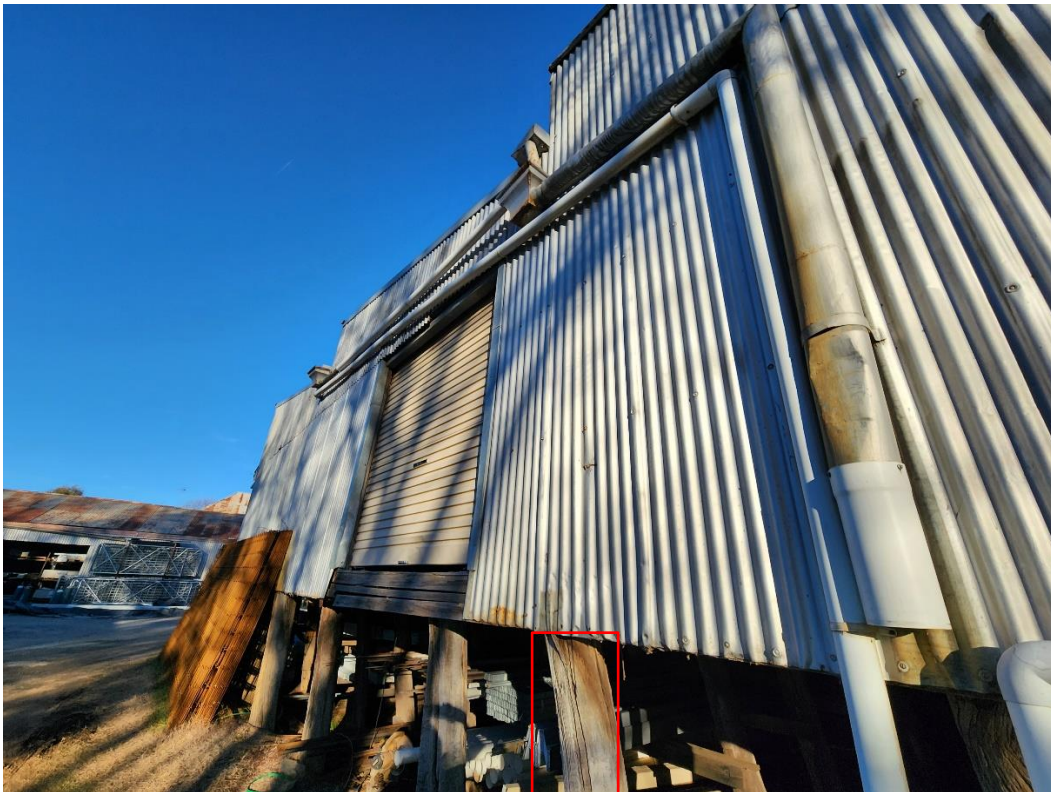
Photo 26: Main Building - A cracked timber stump shown boxed in red. Assessment type: Fair to Poor.

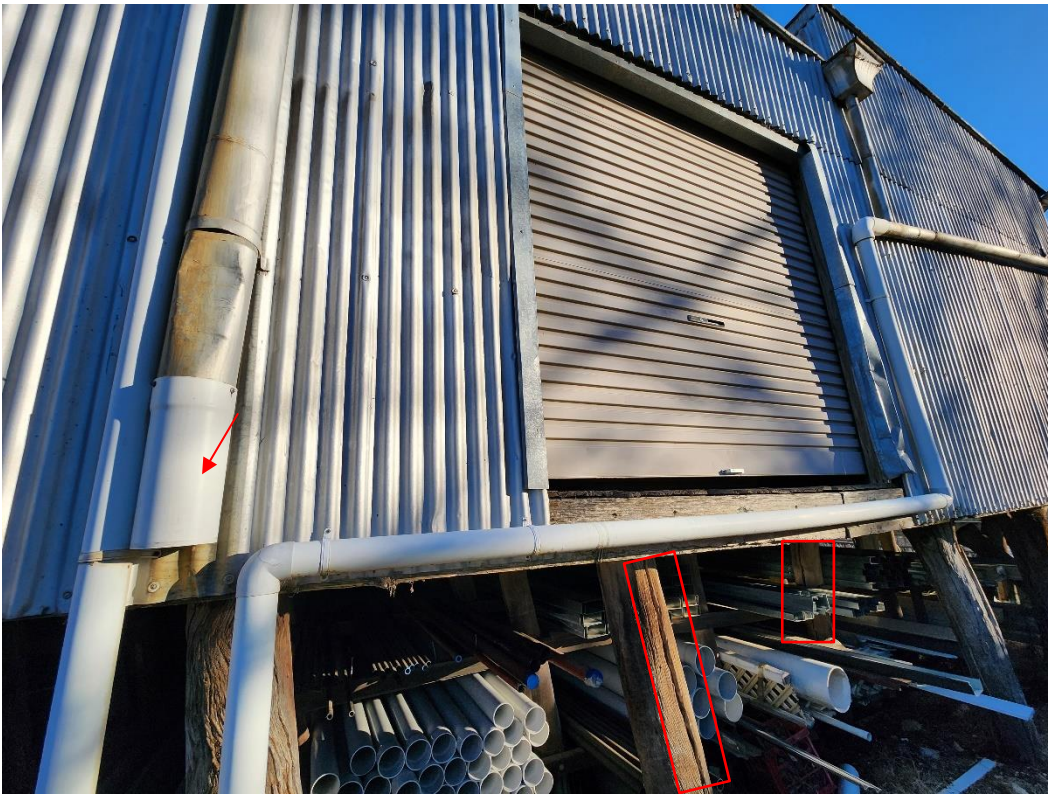
Photo 27: Main Building - Large splits on the timber stumps shown boxed in red. Assessment type: Poor. The downpipe has not been connected to the stormwater system (arrowed red).
