## STRUCTURAL INSPECTION REPORT

Property address: 78 George St,  
Grenfell NSW 2810

Type of inspection report: Structural Inspection Report

Our Reference: JN 24-2023

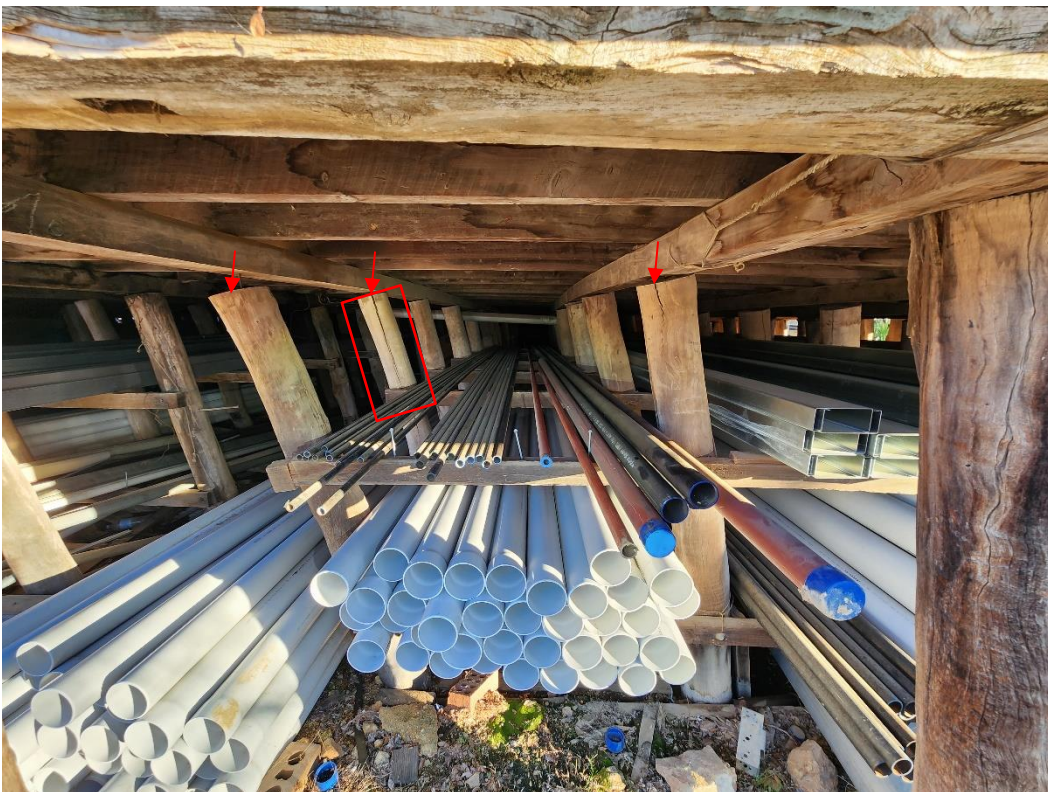
Photo 28: Main Building - Gaps formed between bearers and tops of the timber stumps due to inclination of the stumps shown arrowed in red. Assessment type: Poor. A cracked timber stump shown boxed in red. Assessment type: Poor.

- The majority of the timber stumps in the subfloor have dislocated and inclined up to 16 degrees vertically, thus not supporting the bearers and lost the structural ability to carry the loadings above (photos 2, 3, 4, 5, 6, 7, 8, 9, 22, 23, 24, 28, 29, 30, 34 and 35).
- A significant number of timber stumps in the subfloor space have cracked, split and rotted, thus have lost the structural ability to carry the loadings from above (photos 1, 2, 11, 12, 13, 14, 15, 18, 20, 23, 25, 26, 27, 28, 30, 31, 32, 33, 34, 35, 36 and 37).
- Termite attack found on an internal wall member (photo 49).
- A few downpipes have not been connected to the stormwater system (photos 1 and 27).
- No structural braces have been provided for the roofs, walls and the subfloor.
- Roof leaks at a few locations.

Considering the structural instability of both buildings, it is strongly recommended that both the main building and shed 1 shall be completely demolished as soon as practicable. If any parts of the buildings are to be retained, they can be completely removed during the demolition, redesigned to conform current Australian Standards and NCC and reused if suitable.

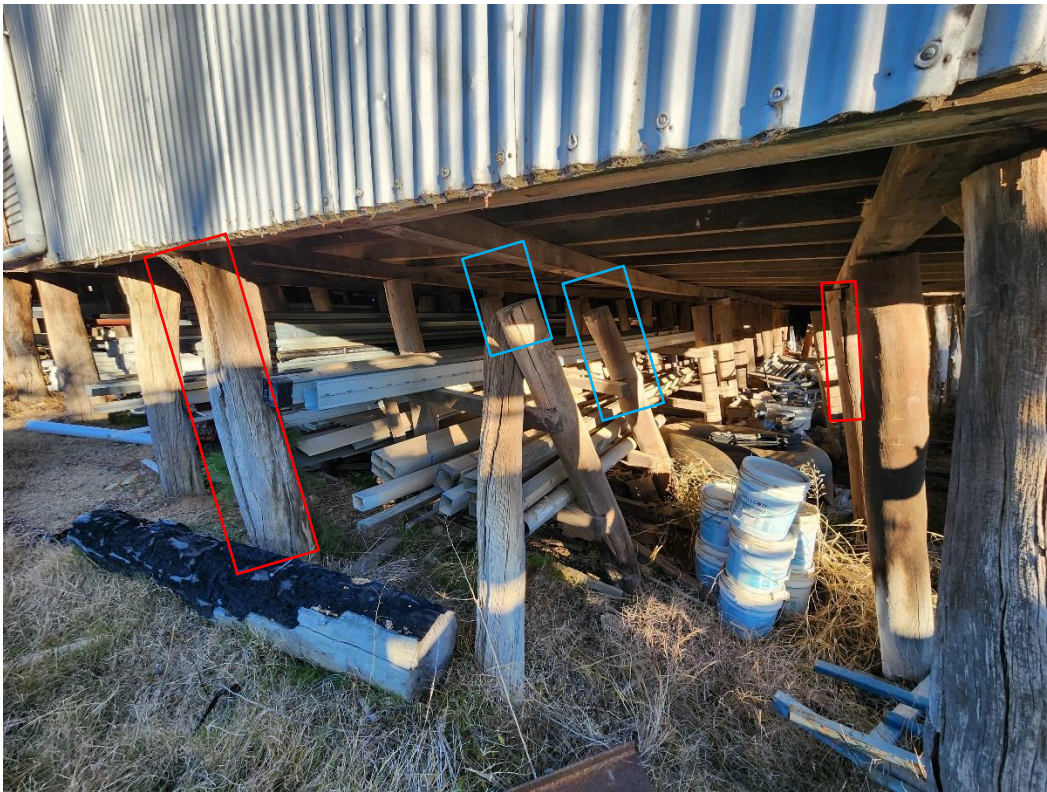
Photo 29: Main Building - The timber stumps with large splits shown boxed in red. Dislocated timber stumps shown boxed in blue. Assessment type: Poor.

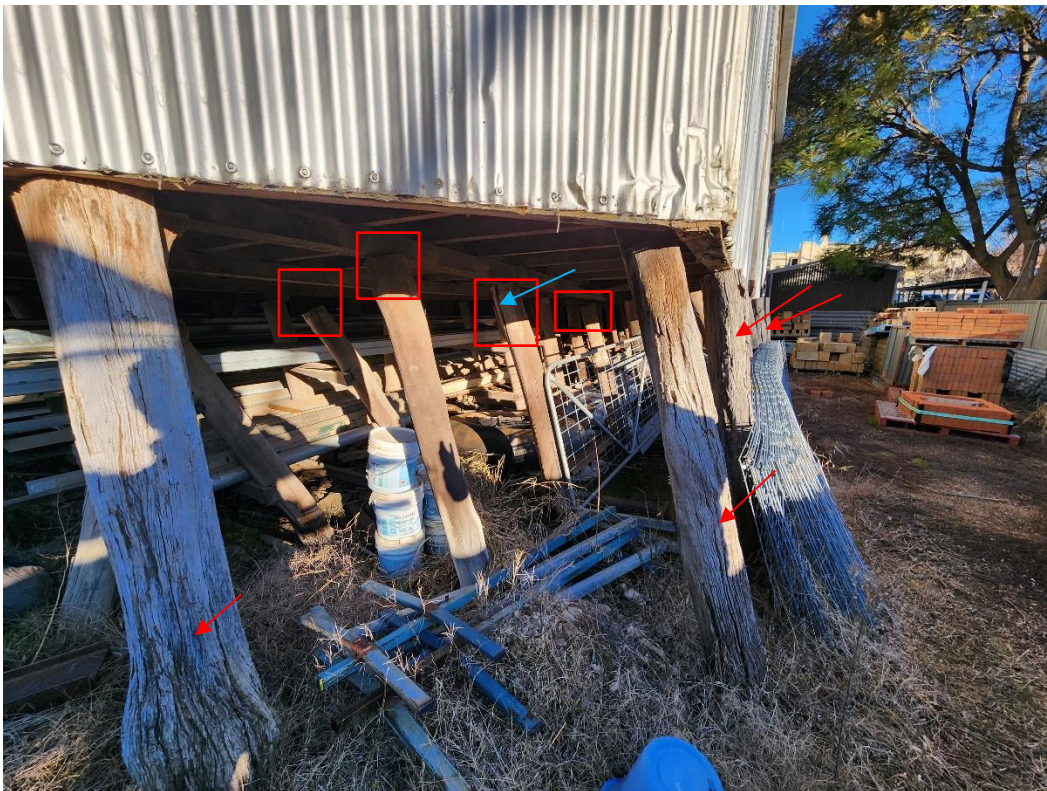
Photo 30: Main Building - Rotted timber stumps shown arrowed in red. A cracked timber shows arrowed in blue. Gaps formed between bearers and tops of the timber stumps due to inclination of the stumps shown boxed in red. Assessment type of all the above defects: Poor.

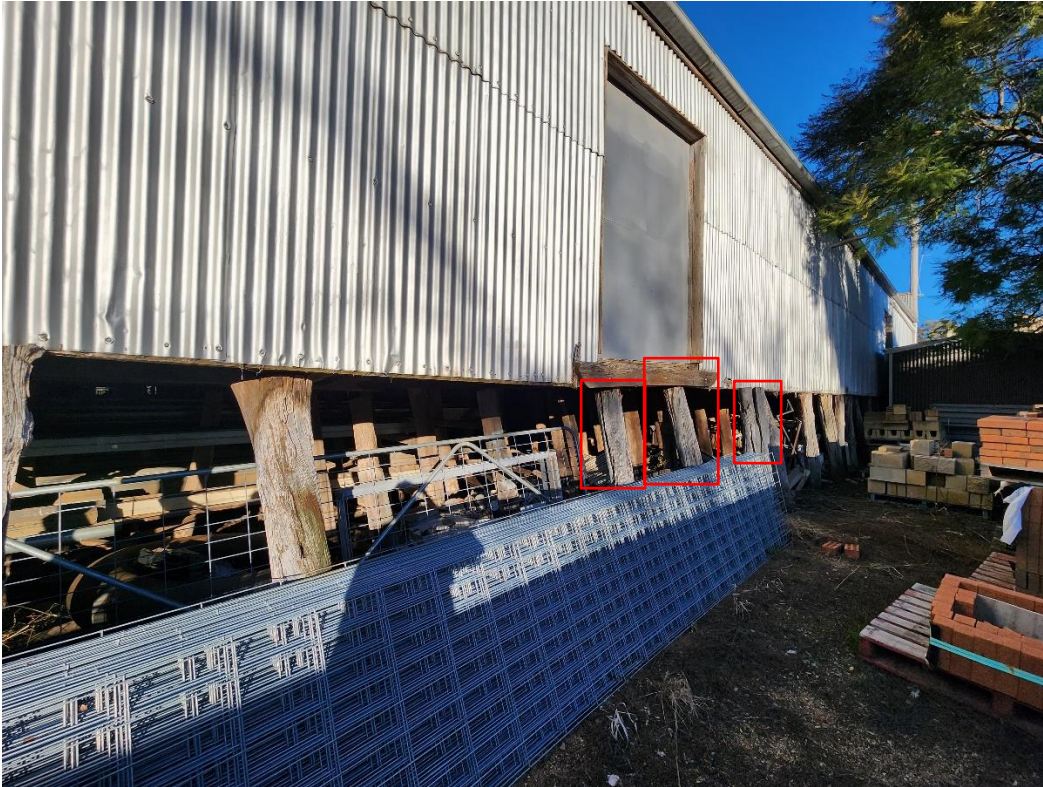
Photo 31: Main Building - The timber stumps with large splits shown boxed in red. Assessment type: Poor.

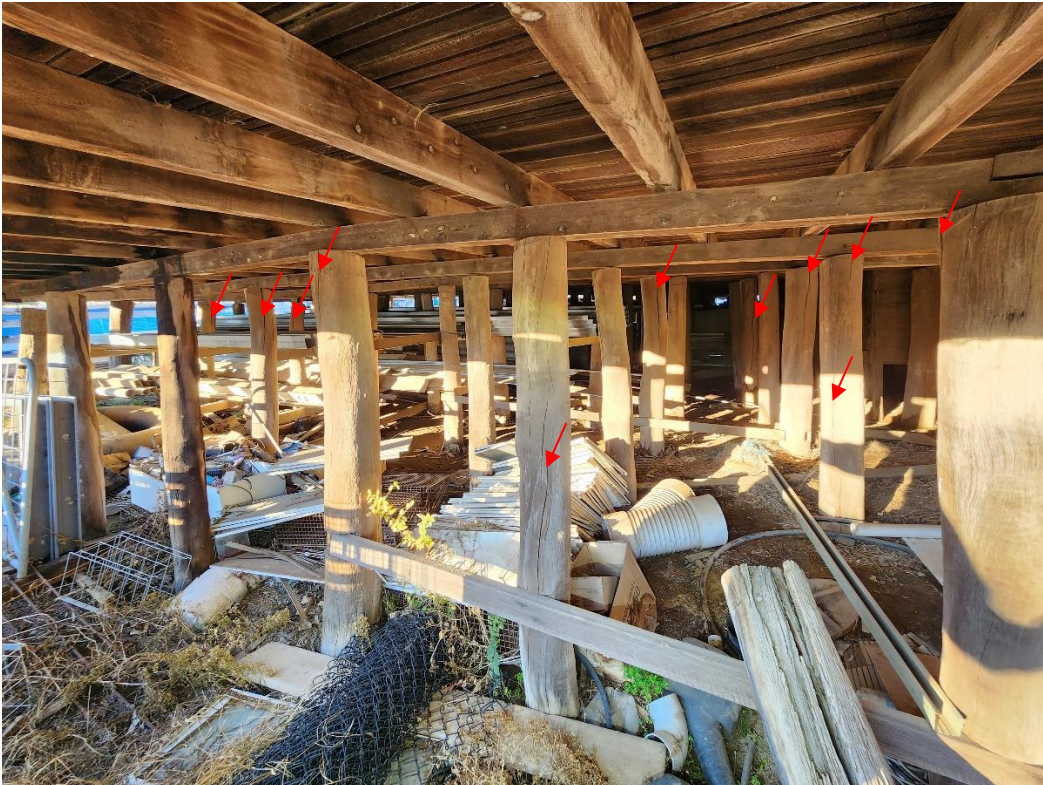
Photo 32: Main Building - cracks on the timber stumps shown arrowed in red. Assessment type: Fair to poor.

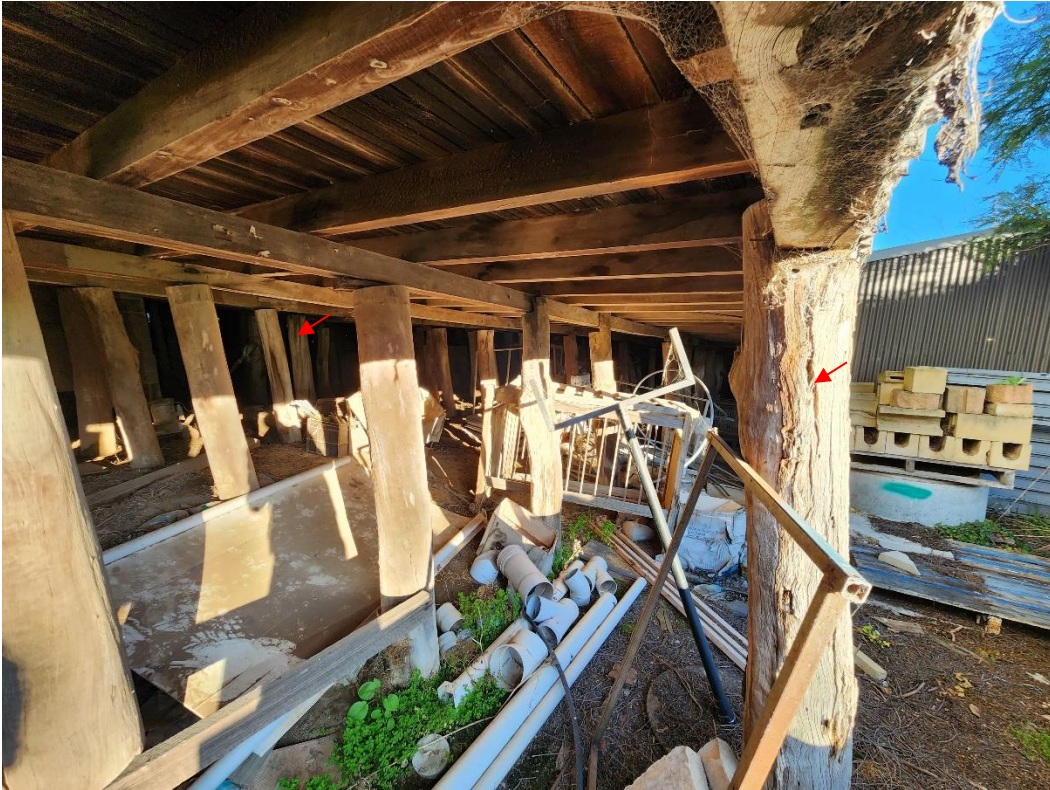
Photo 33: Main Building - Cracks on the timber stumps shown arrowed in red. Assessment type: Fair to poor.

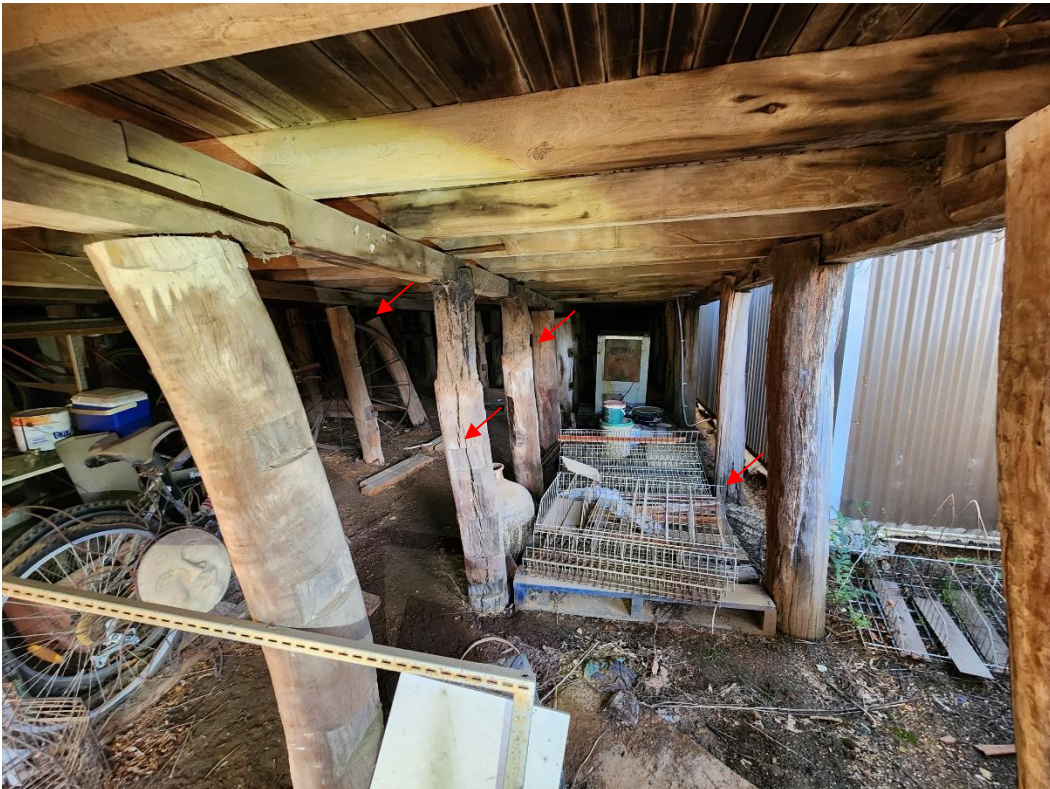
Photo 34: Main Building - Rotted/dislocated/cracked timber stumps shown arrowed in red. Assessment type: Poor.

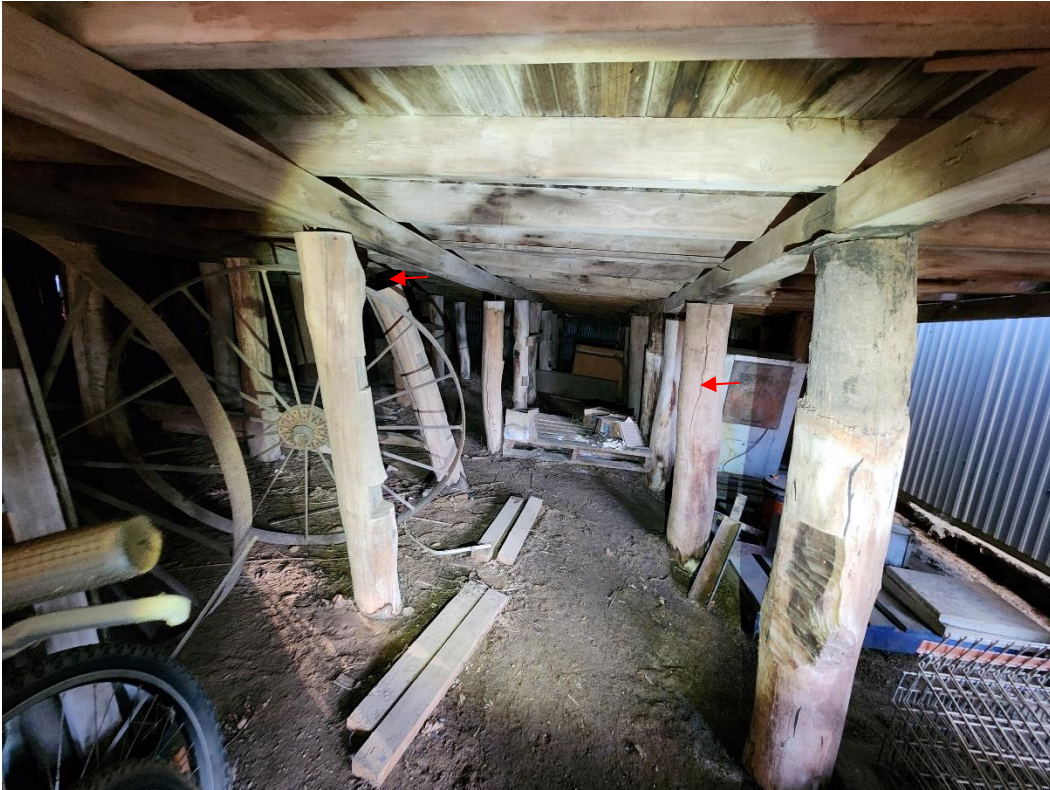
Photo 35: Main Building - Dislocated/cracked timber stumps shown arrowed in red. Assessment type: Poor.

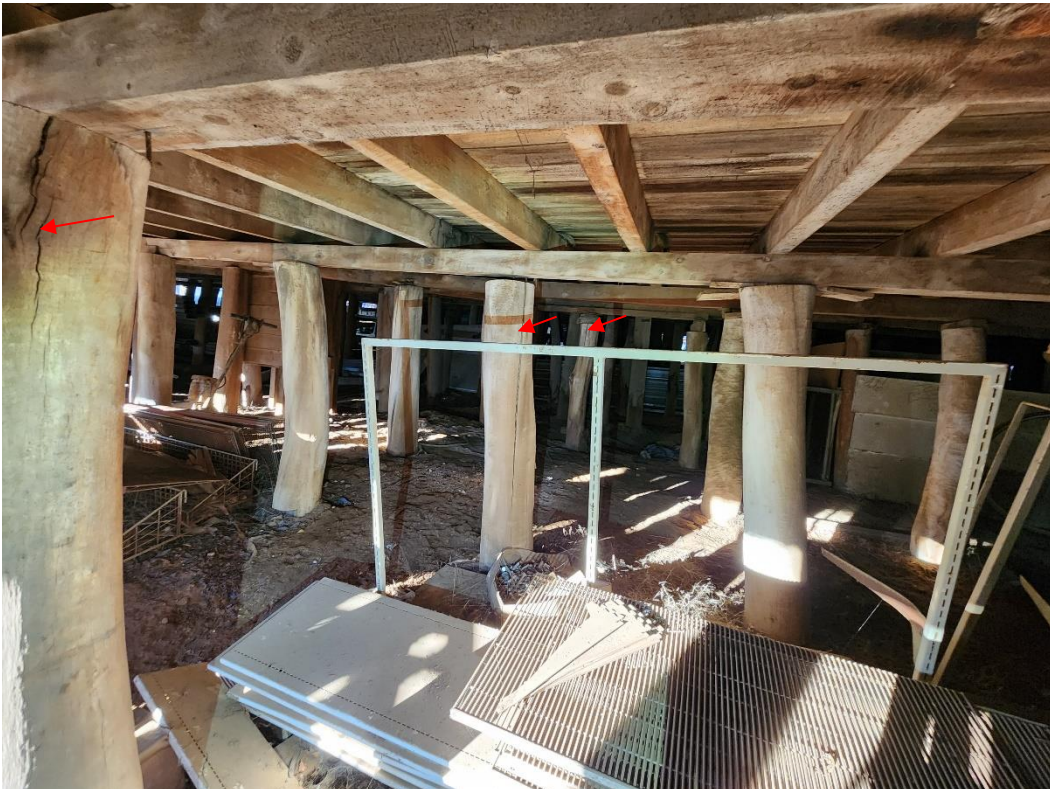
Photo 36: Main Building - Cracked timber stumps shown arrowed in red. Assessment type: Fair to Poor.

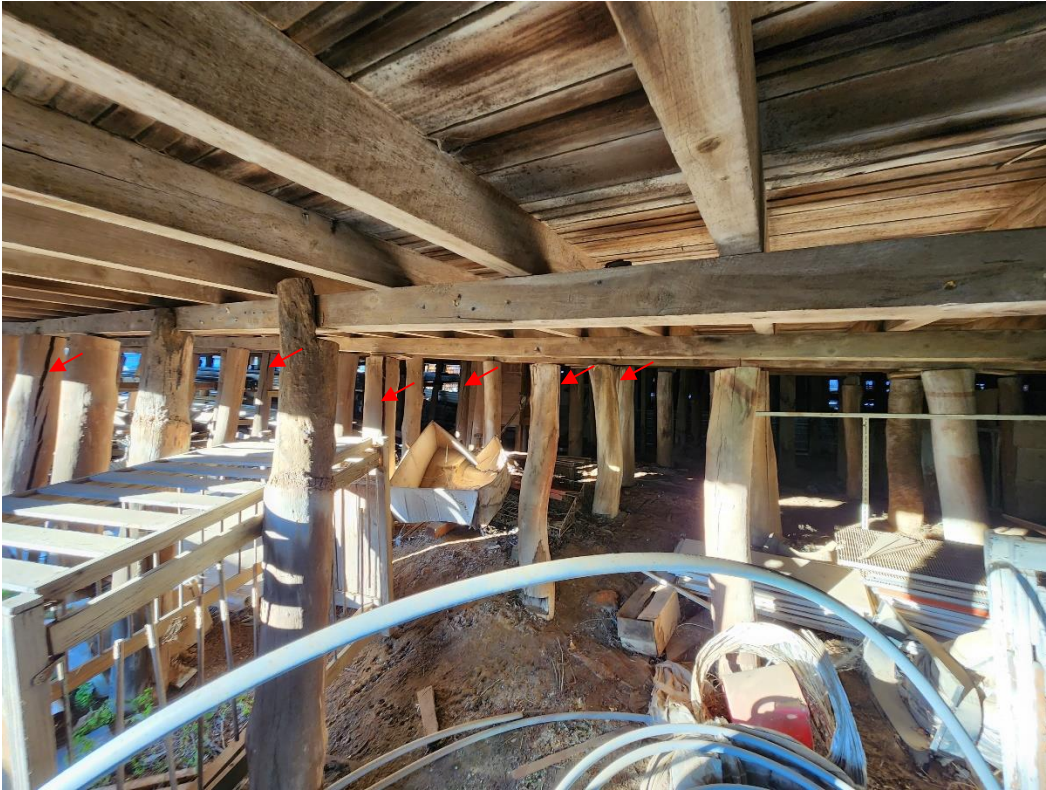
Photo 37: Main Building - Heavily cracked timber stumps shown arrowed in red. Assessment type: Poor.

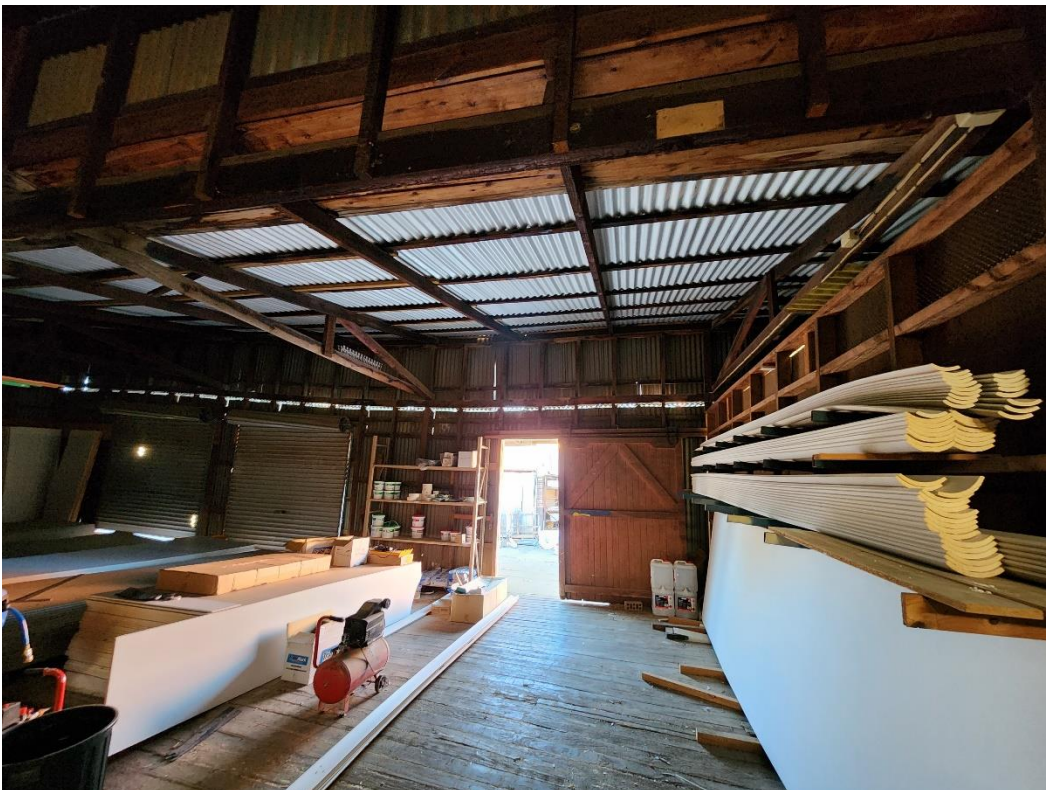
Photo 42: Main Building - A significant amount of footing movement has caused movement in the floors, walls and roller doors.

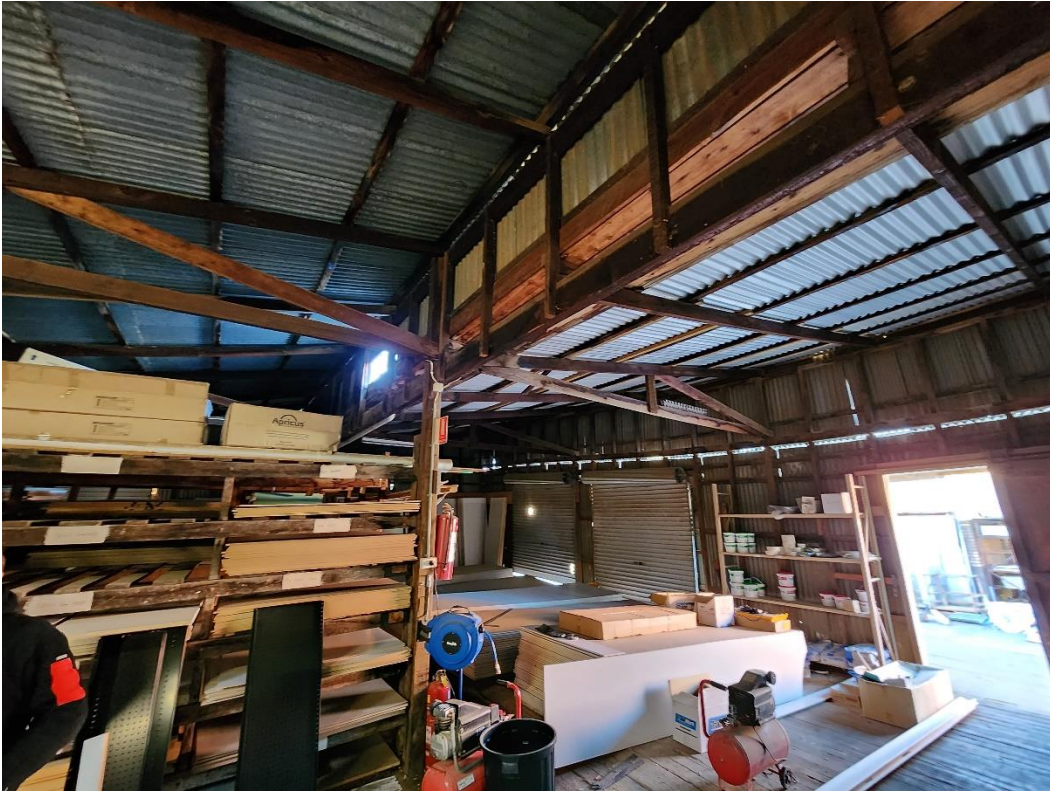
Photo 43: Main Building - A significant amount of footing movement has caused movement in the floors, walls and roller doors.

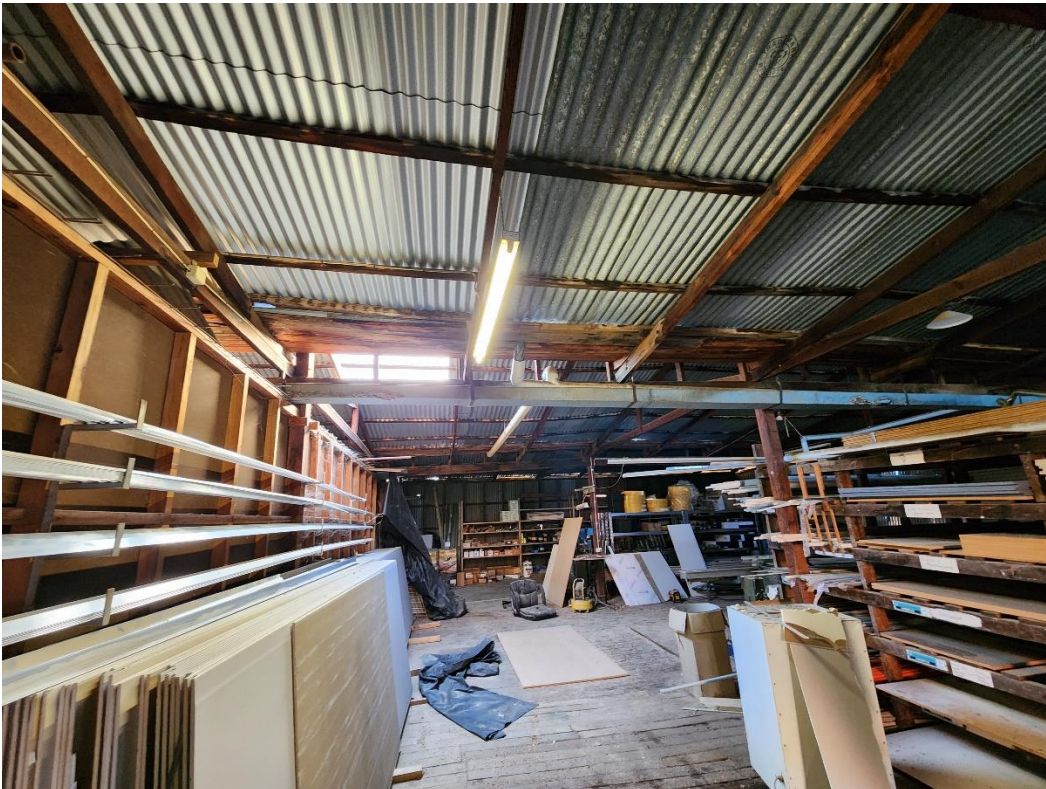
Photo 44: Main Building - A significant amount of footing movement has caused movement in the floors, walls and roller doors.

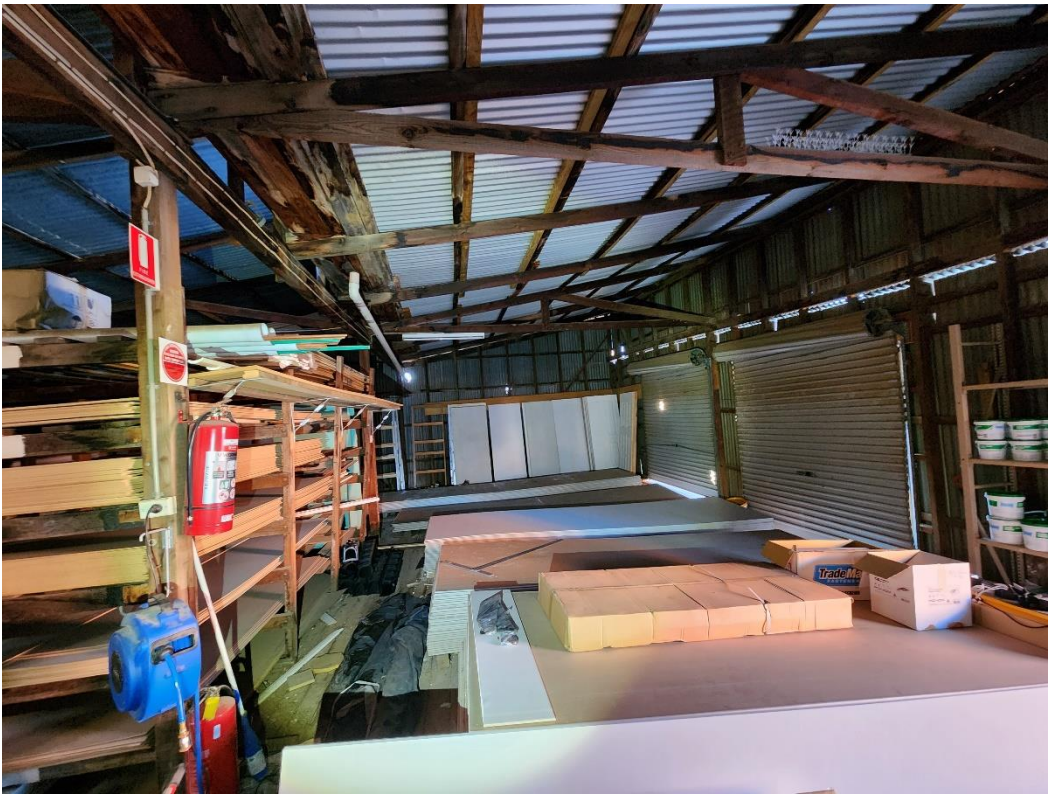
Photo 45: Main Building - A significant amount of footing movement has caused movement in the floors, walls and roller doors.

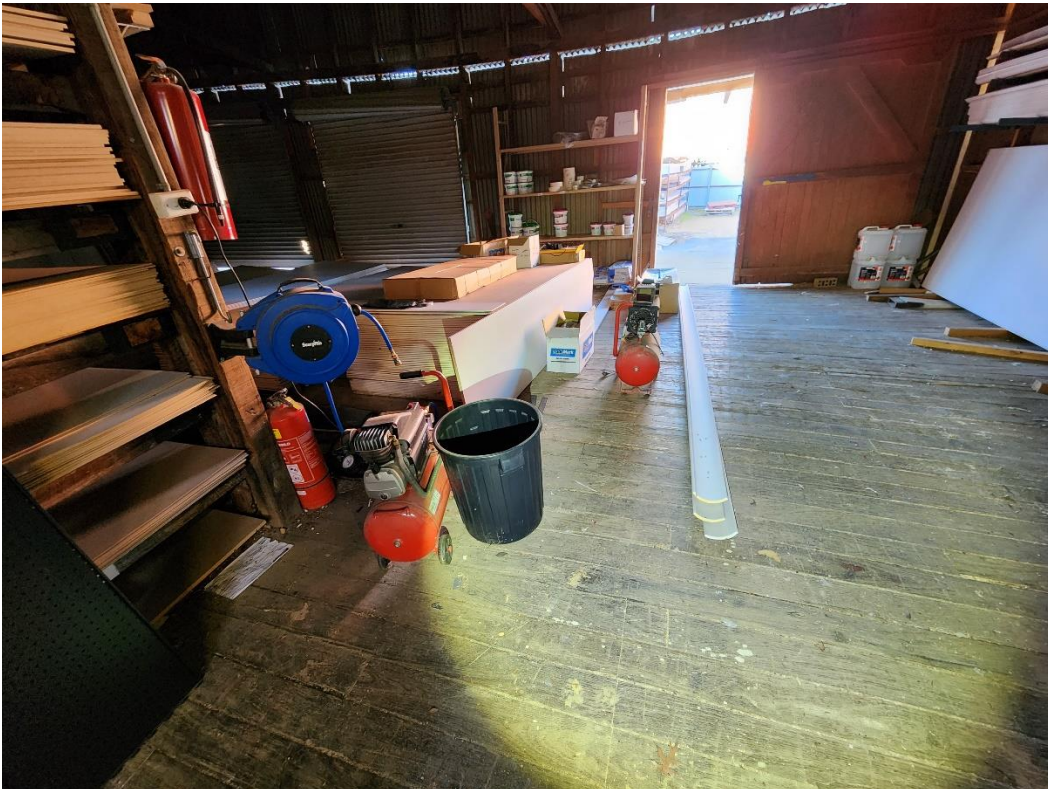
Photo 46: Main Building - A significant amount of footing movement has caused movement in the floors, walls and roller doors.

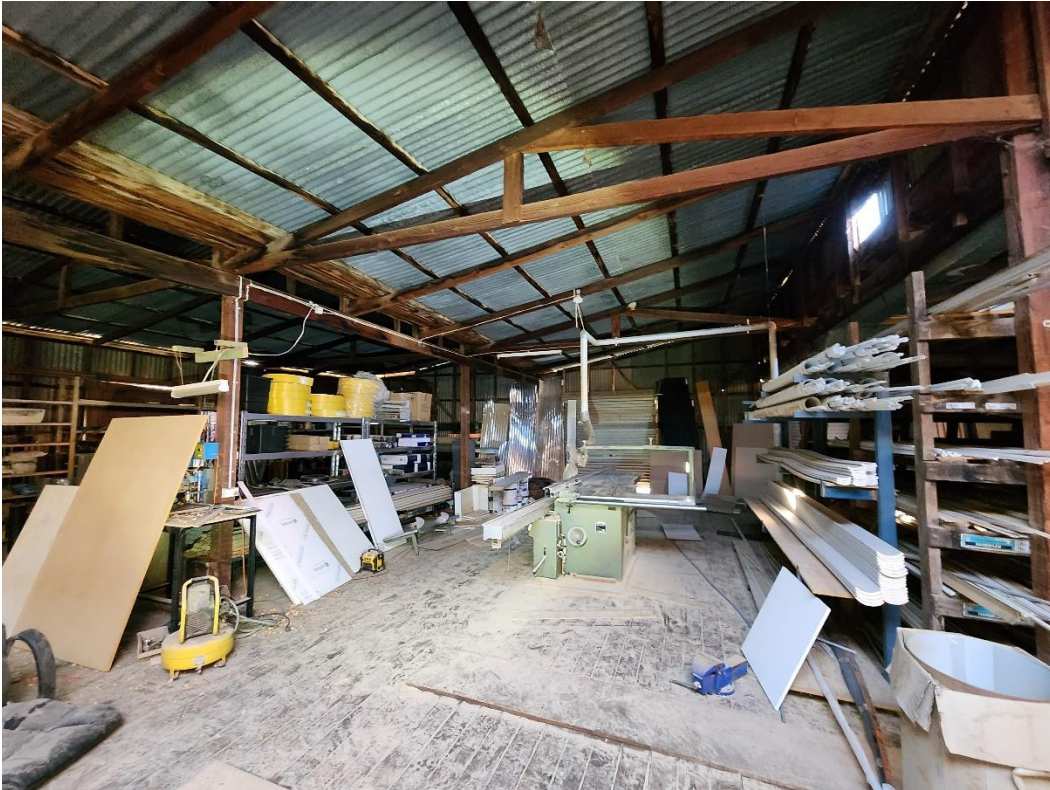
Photo 47: Main Building - A significant amount of footing movement has caused movement in the floors and walls.

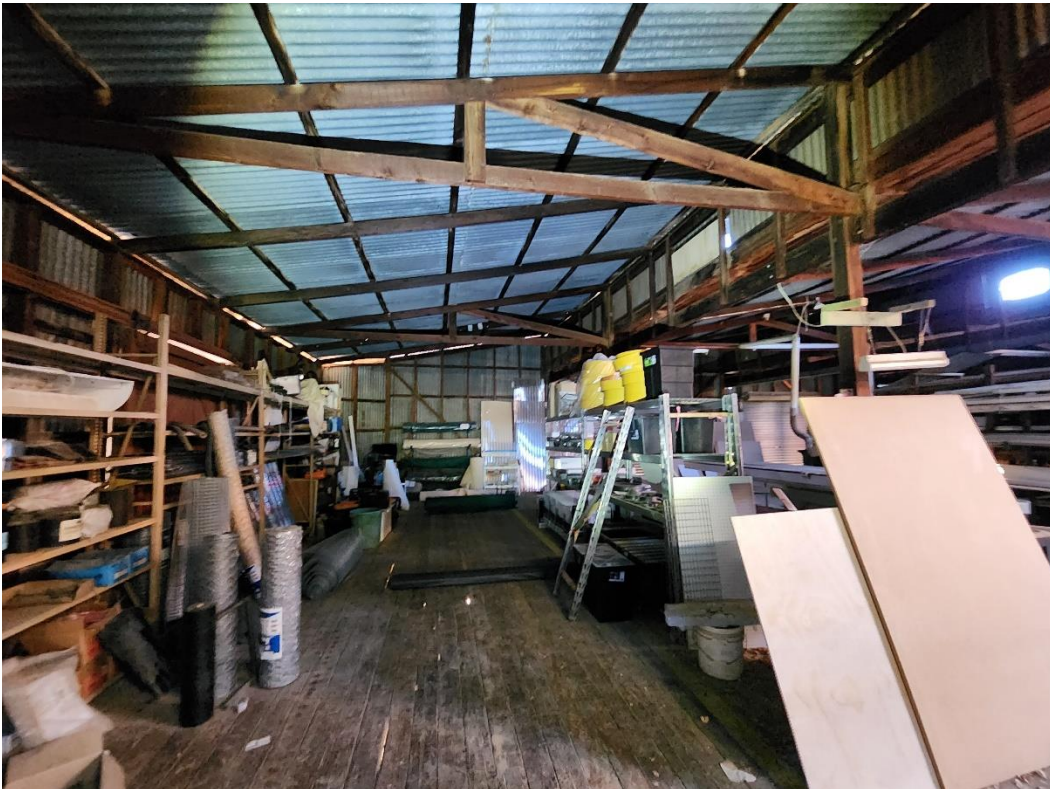
Photo 48: Main Building - A significant amount of footing movement has caused movement in the floors and walls.

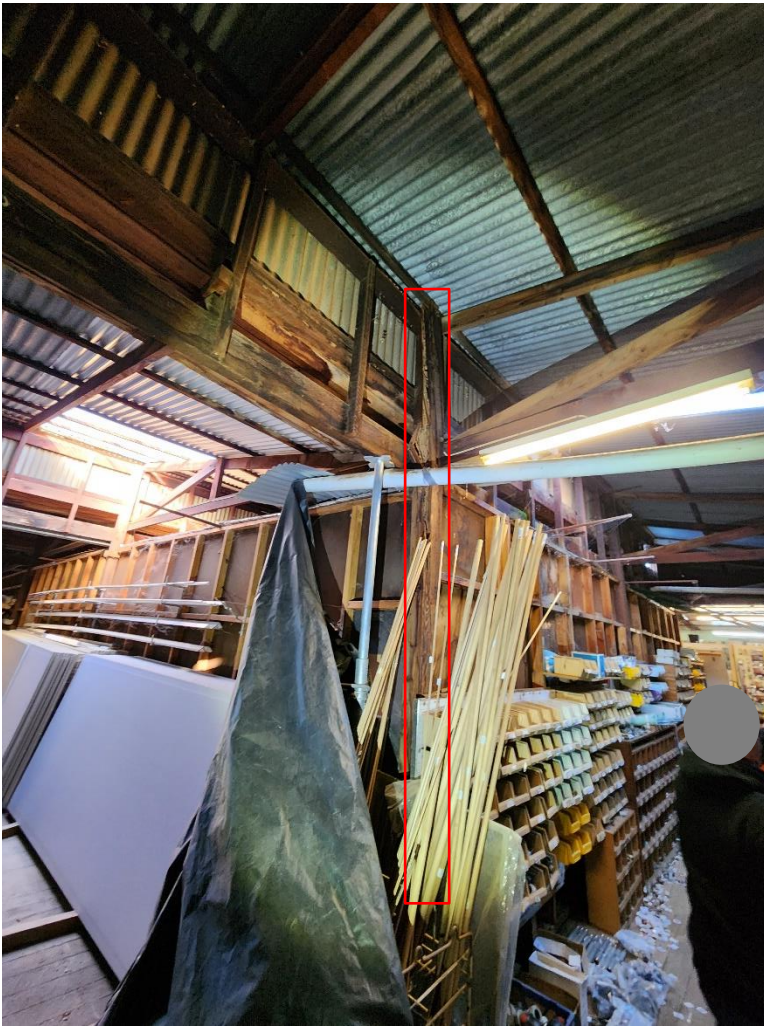
Photo 49: Main Building - Termite attack on the wall member shown boxed in red. Assessment type: Poor.

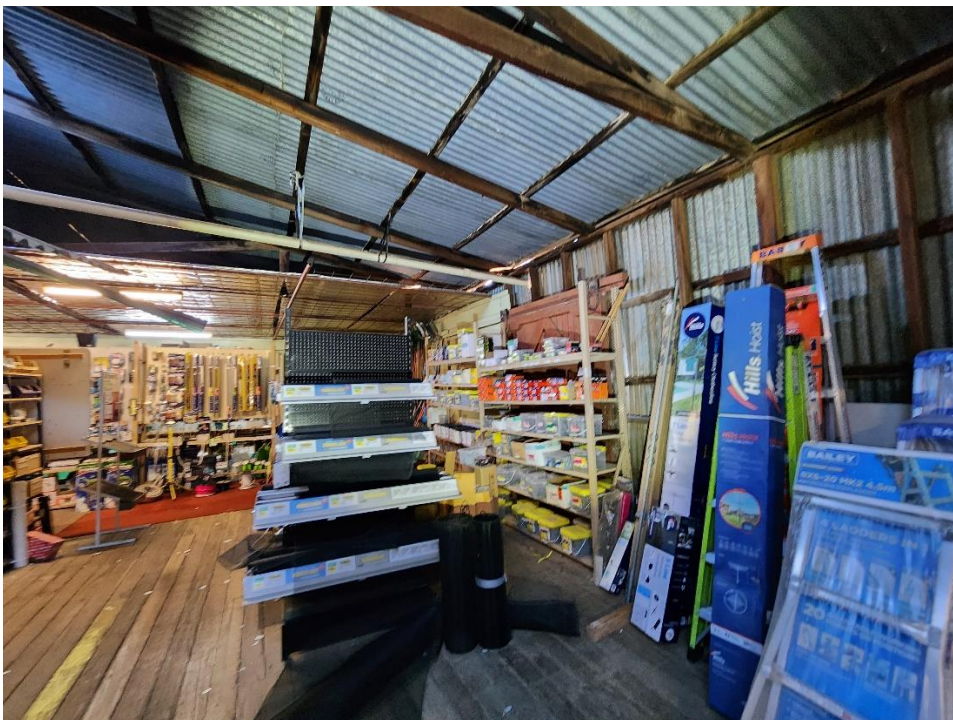
Photo 50: Main Building - A significant amount of footing movement has caused movement in the floors and walls.

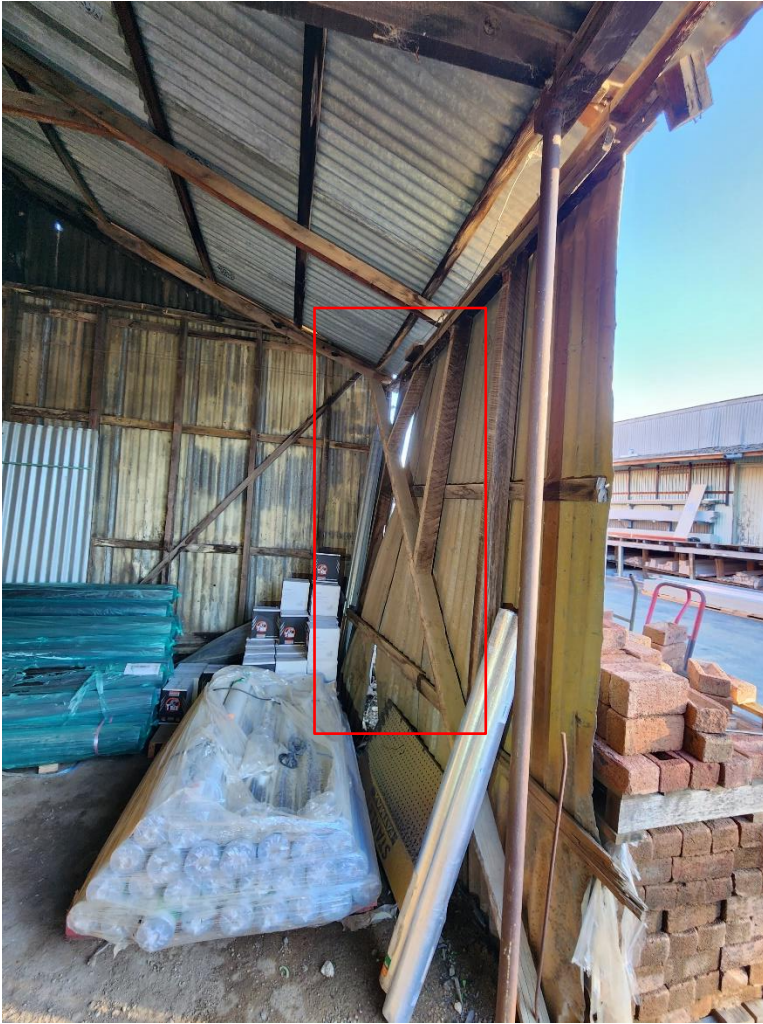
Photo 53: Shed 1 - A collapsing load bearing timber wall shown boxed in red. Assessment type: Poor.

- One of the load bearing walls has partially collapsed (photo 53).
- A few roof trusses are defective, thus not supporting the roof loads adequately (photo 56, 57, 58, 61, 62 and 63).
- No structural braces have been provided for the roof.

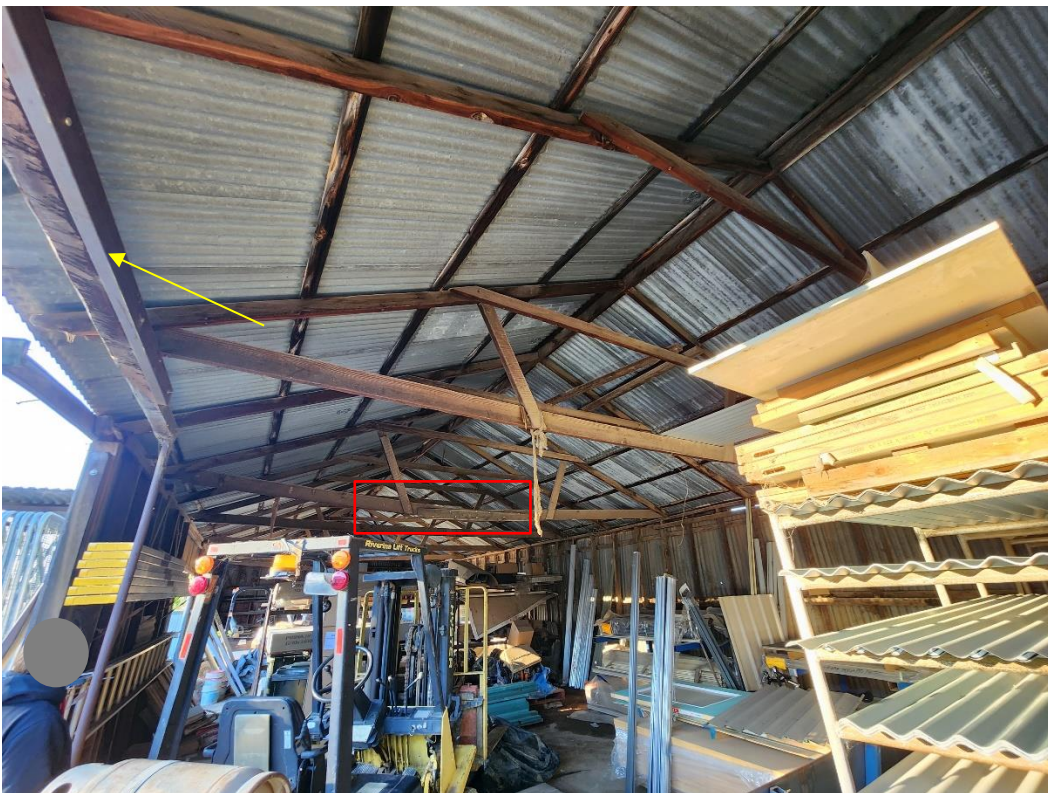
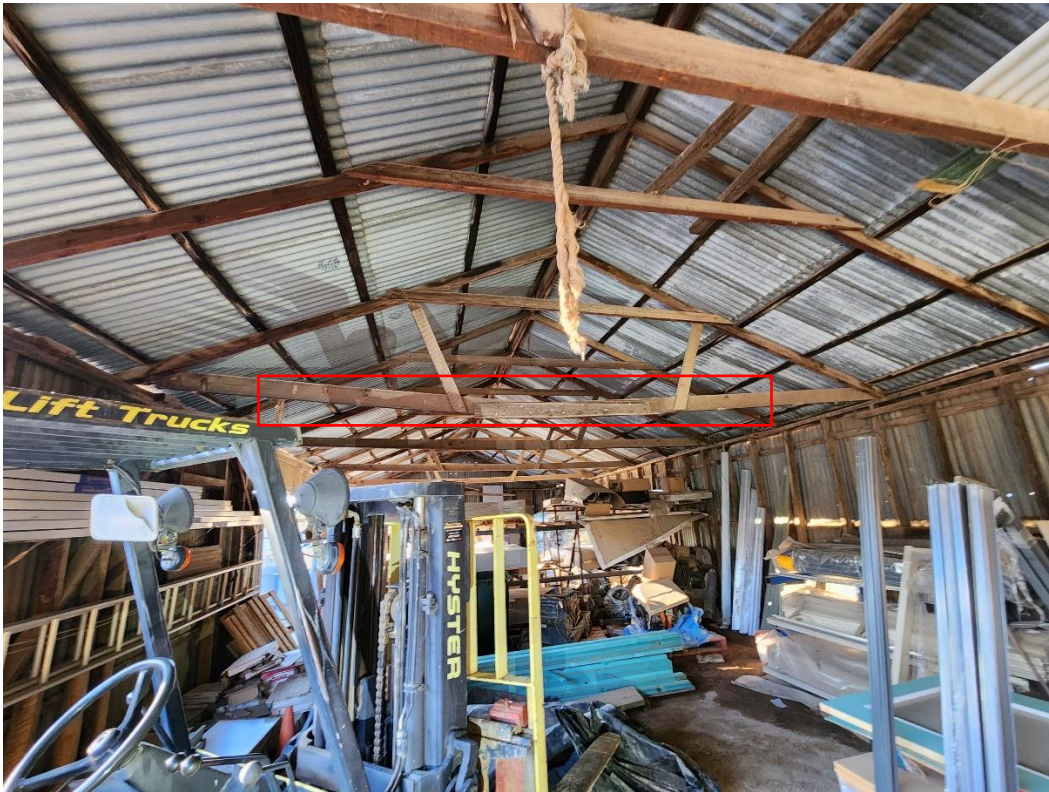
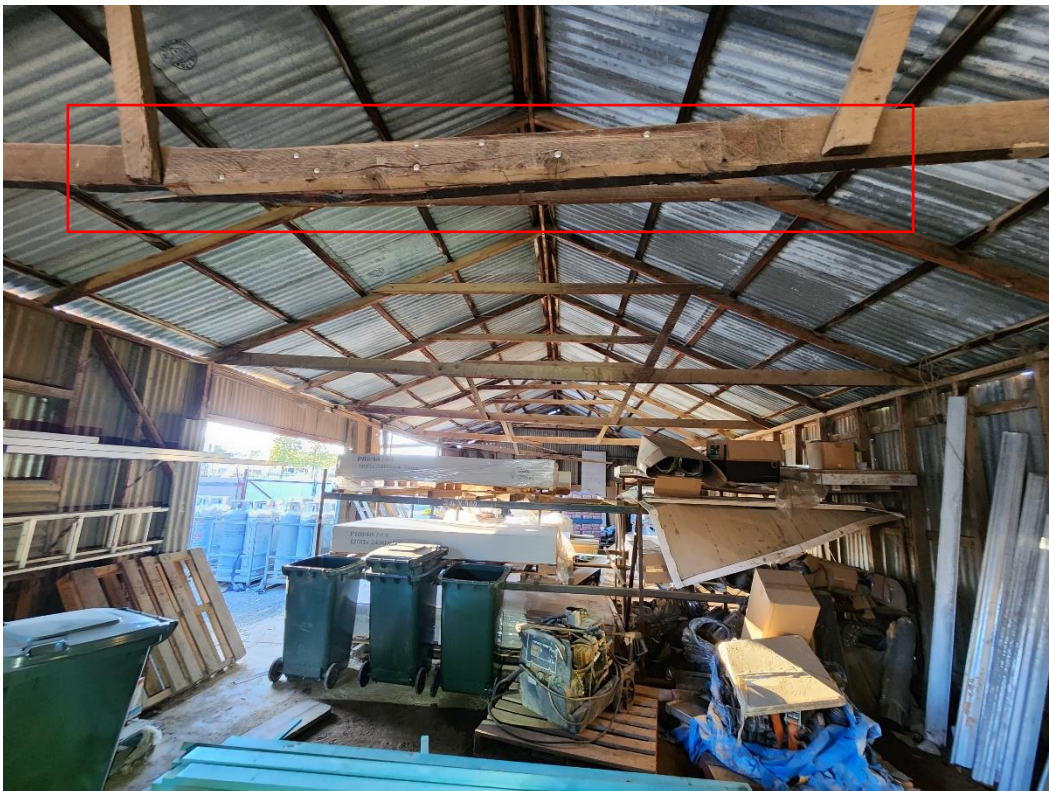
Photo 56: Shed 1 - Deflected/cracked bottom chord of the roof truss shown boxed in red. Assessment type: Poor. Steel lintel and posts provided to support the trusses in an opening (arrowed yellow).

Photo 57: Another of the damage shown in photo 56 above.

Photo 58: A close-up view of the damage shown in photo 56 above.

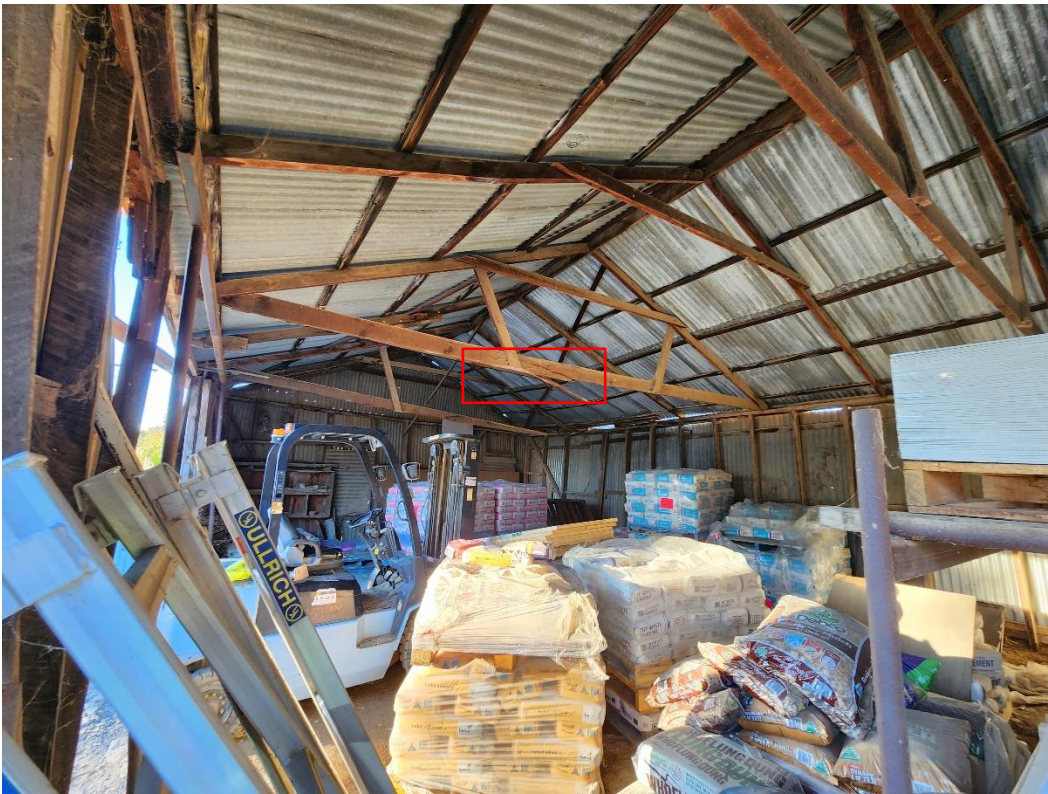
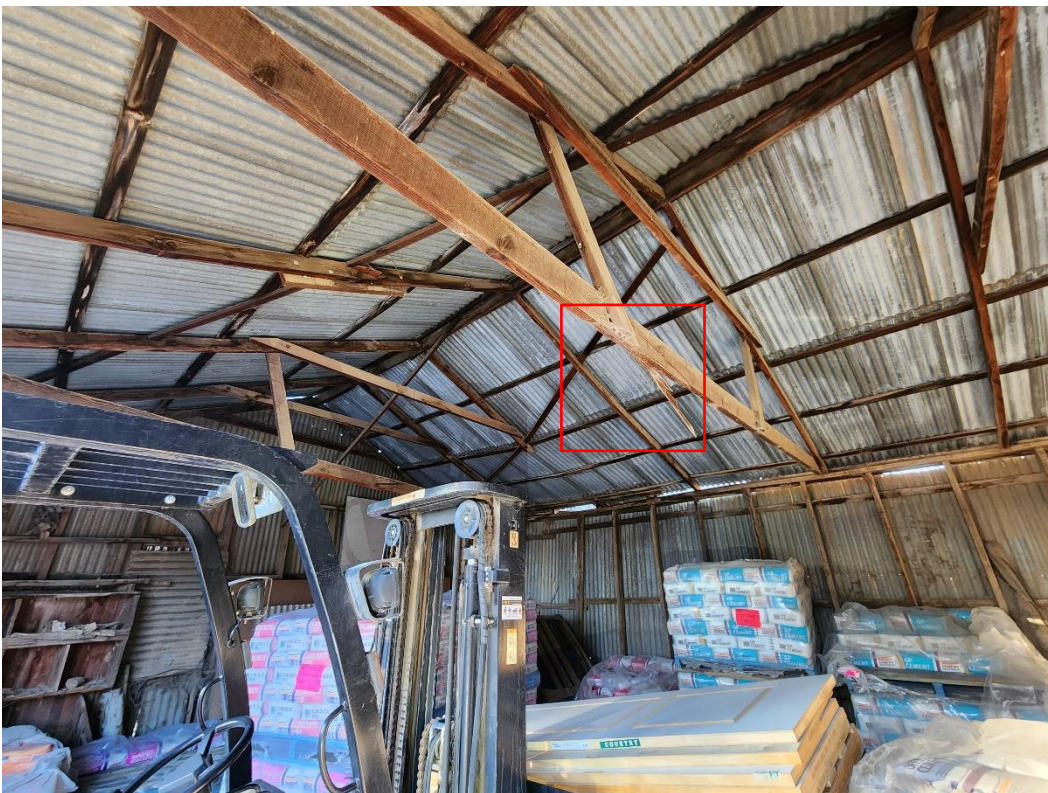
Photo 61: Shed 1 - Deflected/cracked bottom chord of the roof truss shown boxed in red. Assessment type: Poor. No roof braces have been provided.

Photo 62: A close-up view of the damage shown in photo 61 above.

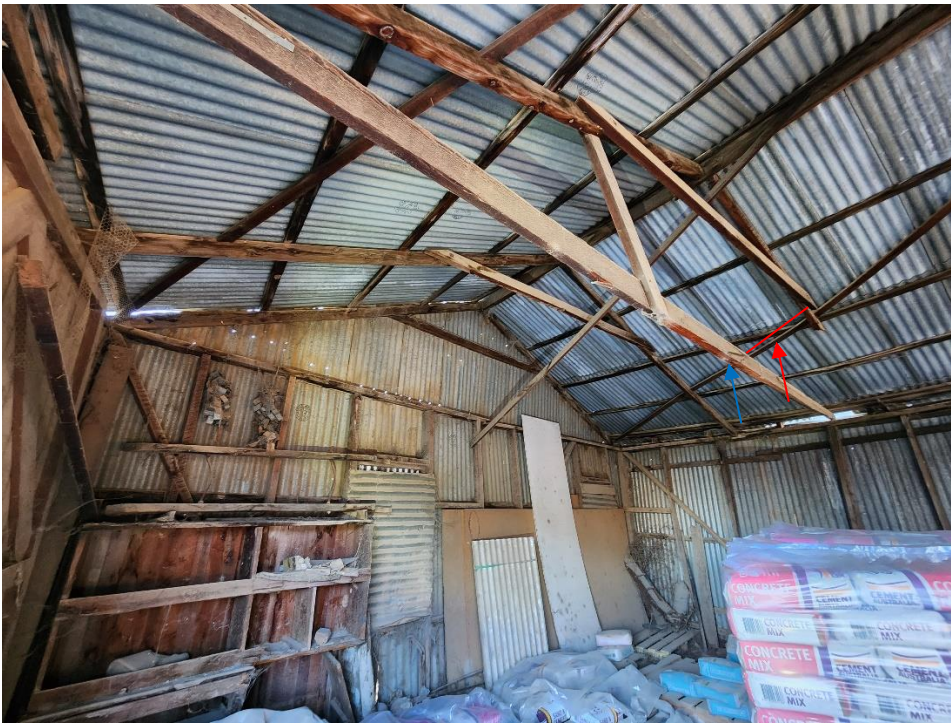
Photo 63: Shed 1. One of the missing struts shown arrowed in red. A defective bottom chord shown arrowed in blue.  
Assessment type: Poor.
