## **Preliminary Geotechnical Investigation Report**

### **Proposed Residential Development**

**32 – 34 Kent Street, Belmore NSW**

**Report No. R25082. Rev0**

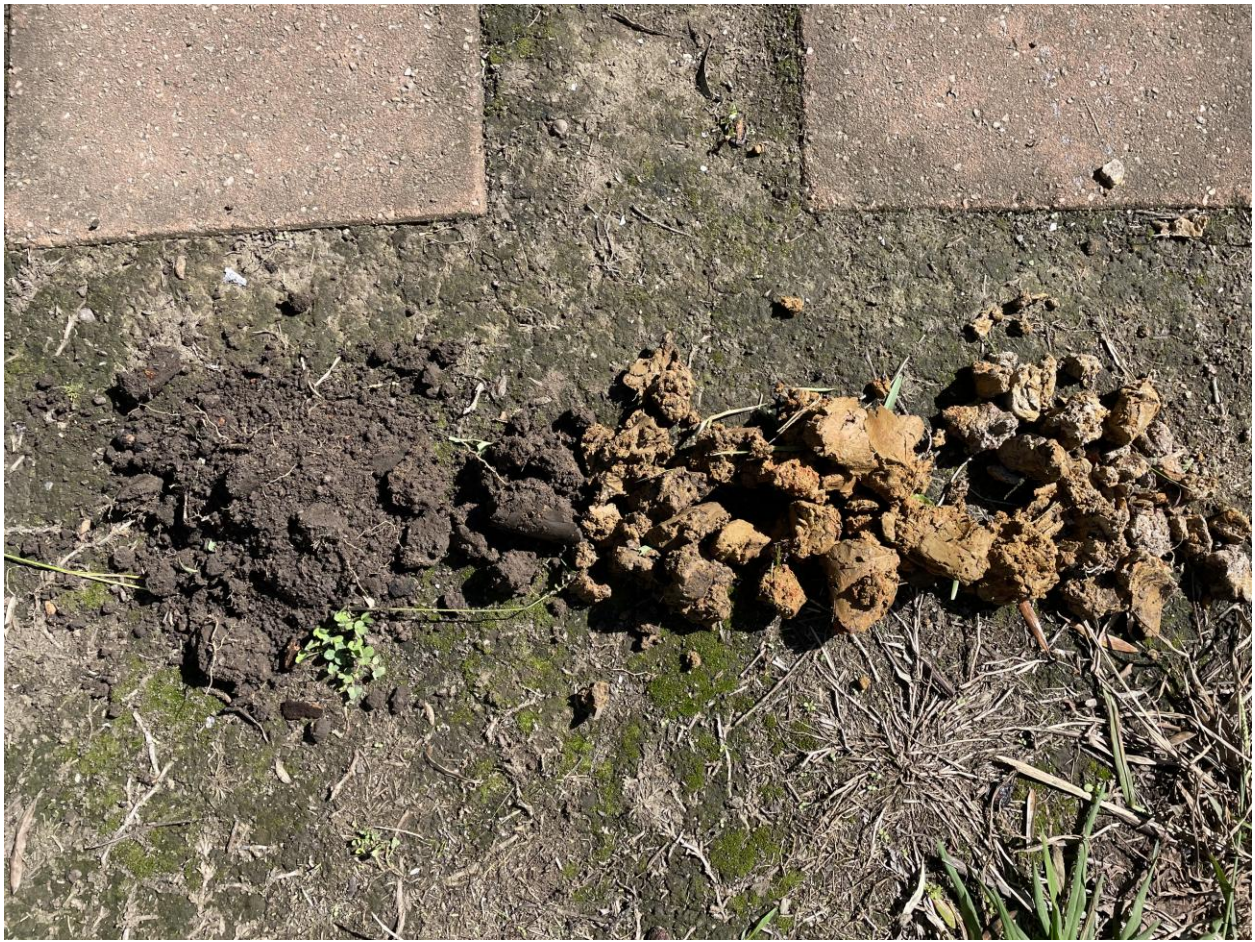
Subsurface Material - BH1

At the borehole locations, the surface material consisted of minor topsoil overlying silty clays of firm to stiff consistency in dry conditions. These materials extended to approximate depths of 0.8 m in BH1 and 0.9 m in BH2. Below these depths, gravelly clays of stiff to very stiff consistency were encountered and continued to the termination depths of 1.0 m in BH1 and 1.3 m in BH2. Further drilling could not be continued below these depths due to refusal on rock floaters/oversized particles.
