GUNUMA LODGE SMIGGIN HOLES NSW

FIRE SAFETY UPGRADE MASTER PLAN DEVELOPED FOR CERTIFYING AUTHORITY REVIEW

DATE: 28 AUGUST 2019
REPORT NO: 0997 – REV B _ FINAL
PREPARED FOR: GUNUMA LODGE PTY
PREPARED BY: J² CONSULTING ENGINEERS | **FIRE SAFETY ENGINEERING**

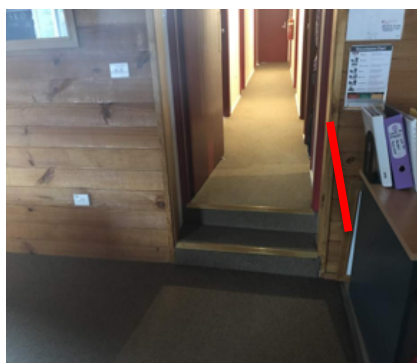
Figure 6 – Handrail to be installed to exit stair in stair for both Nth and Sth wings in compliance with D2.17

5. Handrails are required to be installed on stairs leading down from SOU corridors on both north and south wings leading to the lounge area and to external stair on the ground floor of the southern wing.

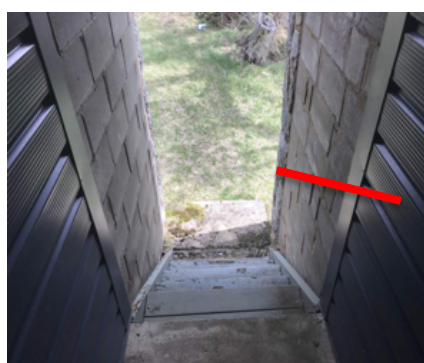
Figure 7 – Handrail to be installed to compliance with D2.17

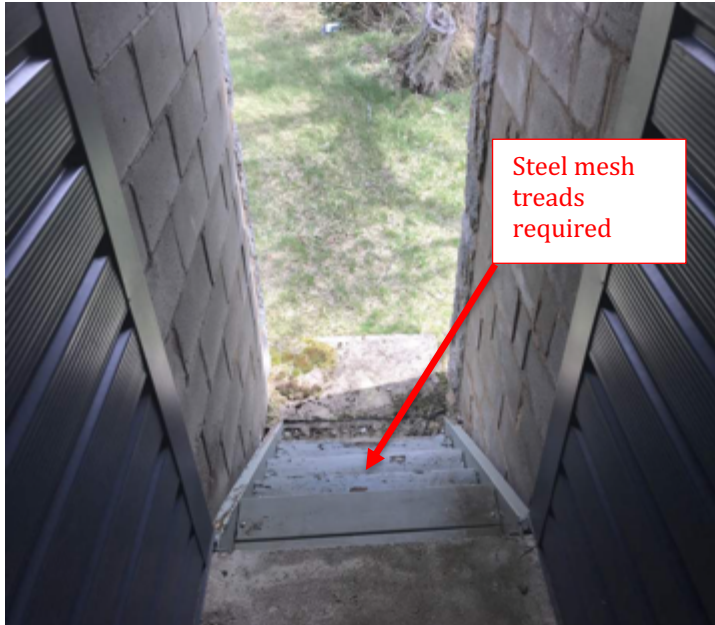
Figure 8 – Timber treads to exit stairs

6. The external stair on the ground floor of the southern wing requires a floor surface that consists of steel mesh or other suitable material to comply with BCA clause G.4

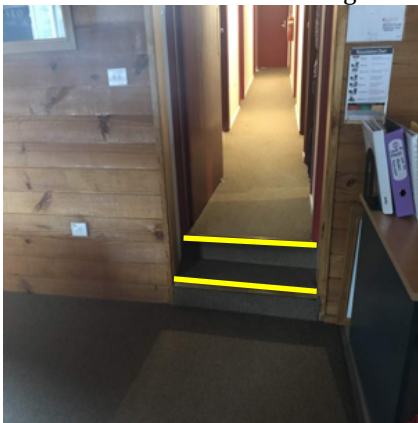
Figure 9 – Corridor door to close to threshold

7. The doors from the northern and southern corridors leading into the common lounge area on the first floor are to have a step no closer to the doorway than the width of the door leaf as required by BCA Clause D2.15. To satisfy performance requirement DP2 we propose the installation of signage in contrasting colours with letters no smaller the 40mm stating “CAUTION WATCH YOUR STEP” on either side of both the northern and southern first floor corridor doors accessing the lounge. In addition to this we propose contrasting in colour slip resistant nosing to be installed to stairs as a further warning to occupants to the potential trip hazard.

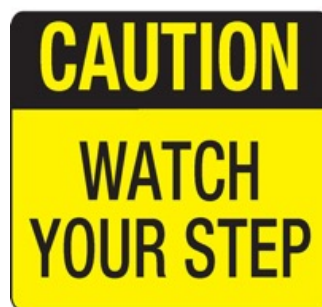
Figure 10 – Signage required to both sides of door

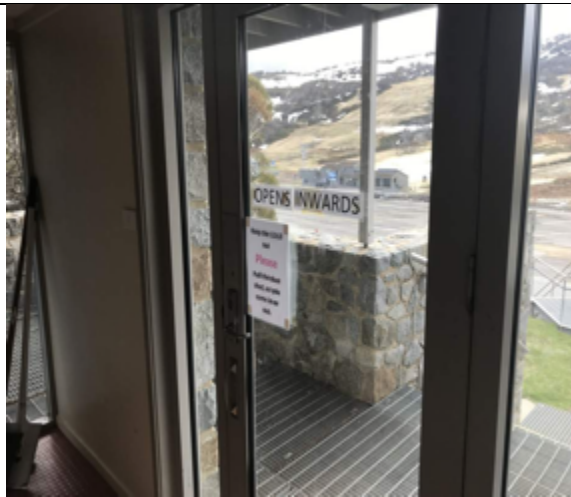
Figure 11 – Temporary open inwards sign to entry door

8. The ground floor main exit door to the west towards Link Road requires a permanent “OPEN INWARDS” sign to be fixed. Currently a temporary sign affixed. Other exit doors should be checked and confirmed for compliance. Decal should be fixed to any glazing which could be confused for an open doorway.

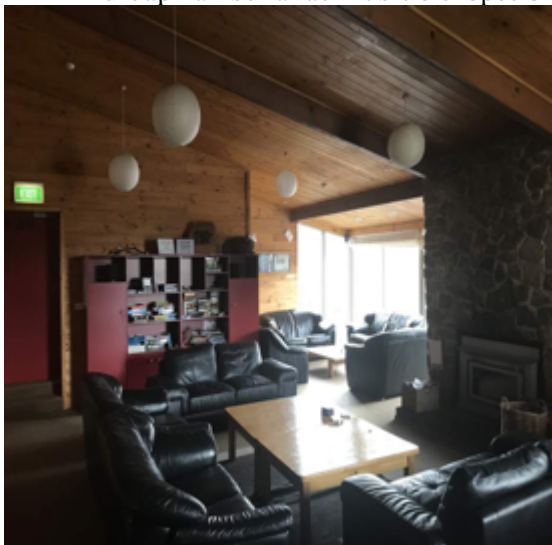
<p>Figure 1 – first floor lounge area</p>

<p>b) The wall lining are primarily pine timber lining boards and do not achieve the required Group number under Table 3 of Spec C1.10</p>

<p>Figure 2- Ground floor games room</p>	Non-Compliant	<p>Deemed to satisfy solution. Install protective covers to all timber lined walls and ceilings (excluding SOU's, public corridors and public lobbies) to achieve a smoke growth rate index not more than 100; or an average specific extinction area less than 250m²/kg This can be achieved via a single layer of 10mm plasterboard.</p> <p>Or</p> <p>Performance solution proposed. Refer to Section 4 performance solution 1 in this report</p>
C1.8	<p>Lightweight construction</p> <p>The following non-compliances were identified with the existing lightweight construction.</p> <ul style="list-style-type: none"> The construction of the building, in particular the lightweight internal timber wall system, does not provide compliant bounding construction between SOUs and between SOUs and the common corridor. Subsequently, in the event of a fire, it is expected that fire would rapidly spread between SOUs and paths of travel. This issue has been addressed via an Alternative Solution. The floor/ceiling system separating the ground floor from the upper level does not achieve an FRL of 30/30/30 as required by Clause 5.1 of Spec C1.1. Some of the ceilings of the upper level, being timber lined, do not achieve the required 	Non-Compliant	<p>Deemed to satisfy solution Install one layer of 16mm thick fire rated plasterboard to the inside face of all timber walls bounding the sole occupancy units on level one and two of the building and; Install one layer of 16mm thick fire rated plasterboard</p>

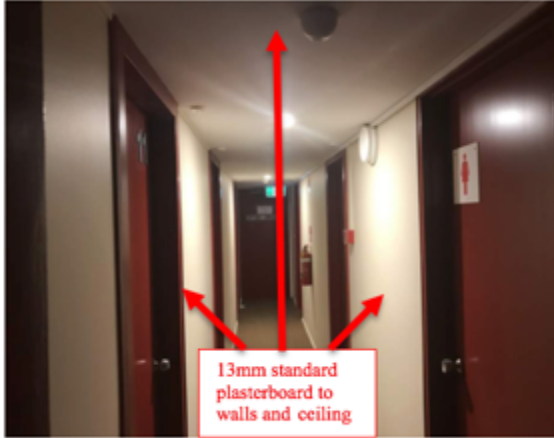
<p>resistance to insipient spread of fire (RISF) of 60 minutes.</p> <ul style="list-style-type: none"> Bathrooms linings adjacent to bedrooms and common areas do not comply.

<p>13mm standard plasterboard to walls and ceiling</p> <p>Figure 3 – First floor corridor</p>

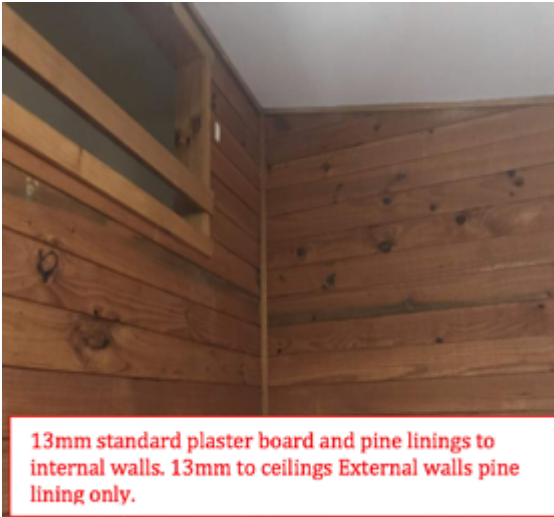
<p>13mm standard plaster board and pine linings to internal walls. 13mm to ceilings External walls pine lining only.</p> <p>Figure 4 – Bedroom first floor</p>		<p>to the inside face of all timber walls bounding public corridors, public lobbies and the like. And; Install on layer of 16mm thick fire rated plasterboard to the inside face of all timber walls bounding the internal stairs. And; Install 1 layer of 16mm fire rated plasterboard all the ceilings on the ground floor to achieve a FRL of 30/30/30 And; Install 1 layer of 16mm thick fire rated plasterboard and 1 layer of 13mm thick fire rated plasterboard to all ceilings of SOU's and public corridors on the first floor to achieve a resistance to the incipient spread of fire (RISF) of not less than 60 minutes.</p> <p>or</p> <p>Performance solution proposed. Refer to Section 4 performance solution 1 in this report</p>

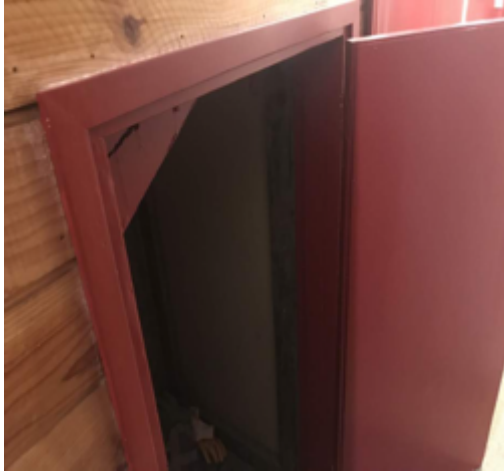
<p>The storage area under the internal stairs was enclosed and appeared to be insufficiently lined and requires a fire door FRL -/60/60</p>

<p>Figure 5 – Enclosure under stairs no FRL</p>		<p>The storage area under the stairs is to be lined with 1 layer of 16mm fire check plasterboard and a fire door and jamb achieving a -/60/30 rating needs to be fitted.</p> <p>Install sprinkler system as alternative.</p>
D2.17	<p>Handrails</p> <p>a) Handrails are required to be installed on stairs leading down from SOU corridors on both north and south wings leading to the lounge area.</p>

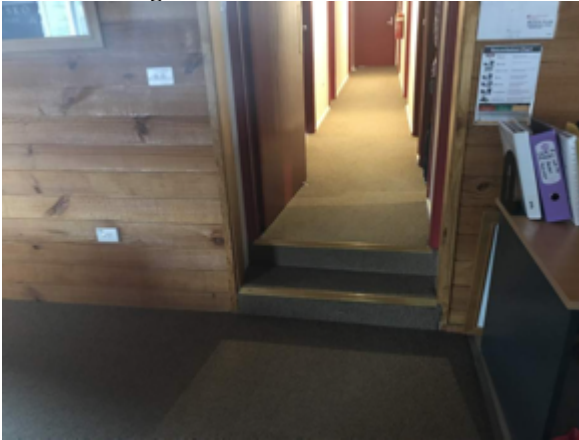
<p>Figure 6 – Stair requires handrail</p>	Non-Compliant	<p>Deemed to satisfy solution</p> <p>Handrails are required to be installed on stairs leading down from SOU corridors on both north and south wings leading to the lounge area complying with D2.17</p>

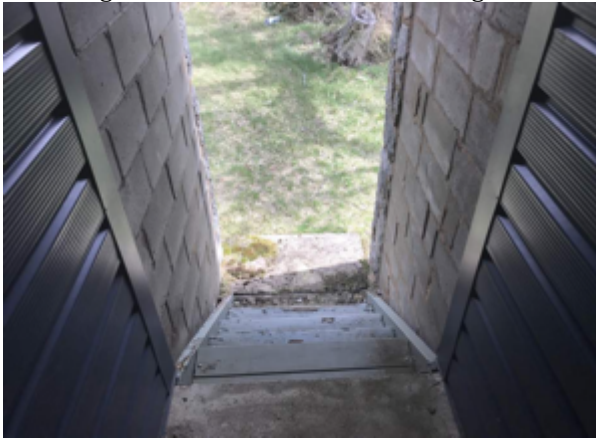
<p>Figure 7 – Stair requires handrail</p>	Non-Compliant	Deemed to satisfy solution Handrail to be installed to external stair on the ground floor of the southern wing complying with D2.17
G4.7	<p>External trafficable structures The external stair on the ground floor of the southern wing requires a floor surface that consists of steel mesh or other suitable material.</p>

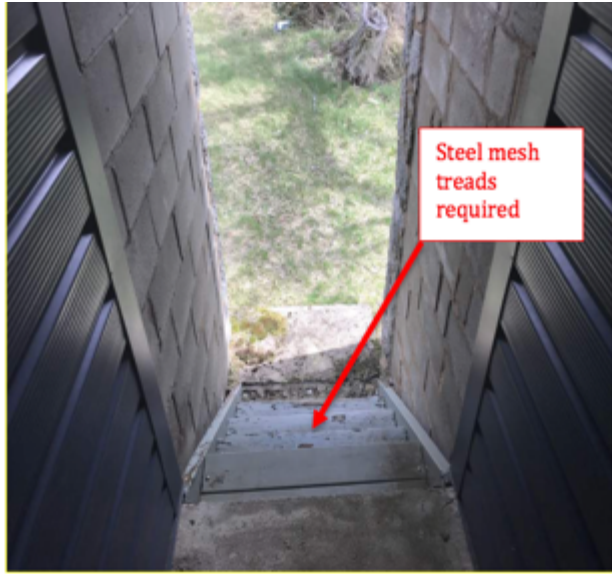
<p>Figure 8 – Timber treads to exit stairs</p>	Non-Compliant	Deemed to satisfy solution Install stair treads with a surface that consists of steel mesh or other suitable material.
	<p>Thresholds The doors from the northern and southern corridors leading into the common lounge area have a step closer to the doorway than the width of the door leaf.</p>

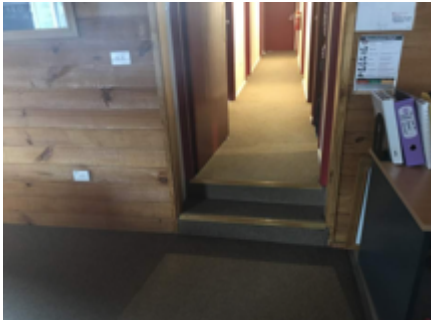
D2.15	Figure 9 – step closer to the doorway than the width of the door leaf	Non-Compliant	Performance solution proposed. Refer to Section 5 performance solution 2
G4.3	External doorways The round floor main exit door to the west towards Link Road requires a permanent “OPEN INWARDS” sign to be fixed. Currently a temporary one there. Other exit doors should be checked and confirmed for compliance.

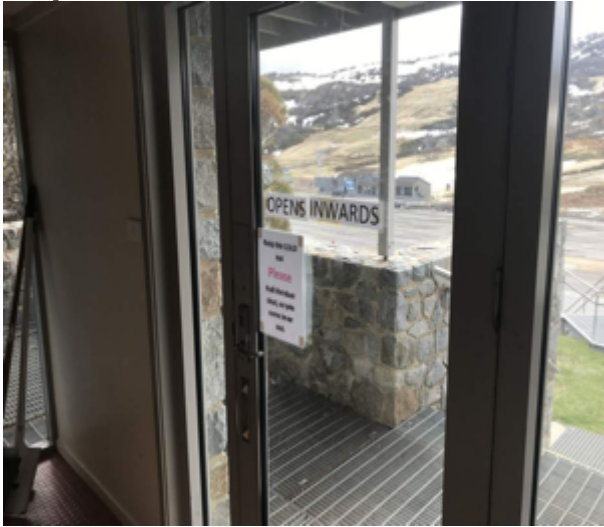
<p>Figure 11 – Temporary open inwards sign to entry door</p>	Non-Compliant	Deemed to satisfy solution requires a permanent “OPEN INWARDS” sign to be fixed. Other exit doors should be checked and confirmed for compliance.
E1.3 & G4.8	Fire Hydrants Fire hydrant coverage is required 500m ²	Potential non-Compliance	
E1.4 & G4.8	Fire Hose Reels Fire hose reels were required and installed under the superseded requirements of G4.8.	Compliant	No upgrade proposed
E1.6	Portable Fire Extinguishers Extinguishers are required to provide protection to the building and appear to be provided.	Compliant	No upgrade proposed

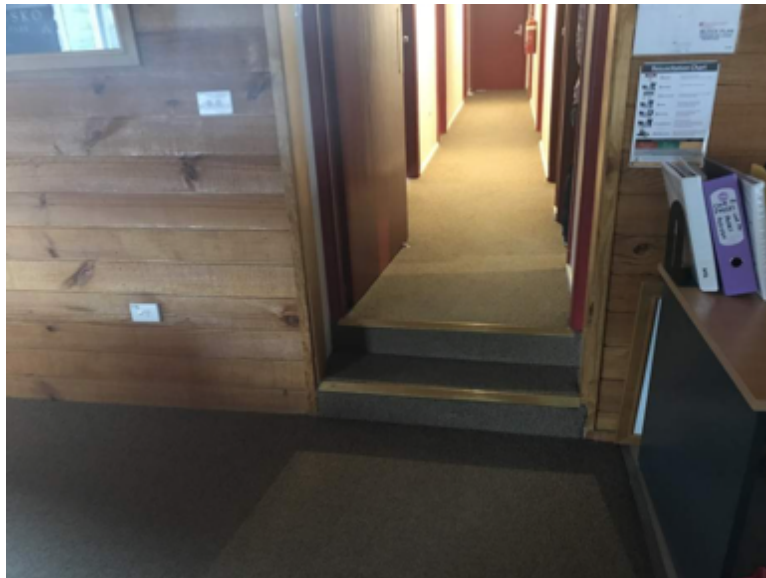
In accordance with D2.15 above, a doorway threshold cannot incorporate a step or ramp at any point closer to the doorway than the width of the door leaf. As can be seen in the figures below, there is a non-compliance with the above.

Figure 9 – step closer to the doorway than the width of the door leaf

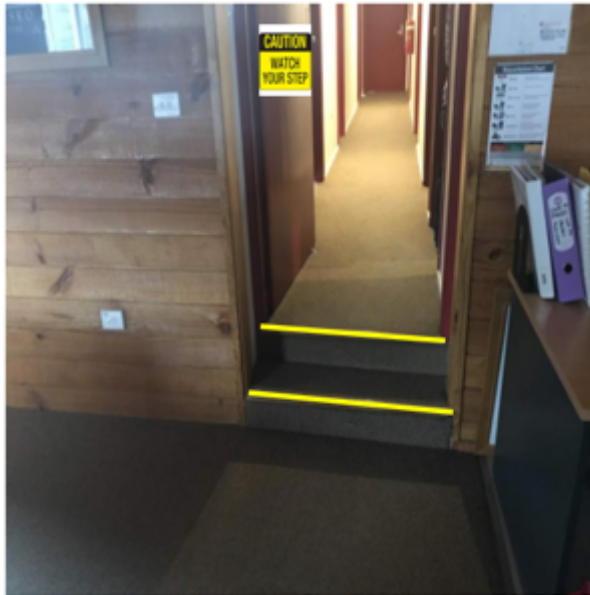
The major risk of the depicted situation is of a trip hazard by occupants exiting and entering the SOU corridors from the lounge area. It is assumed, that being a club lodge, occupants are familiar with the layout of the building.

Figure 9 – Corridor door to close to threshold

To reduce this risk, it is proposed to install signage to either sides of the corridor doors in a contrasting colour with letters no less than 40mm high stating “CAUTION WATCH YOUR STEP”. Additionally, it is proposed to install nosing’s to the stairs in a contrasting colour in order to further inform occupants of the potential trip hazard. See figures 9 and 10 below.
