Tree Assessment – Flash Report

7 Rex St. Goulburn

Date of Report: 15 July 2023

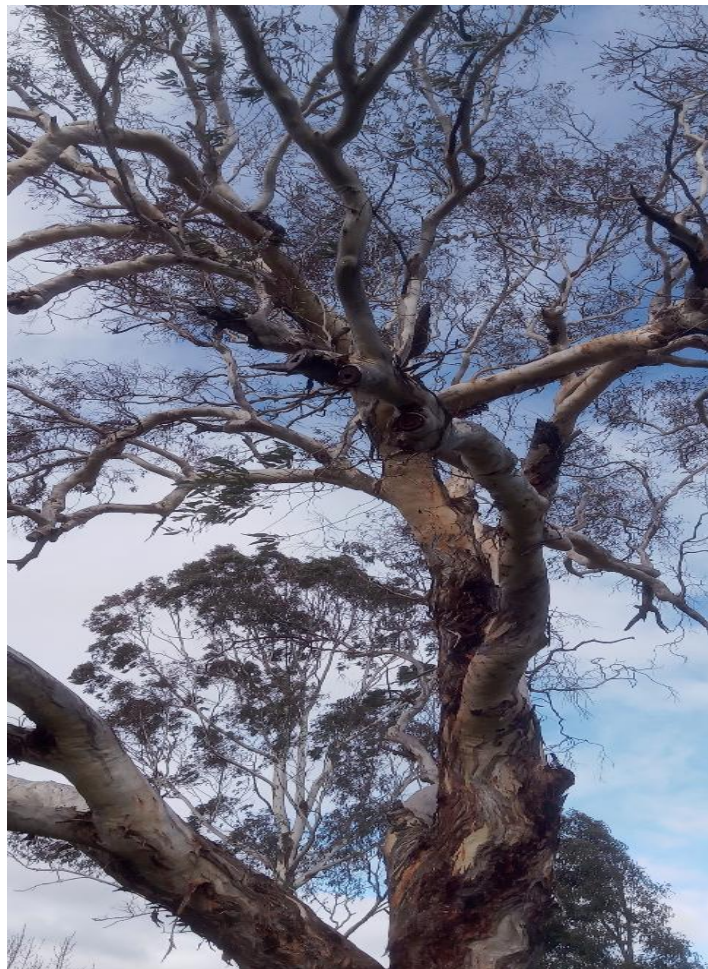
Fig. 1 Tree number 1 – *Eucalyptus melliodora*

Tree No. 1: The first tree is located in the front and to the right of the property. As can be seen in **Figs. 1, 2 & 3**, the tree's canopy appears to be showing signs of stress and has suffered from multiple branch failures in the past and bad pruning cuts, resulting in irregular branching and poor wound closure.

- Due to the poor health of the first tree, I would recommend removing the tree, as it is quite close to the house and the possibility of injury from fallen branches is a real concern.

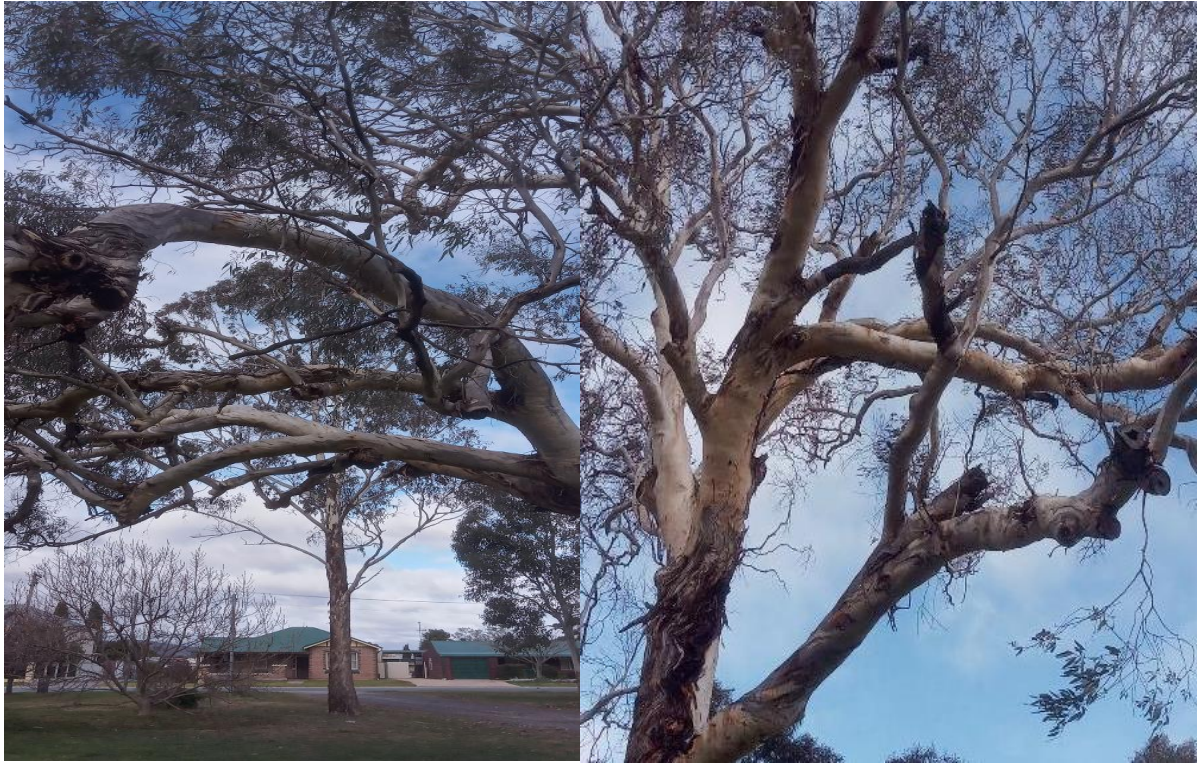
Fig. 2 & 3 Poor pruning & irregular branching.

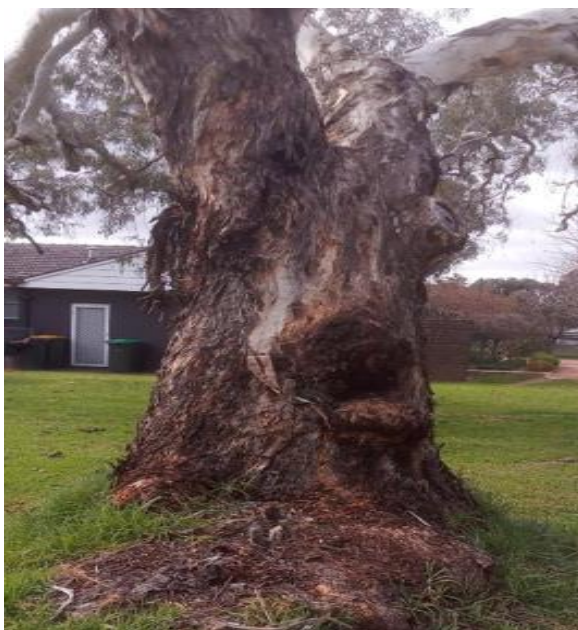
Fig. 4 Base of tree.

The trunk crown, as can be seen by **Fig. 4** has a good trunk taper, but has some growth deformities at its base. There were some drill holes present at the base as well, which the owner assured me was for the purpose of having someone check the tree for termites and not for poisoning the tree. (See **Fig. 5**)

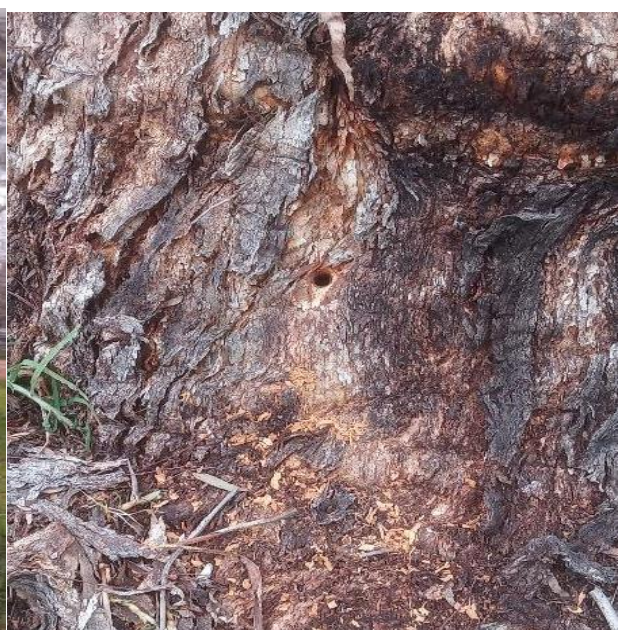
Fig. 5 Drill holes observed at base.

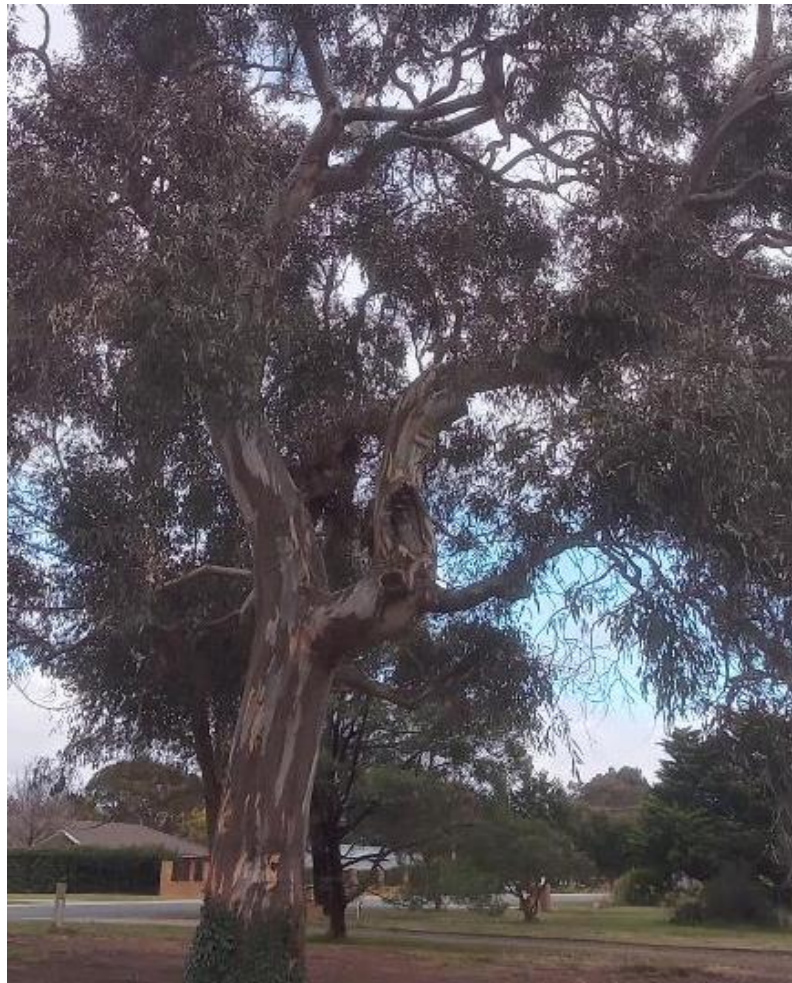
Fig. 6 Tree No. 2: *Eucalyptus blakelyi*

This tree is structurally sound at the base and most of the branch attachments, though there is a large wound at one of the main scaffold branches (possibly cocky damage, see **Figs. 6 & 7**), and some evidence of current and past branch failures (see **Fig. 8**).

- The second tree also has potential for causing harm, due to fallen branches, but its location away from the house lowers the risk of the hazard substantially. I would recommend dead wood pruning this tree and removing any crossing or irregular branches.

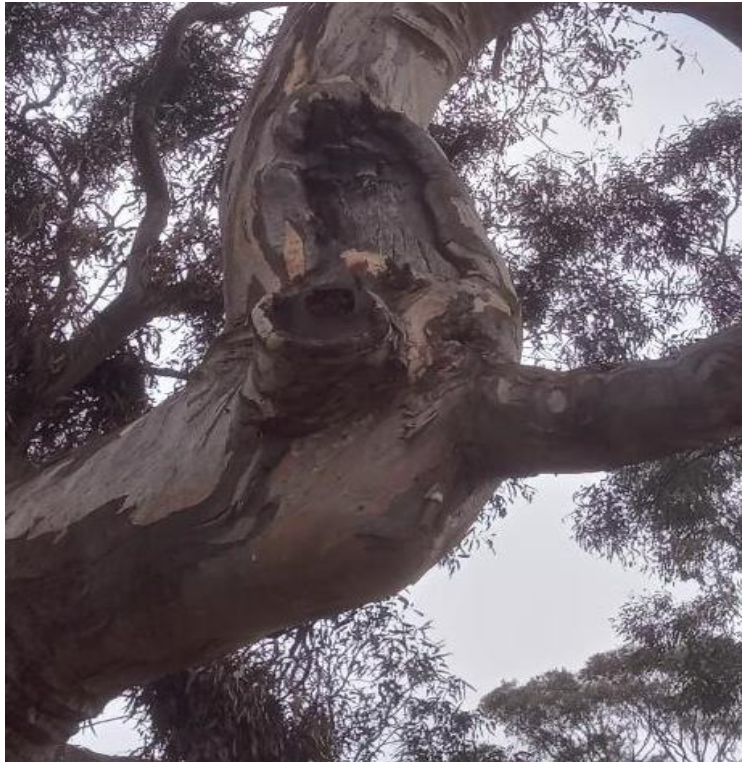
Fig. 7 Large wound at scaffold branch.

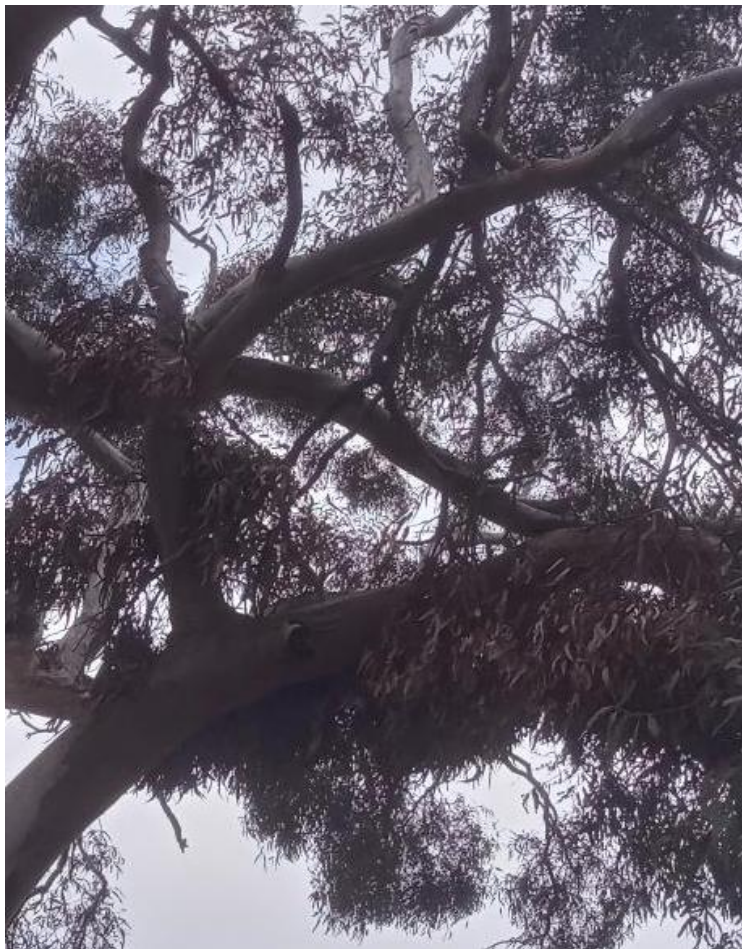
Fig. 8 Some broken and hanging branches.

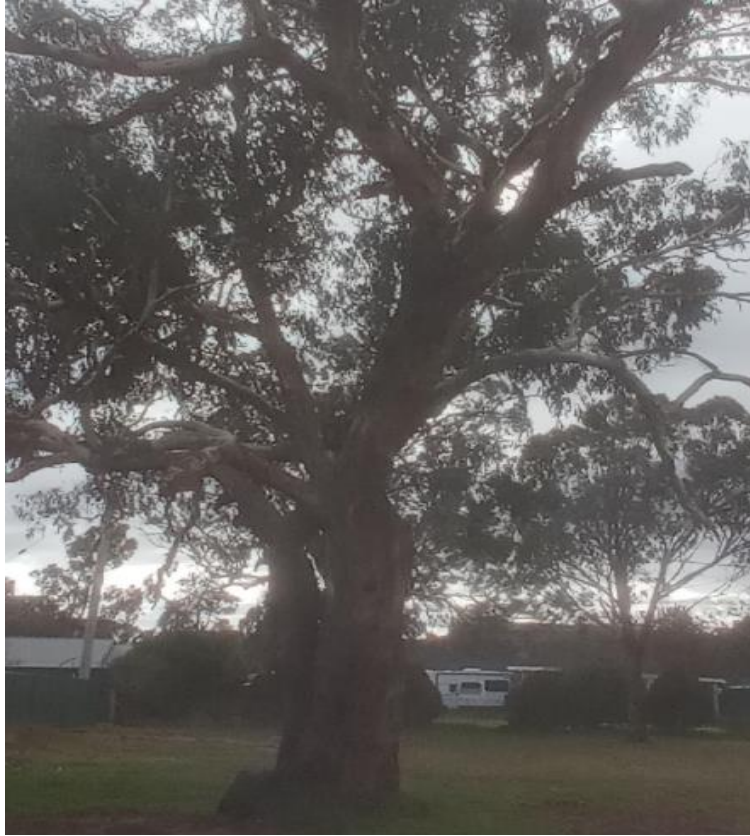
Fig. 9 Tree number three: *Eucalyptus melliodora*.

Tree No. 3: The third tree is located in the back yard of the property to the left and behind the front gate. This tree also slightly overhangs the neighbour's property.

- I would recommend removing the third tree, due to proximity to both the owner's house and the neighbour's property. This recommendation is due to the multiple issues with the tree, including: trunk rot, evidence of many failed branches in the past, and gall growths on branches. Addressing all of these problems, without removing the tree, would lead to high and unreasonable maintenance costs and compromising the aesthetic and structural integrity of the tree.

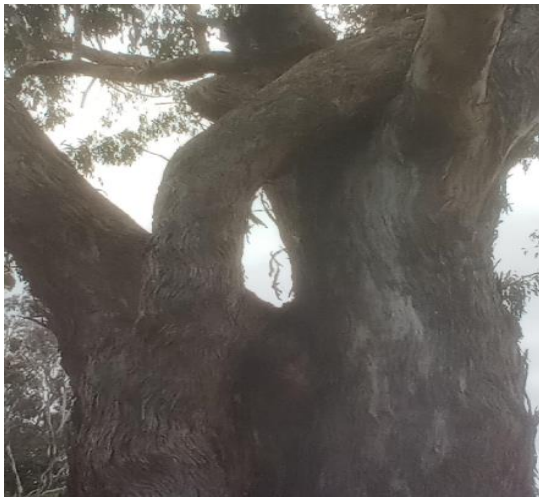
The third tree has some irregular branching and trunk formation (see **Figs. 10**) and there is some rot within the trunk at approximately 2.5m above the ground and extending to 3m (see **Fig. 11**).

Fig. 10 Irregular branching.

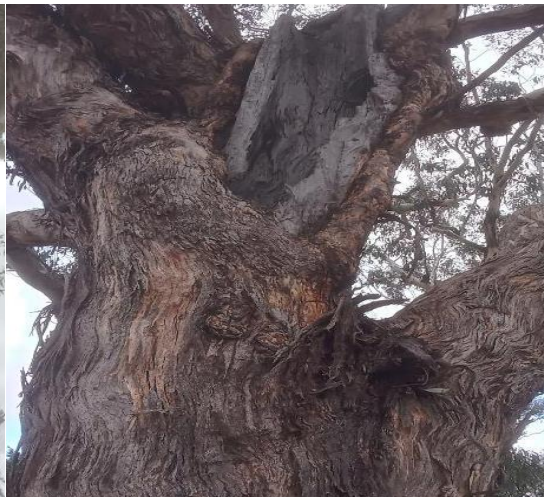
Fig. 11 Trunk rot present.

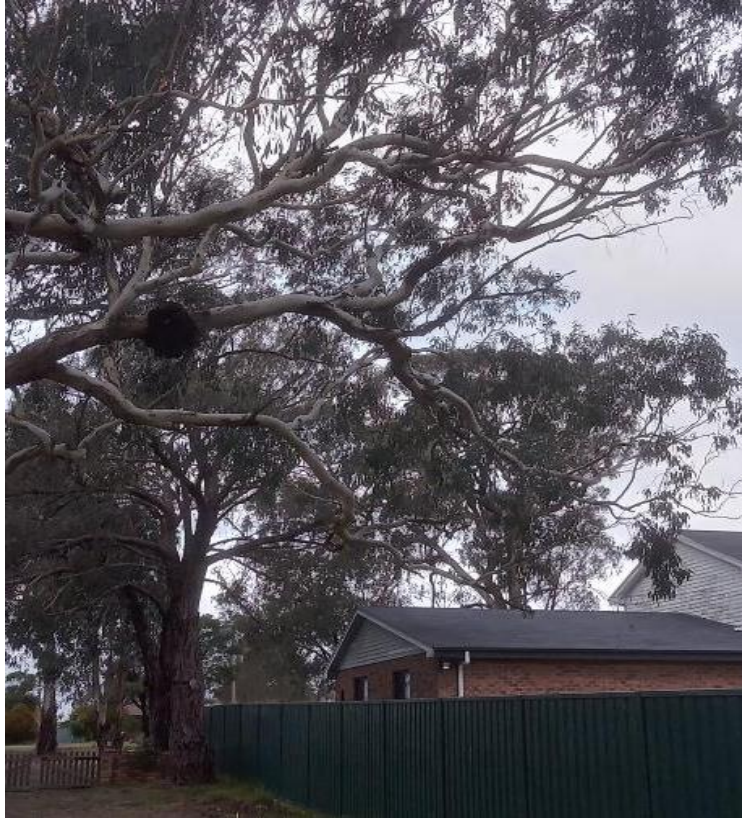
There are also some branches with galls on them which hang over the neighbour's property (see **Fig. 12**). There also multiple branches in the canopy that have failed in the past (see **Fig. 13**).

Fig. 12 Galled branches over neighbours' fence.

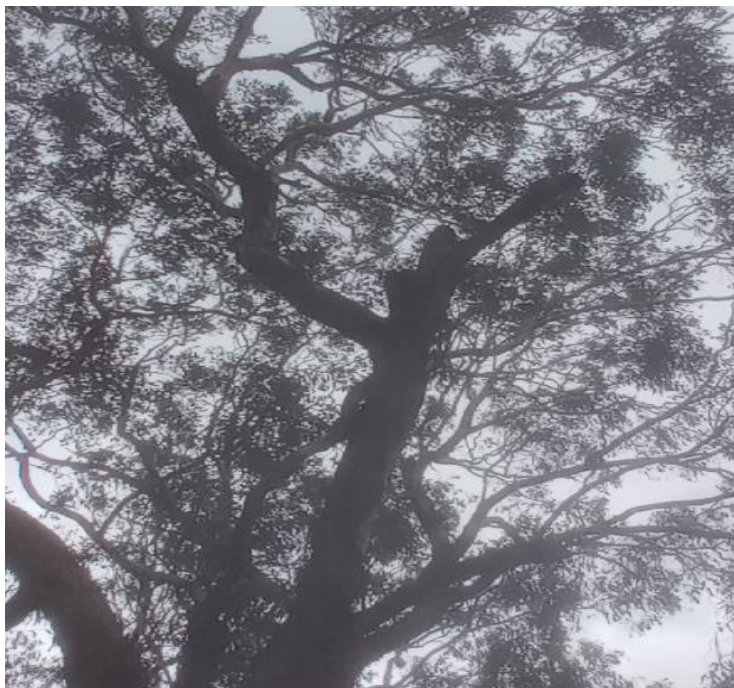
Fig. 13 Old failed branches from canopy.
