UNIVERSAL DRILLING Pty Ltd

Date of Fieldwork	10.03.2025
Our reference	1003202543SAPPHIREDR-01
Job Order Number	Order Number: au26-113/37
Site Address	No.43 Sapphire Drive, Diamond Beach, NSW 2430
Client / Site Contact	Munuela & Steve QUIRK
Site Plans received building footprint identified Y/N	Y
Land searches (flooding, services, easements)	Sloping block in an established suburb of Diamond Beach.
Site Fill Subdivisional, Single block Controlled / Uncontrolled AS3798 Earthworks Report Supplied Y/N Report Number:	Yes minimal at the front of the block (roadside) Single block Assumed Uncontrolled Not at this stage N/A

Site Classification (AS 2870)	Class P
Site Reactivity	H1 reactivity
Reactivity (AS1289.7.1.1 - ISS)	3.9
Wind Rating	N2 (coastal but has topographic protection)

INDICATIVE ALLOWABLE BEARING CAPACITY ASSESSMENT

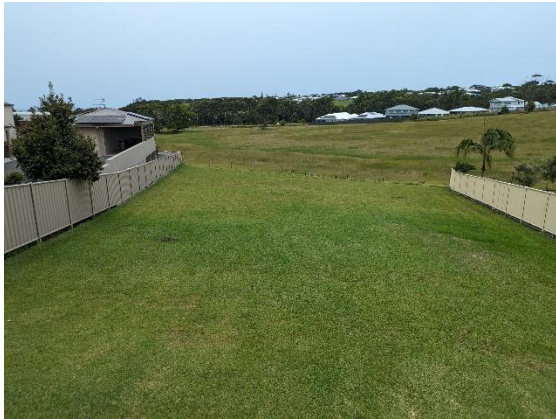
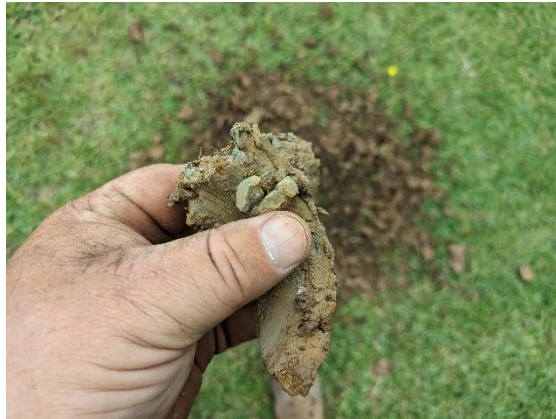
(A) New Home Build (B) Virgin Site with prepared pad (C) Existing Home rebuild (D) Existing Home Addition (E) Pool (F) Shed	A
Trees & other impediments	No trees or gardens however drainage from the top(front) of the block has created some soft soils, a complete stripping and inspection of the site is required before construction.

Notes: Some soft soils becoming firm over very stiff CLAYS and extremely weathered rock (see Dynamic cone penetrometer results and engineers bearing assessment, a complete stripping of the site will reveal any further soft soils.

Notes: Some soft soils due to poor site drainage, this should be arrested when stripping the site and constructing retaining walls to divert stormwater away from the front of the house.
