Ref: 25074

19th June 2025

RE: Pedestrian Overbridge at Warringah Road, Forestville, NSW
DA For Continued Signage Use, Structural Feasibility and Safety Report

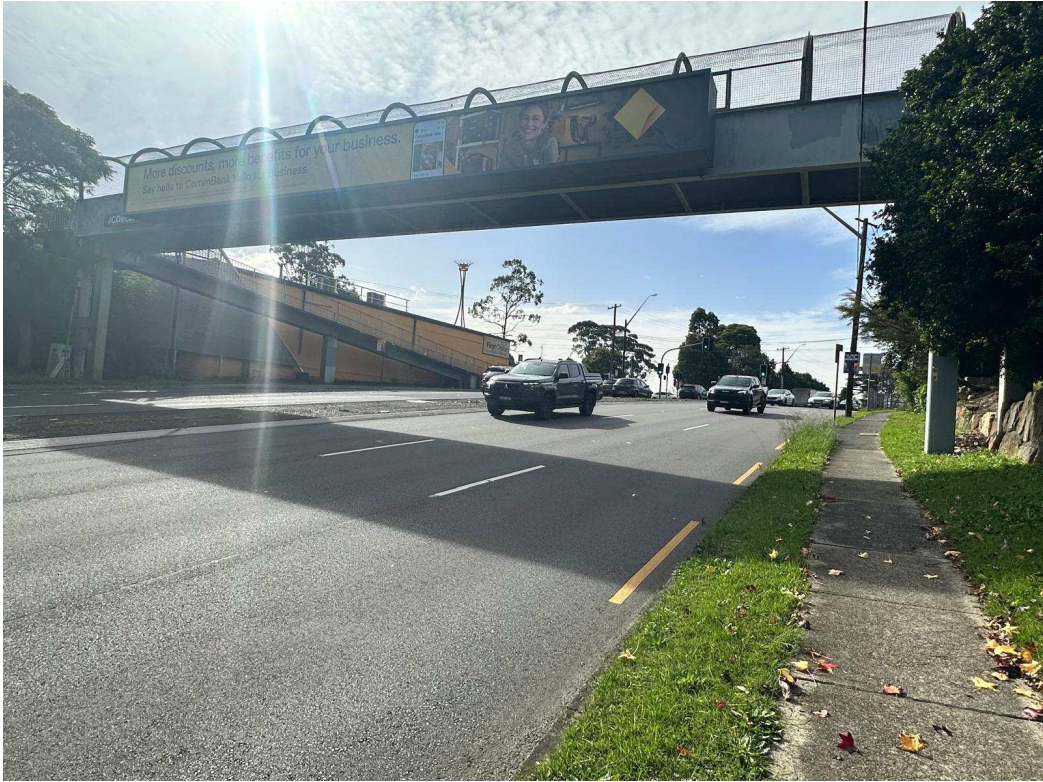
Photo 1

The existing sign is backlit landmark sign. The sign consists of a steel box that is fixed to one side of a steel girder footbridge located over Warringah Rd. There are steel frames that are welded to the top flange of the bridges steel girder and also bolted to the web of the girder. Horizontal rails are fixed to the frames. Z brackets are fixed to the back of the sign box and the Z brackets fit over rails connecting the box to the support frames. The sign face is 18m horizontal x 1.5m vertical. Refer to photo 1 to 6.

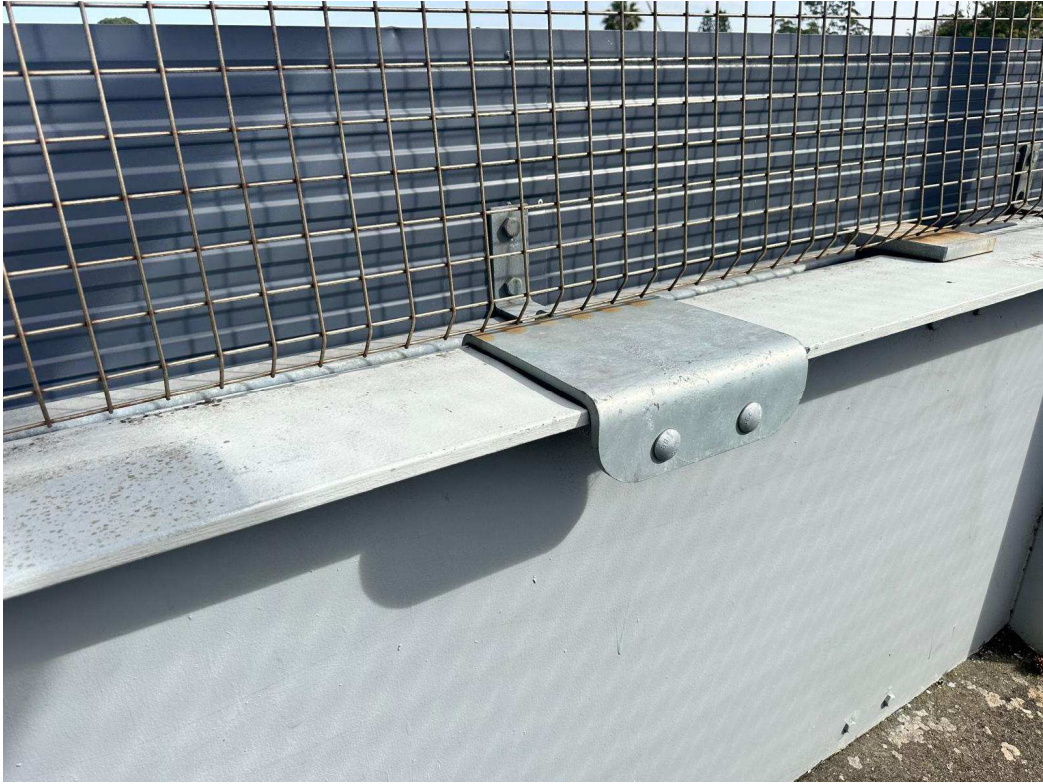
Photo 3

Safety cables to stop the boxes falling onto the road during vehicle impact have also been installed. Refer to photo 3 to 5.

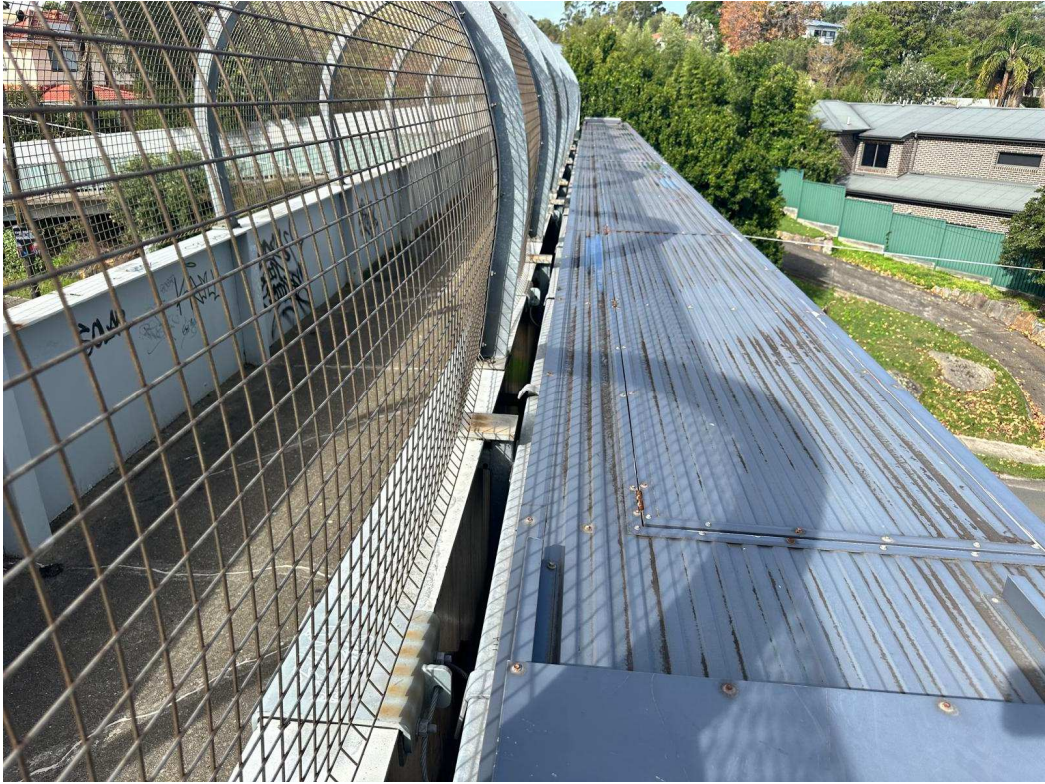
Photo 5

- The steel frames connecting the sign box to the bridge are generally in good condition with some minor surface corrosion. Refer to photo 5 and 6.
The sign box is also generally in good condition with some minor surface corrosion. Refer to photo 8.
There was however significant corrosion in one of the horizontal SHS members in the top of the box at the central splice location in the boxes steel frame. The corrosion was located near the banner where the forces are less than the back of the box as the structural members cantilever from the back of the box. Refer to photos 9 and 10.

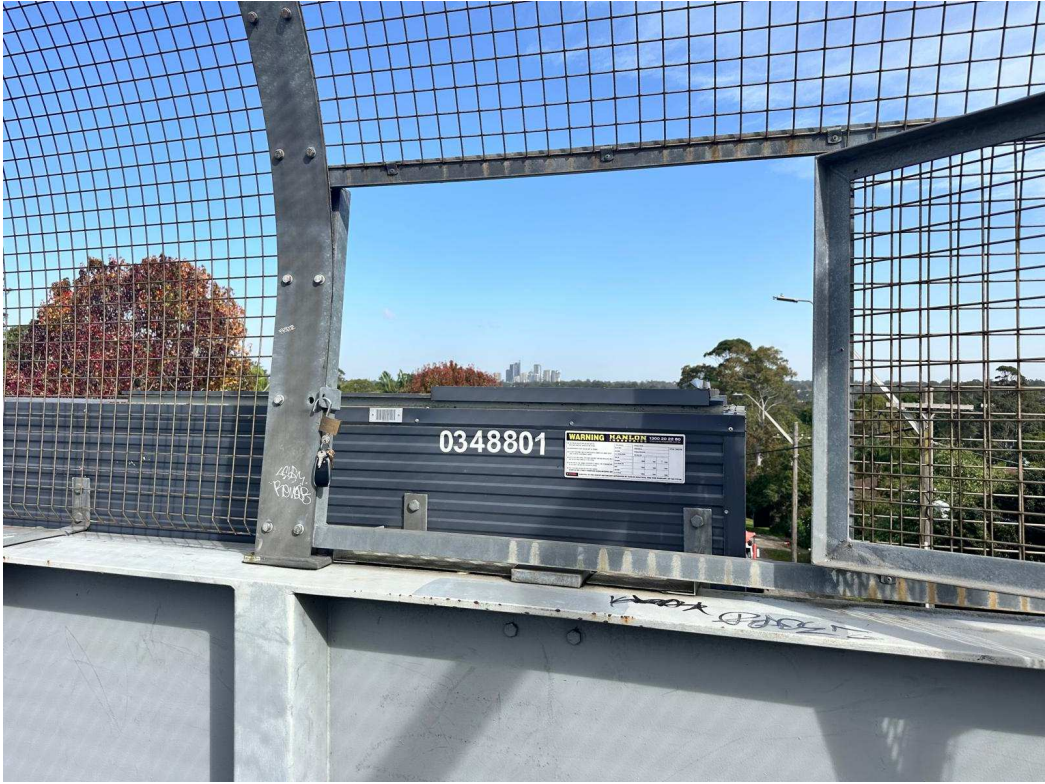
Photo 7

The sign box is located on the outside of the safety screen. Access to the sign box is from a hatch in the side of the safety screen. Refer to photo 7. There is a hatch in the top of the sign box and a permanent ladder inside the sign box underneath the hatch.

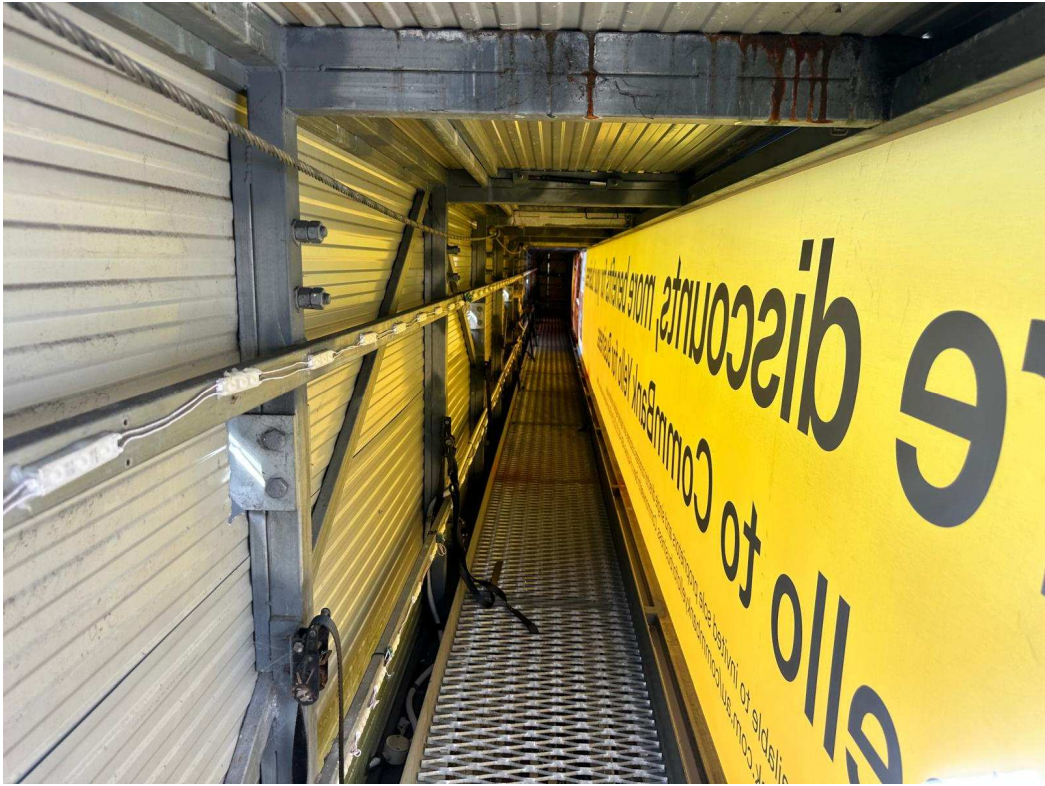
Photo 8

When the banner is replaced, it is done from a walkway inside the box without having to stop the traffic below the sign. There is a horizontal cable running the length of the box that workers replacing the banner can fix their harnesses to. Refer to photo 8.

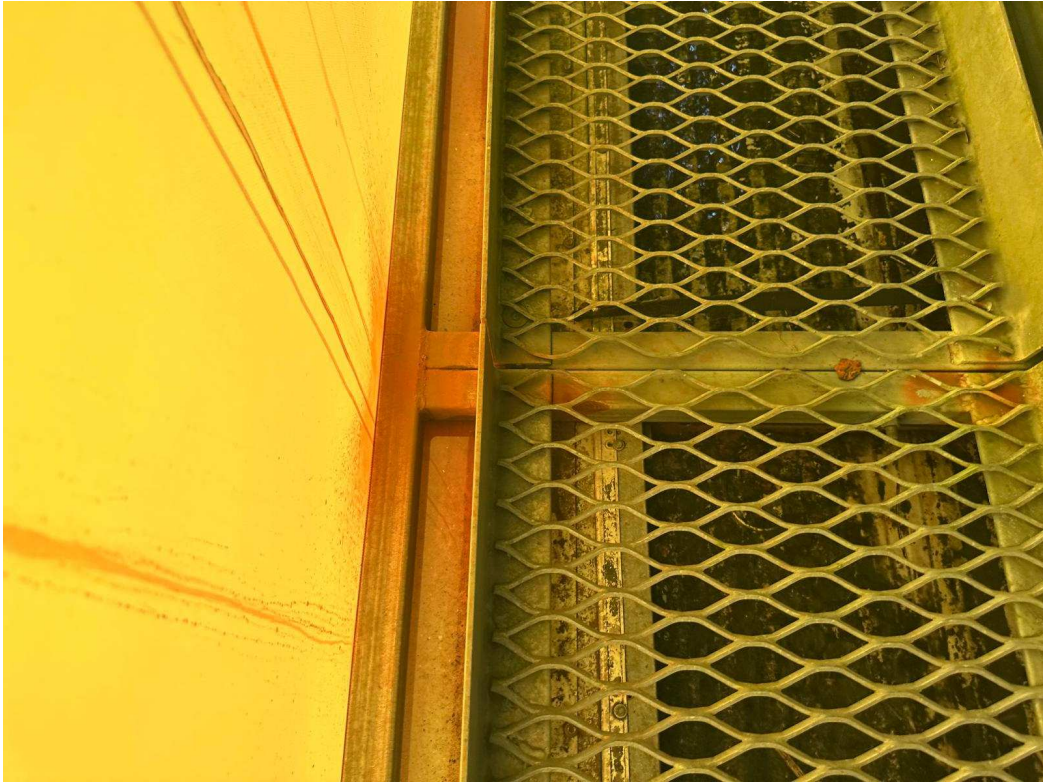
Photo 11

There was also some surface corrosion in the bottom members near the splice location. Refer to photo 11.

- The sign box is rated as category 3 by DBCE. ie Moderate damage, excessive or widespread corrosion. Rectified and re-inspection required within 8 months.
 1. The corrosion should be removed with a mechanical wire brush.
 2. Steel compensating plates should be welded over the area where there is a loss of section.
 3. The joint in the cladding over to be correctly sealed.This information will be provided to JCDecaux along with the category 3 rating for rectification within the 8-month period.
- There are presently no safety issues requiring fixing.
