## **Hazardous Building Materials (HAZMAT) Report**

**Former Shoalhaven Anglican School**

**17 Croobyar Milton NSW**

**Project 89390.08**

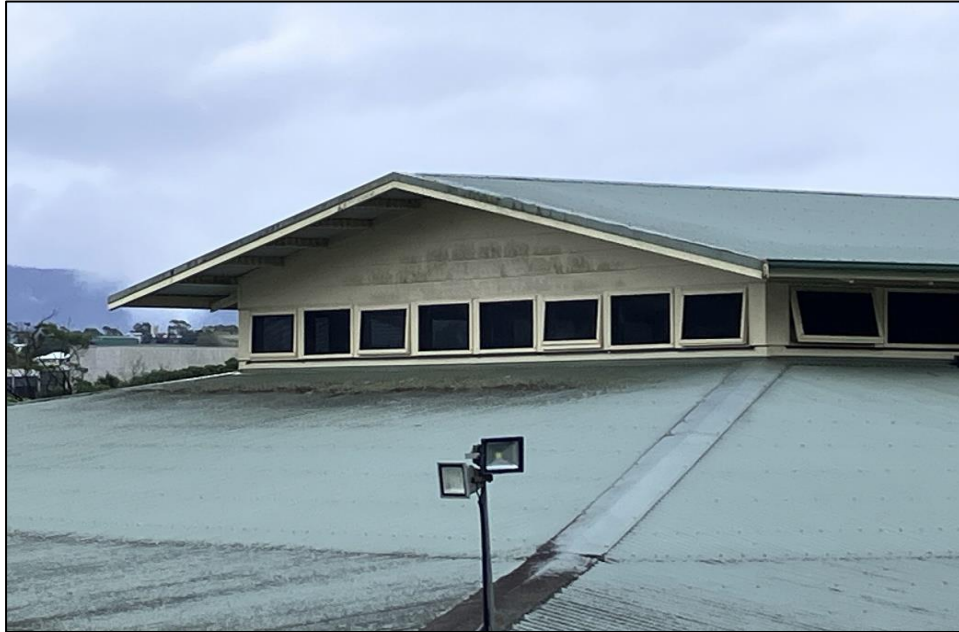
Photograph 1: B00A, exterior, upper level, wall and gables generally, weatherboard linings, suspected non-asbestos.

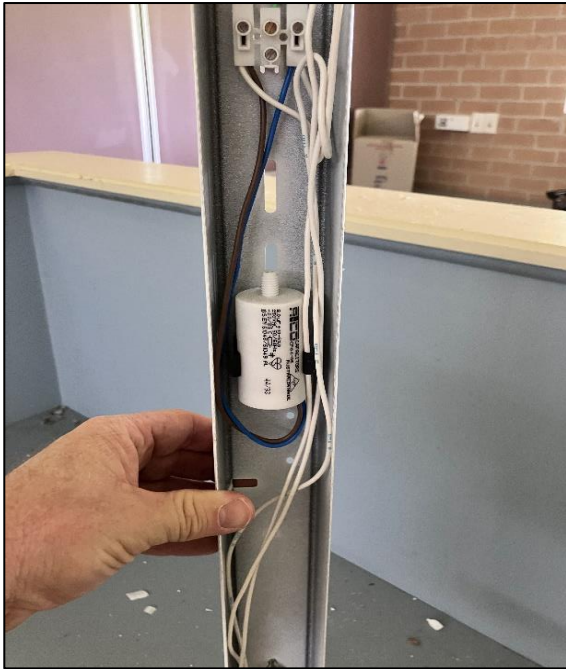
Photograph 11: B00A, AR0008, damaged fluorescent light fittings, plastic capacitor, nil PCB identified.

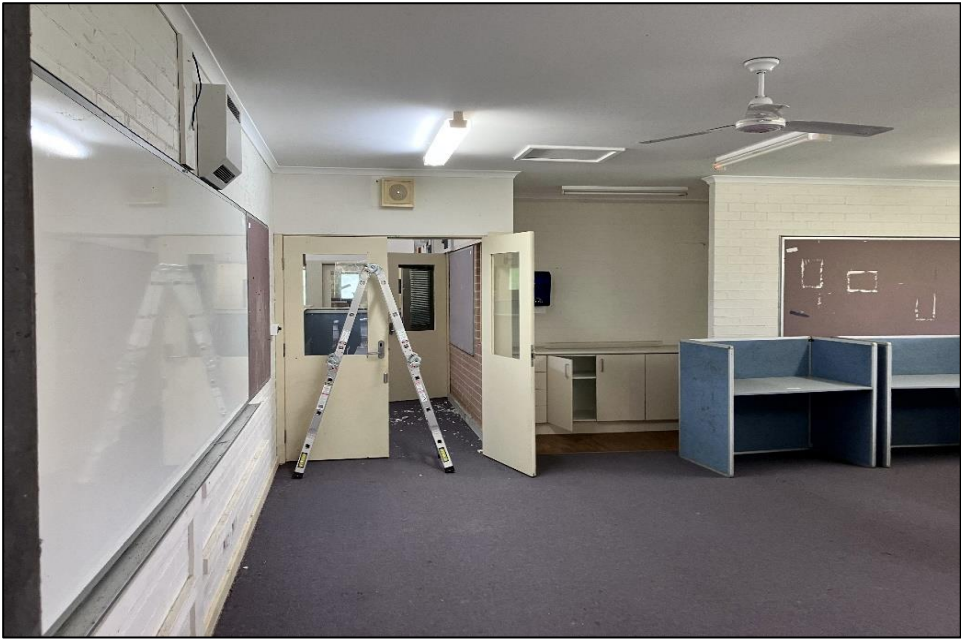
Photograph 12: B00A, rooms and areas in general, fluorescent light and fan fittings, internal components, nil PCB (suspected).

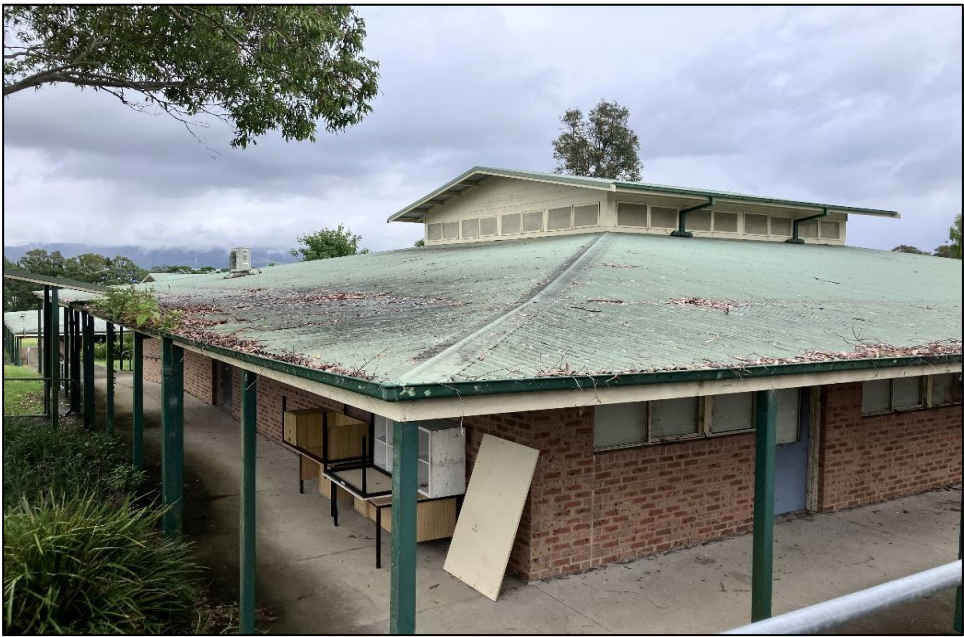
Photograph 1: B00B, exterior, upper level, walls, weatherboard linings, suspected non-asbestos.

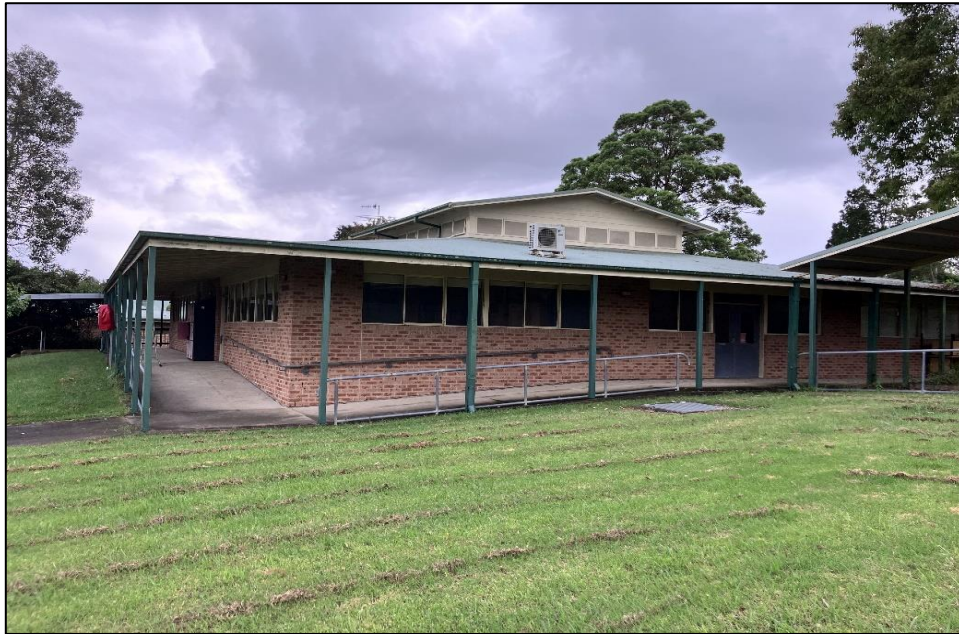
Photograph 11: B00B, exterior, roof, air-conditioning unit(s), unidentified, inaccessible.

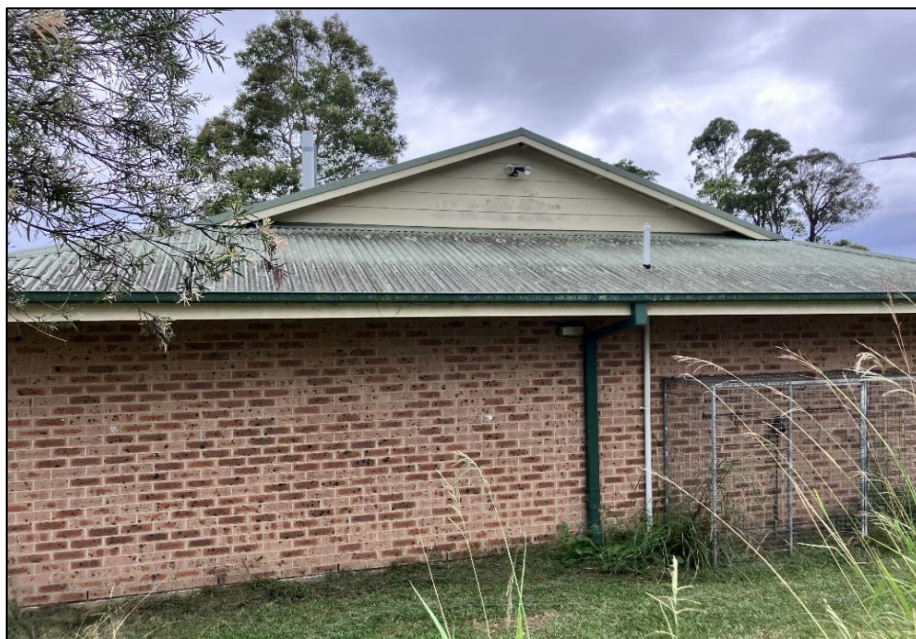
Photograph 1: B00C, exterior, gables, weatherboard linings, inaccessible.

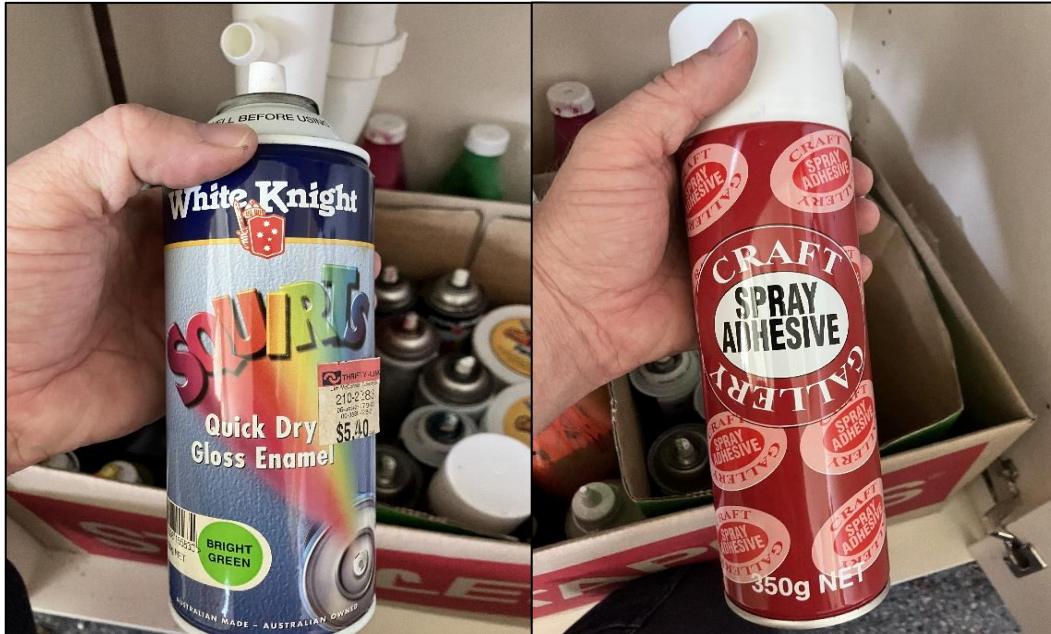
Photograph 13: B00C, CR0002, various locations, general laboratory / craft supplies.

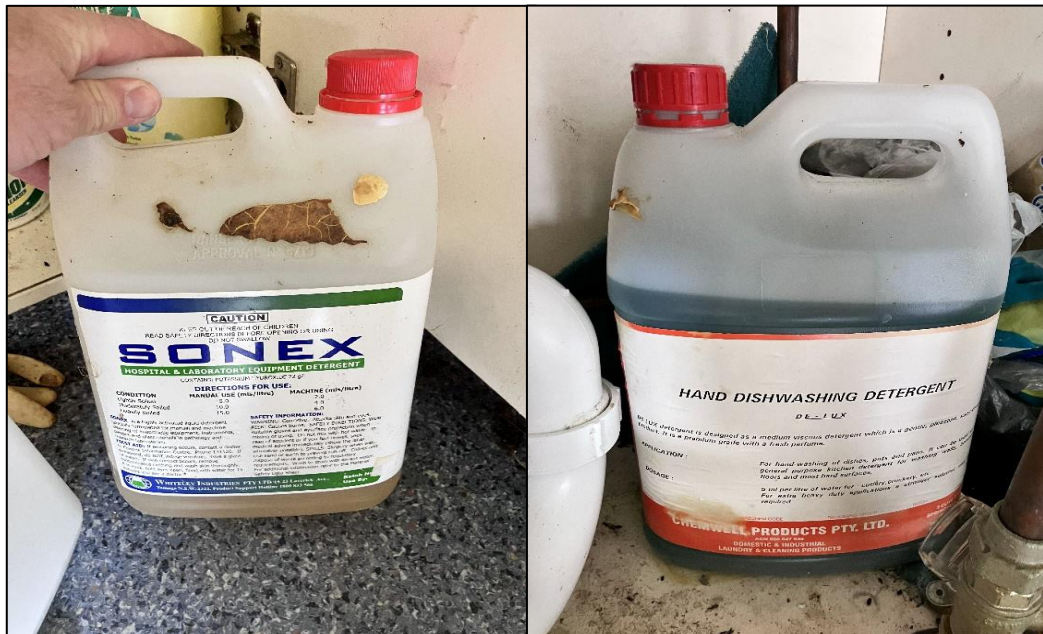
Photograph 14: B00C, CR0002, various locations, detergents.

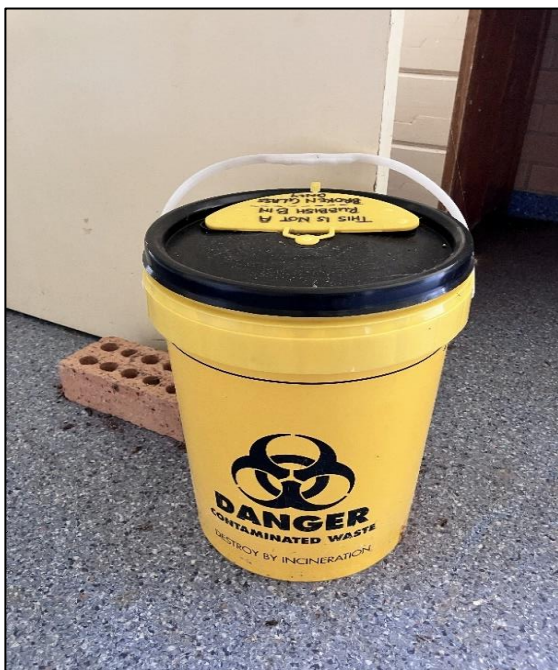
Photograph 16: B00C, CR0002, yellow biohazard bucket, Labelled as containing broken glass.

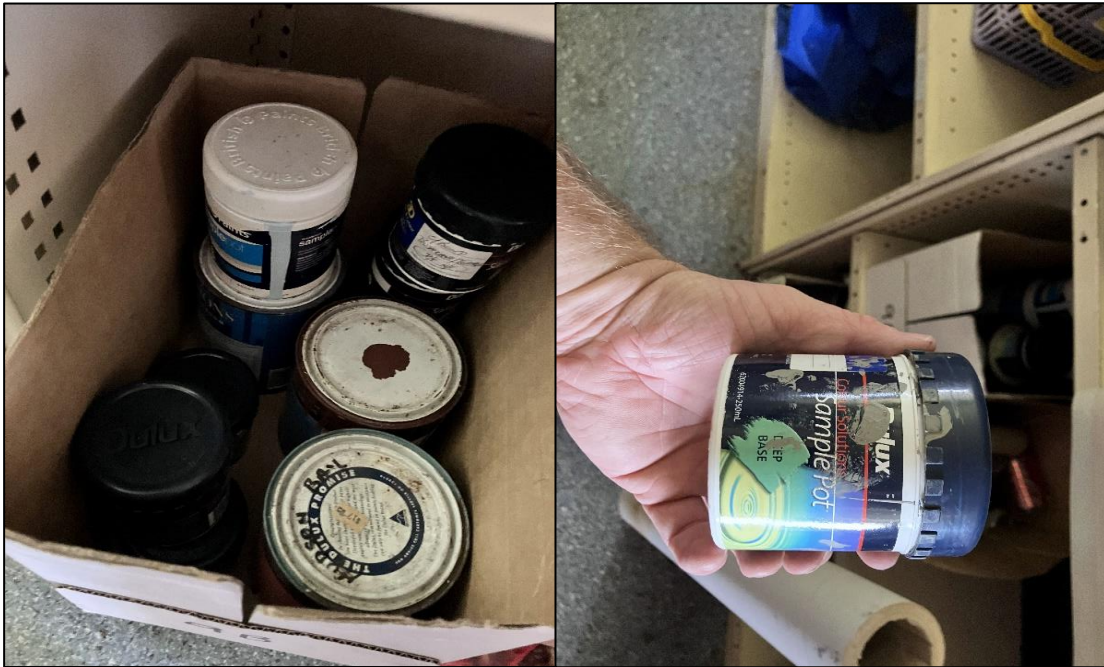
Photograph 18: B00C, CR0007, general laboratory / craft supplies (e.g. paints, diatomaceous earth (or similar) and sawdust).

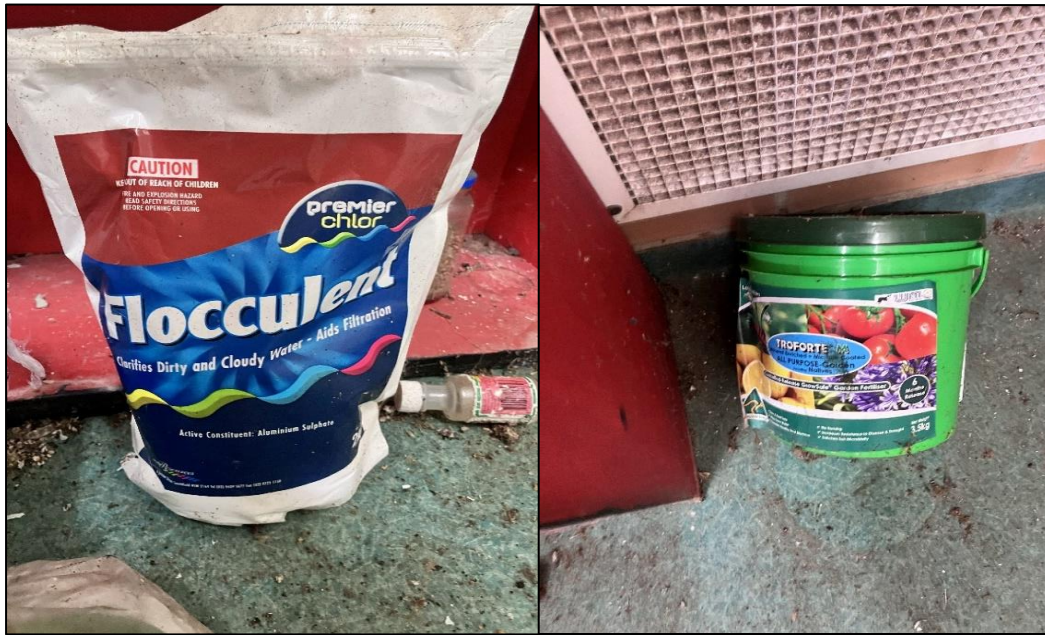
Photograph 23: B00C, CR0006, general laboratory supplies including detergent, over cleaner, Perlite, concrete, fertiliser, flocculant, aerosols etc.

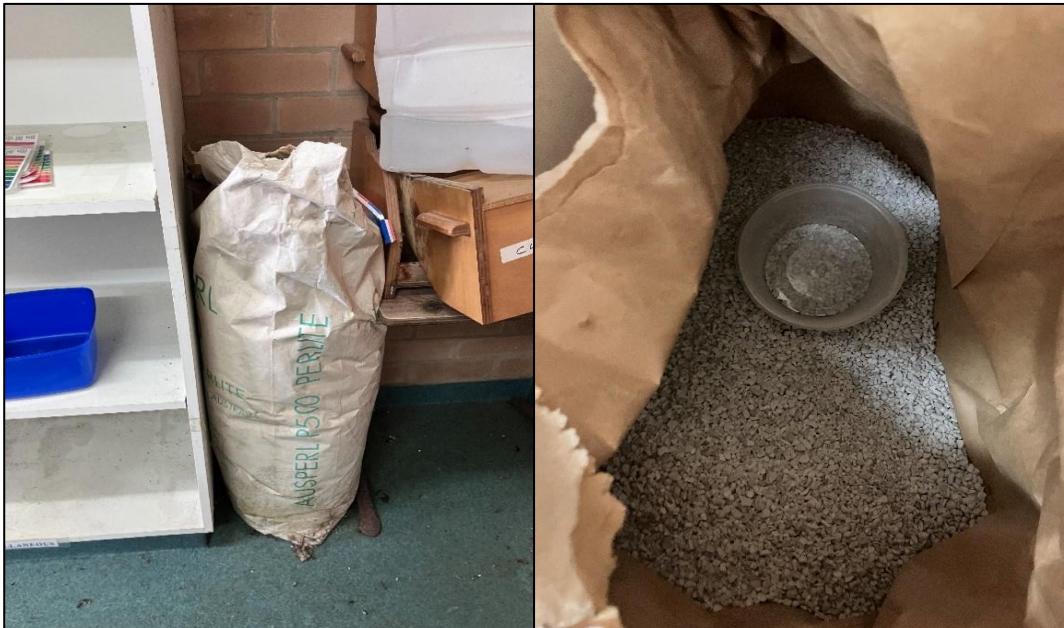
Photograph 24: B00C, CR0006, general laboratory supplies including detergent, over cleaner, Perlite, concrete, fertiliser, flocculant, aerosols etc.

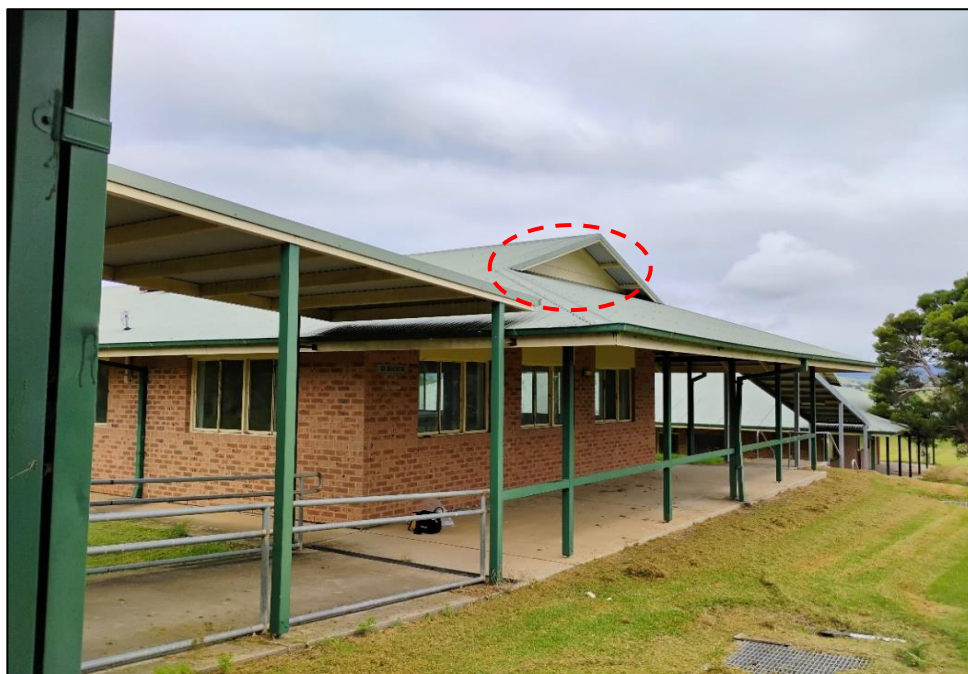
Photograph 1: B00D, exterior, north and south façade, gables, weatherboard linings, suspected non-asbestos.

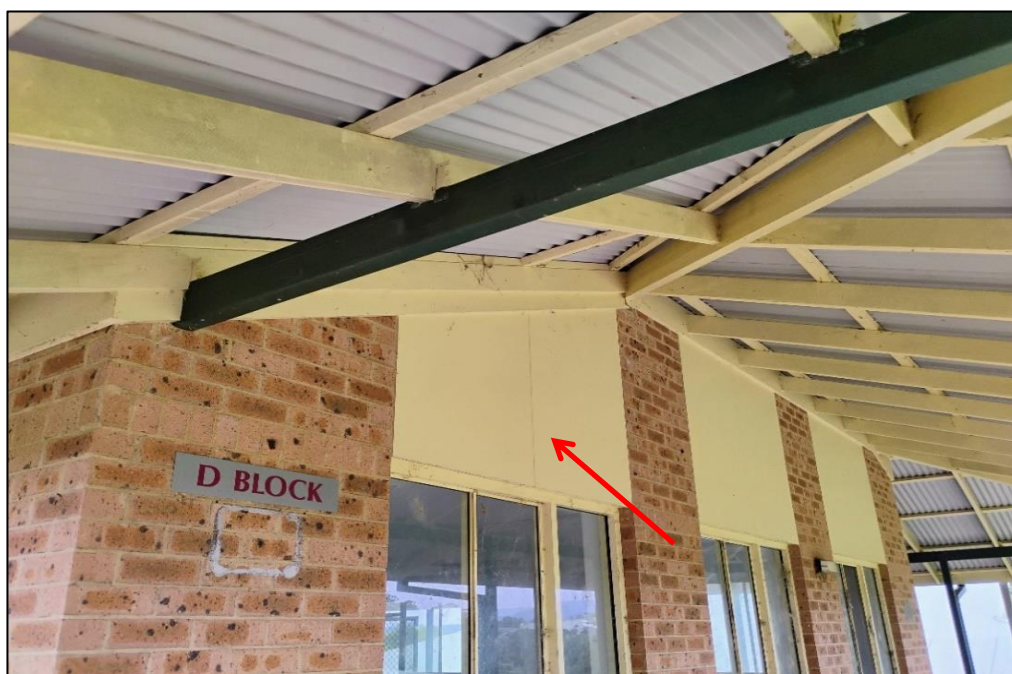
Photograph 2: B00D, exterior, north façade, infill, fibre cement sheeting, no asbestos detected by analysis.

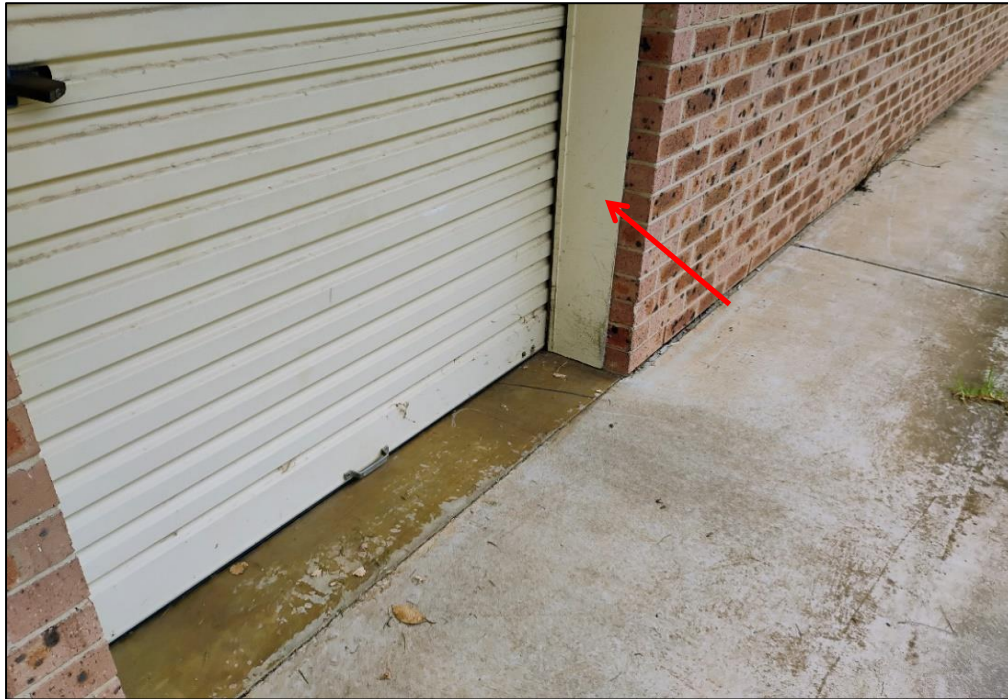
Photograph 3: B00D, exterior, framing around DR007 entrance, fibre cement sheeting, no asbestos detected by analysis.

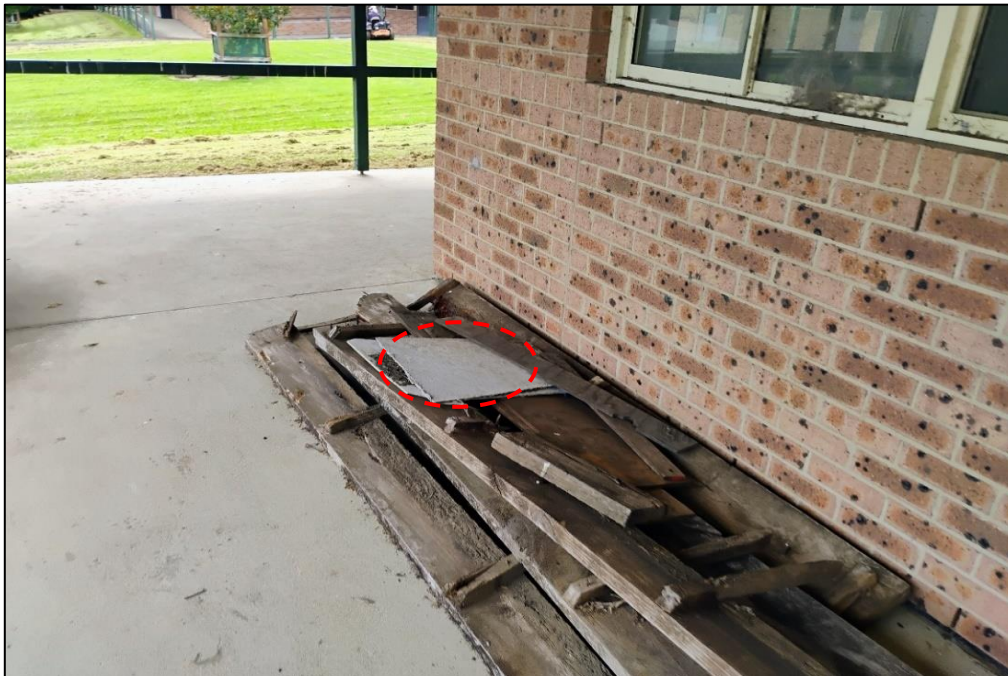
Photograph 4: B00D, exterior, DR0010, west façade, waste materials, fibre cement sheeting, no asbestos detected by analysis.

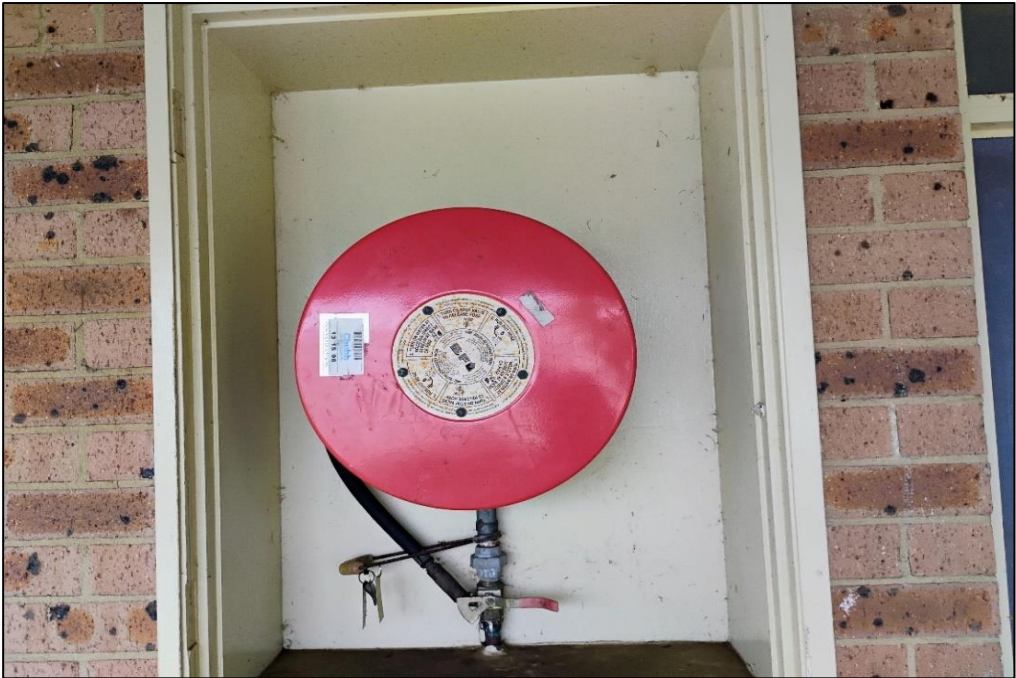
Photograph 5: B00D, exterior , west façade, fire hose recess wall, fibre cement sheeting, no asbestos detected by analysis.

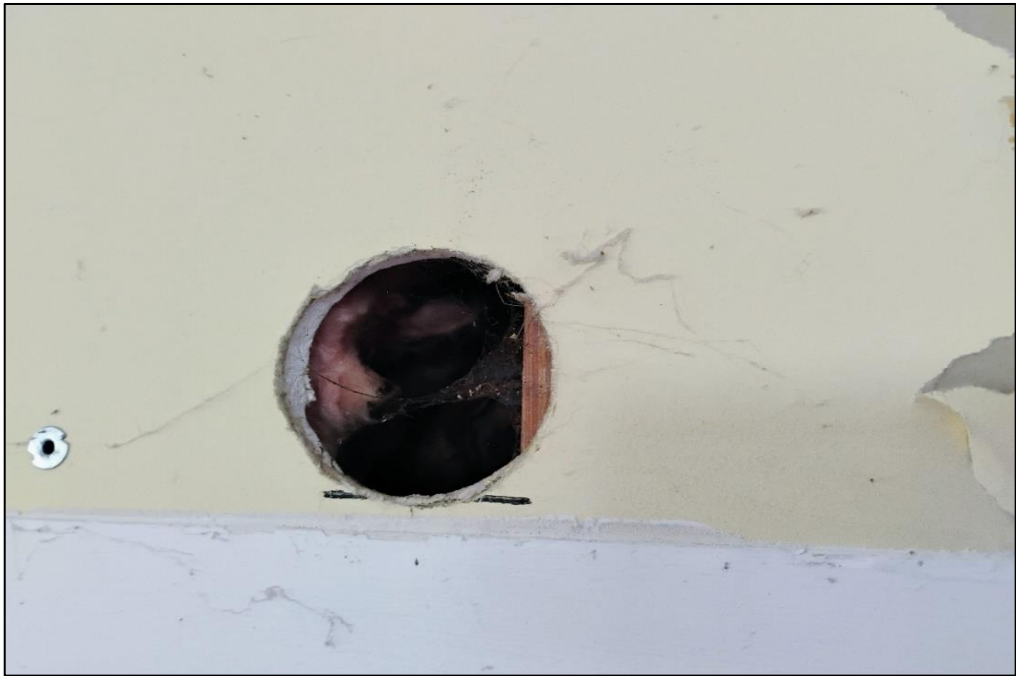
Photograph 6: B00D, rooms and areas in general, walls, insulation, SMF identified visually.

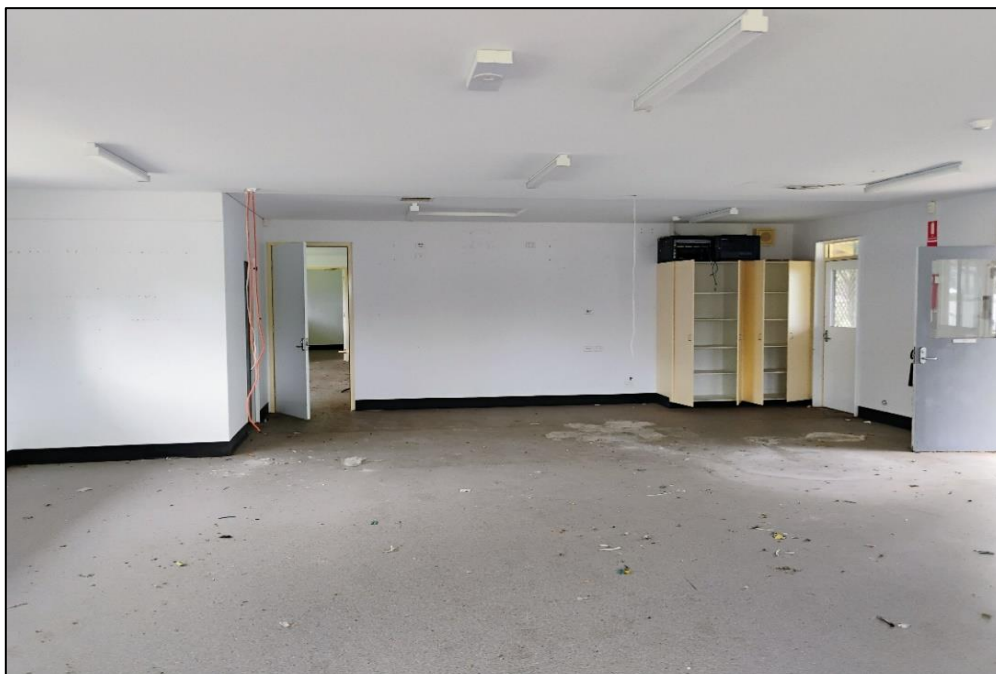
Photograph 7: B00D, rooms and areas in general, fluorescent light fittings, internal components, nil PCB (suspected).

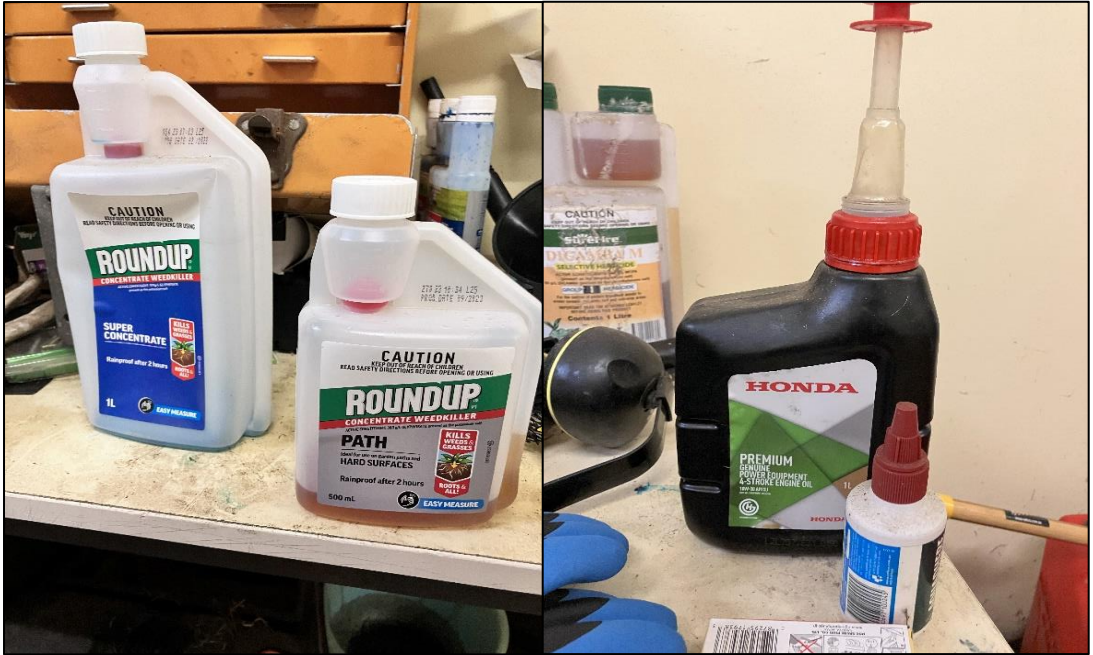
Photograph 11: B00D, DR0007, throughout, various chemical products including fuels, oils, herbicides, paints and various other products.

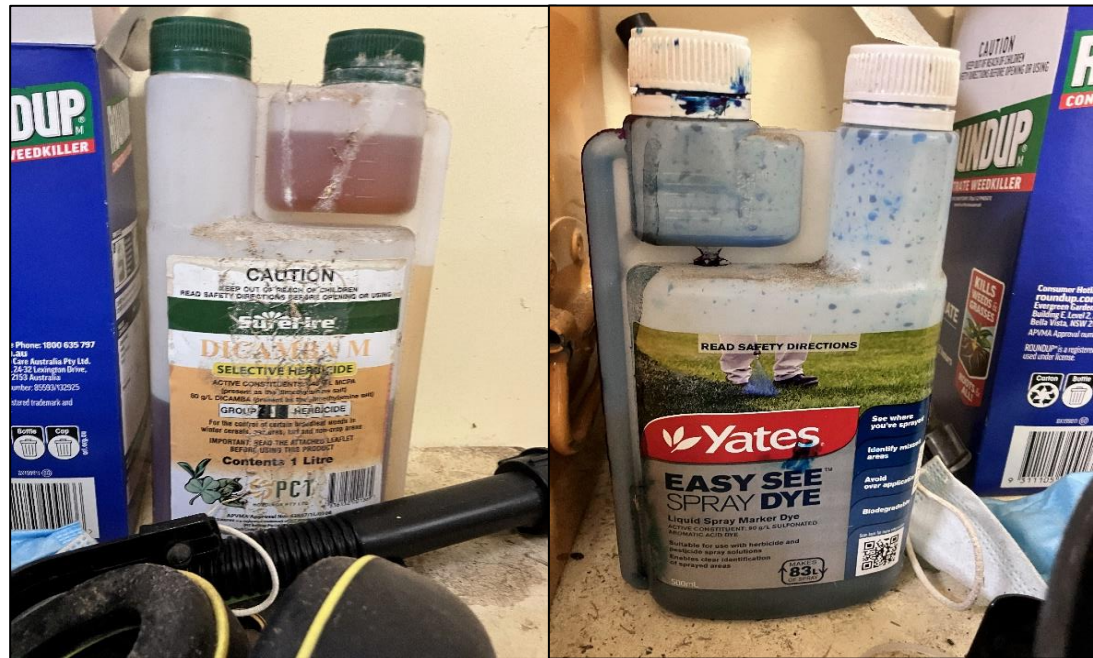
Photograph 12: B00D, DR0007, throughout, various chemical products including fuels, oils, herbicides, paints and various other products.

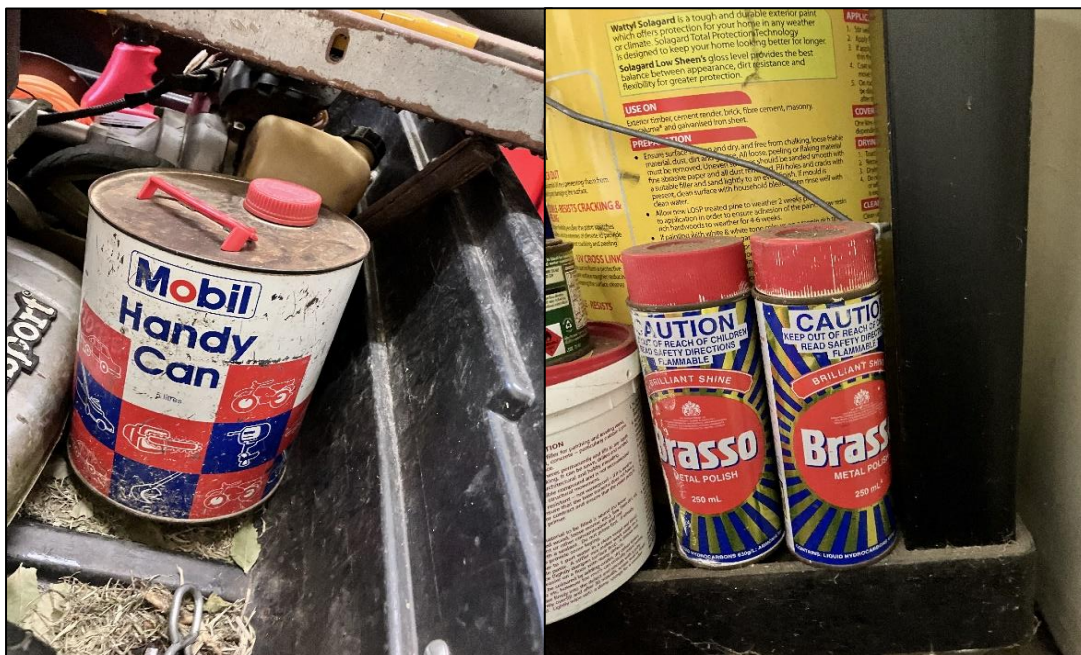
Photograph 13: B00D, DR0007, throughout, various chemical products including fuels, oils, herbicides, paints and various other products.

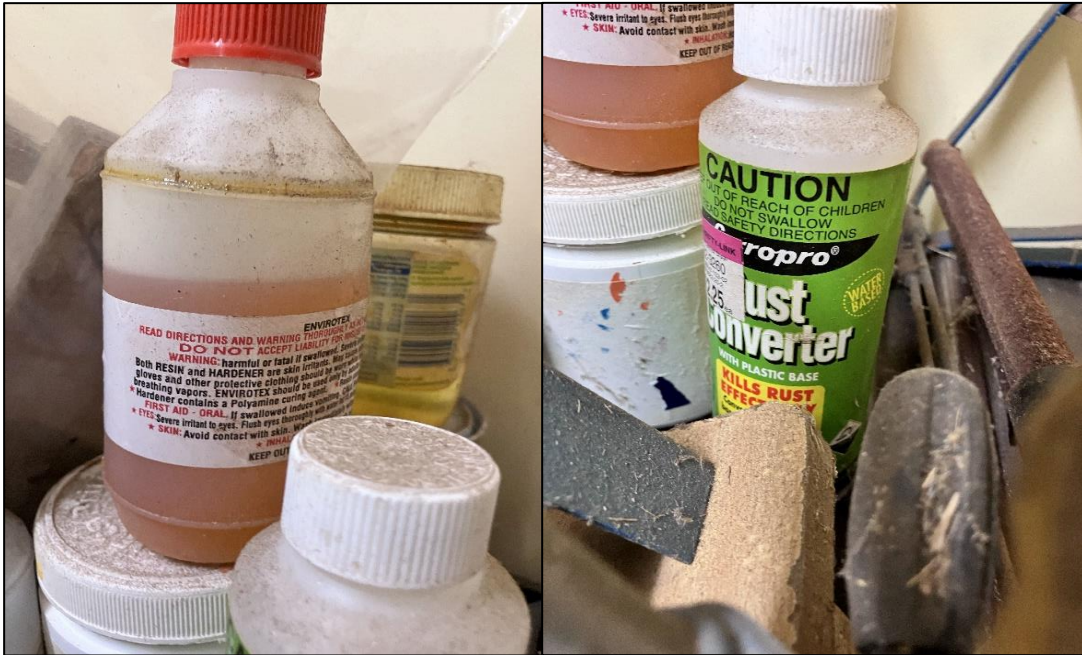
Photograph 15: B00D, DR0007, throughout, various chemical products including fuels, oils, herbicides, paints and various other products.

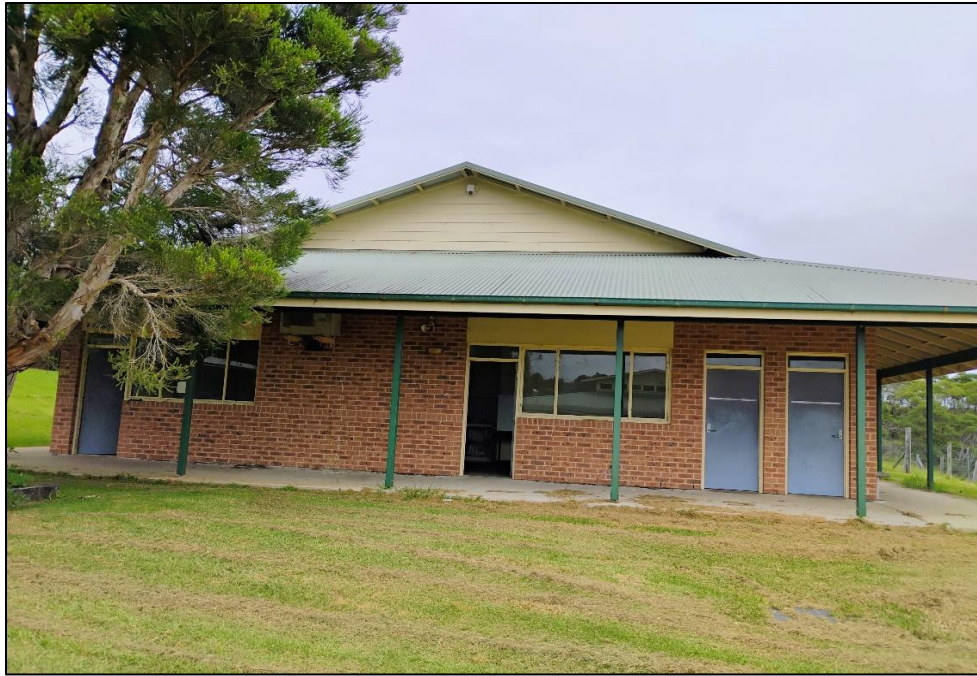
Photograph 1: B00E, exterior, north and south façade, gables, weatherboard linings, inaccessible.

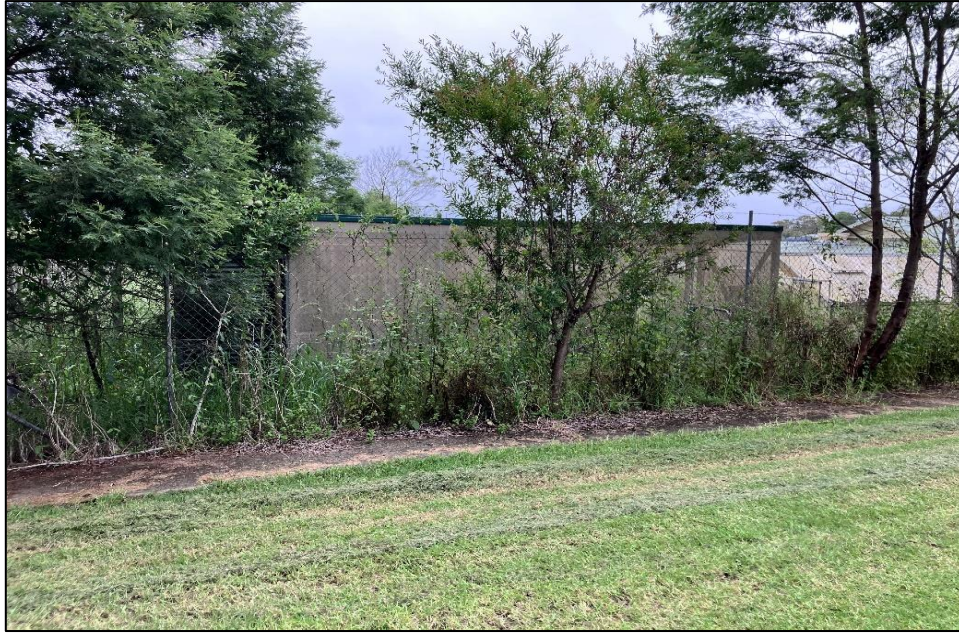
Photograph 1: B00F, inaccessible inside security (barbed wire) fencing.

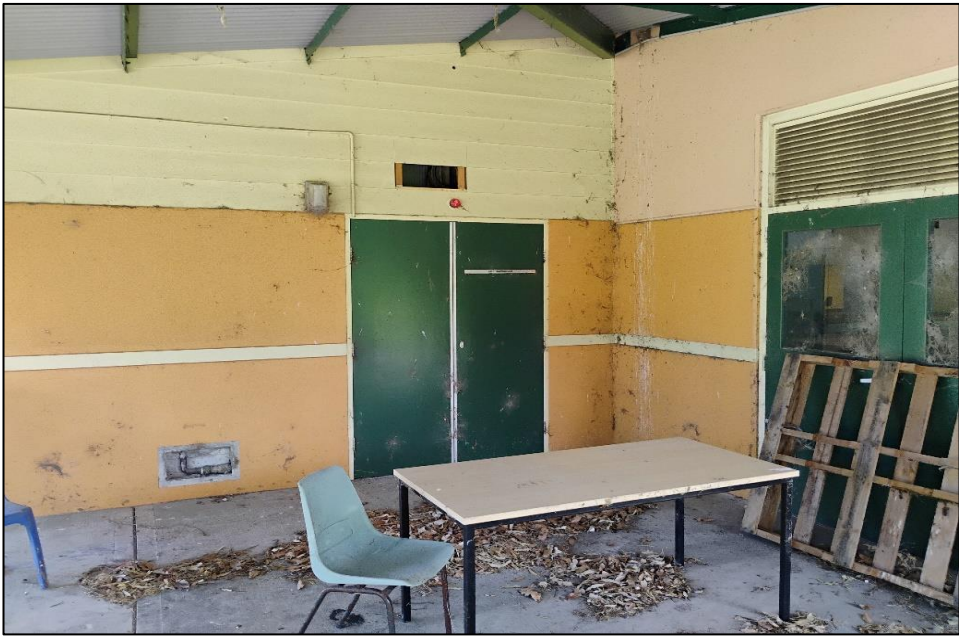
Photograph 1: B00I, exterior, northern façade, weatherboard headlining, fibre cement product, no asbestos detected by analysis.

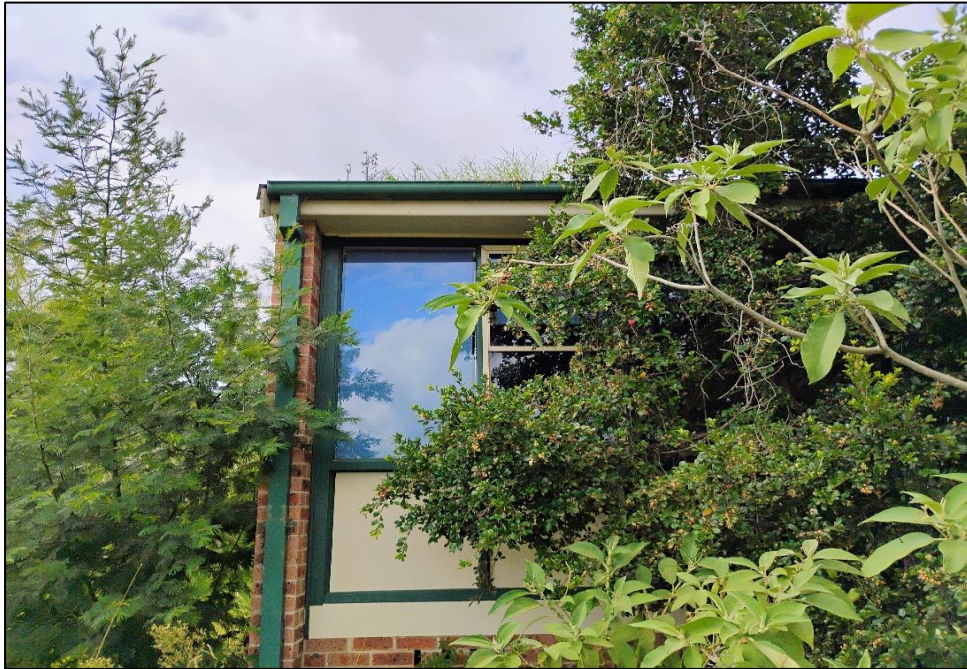
Photograph 1: B00P, exterior, west façade, infills, eave linings, fibre cement sheeting, no asbestos detected by analysis.

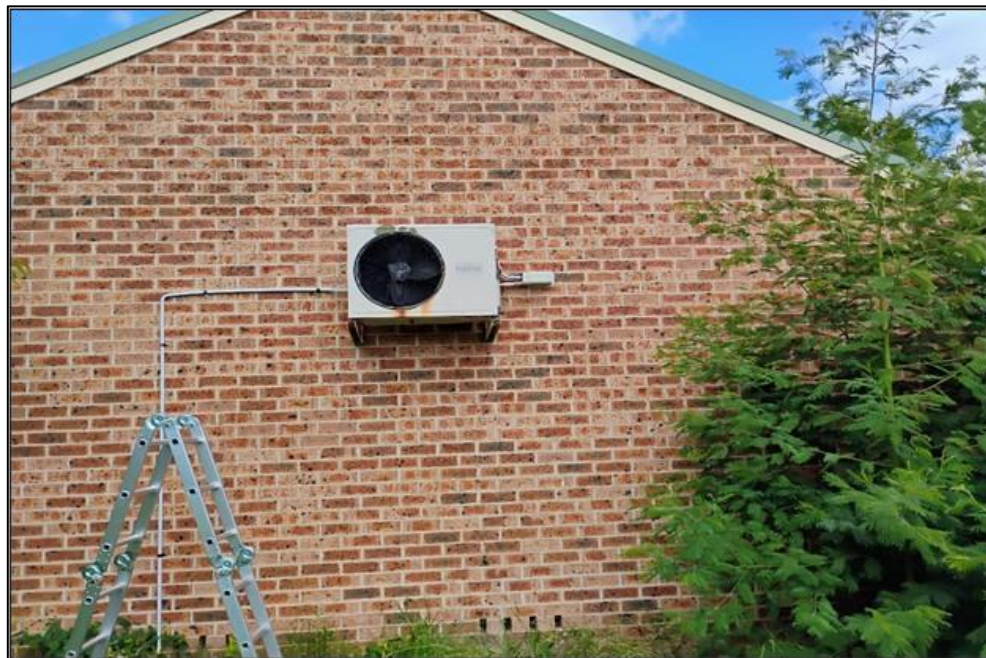
Photograph 2: B00P, exterior, northern façade, air conditioning unit, R22, ODS identified.

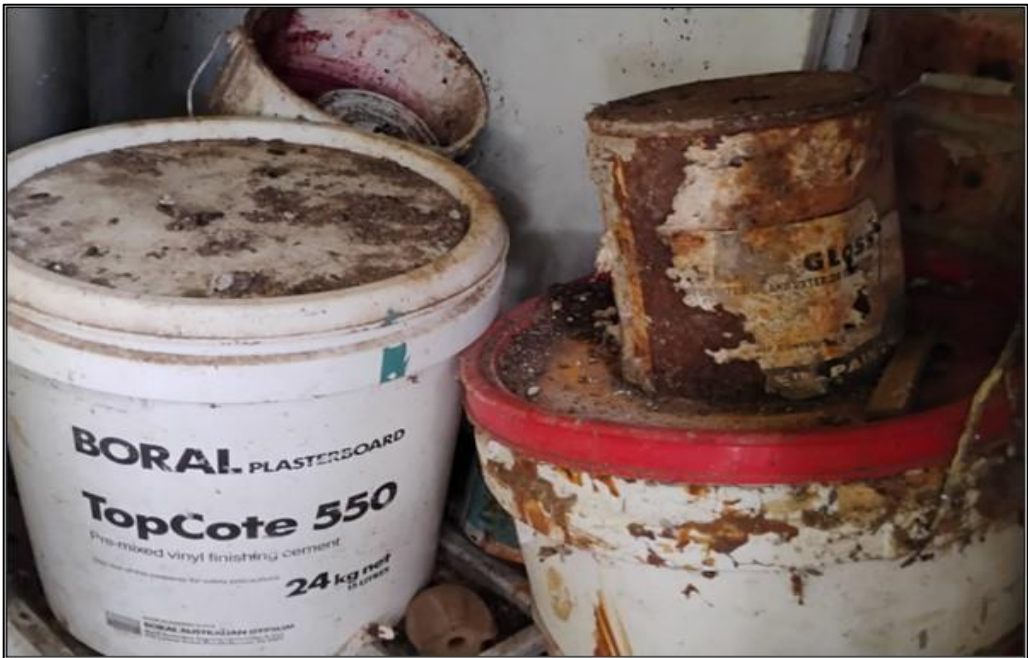
Photograph 4: B00P, sub floor area, general construction supplies/waste.

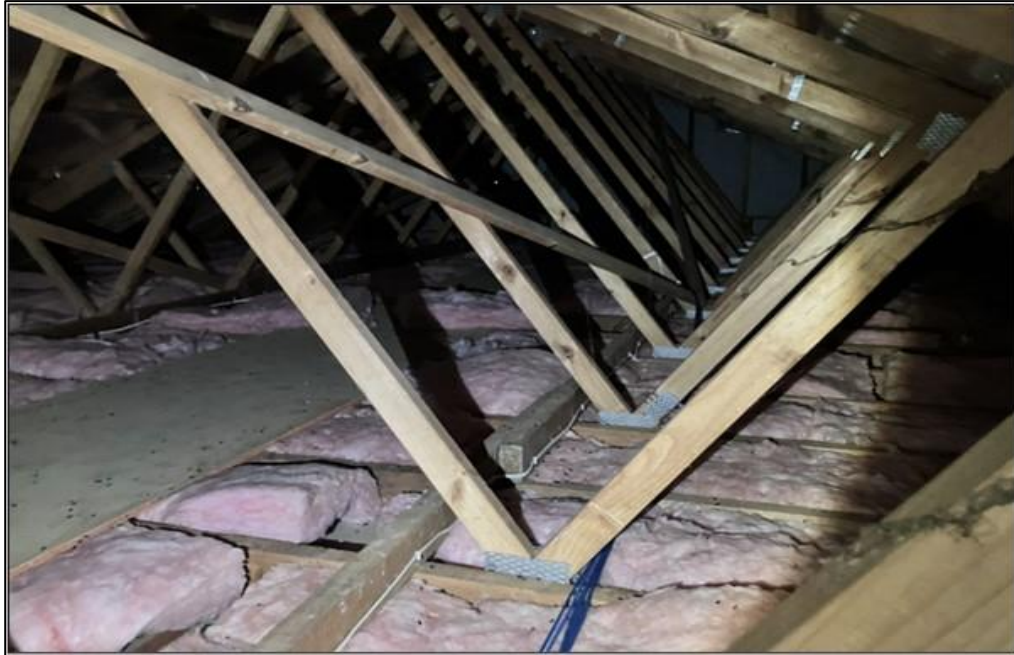
Photograph 5: B00P, ceiling cavity, top of ceiling, insulation (SMF identified visually).

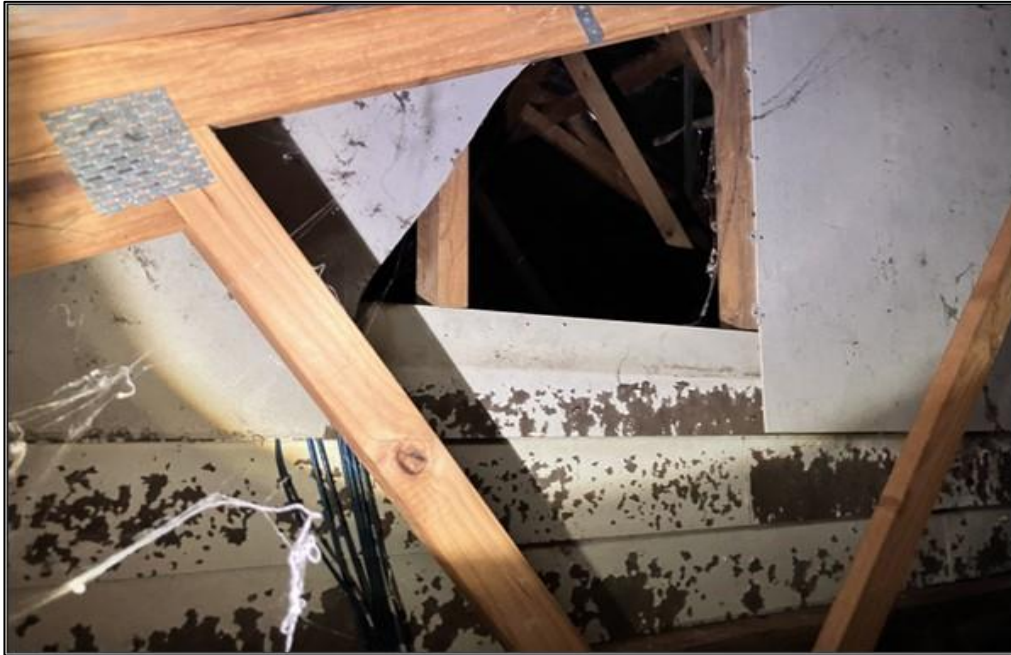
Photograph 7: B00P, ceiling cavity, bulkhead, fibre cement sheeting, no asbestos detected by analysis.

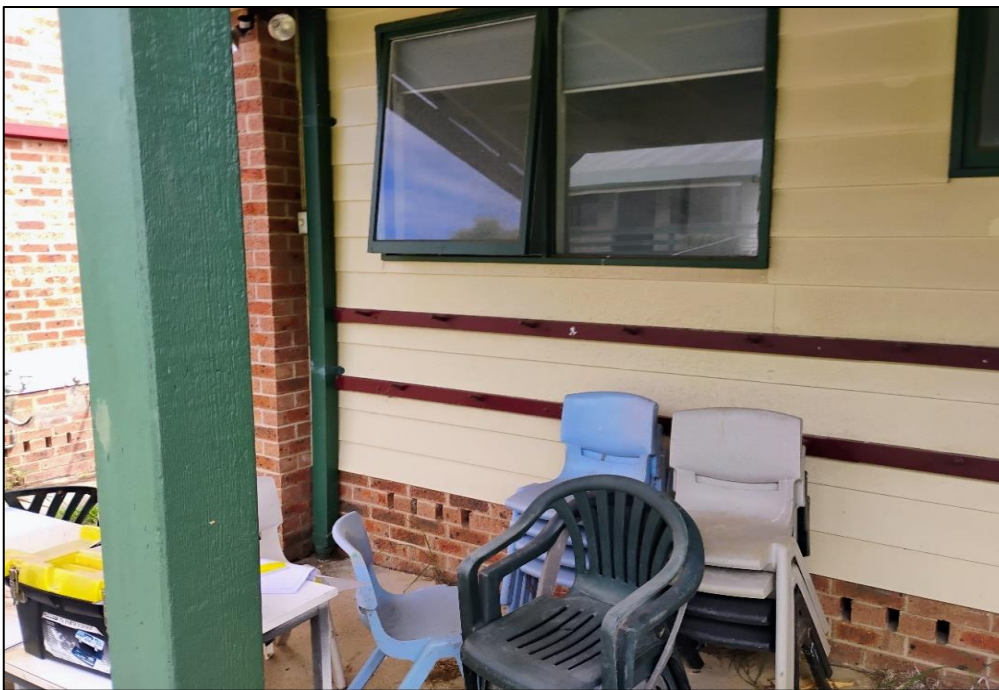
Photograph 8: B00P, exterior, east façade, weatherboard walls (cream paint), bag hooks (maroon paint) and window frames (green paint).

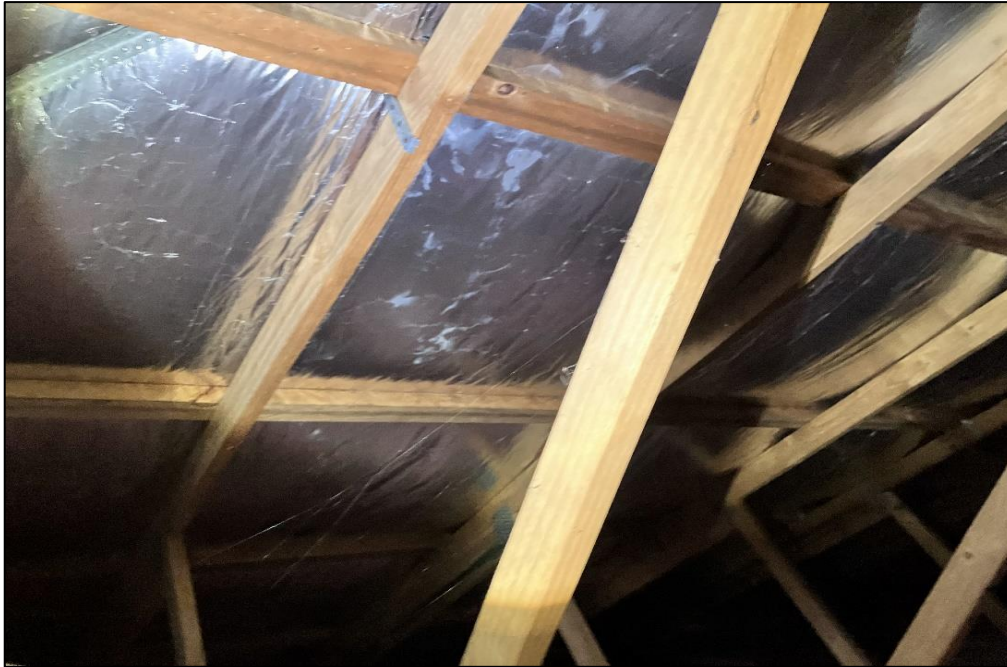
Photograph 9: B00P, rooms and areas in general, ceiling cavity, underside of roof, insulation, SMF identified visually.

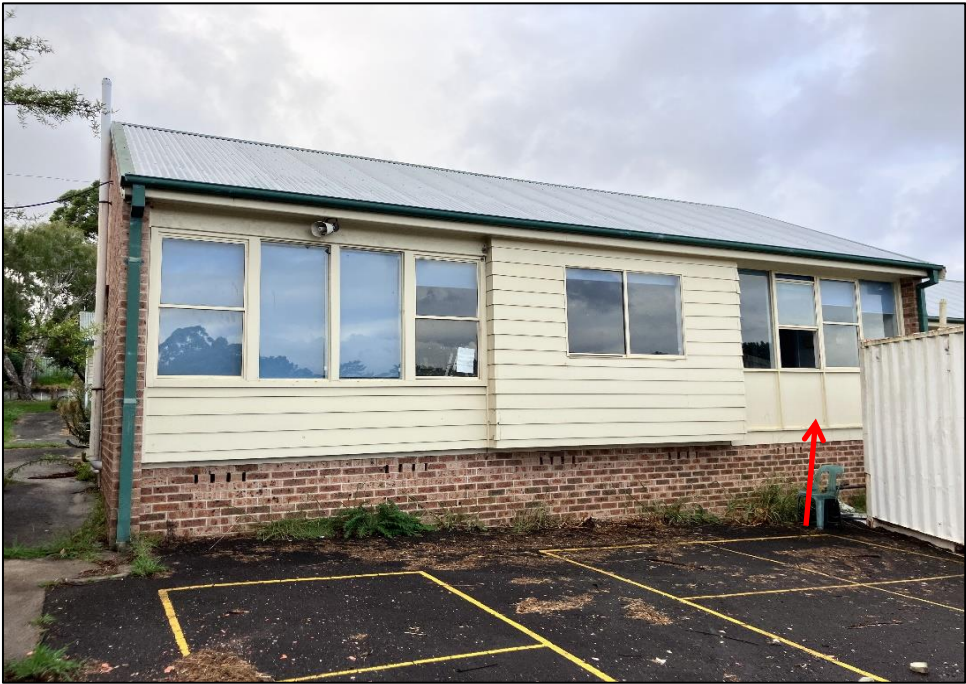
Photograph 1: B00Q, exterior, west façade, wall / infill panels, fibre cement sheeting, no asbestos detected by analysis.
