## **Hazardous Building Materials (HAZMAT) Report**

**Former Shoalhaven Anglican School**

**17 Croobyar Milton NSW**

**Project 89390.08**

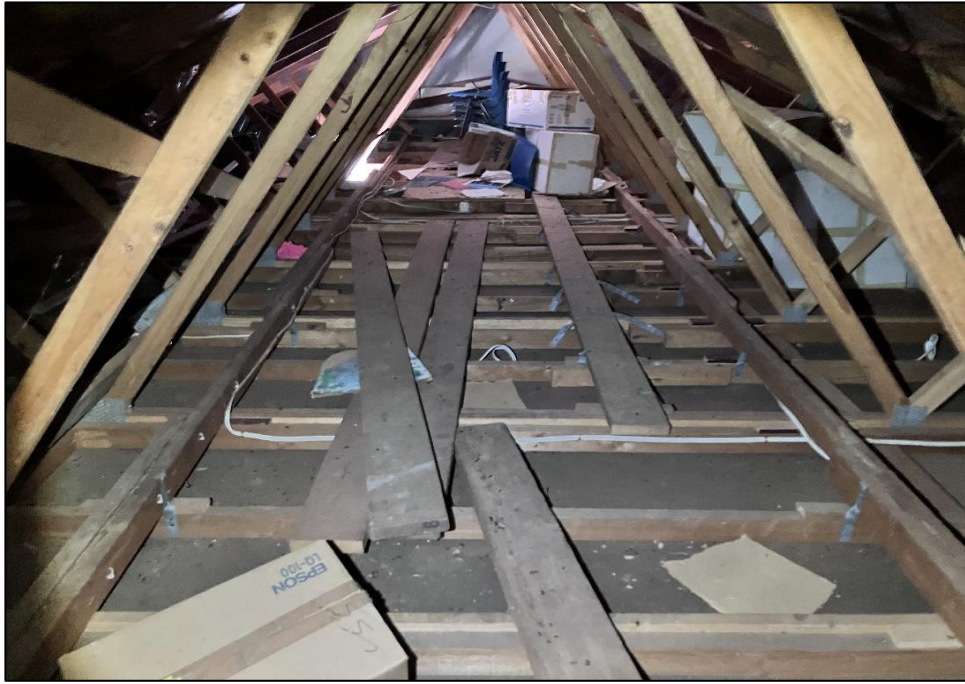
Photograph 5: B00Q, QR003, ceiling cavity, settled dust / debris, elevated lead concentration not identified.

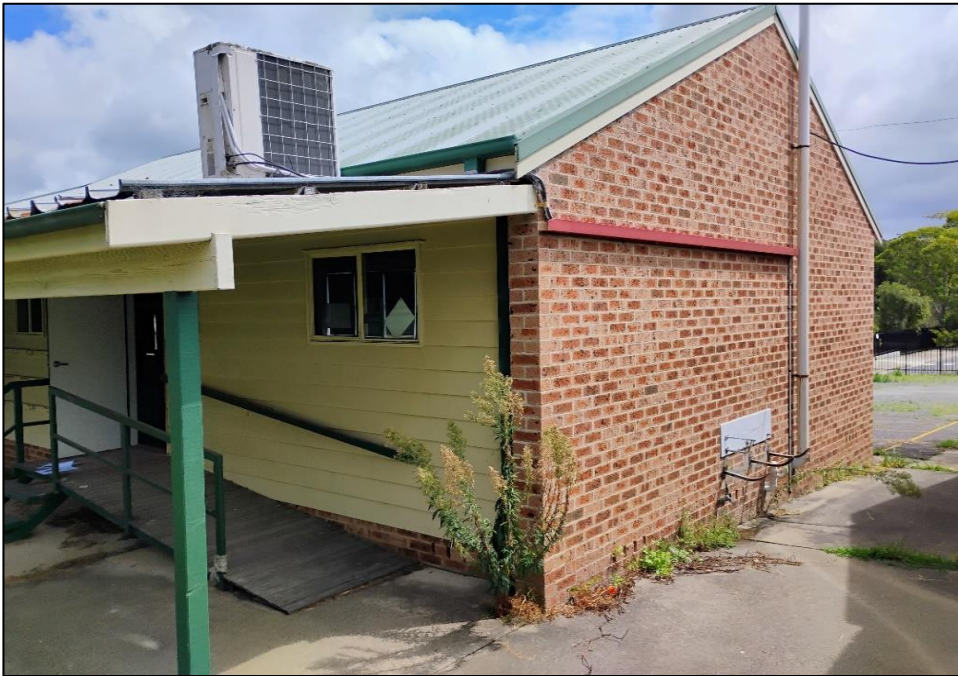
Photograph 8: B00Q, exterior,QR003, roof, air conditioning unit, R410A, nil ODS identified.

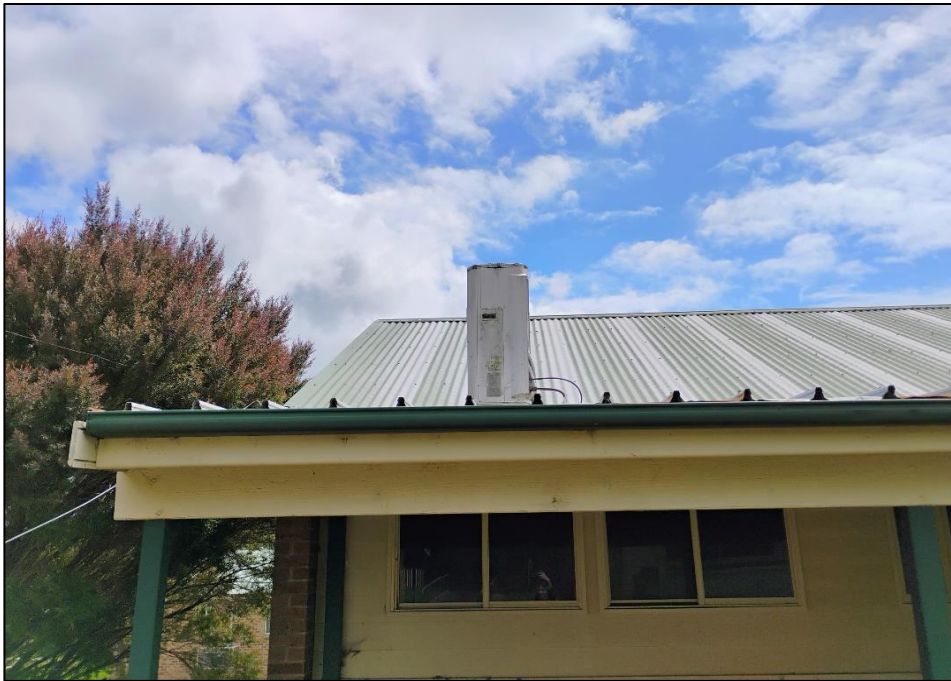
Photograph 9: B00Q, exterior,QR004, roof, air conditioning unit, R410A, nil ODS identified.

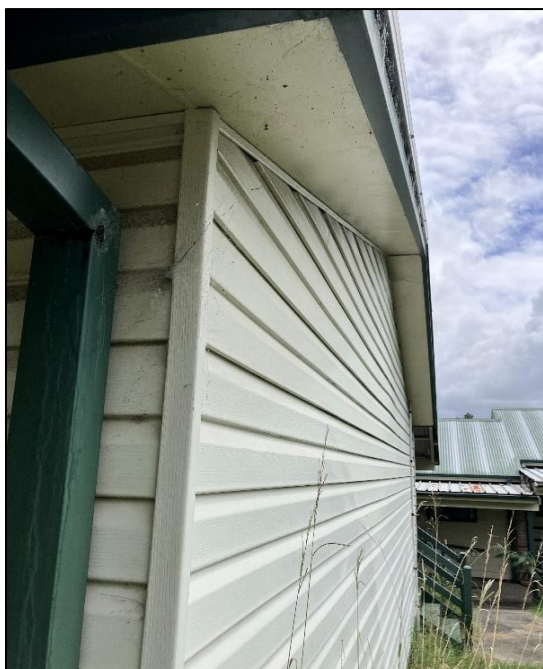
Photograph 1: B00R, exterior, eave linings, fibre cement sheeting, no asbestos detected by analysis.

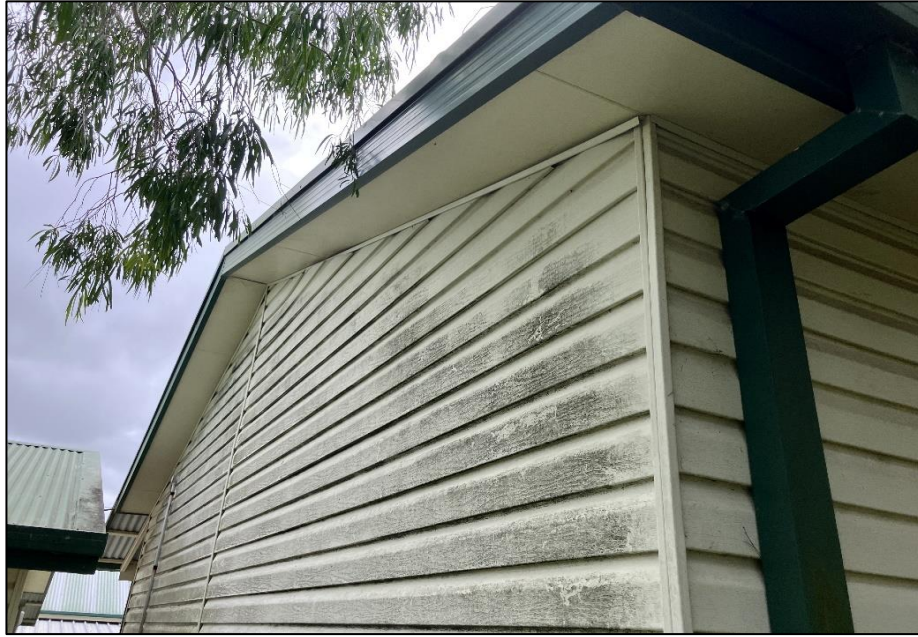
Photograph 1: B00S, exterior, eave linings, fibre cement sheeting, no asbestos detected by analysis.

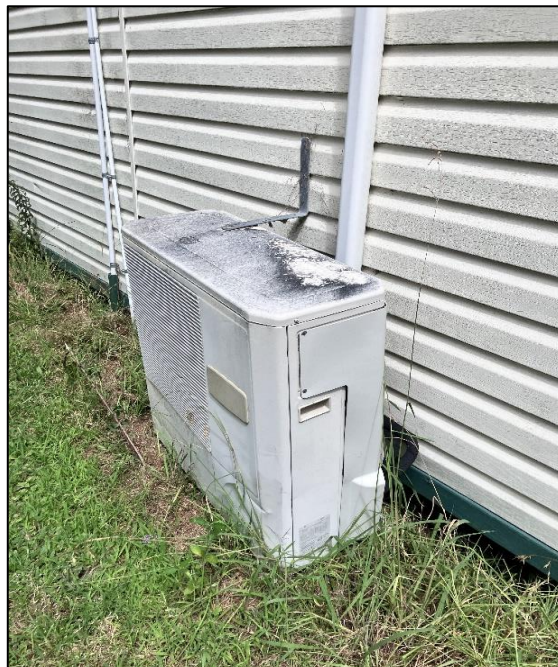
Photograph 8: B00S, exterior, air conditioning unit, R22, ODS identified.

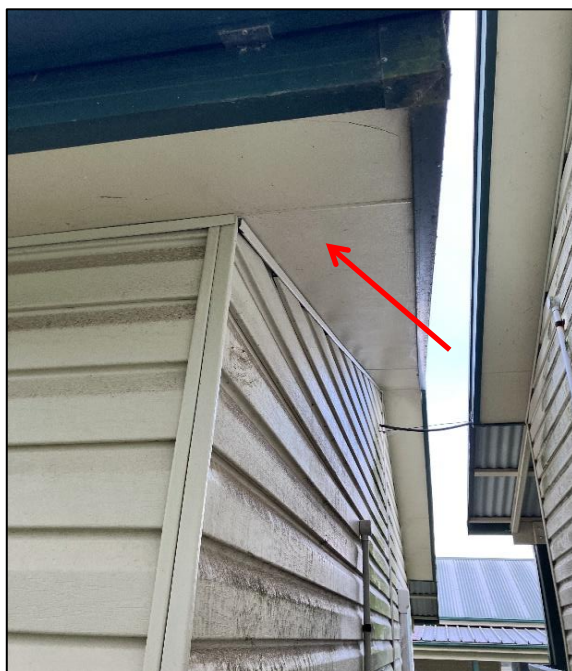
Photograph 1: B00T, exterior, eave linings, fibre cement sheeting, no asbestos detected by analysis.

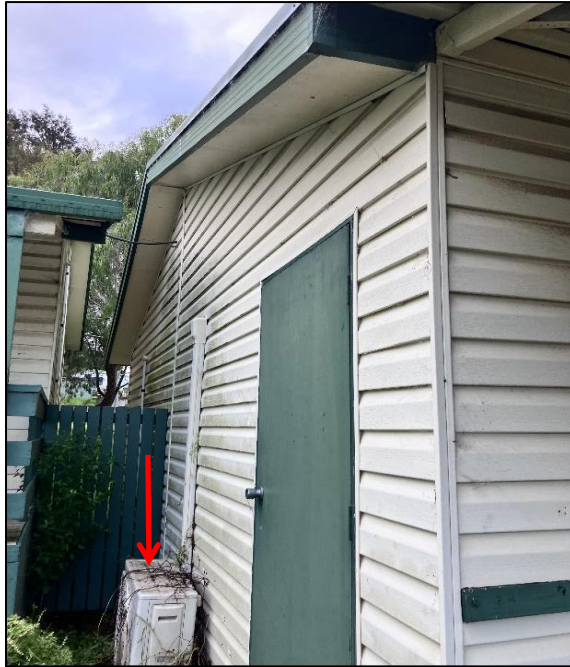
Photograph 5: B00T, exterior, roof, air conditioning unit, R410A, nil ODS identified.

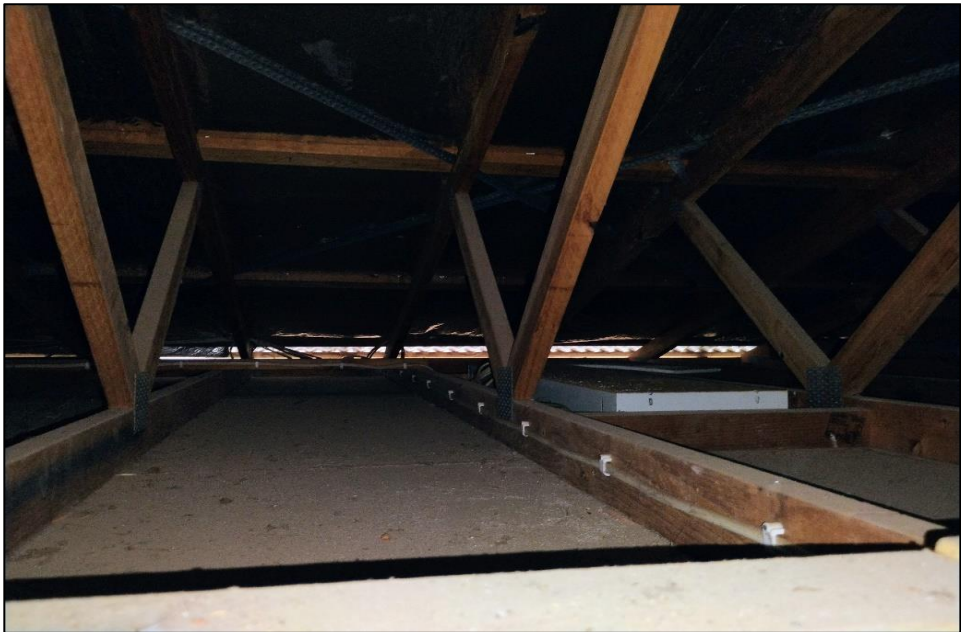
Photograph 6: B00T, rooms and areas in general, ceiling cavity, settled dust / debris, elevated lead concentration detected.

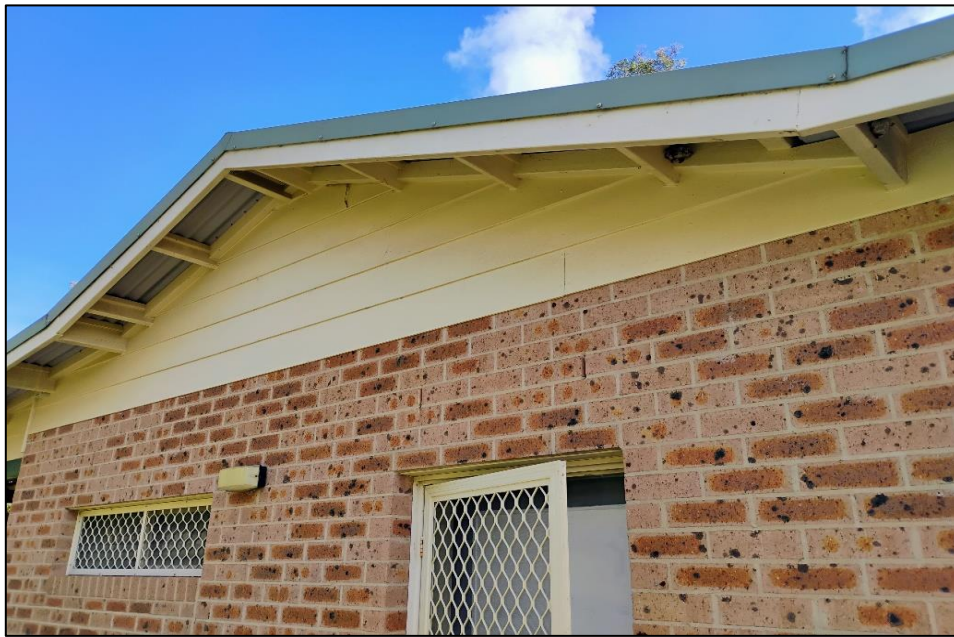
Photograph 1: B00U, exterior, northern façade, weatherboard lining, fibre cement sheeting, no asbestos detected by analysis.

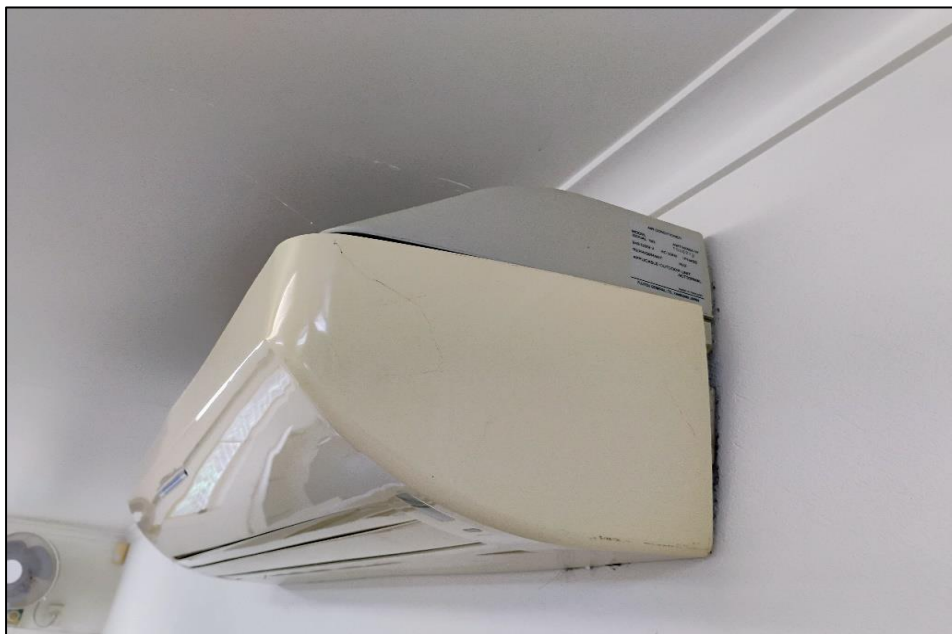
Photograph 9: B00U, exterior, roof, air conditioning unit(s), R22, ODS identified.

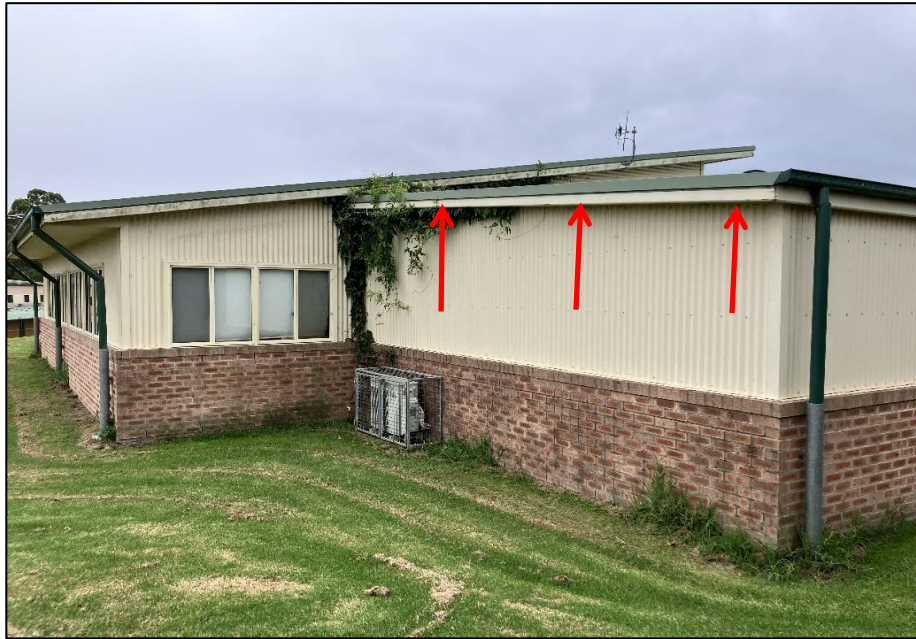
Photograph 1: B00V, exterior, western façade, south end, eave lining, no asbestos detected by analysis.

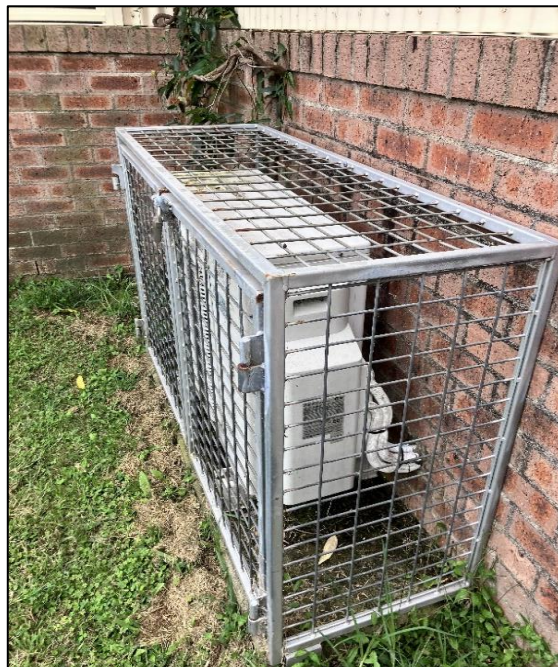
Photograph 8: B00V, exterior, western façade, south end, air conditioning unit, R410A, nil ODS identified.

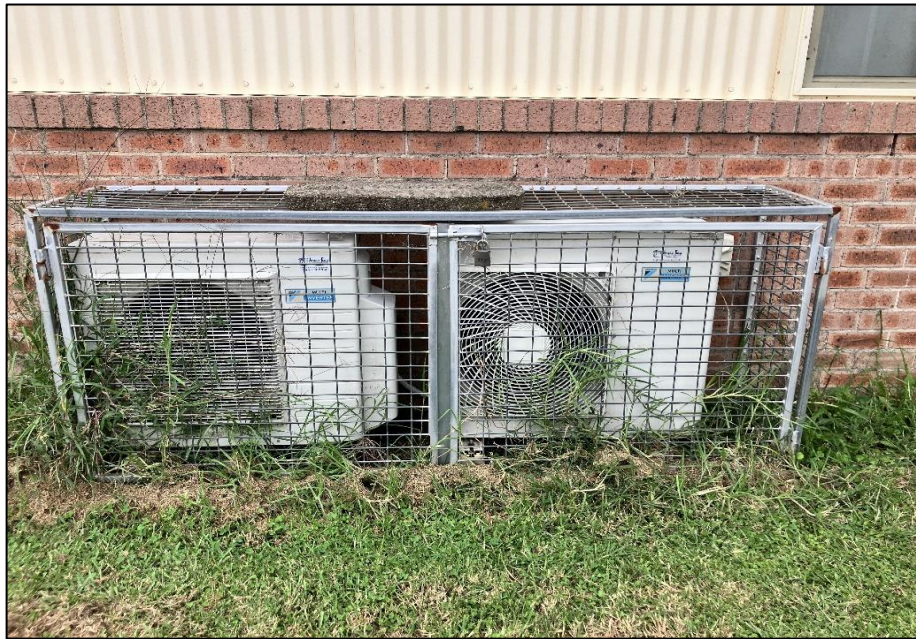
Photograph 9: B00V, exterior, western façade, north end, air conditioning units (x2), R410A, nil ODS identified.

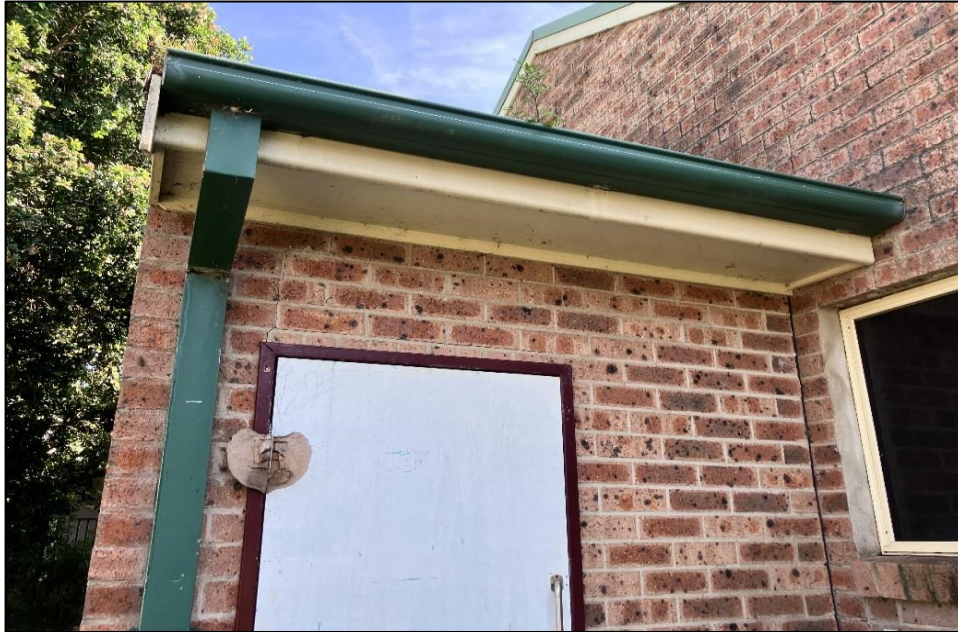
Photograph 1: B00W, exterior, WR0015, eave lining, fibre cement sheeting, no asbestos detected by analysis.

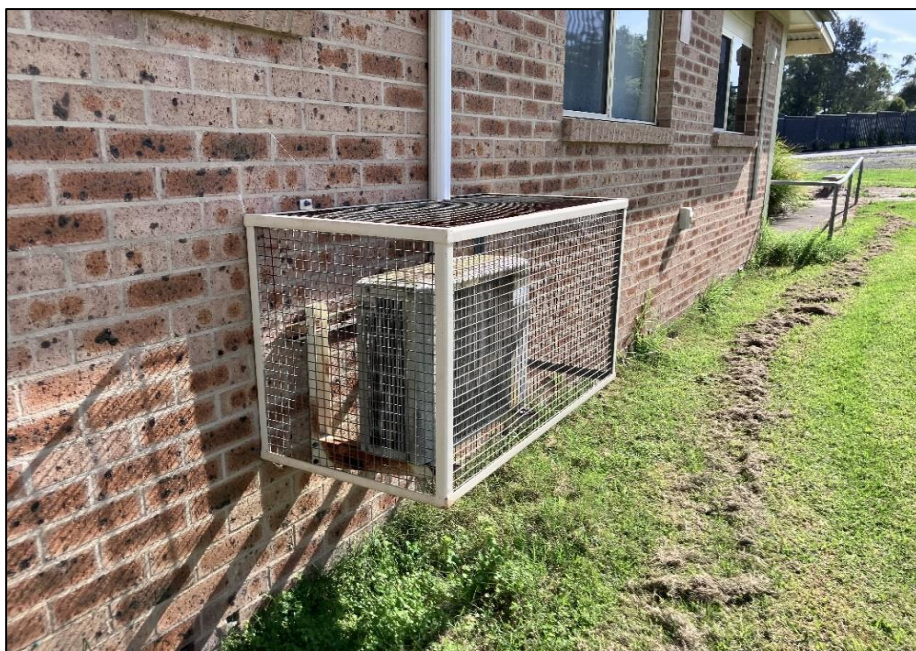
Photograph 16: B00W, exterior, southeastern façade, Fujitsu air conditioner, not determined, inaccessible / illegible compliance plate(s).

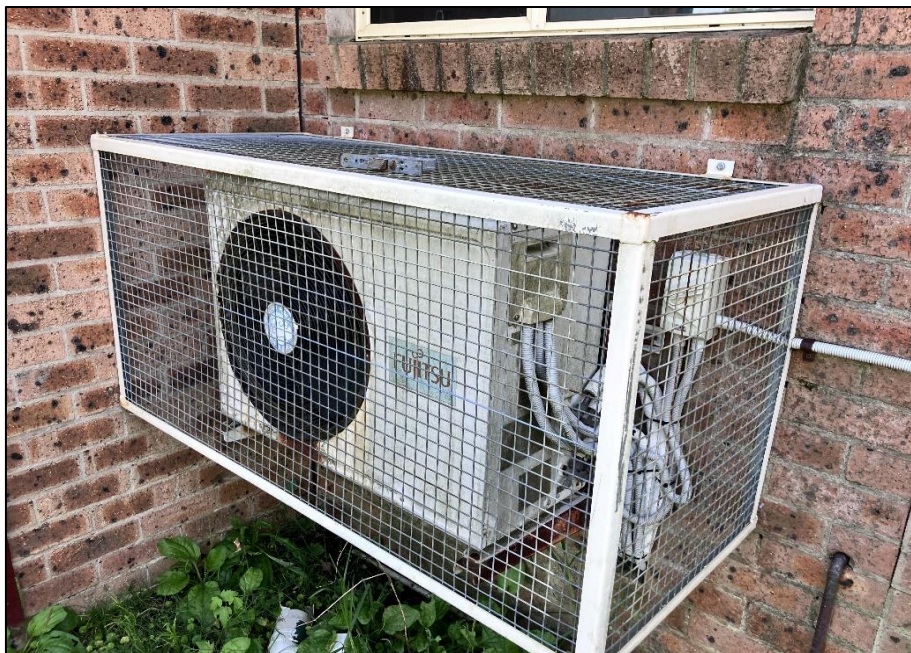
Photograph 17: B00W, exterior, southwestern façade, Fujitsu air conditioner, R22, ODS identified.

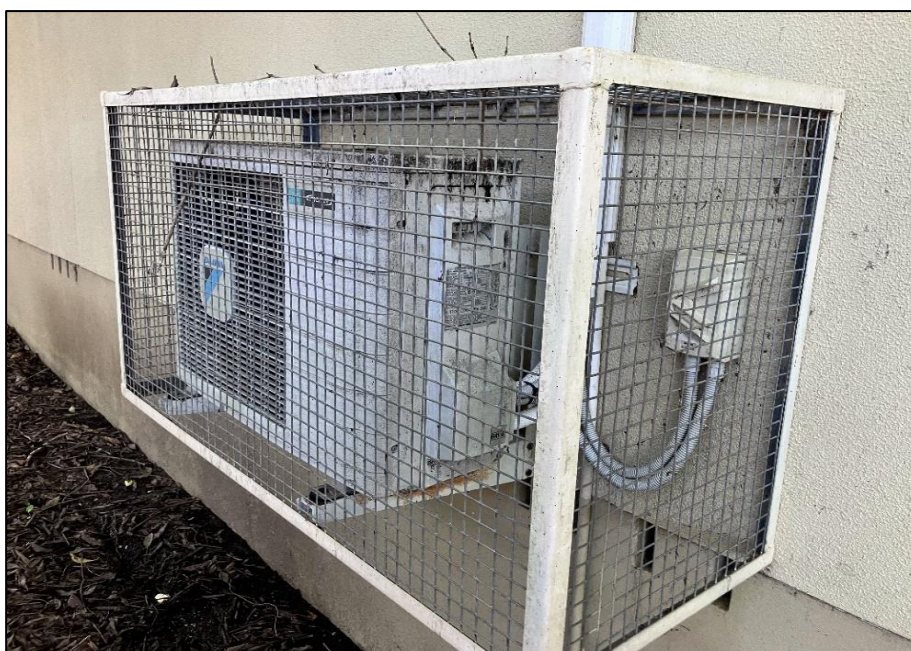
Photograph 18: B00W, exterior, northern façade, Daikin air conditioning unit, R410A, nil ODS identified.

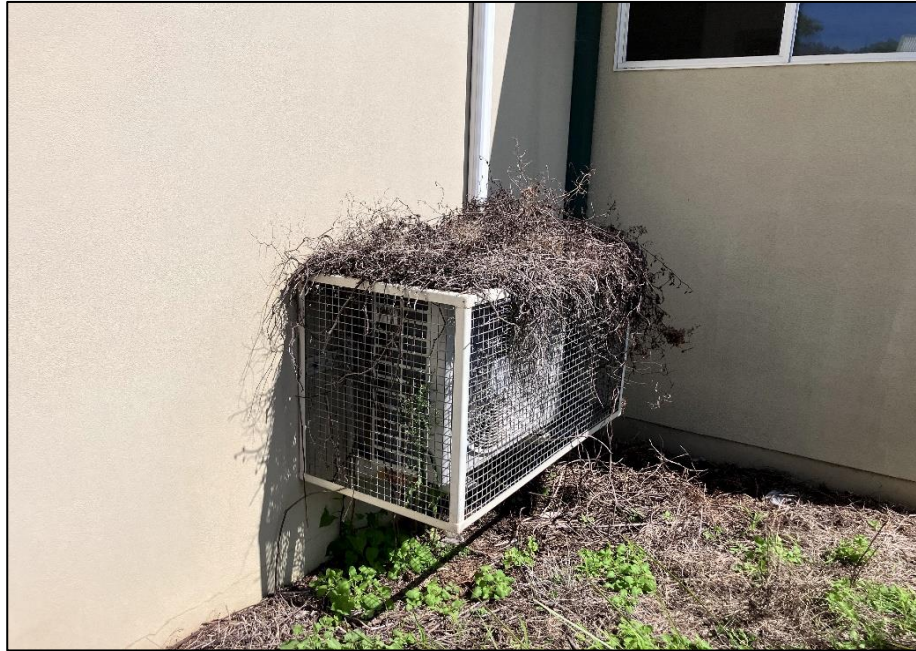
Photograph 19: B00W, exterior, northeastern façade, air conditioning unit, R410A, nil ODS identified.
