# Preliminary Site Investigation

360 Wallarobba-Brookfield Rd,  
Brookfield NSW 2420

January 2026

| Project Reference | S00931 |

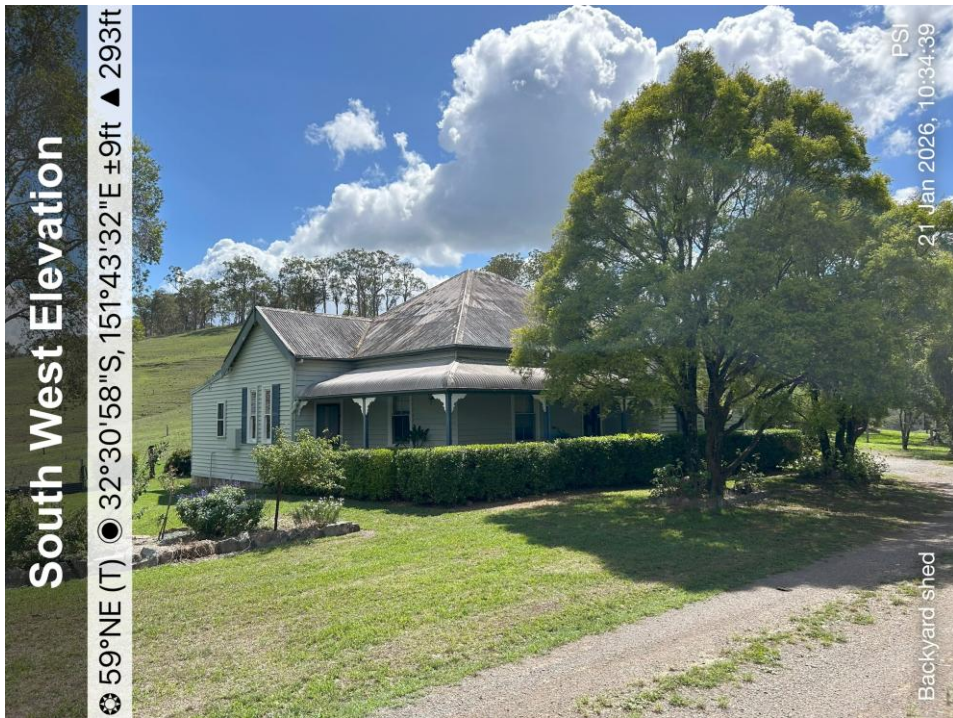
Photo 1: Overview of the residential dwelling.

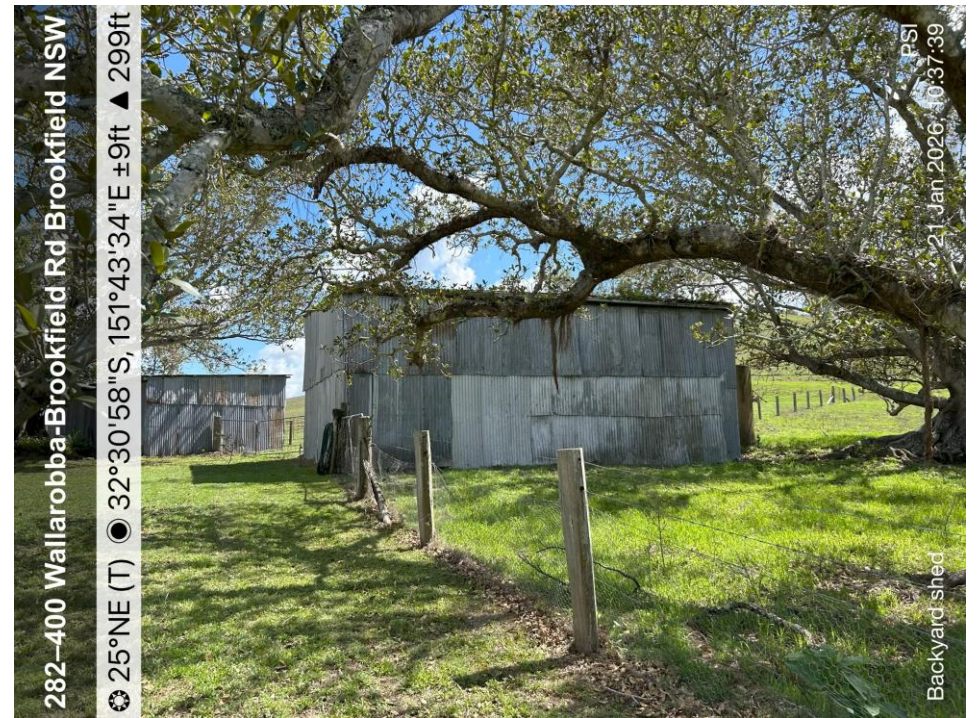
Photo 2: Overview of the shed to the eastern section of the investigation area.

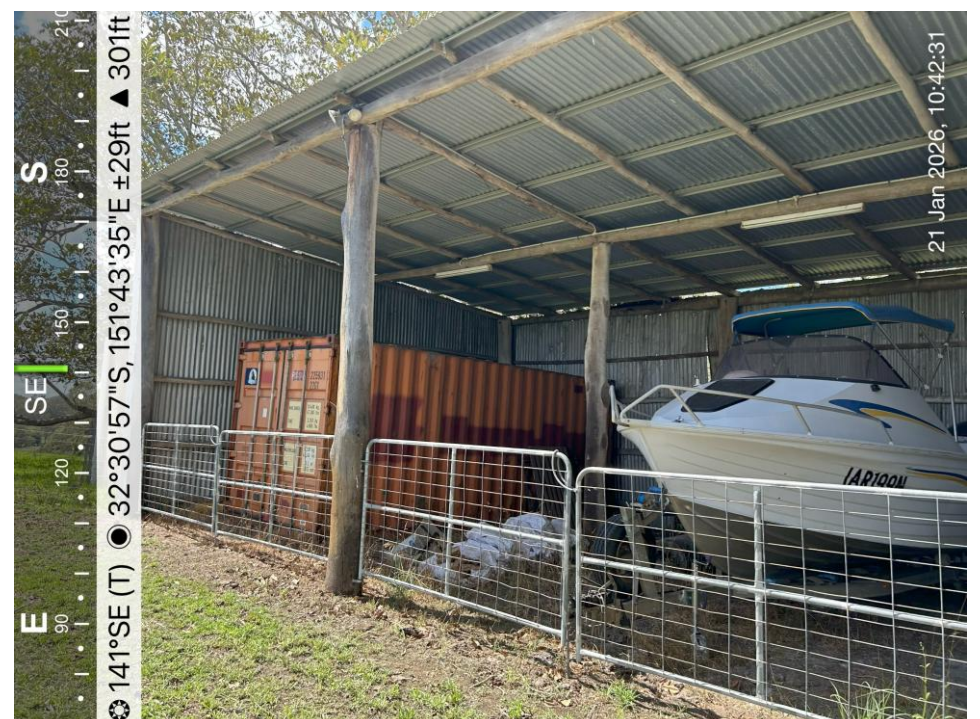
Photo 4: Overview of the shed located to the eastern section of the site, used for storage.

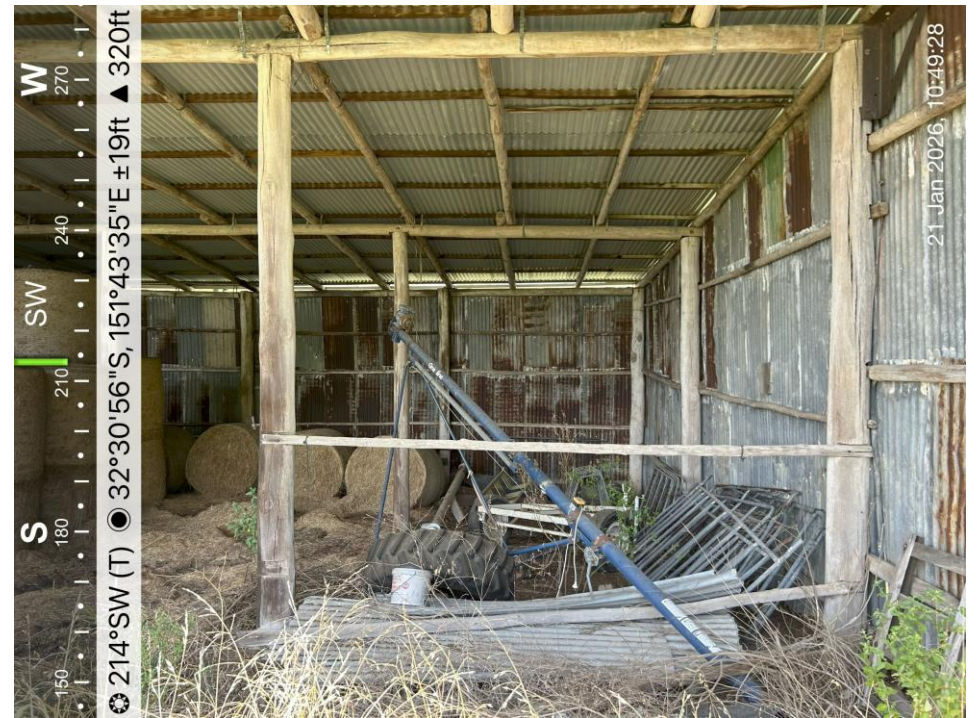
Photo 8: Internal view of the northeastern storage shed.

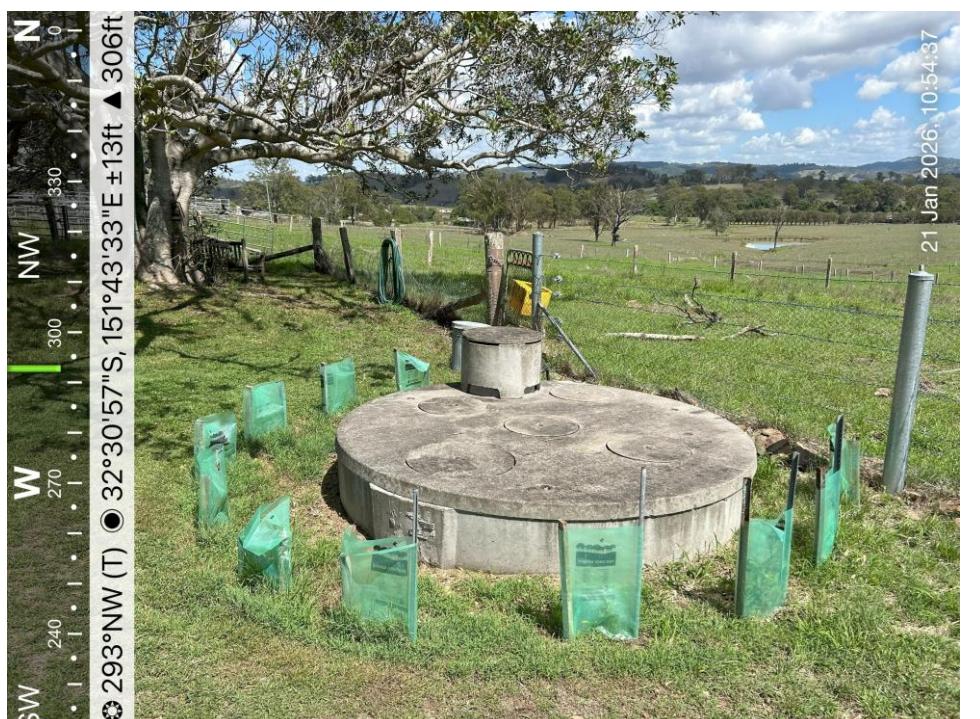
Photo 10: Overview of the underground septic tank adjacent to the northeastern side of the residential dwelling.

- In the event of any unexpected finds, including odorous and/or stained soil material or underground tank storage, Nova Pacific must be notified immediately for further investigation; and

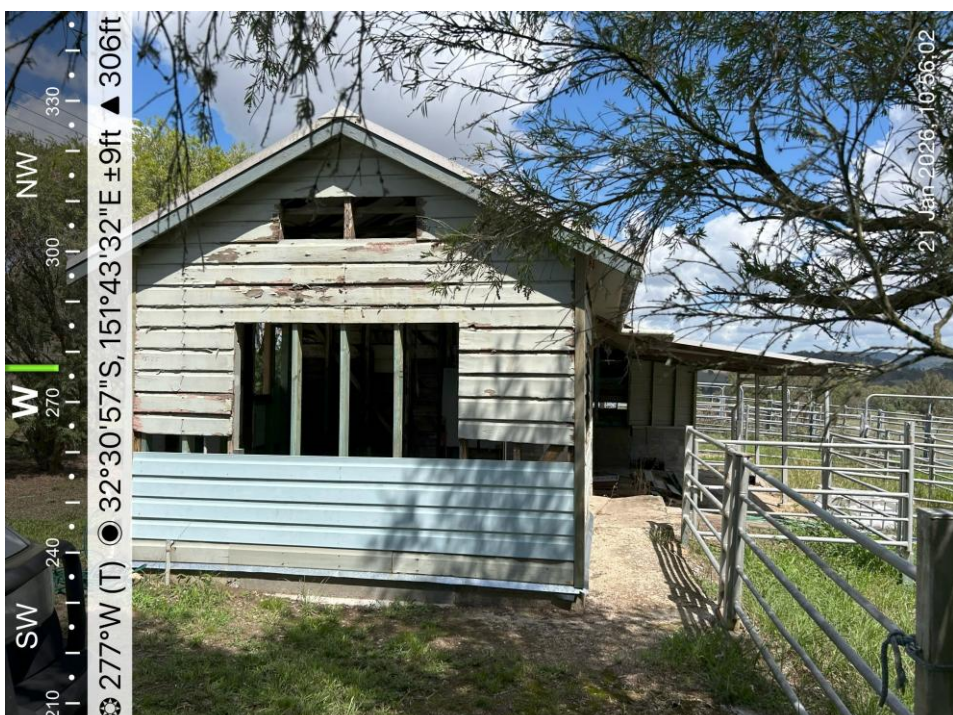
Photo 11: View of the livestock shelter located to the western section of the site.

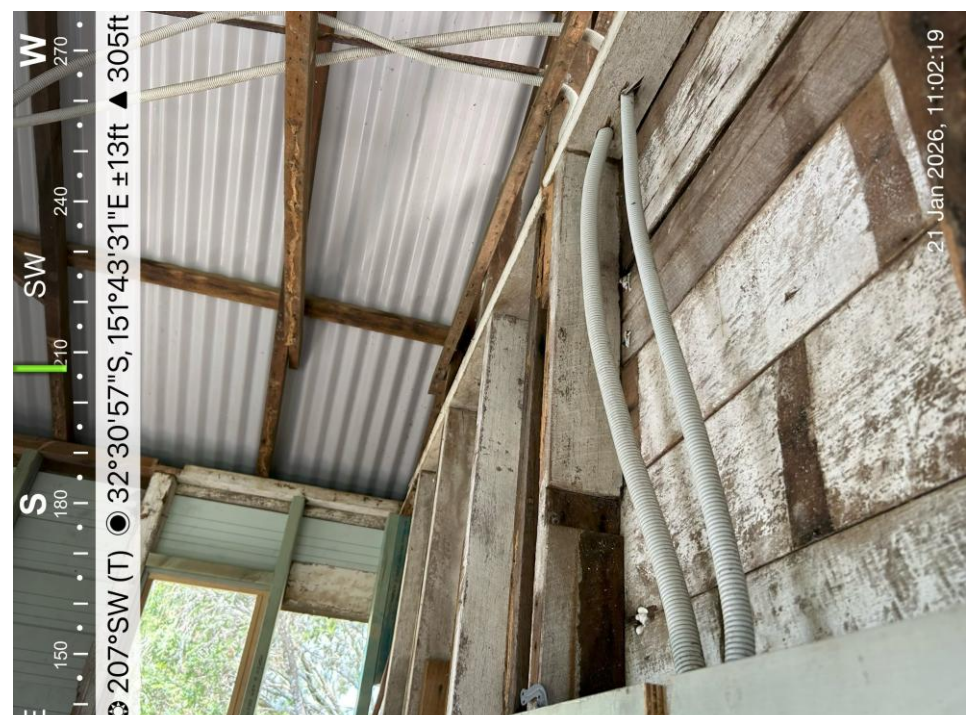
Hazardous materials, such as asbestos and lead-based paints, used on old buildings present the potential for soil contamination due to weathering and damage. When ACMs break down, asbestos fibres can be released into the air and settle in surrounding soil, leading to long-term contamination. A similar process is observed with lead-based paint when deteriorating due to weathering can deposit on soil, posing a persistent risk as lead does not degrade and can accumulate over time. The disturbance of hazardous materials in structures or existing within soils, has the capacity to impact human health through dermal contact, incidental ingestion, and incidental inhalation of volatilising contaminants and/or asbestos fibres.

- During the site inspection, aged building materials were observed across the site, including possible ACM and lead base paints. Flaking paints were found on the walls of the livestock handling area located southwestern section of the site; and

Photo 12: Closeup view of the internal walls of the livestock shelter.

- A Hazardous Building Materials Survey (HAZMAT) should be undertaken to confirm the presence or absence of hazardous materials within any buildings proposed for demolition and/or renovation;
