# Hazardous Materials Survey

**Geosel Consulting Pty Ltd**

17 Haig Avenue, Georges Hall NSW

**Report Title** Hazardous Materials Survey  
**Project Reference Number:** WEC326.HMS  
**Document Date:** 21 August 2025

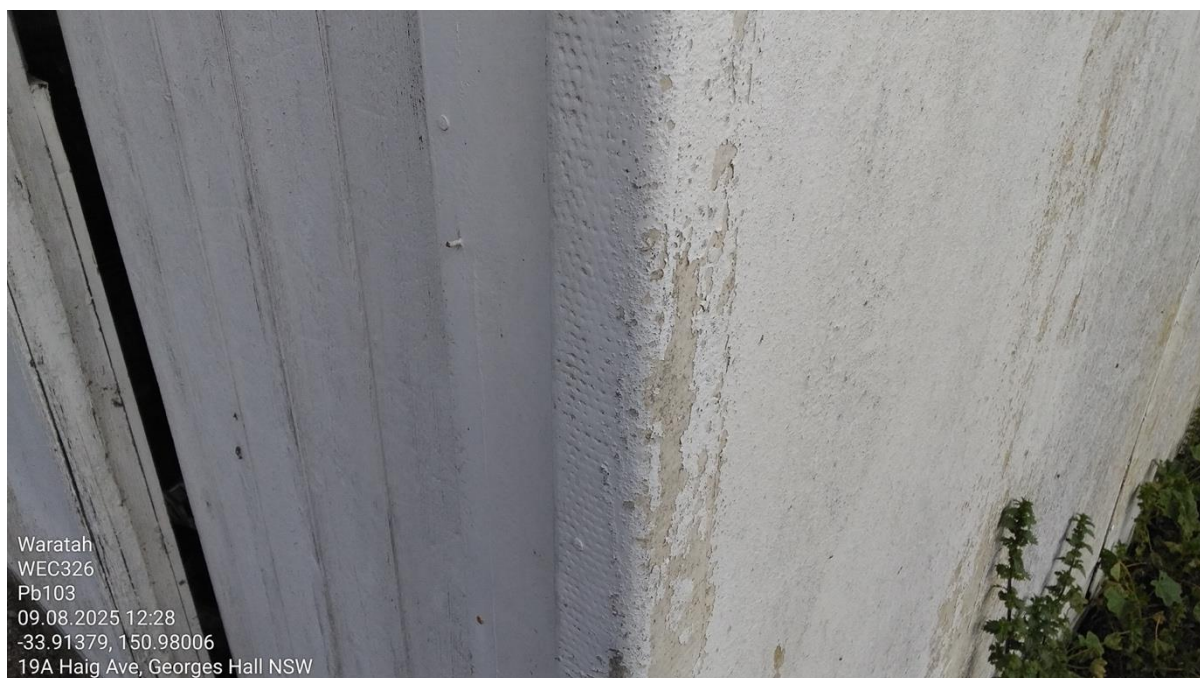
**Photograph 1:**

| Location Description | Material | Condition | Sample ID | Analytical Result | Estimated Quantity | Accessibility | Priority Rating | Recommendations | Photograph Register |
|---|---|---|---|---|---|---|---|---|---|
| Auxiliary shed exterior, surface of walls, throughout | White paint system | Poor | Pb103 | 0.016%w/w | 50m <sup>2</sup> | Regular | NA | NA | Photograph 1 |

Auxiliary shed exterior, surface of walls, throughout, white paint system, Pb103

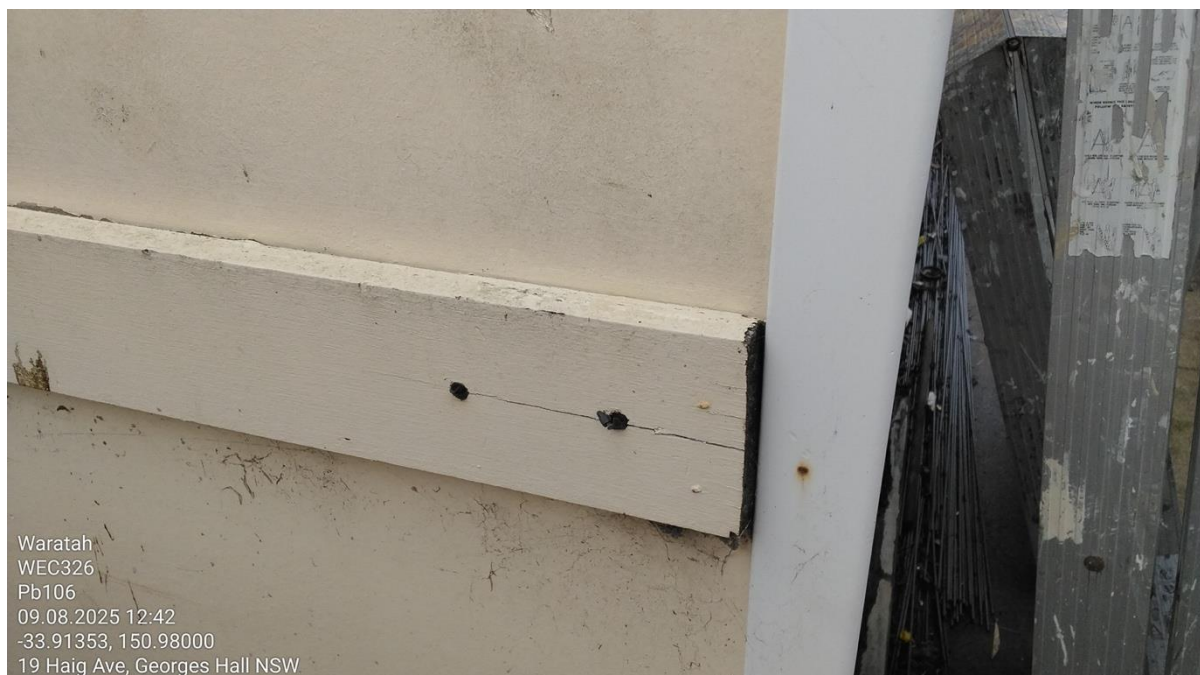
**Photograph 2:**

| Location | Material Description |
|---|---|
| Main exterior, surface of walls, throughout | Lead based cream paint system |

| Location Description | Material | Condition | Sample ID | Analytical Result | Estimated Quantity | Accessibility | Priority Rating | Recommendations | Photograph Register |
|---|---|---|---|---|---|---|---|---|---|
| Main dwelling exterior, surface of walls, throughout | Cream paint system | Good | Pb106 | 0.38%w/w | 100m <sup>2</sup> | Regular | Priority 3 -Low risk in present condition | Avoid abrasive activity in vicinity of material during demolition | Photograph 2 |

Main dwelling exterior, surface of walls, throughout, cream paint system, Pb106

LBP on structures from residential / educational / child-care premises must be removed prior to demolition. Any LBP waste generated is pre-classified as Hazardous Waste (EPA, 2014) unless LBP is removed.

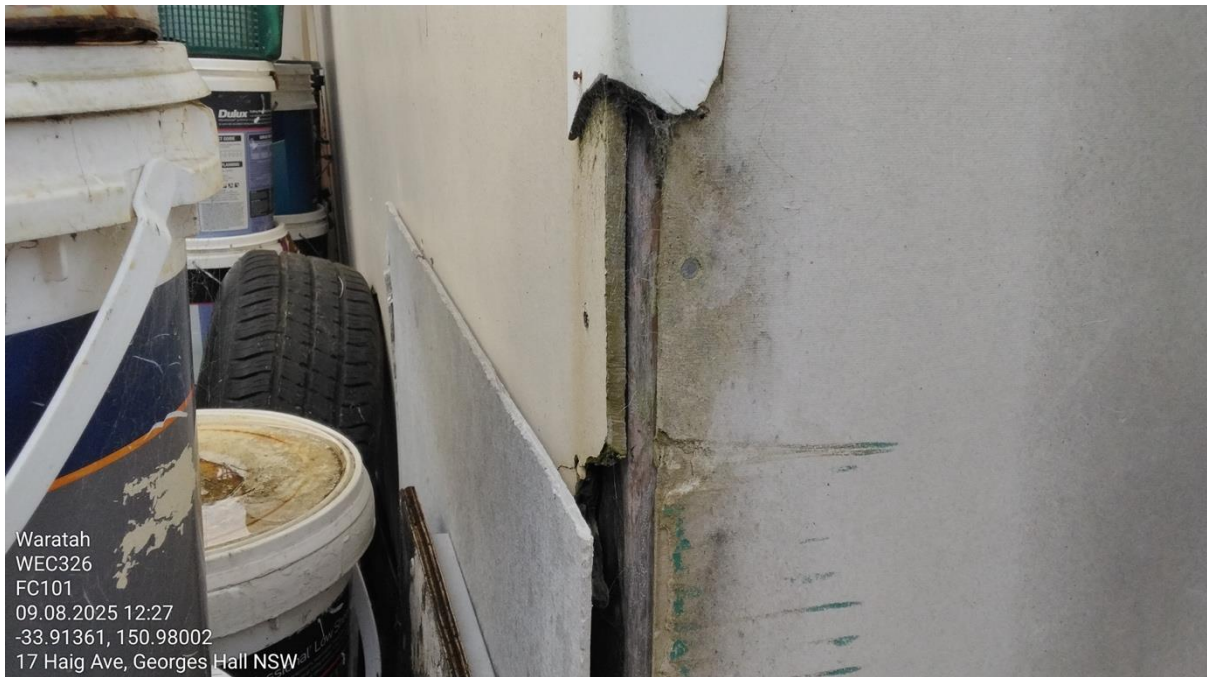
**Photograph 3:**

| Location Description | Material | Condition | Sample ID | Analytical Result | Estimated Quantity | Accessibility | Priority Rating | Recommendations | Photograph Register |
|---|---|---|---|---|---|---|---|---|---|
| Main exterior, walls, throughout | Cement sheet | Good | FC101 | No asbestos detected | 100m <sup>2</sup> | Maintenance only | NA | NA | Photograph 3 |

Main dwelling exterior, walls, throughout, cement sheet, FC101

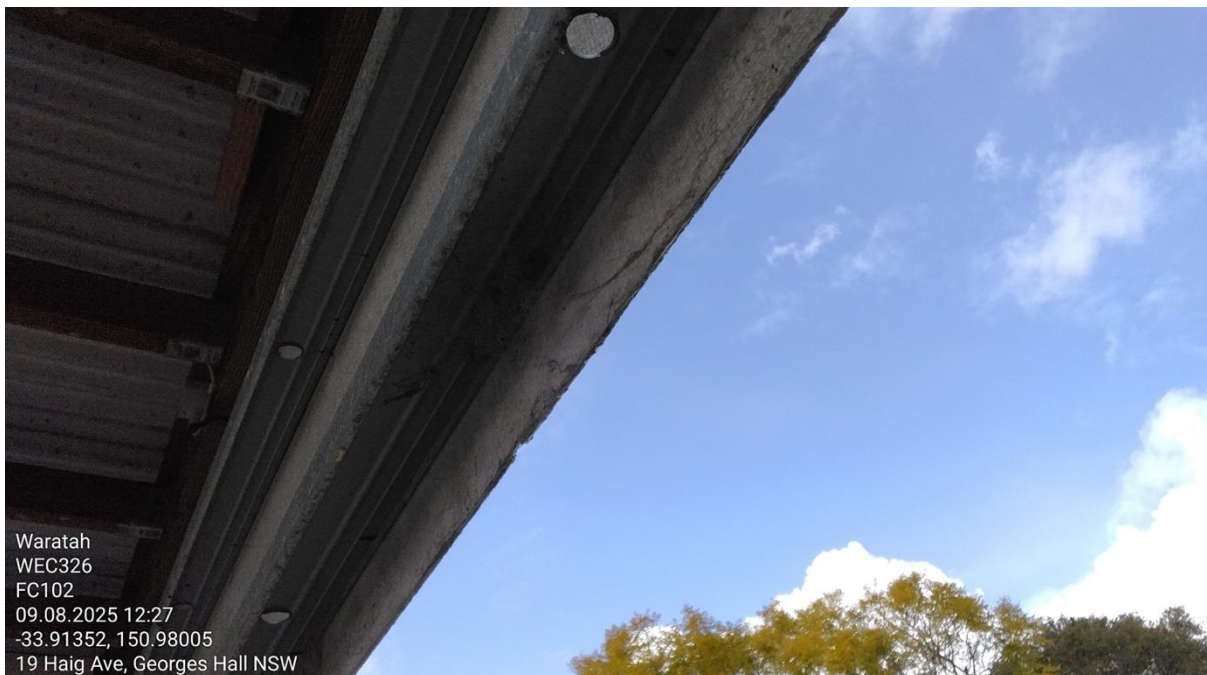
**Photograph 4:**

| Location Description | Material | Condition | Sample ID | Analytical Result | Estimated Quantity | Accessibility | Priority Rating | Recommendations | Photograph Register |
|---|---|---|---|---|---|---|---|---|---|
| Main exterior, south extension, walls & fascia board | Cement sheet | Good | FC102 | No asbestos detected | 30m <sup>2</sup> | Regular | NA | NA | Photograph 4 |

Main dwelling exterior, south extension, walls & fascia board, cement sheet, FC102

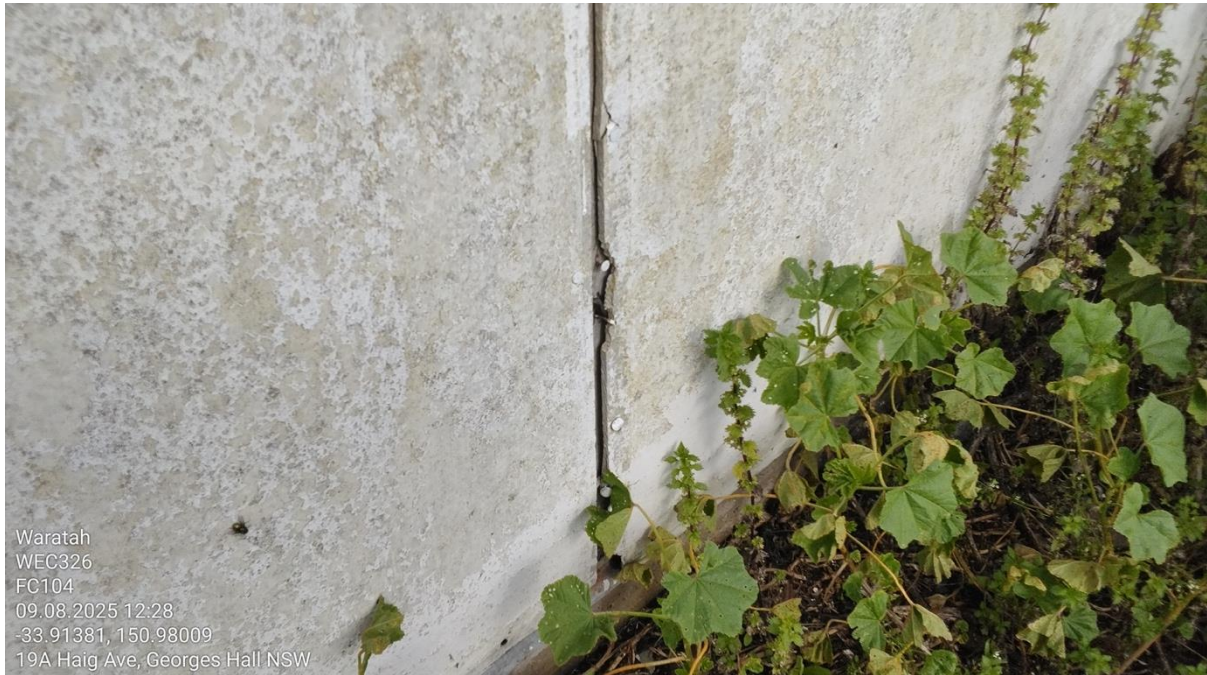
**Photograph 5:**

| Location | Material Description |
|---|---|
| Auxiliary exterior, walls, throughout | ACM sheet |

| Location Description | Material | Condition | Sample ID | Analytical Result | Estimated Quantity | Accessibility | Priority Rating | Recommendations | Photograph Register |
|---|---|---|---|---|---|---|---|---|---|
| Auxiliary exterior, walls, throughout | Cement sheet | Fair | FC104 | Amosite & chrysotile asbestos detected | 50m <sup>2</sup> | Regular | Priority 3 -Low risk in present condition | Remove prior to demolition | Photograph 5 |

Auxiliary shed exterior, walls, throughout, cement sheet, FC104

Any asbestos containing materials (ACM) should be removed prior to the commencement of any demolition / refurbishment works. ACM removal should be completed in accordance with the following regulations and codes of practice;

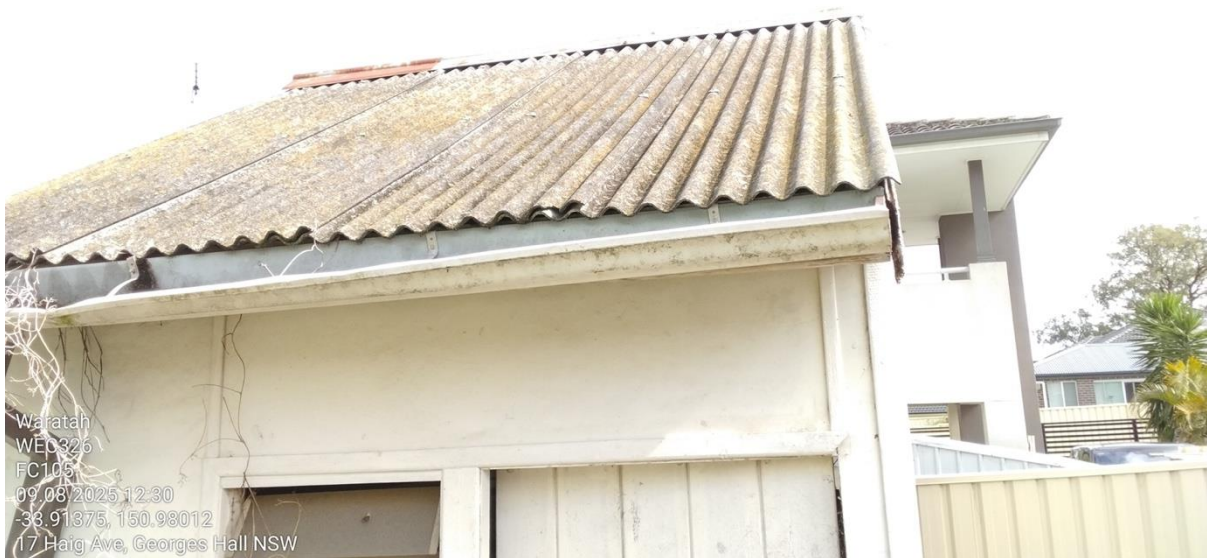
**Photograph 6:**

| Location | Material Description |
|---|---|
| Auxiliary exterior, roof | Corrugated ACM sheet |

| Location Description | Material | Condition | Sample ID | Analytical Result | Estimated Quantity | Accessibility | Priority Rating | Recommendations | Photograph Register |
|---|---|---|---|---|---|---|---|---|---|
| Auxiliary exterior, roof | Corrugated cement sheet | Poor | FC105 | Chrysotile & crocidolite asbestos detected | 10m <sup>2</sup> | Maintenance only | Priority 3 – Low risk in present condition | Remove prior to demolition | Photograph 6 |

Auxiliary shed exterior, roof, corrugated cement sheet, FC105

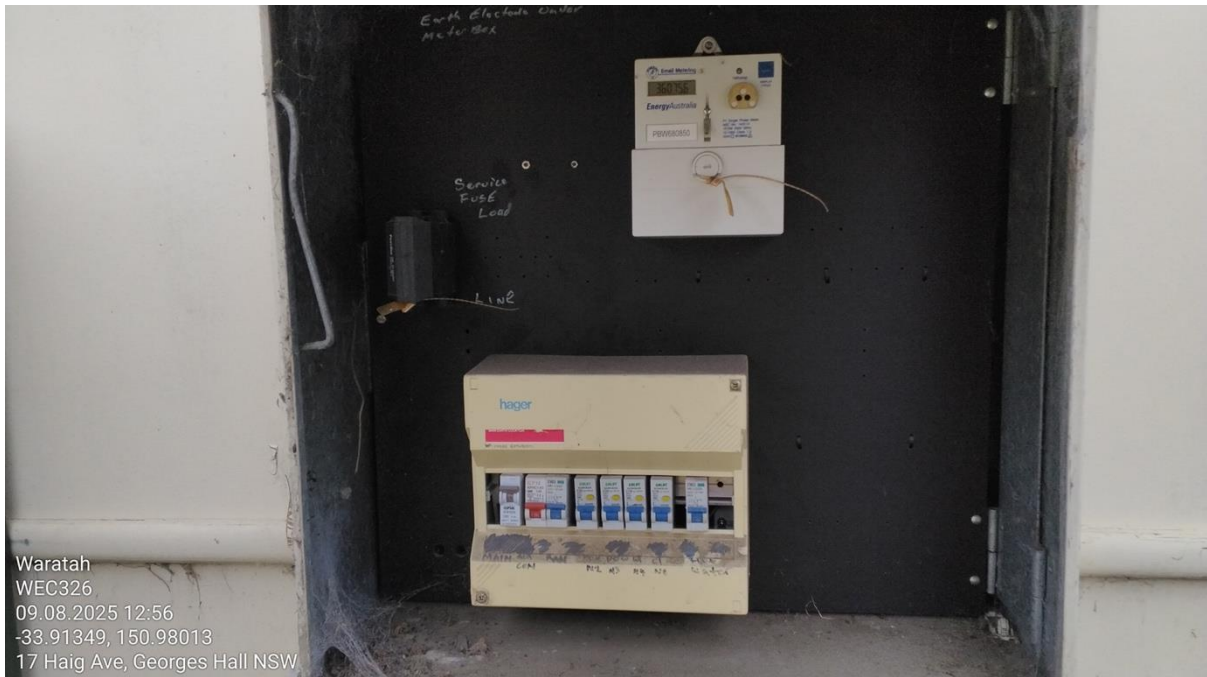
**Photograph 7:**

| Location | Material Description |
|---|---|
| Main exterior, east wall, adjacent northeast corner, power distribution board | ACM backing panel |

| Location Description | Material | Condition | Sample ID | Analytical Result | Estimated Quantity | Accessibility | Priority Rating | Recommendations | Photograph Register |
|---|---|---|---|---|---|---|---|---|---|
| Main exterior, east wall, adjacent northeast corner, power distribution board | Fibre cement backing panel | Good | Visual assessment | Presumed to comprise ACM | 1 unit | Maintenance only | Priority 3 -Low risk in present condition | Remove prior to demolition | Photograph 7 |

Main dwelling exterior, east wall, adjacent northeast corner, power distribution board, ACM backing panel

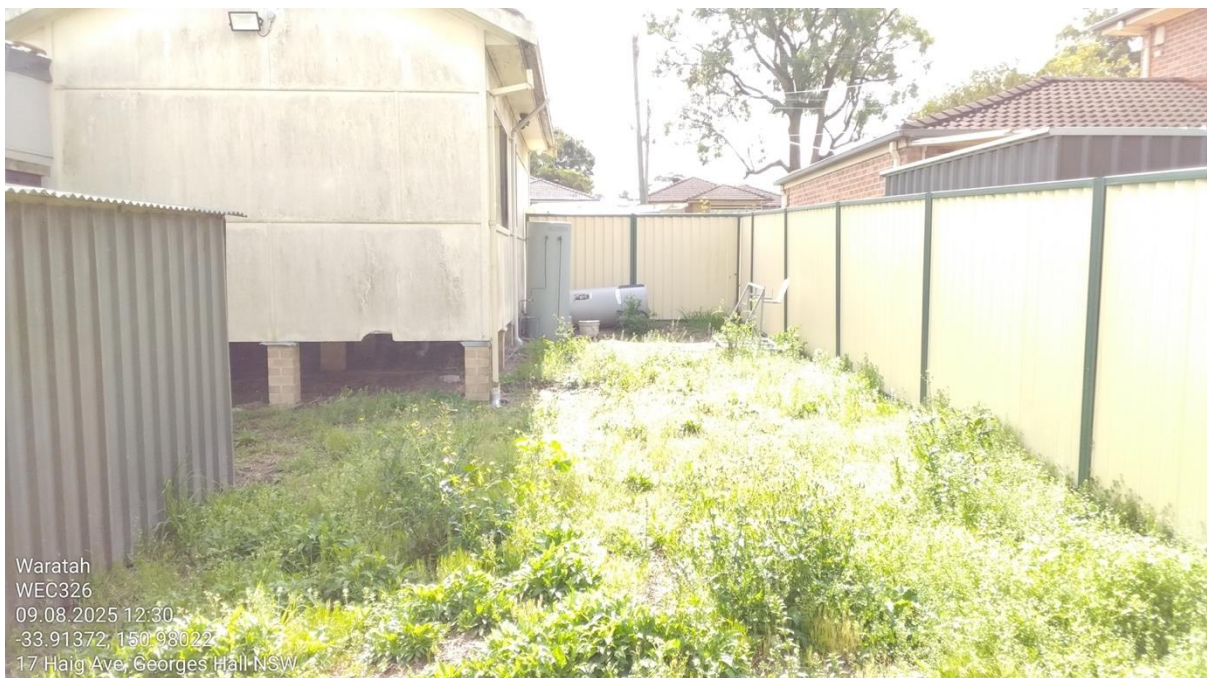
**Photograph 8:**

| Location | Material Description |
|---|---|
| Main exterior, east wall, adjacent south of partition fence, hot water system | SMF lining |

| Location Description | Material | Condition | Sample ID | Analytical Result | Estimated Quantity | Accessibility | Priority Rating | Recommendations | Photograph Register |
|---|---|---|---|---|---|---|---|---|---|
| Main exterior, east wall, adjacent south of partition fence, hot water system | SMF lining | Good | Visual assessment | Presumed to contain SMF | 2 units | Maintenance only | Priority 4 – Negligible risk in present condition | Remove during demolition | Photograph 8 |

Main dwelling exterior, east wall, adjacent south of partition fence, hot water system

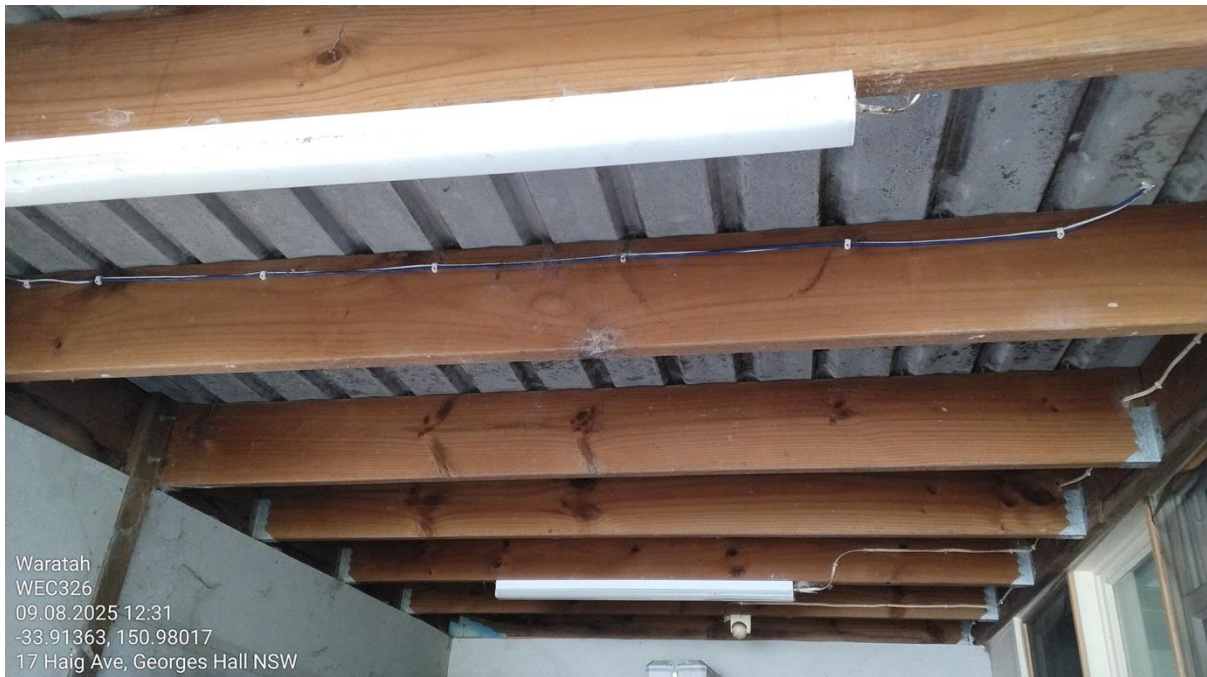
**Photograph 9:**

| Location | Material Description |
|---|---|
| Main exterior, south extension, rafters, fluorescent light fixtures | PCB-containing fluorescent light capacitors |

| Location Description | Material | Condition | Sample ID | Analytical Result | Estimated Quantity | Accessibility | Priority Rating | Recommendations | Photograph Register |
|---|---|---|---|---|---|---|---|---|---|
| Main exterior, south extension, rafters, fluorescent light fixtures | Fluorescent light capacitors | Good | Visual assessment | Presumed to contain PCBs | 2 units | Maintenance only | Priority 4 – Negligible risk in present condition | Remove during demolition | Photograph 9 |

Main dwelling exterior, south extension, rafters, fluorescent light fixtures
