# Site Classification Report

Client: McDonald Jones Homes

Project Address: Lot 152 #8 Menin Place Milperra NSW

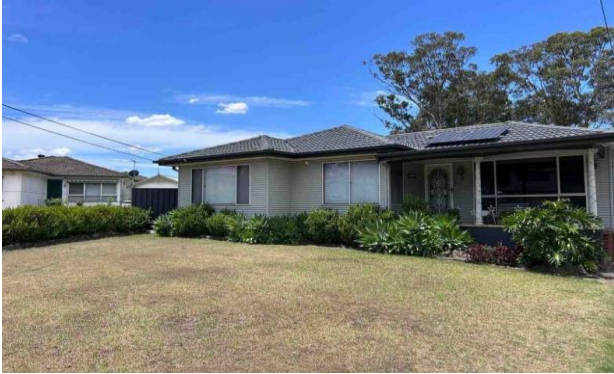
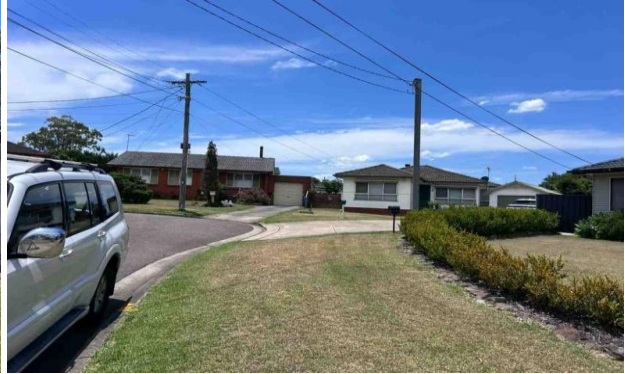
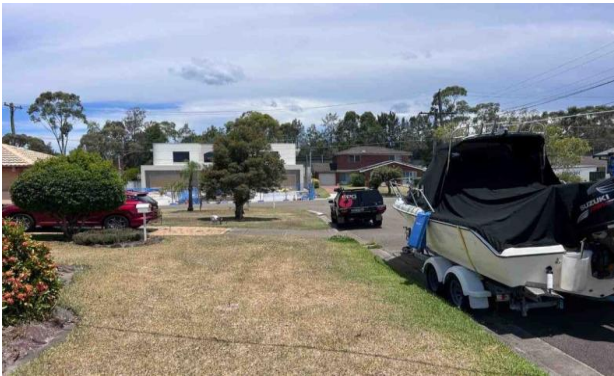
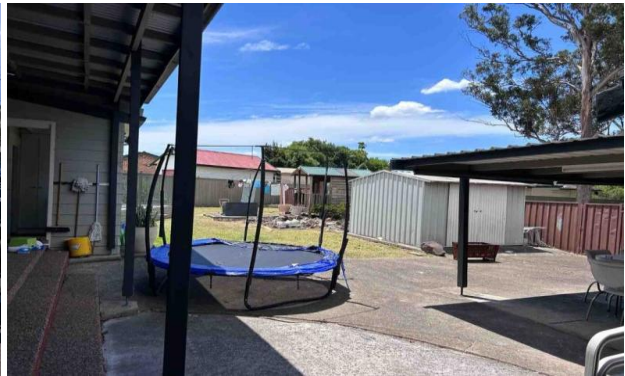
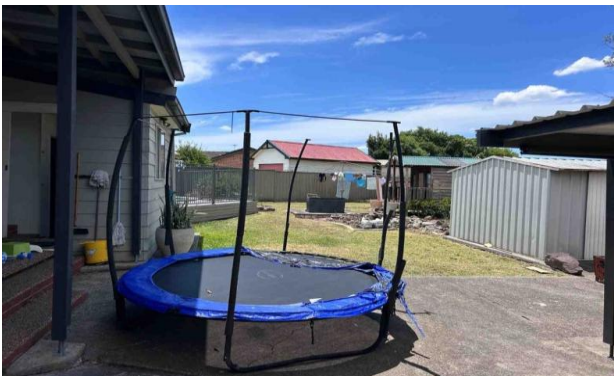
### 3. SITE PHOTOGRAPHS

*Existing House and Shed and Pool on Site. Sewer & Stormwater & Electrical Services are Noted in Proximity of Proposed Building Pad*
