**202607-7400: 361 HUME HIGHWAY, BANKSTOWN, NSW 2200**  
**5/-DP9522**

**STRUCTURAL LETTER: VEHICLE IMPACTED SHOP FRONT AWNING**  
**DEVELOPMENT APPLICATION**

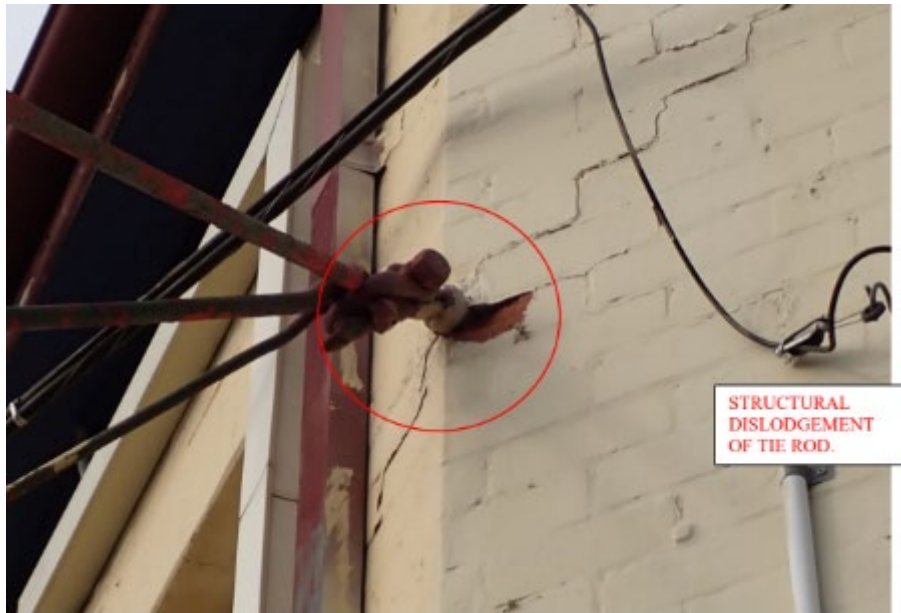
- a) There is a risk of collapse from the extensive structural damage in the form of distortion to the structural steel tie rods and framing of the shop-front awning. In the interest of public safety, demolition and reconstruction of the shop-front awning is the only course of action that is structurally safe.

In the interest of public safety and to mitigate future incidents, we consider that the demolition and reconstruction of the shop-front awning is necessary. The demolition and reconstruction of the shop-front awning has been designed to comply with structural adequacy requirements in the Building Codes as well as the Council LEP requirements for kerb clearances to mitigate similar incidents from occurring in the future.

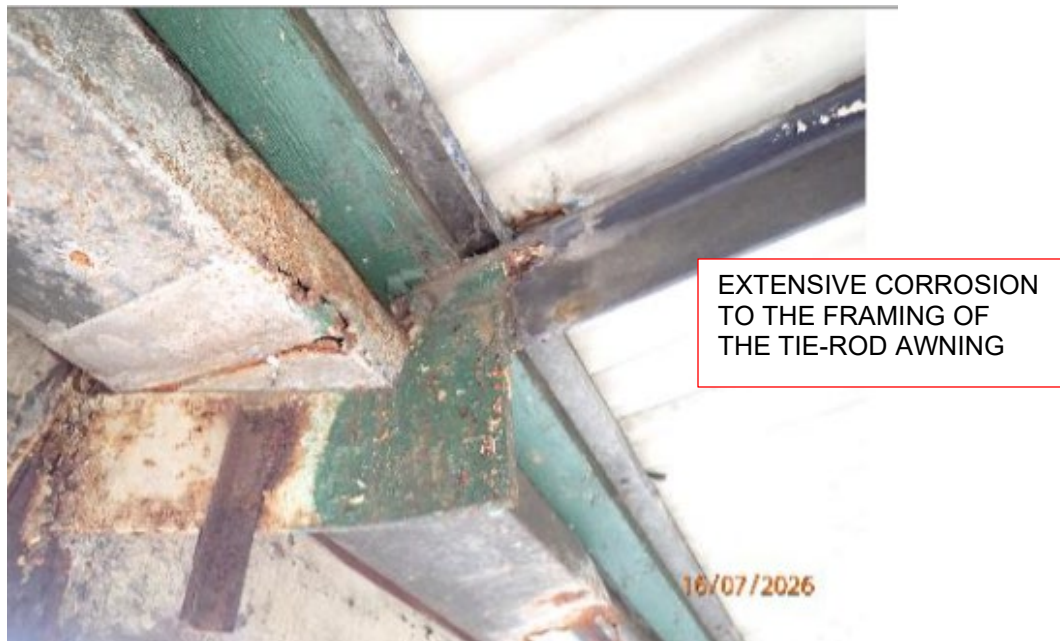
- b) Structural rectification of the existing tie-rod awning is not feasible due to the extensive corrosion to the existing structural tie-rod system and framing. Localised repairs are insufficient in providing the required strength and serviceability for tie-rod awnings.

STRUCTURAL  
DISTORTION OF THE  
TIE-ROD AWNING BEAM

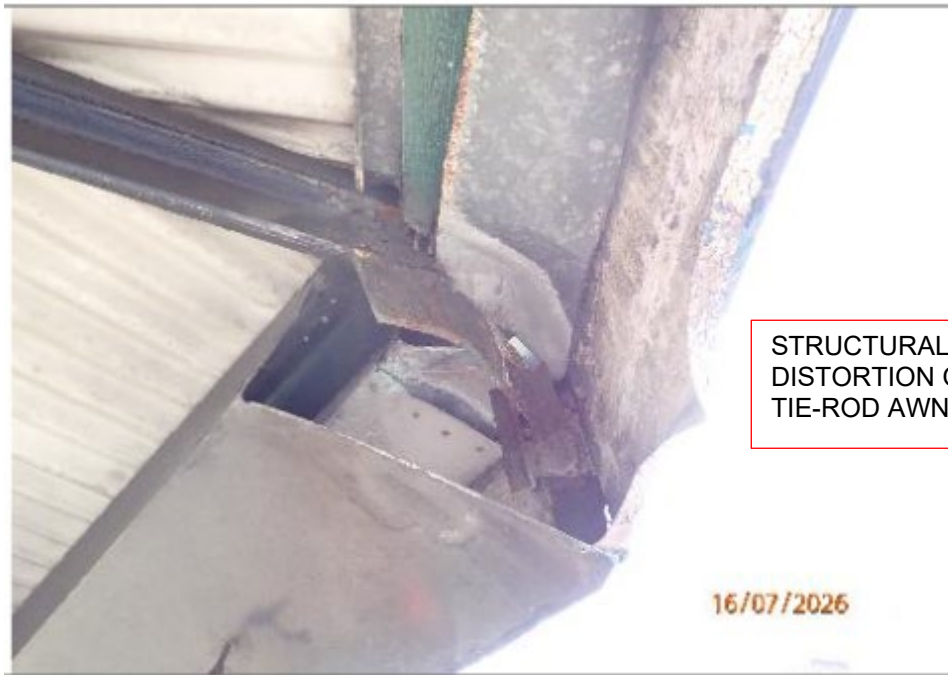
STRUCTURAL DISTORTION  
AND SAGGING OF THE  
TIE-ROD AWNING

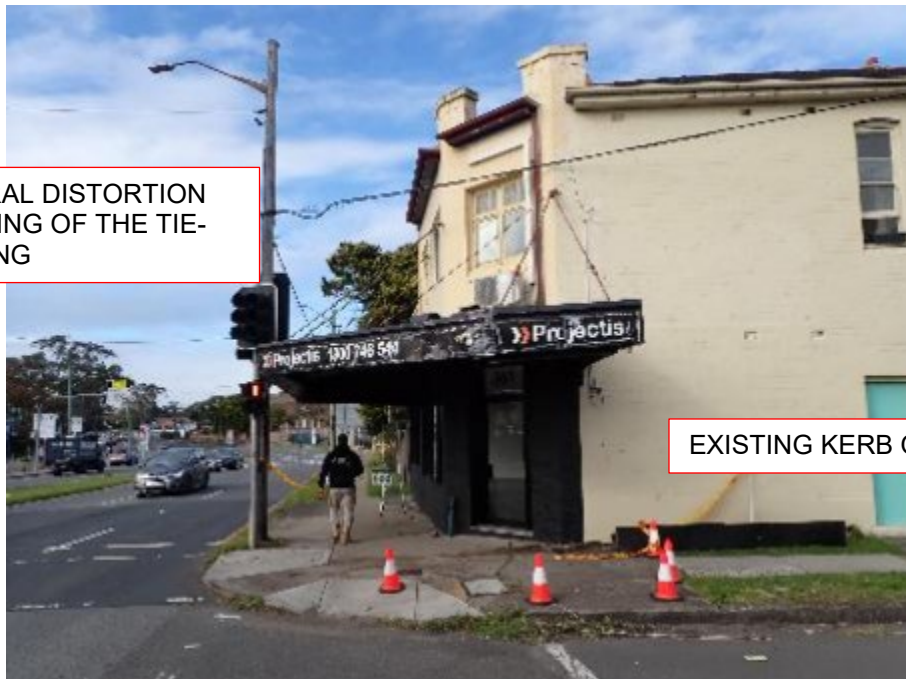
- c) There remains a risk of similar incidents occurring in the future due to the existing insufficient kerb clearance. The existing awning structure cannot be structurally altered to comply with the current kerb offset requirements under the current Canterbury-Bankstown Development Control Plan (2023) due to the existing age and original construction methodology.

EXISTING KERB OFFSET
