# **BUILDING CODE OF AUSTRALIA (BCA) ASSESSMENT REPORT**

| <b>Property:</b> | 104 Mittagong Road, Bowral<br>Local Government Area—Wingecarribee Shire Council |
| <b>Date of Report:</b> | 20 <sup>th</sup> October 2020 |

**Property:** 104 Mittagong Road, Bowral  
**Description:** Semi detached single storey dwelling with a detached carport at the rear of the dwelling  
**Date of Inspection:** 19<sup>th</sup> October 2020

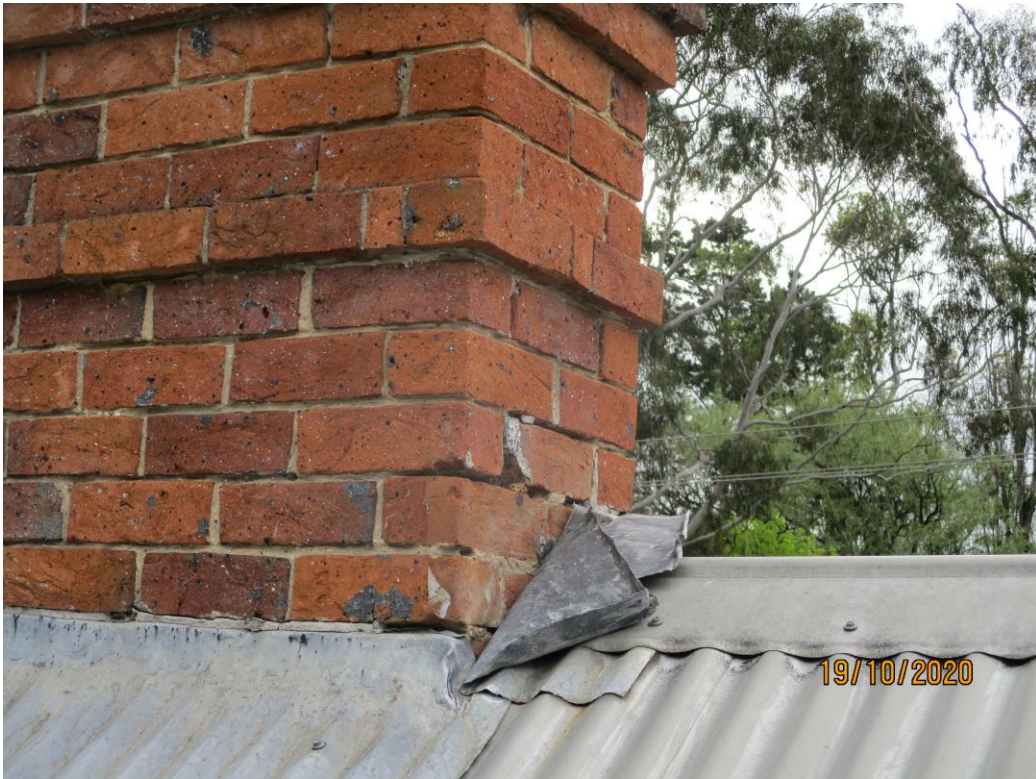
Weather proofing of wall openings to windows and doors and flashings appear to be adequate. The flashings of the chimney are damaged. *Remedial - repair the flashings to ensure that the chimney is weather proof (refer to picture 1 attached)*. Some of the weatherboards have fungal decay which may allow the entry of moisture into the building *Remedial – replace damaged weatherboards refer to picture 11 attached*.

1. Repair the flashings to ensure that the chimney is weather-proof

1. There is an electrical conduit service going through fire separating wall, this service has to be protected at the wall penetration and the gap around the service needs to be filled with fire protective material.
2. The gable end framing abutting the fire separating wall needs to be fire protected.
3. Repair the flashings to ensure that the chimney is weather proof.

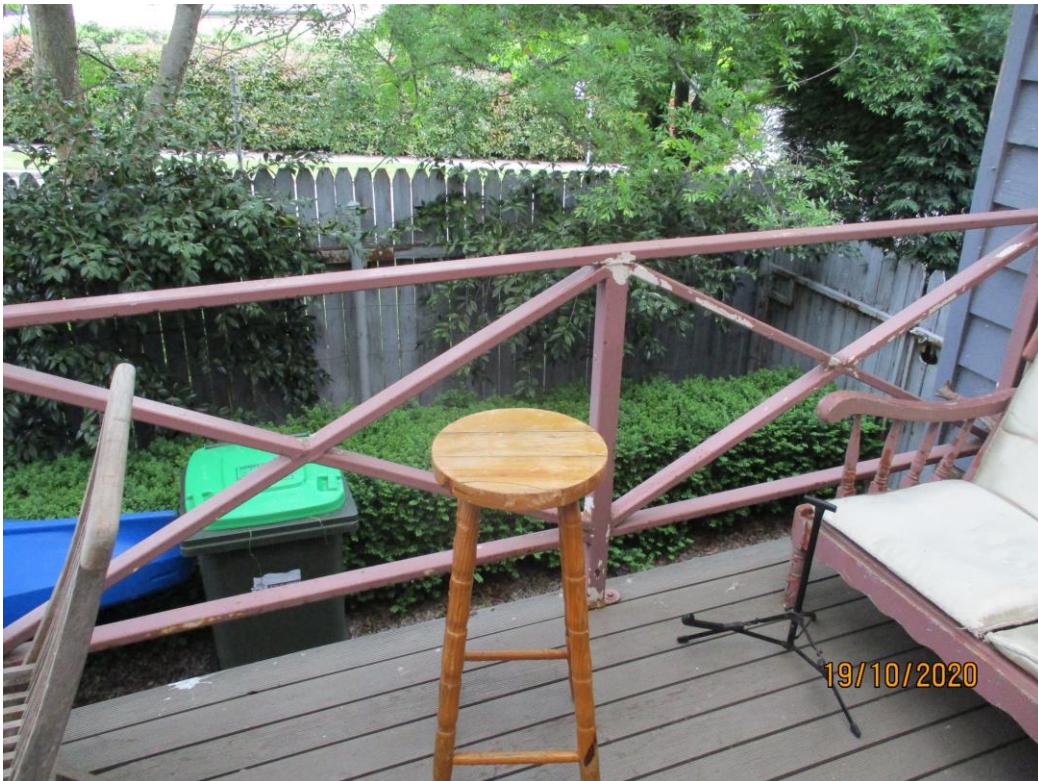
Front entry landing, front veranda and side veranda are more than 1m above ground level, there is a balustrade less than 1m above deck level and has openings of more than 120mm. *It is recommended to comply with the Building Code that a balustrade be installed at least 1m in height having openings in the balustrade of no more than 120mm (refer to picture 2 attached).*

2. Balustrade should be installed at least 1m in height having openings in the balustrade of no more than 120mm

4. It is recommended to comply with the Building Code that a balustrade be installed at least 1m in height having openings in the balustrade of no more than 120mm to front entry landing, front verandah and side verandah.

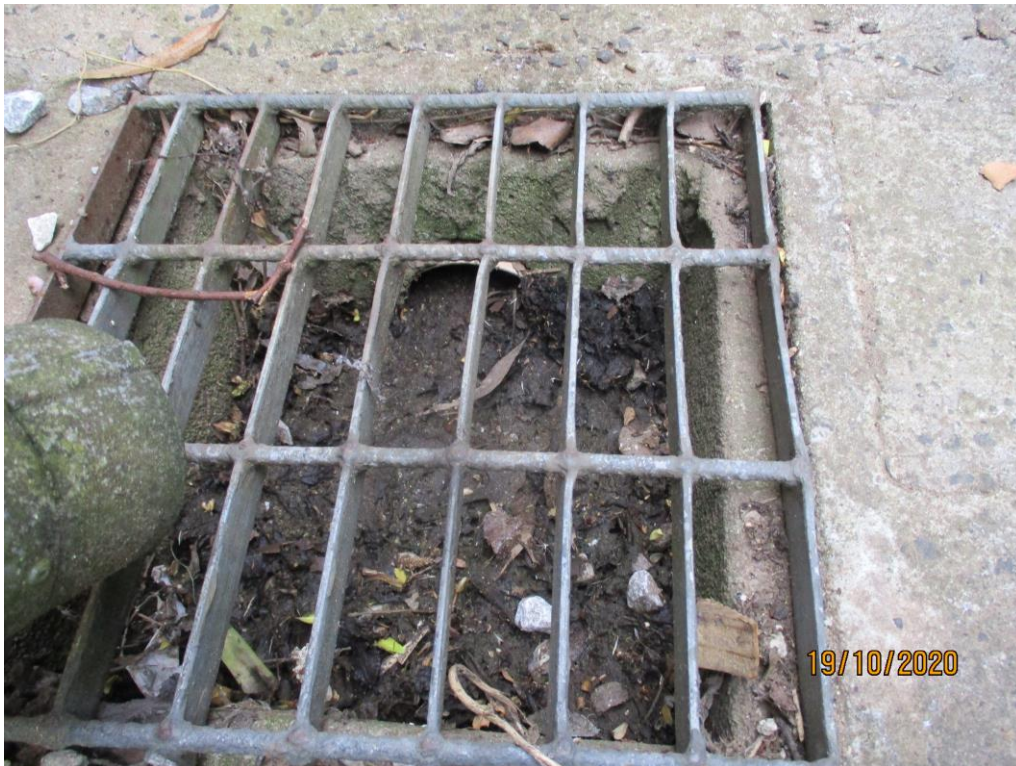
The stormwater from roof water downpipes are directed to a grated stormwater pit, the pit is significantly blocked *Remedial – clean out the stormwater pit and ensure that the stormwater is freely draining (refer to picture 3 attached)*.

3. Clean out the stormwater pit and ensure that the stormwater is freely draining

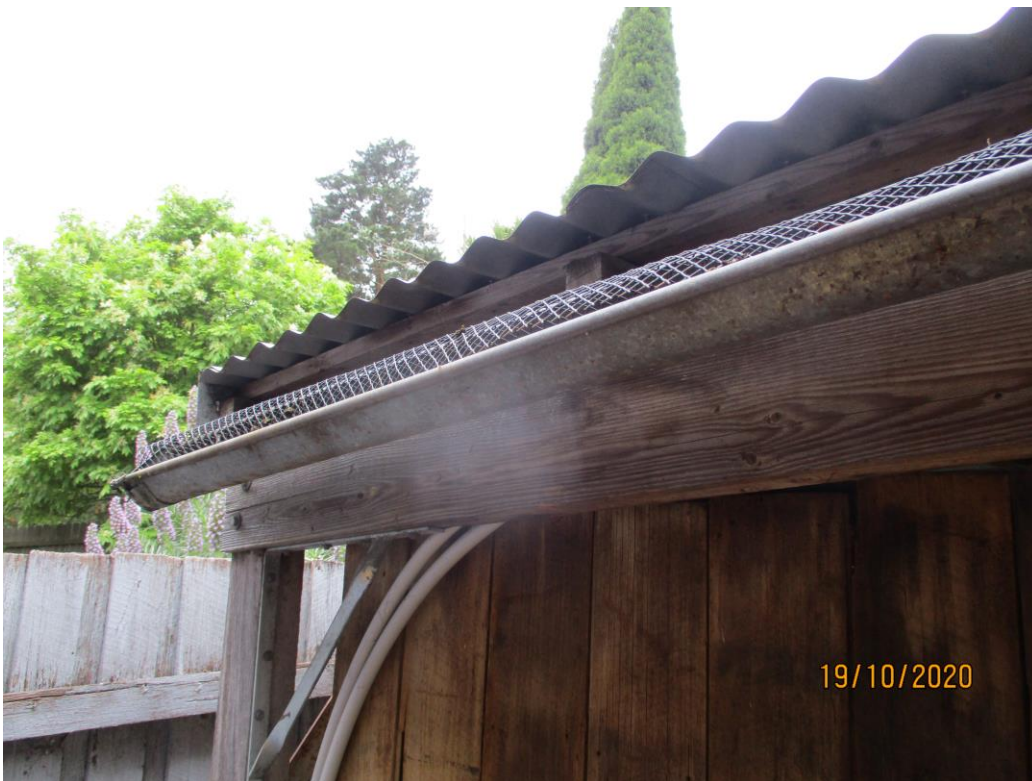
Roof gutter of detached carport has partly collapsed *Remedial – properly support roof gutter (refer to picture 4 attached)*.

4. Properly support roof gutter of detached carport.

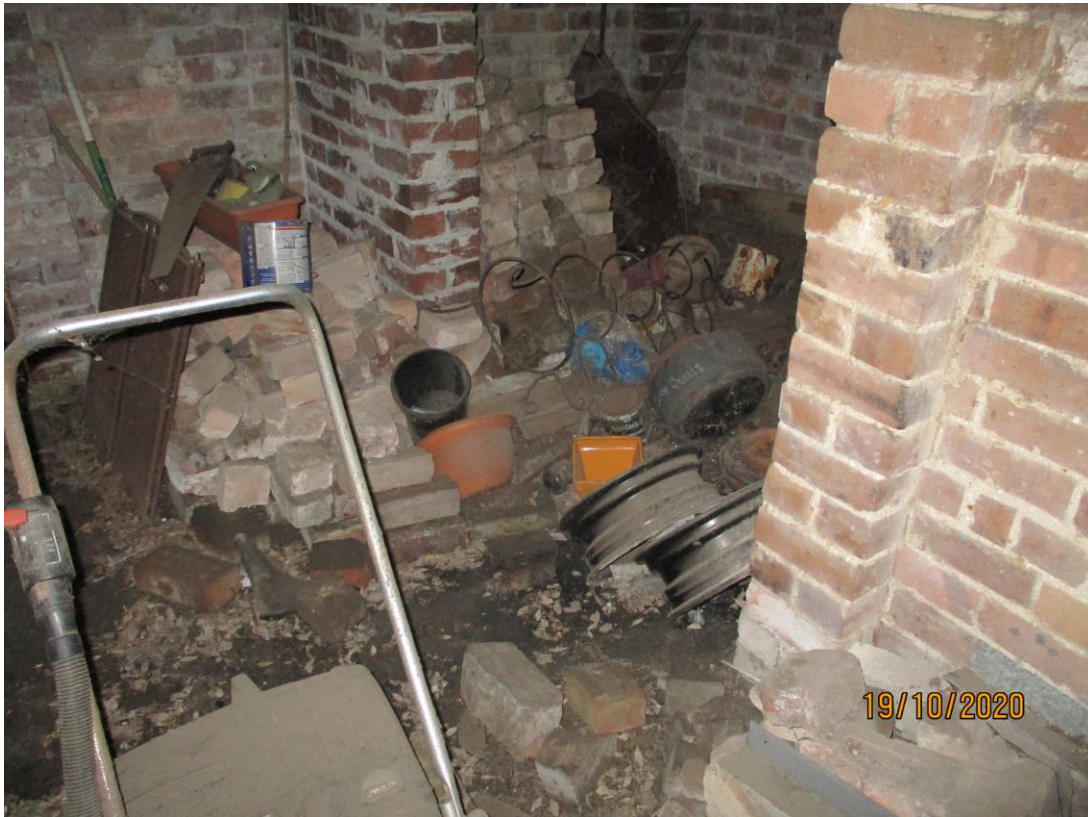
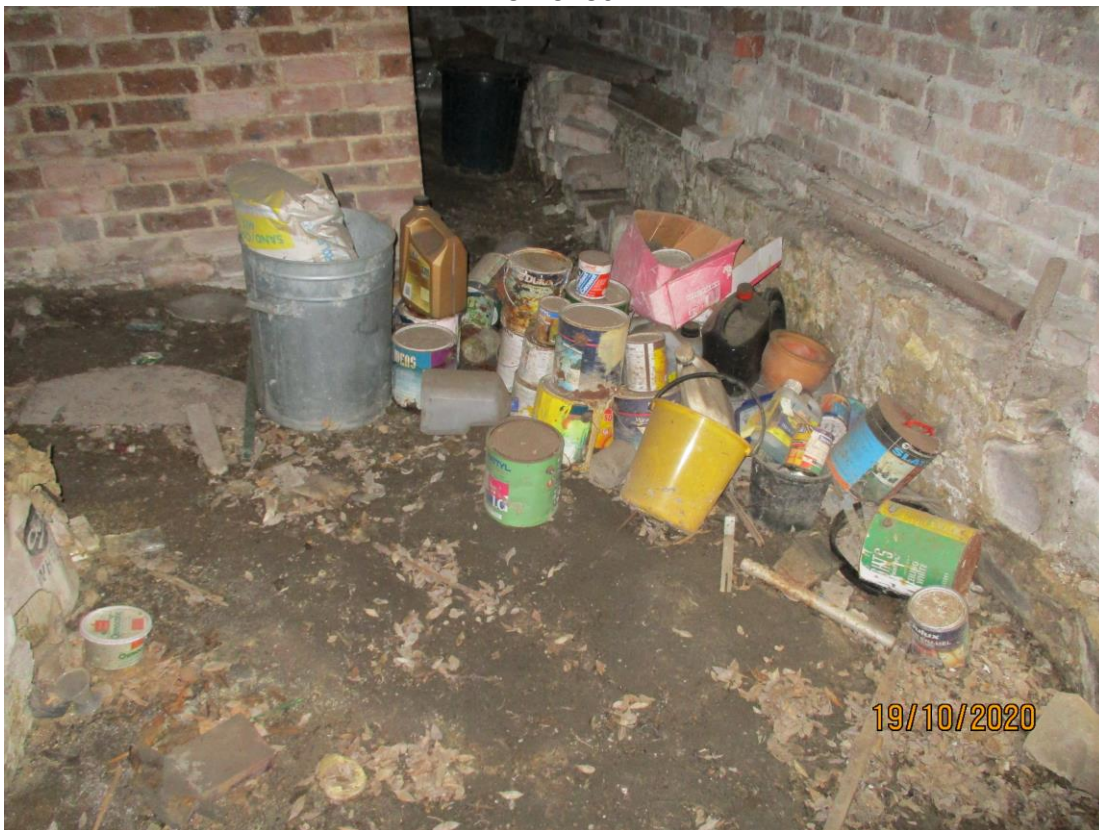
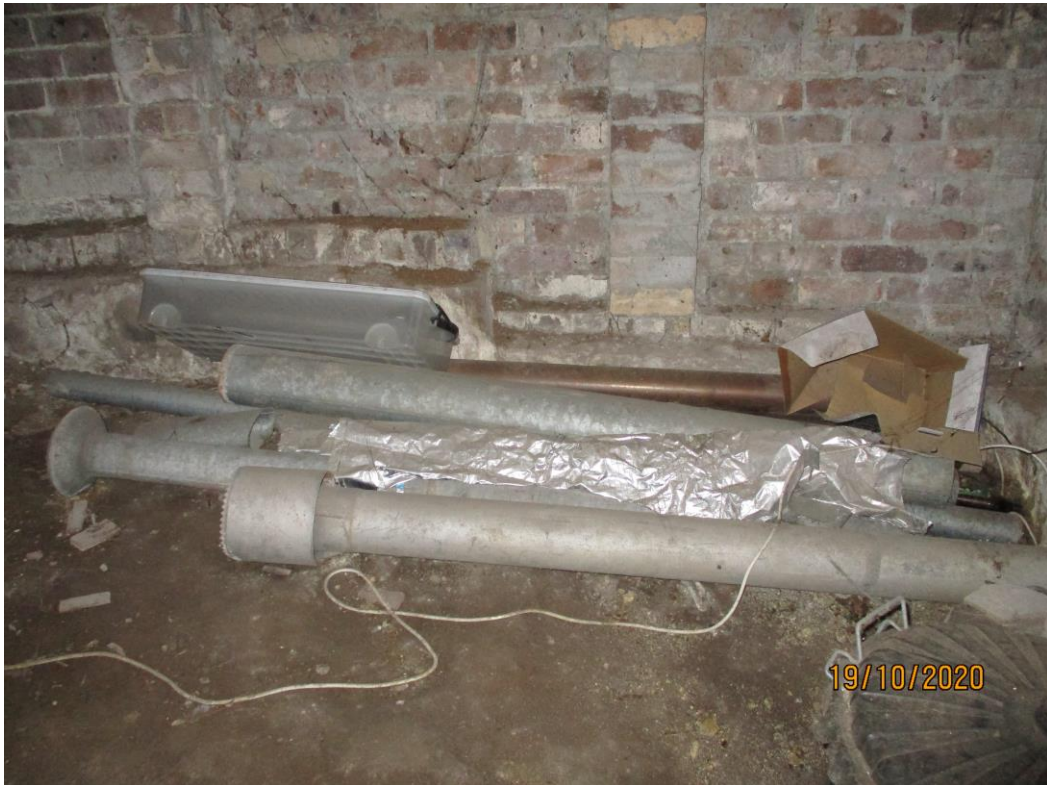
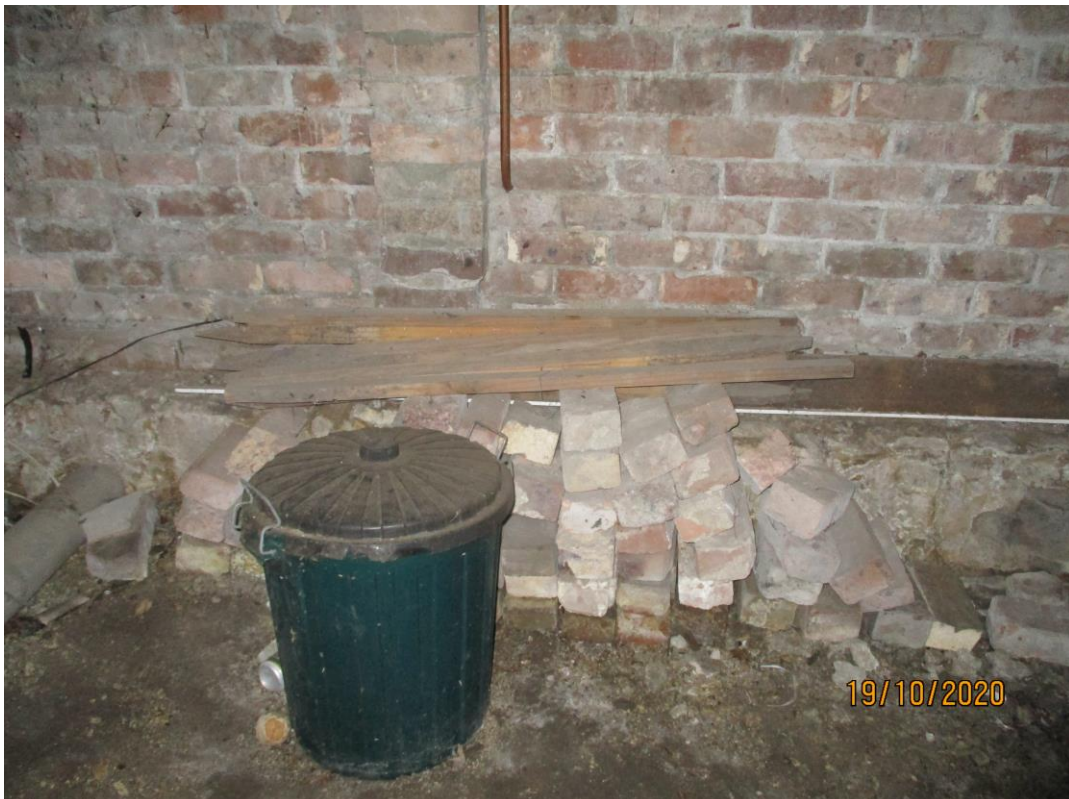
There is subfloor ventilation to the perimeter external walls generally complying with the Building Code, however there is a significant amount of debris in the subfloor which will need to be removed (refer to pictures 5, 6, 7 & 8 attached) – *It is recommended that the debris be removed*

5. Significant amount of debris in the subfloor which will need to be removed

6. Significant amount of debris in the subfloor which will need to be removed

7. Significant amount of debris in the subfloor which will need to be removed

8. Significant amount of debris in the subfloor which will need to be removed

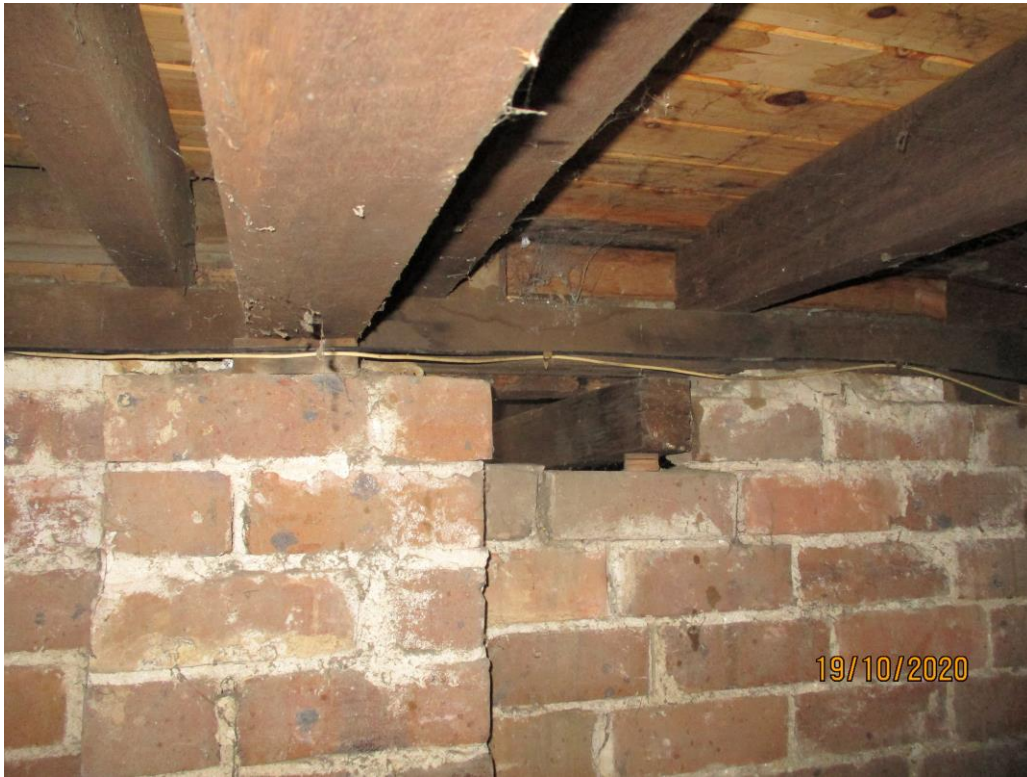
There is no termite protection system to the subfloor framing, it is recommended that a termite protection system be installed to protect the structural timbers of the building (refer to picture 9 & 10 attached)

9. There is no termite protection system to the subfloor framing, it is recommended that a termite protection system be installed to protect the structural timbers of the building

8. There is no termite protection system to the subfloor framing, it is recommended that a termite protection system be installed to protect the structural timbers of the building

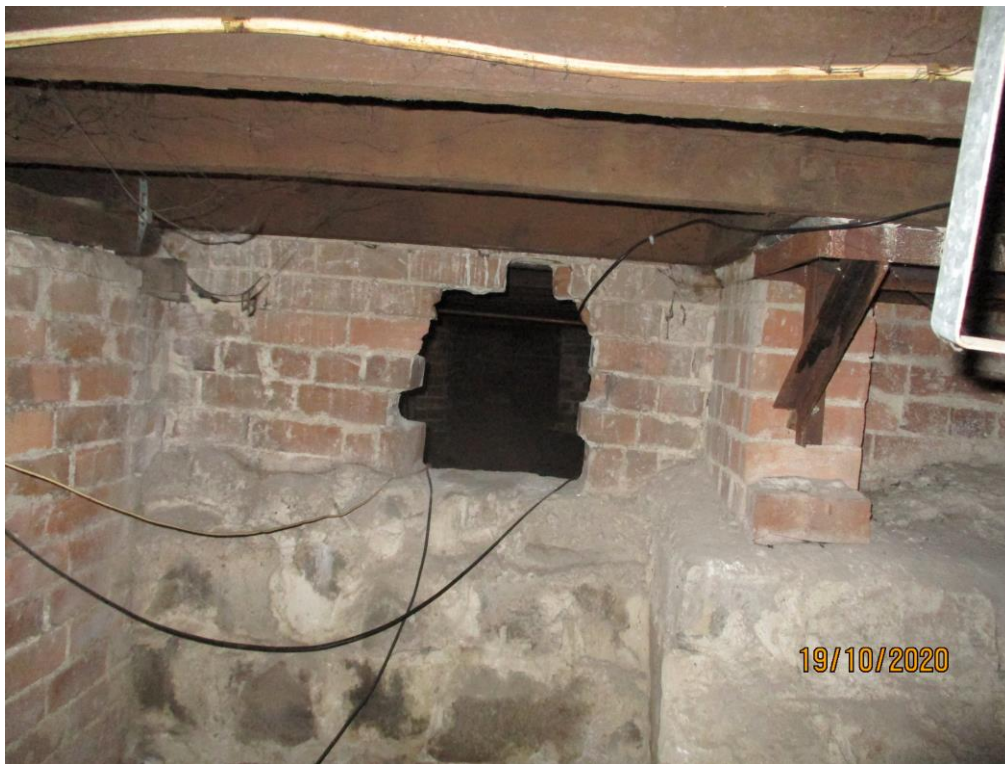
The brick fire separating wall between the attached dwellings has an opening in the subfloor which would allow a fire to move between the attached dwellings in the subfloor area. *It is recommended that the opening be closed with brickwork to prevent the passage of fire – (refer to picture10 attached).*

10. It is recommended that the opening be closed with brickwork to prevent the passage of fire.

9. It is recommended that the opening in the fire separating wall be closed with brickwork to prevent the passage of fire.
10. Any floor framing or timbers or service cables passing through the brick fire separating wall must (including roof space) be protected with a proprietary fire protection system.

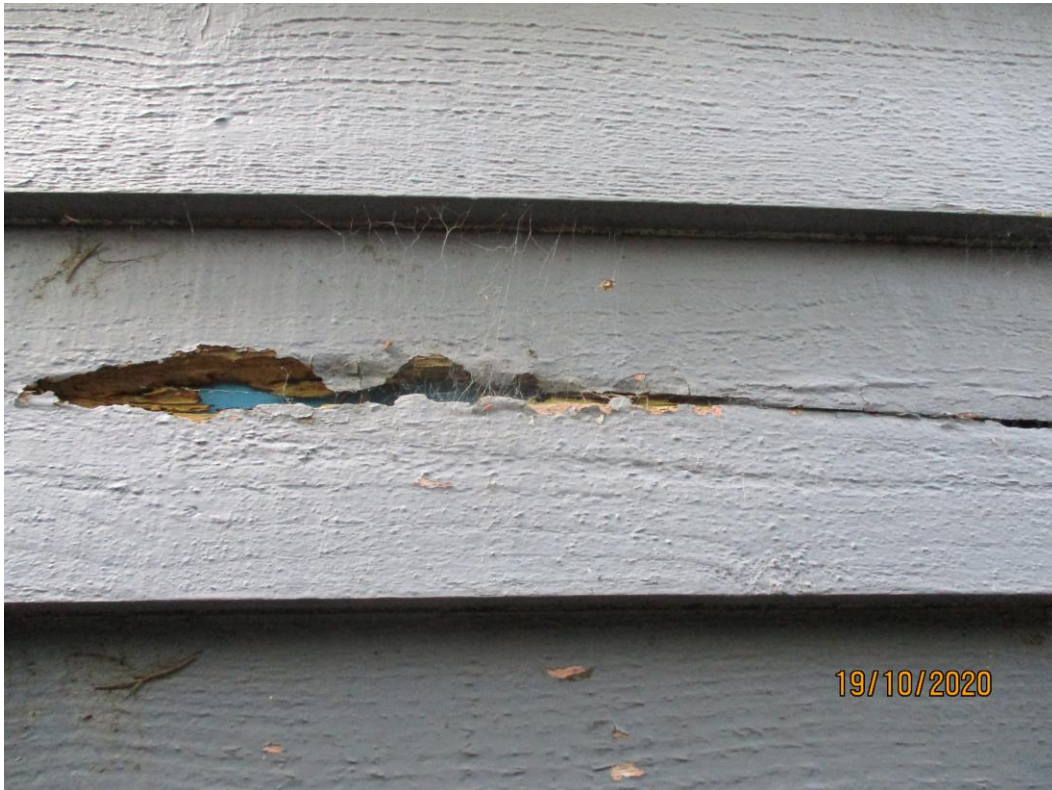
11. Some of the weatherboards have fungal decay which may allow the entry of moisture into the building

11. Some of the weatherboards have fungal decay which may allow the entry of moisture into the building – repair or replace affected weatherboards.
12. The front entry steps from the street footpath should be reformed for safe access in compliance with the Building Code.

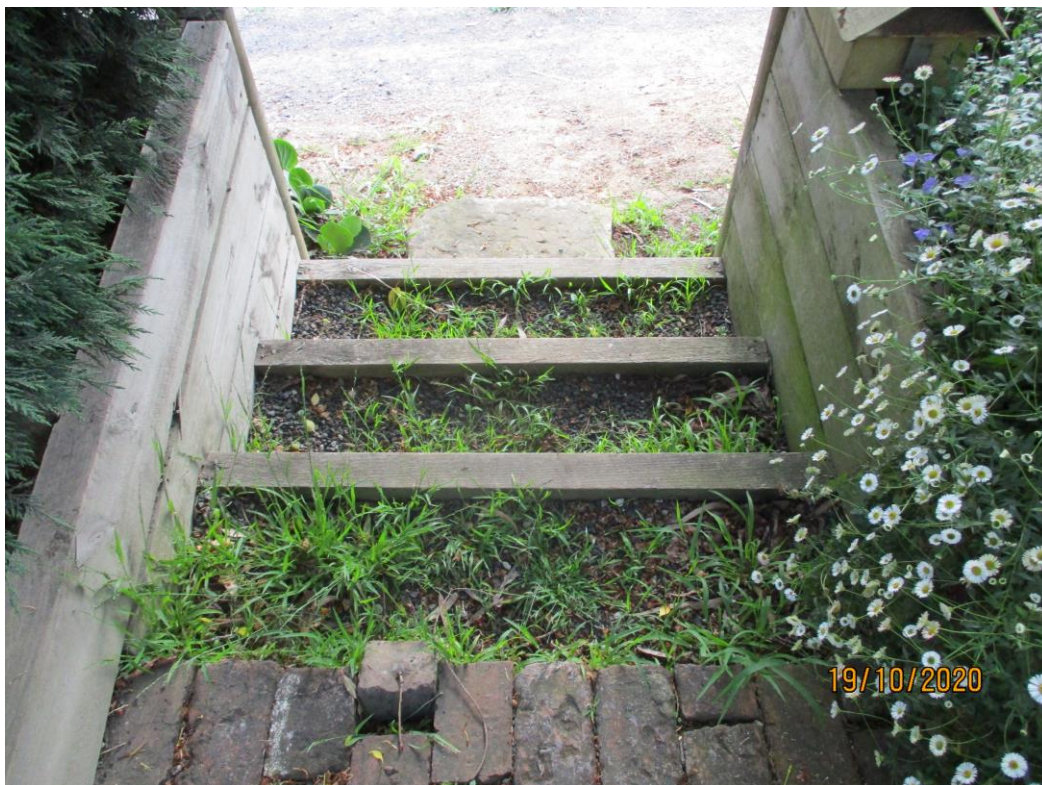
The front entry steps from the street footpath should be reformed for safe access in compliance with the Building Code (refer to picture 12 attached).

12. The front entry steps from the street footpath should be reformed for safe access in compliance with the Building Code.
