River Stability Assessment - Proposed Expansion of Sand Dredging Operations at Terara Shoalhaven Sand, Pig Island, Terara, NSW

P1806743JR01V01
March 2019

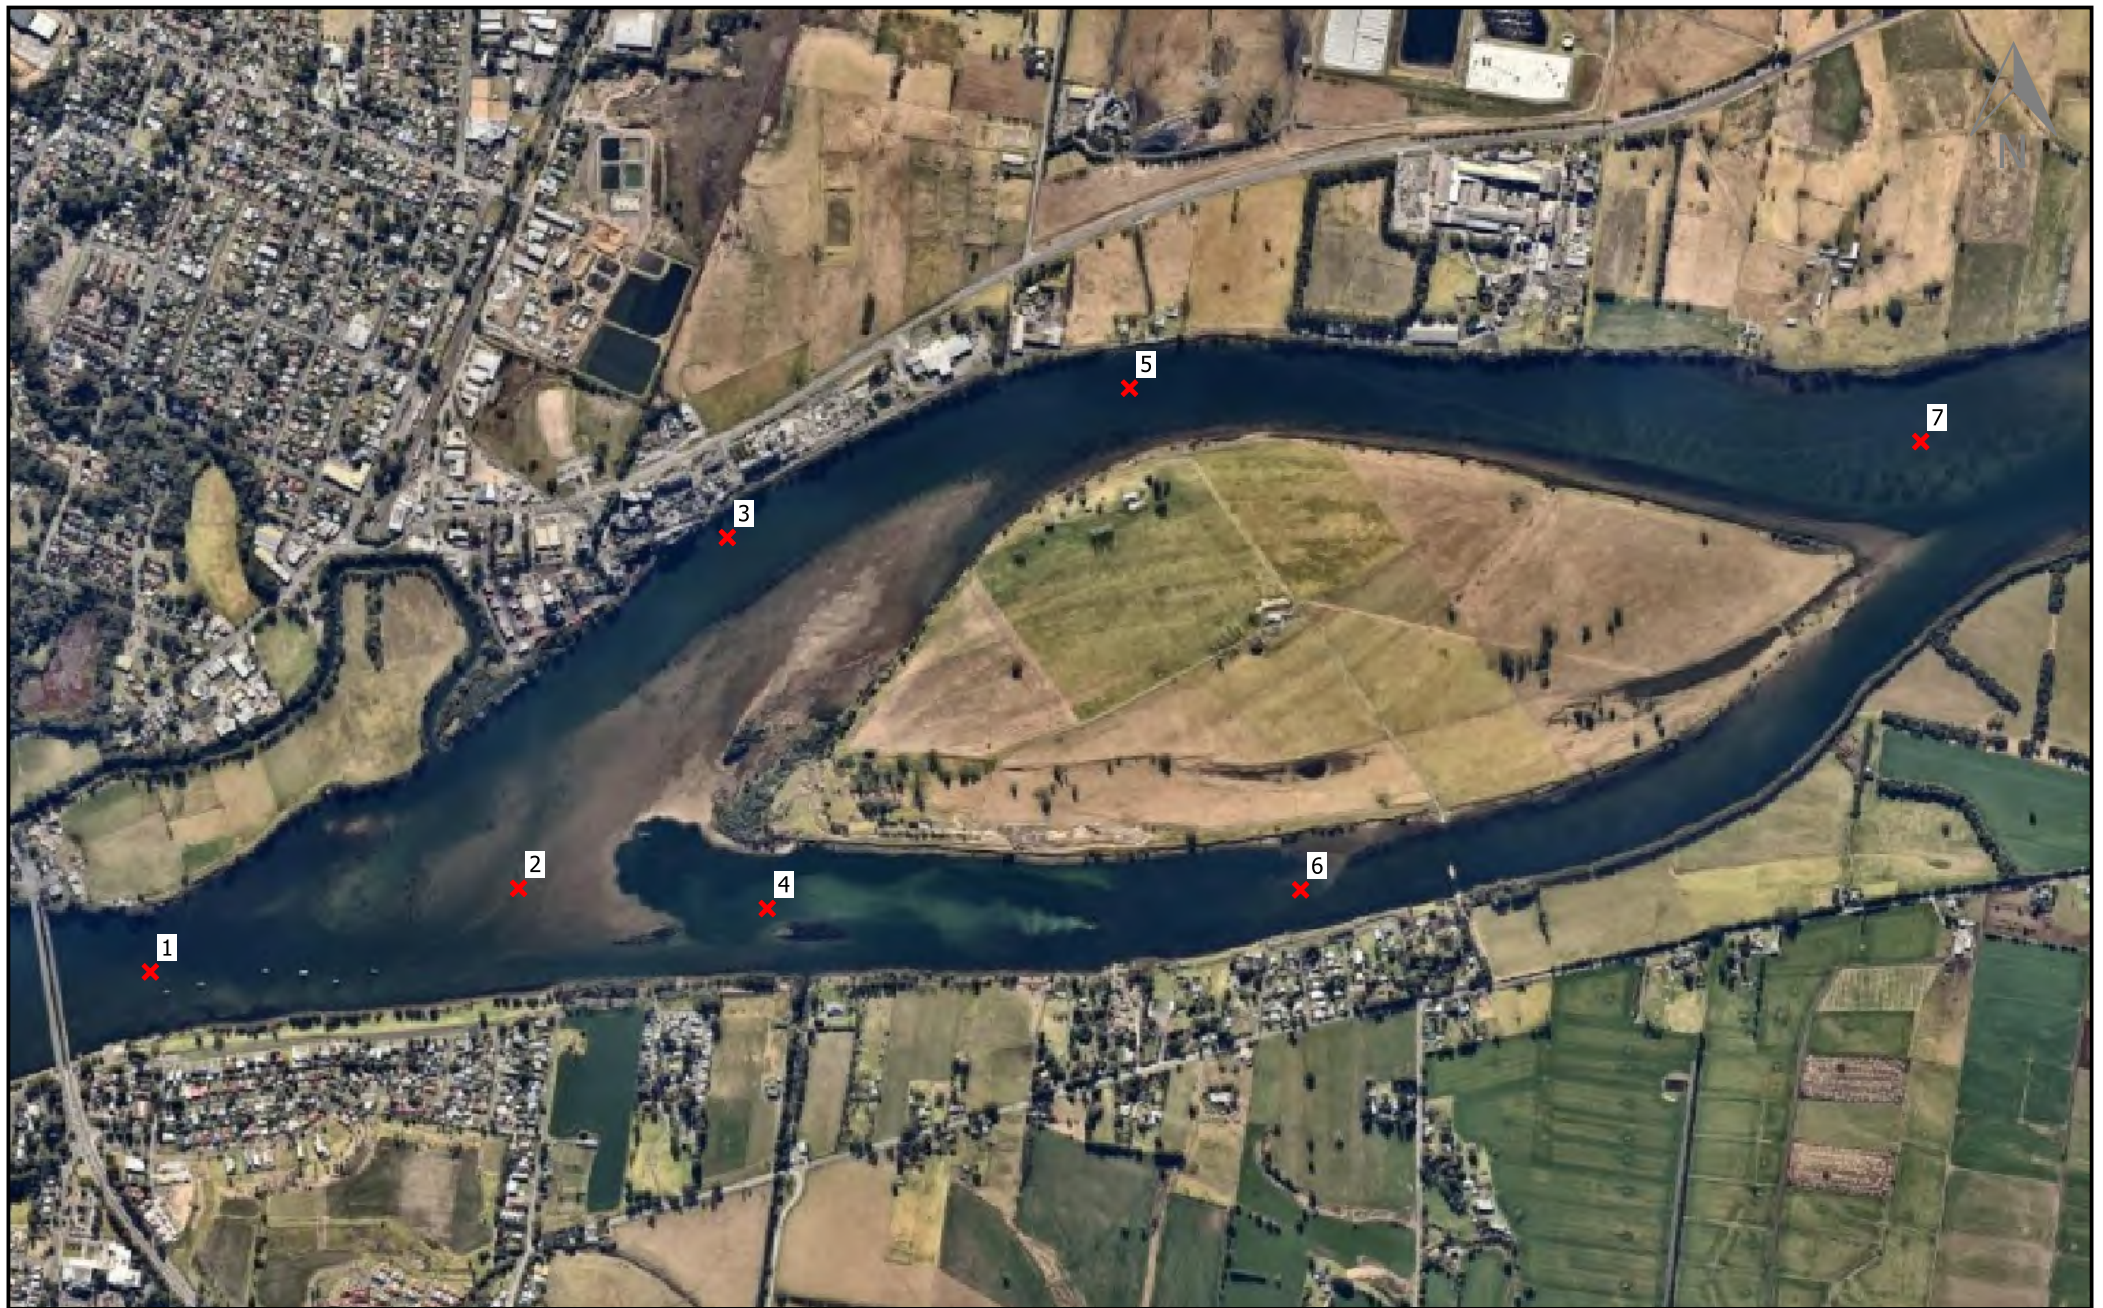
Hydraulic Modelling - Study Area & Velocity Observation Points
Pig Island, Shoalhaven River, NSW
19/02/2019
Figure 3

Hydraulic modelling prepared for the flood study (MA, 2019c) calculated peak velocities for both existing and post dredging expansion river channel velocities (m/s) for seven observation locations (refer to Figure 3, Attachment A).

Point	10 ¹	100 ¹	200 ¹	500 ¹	PMF ¹
1	0.4%	0.5%	0.1%	0.1%	0.0%
2	-0.6%	-1.8%	-1.5%	-0.8%	-0.2%
3	0.3%	7.3%	8.3%	7.9%	6.2%
4	-0.4%	2.0%	2.7%	3.2%	3.3%
5	-0.1%	1.3%	1.8%	2.5%	5.5%
6	-1.7%	0.0%	0.5%	1.3%	1.9%
7	0.8%	1.2%	1.4%	1.3%	1.3%

1. The proposed extraction works are not anticipated to have a significant impact on existing river bank erosion due to impact scour, as river velocities are not anticipated to be significantly changed as a result of the proposed expansion to extraction works.

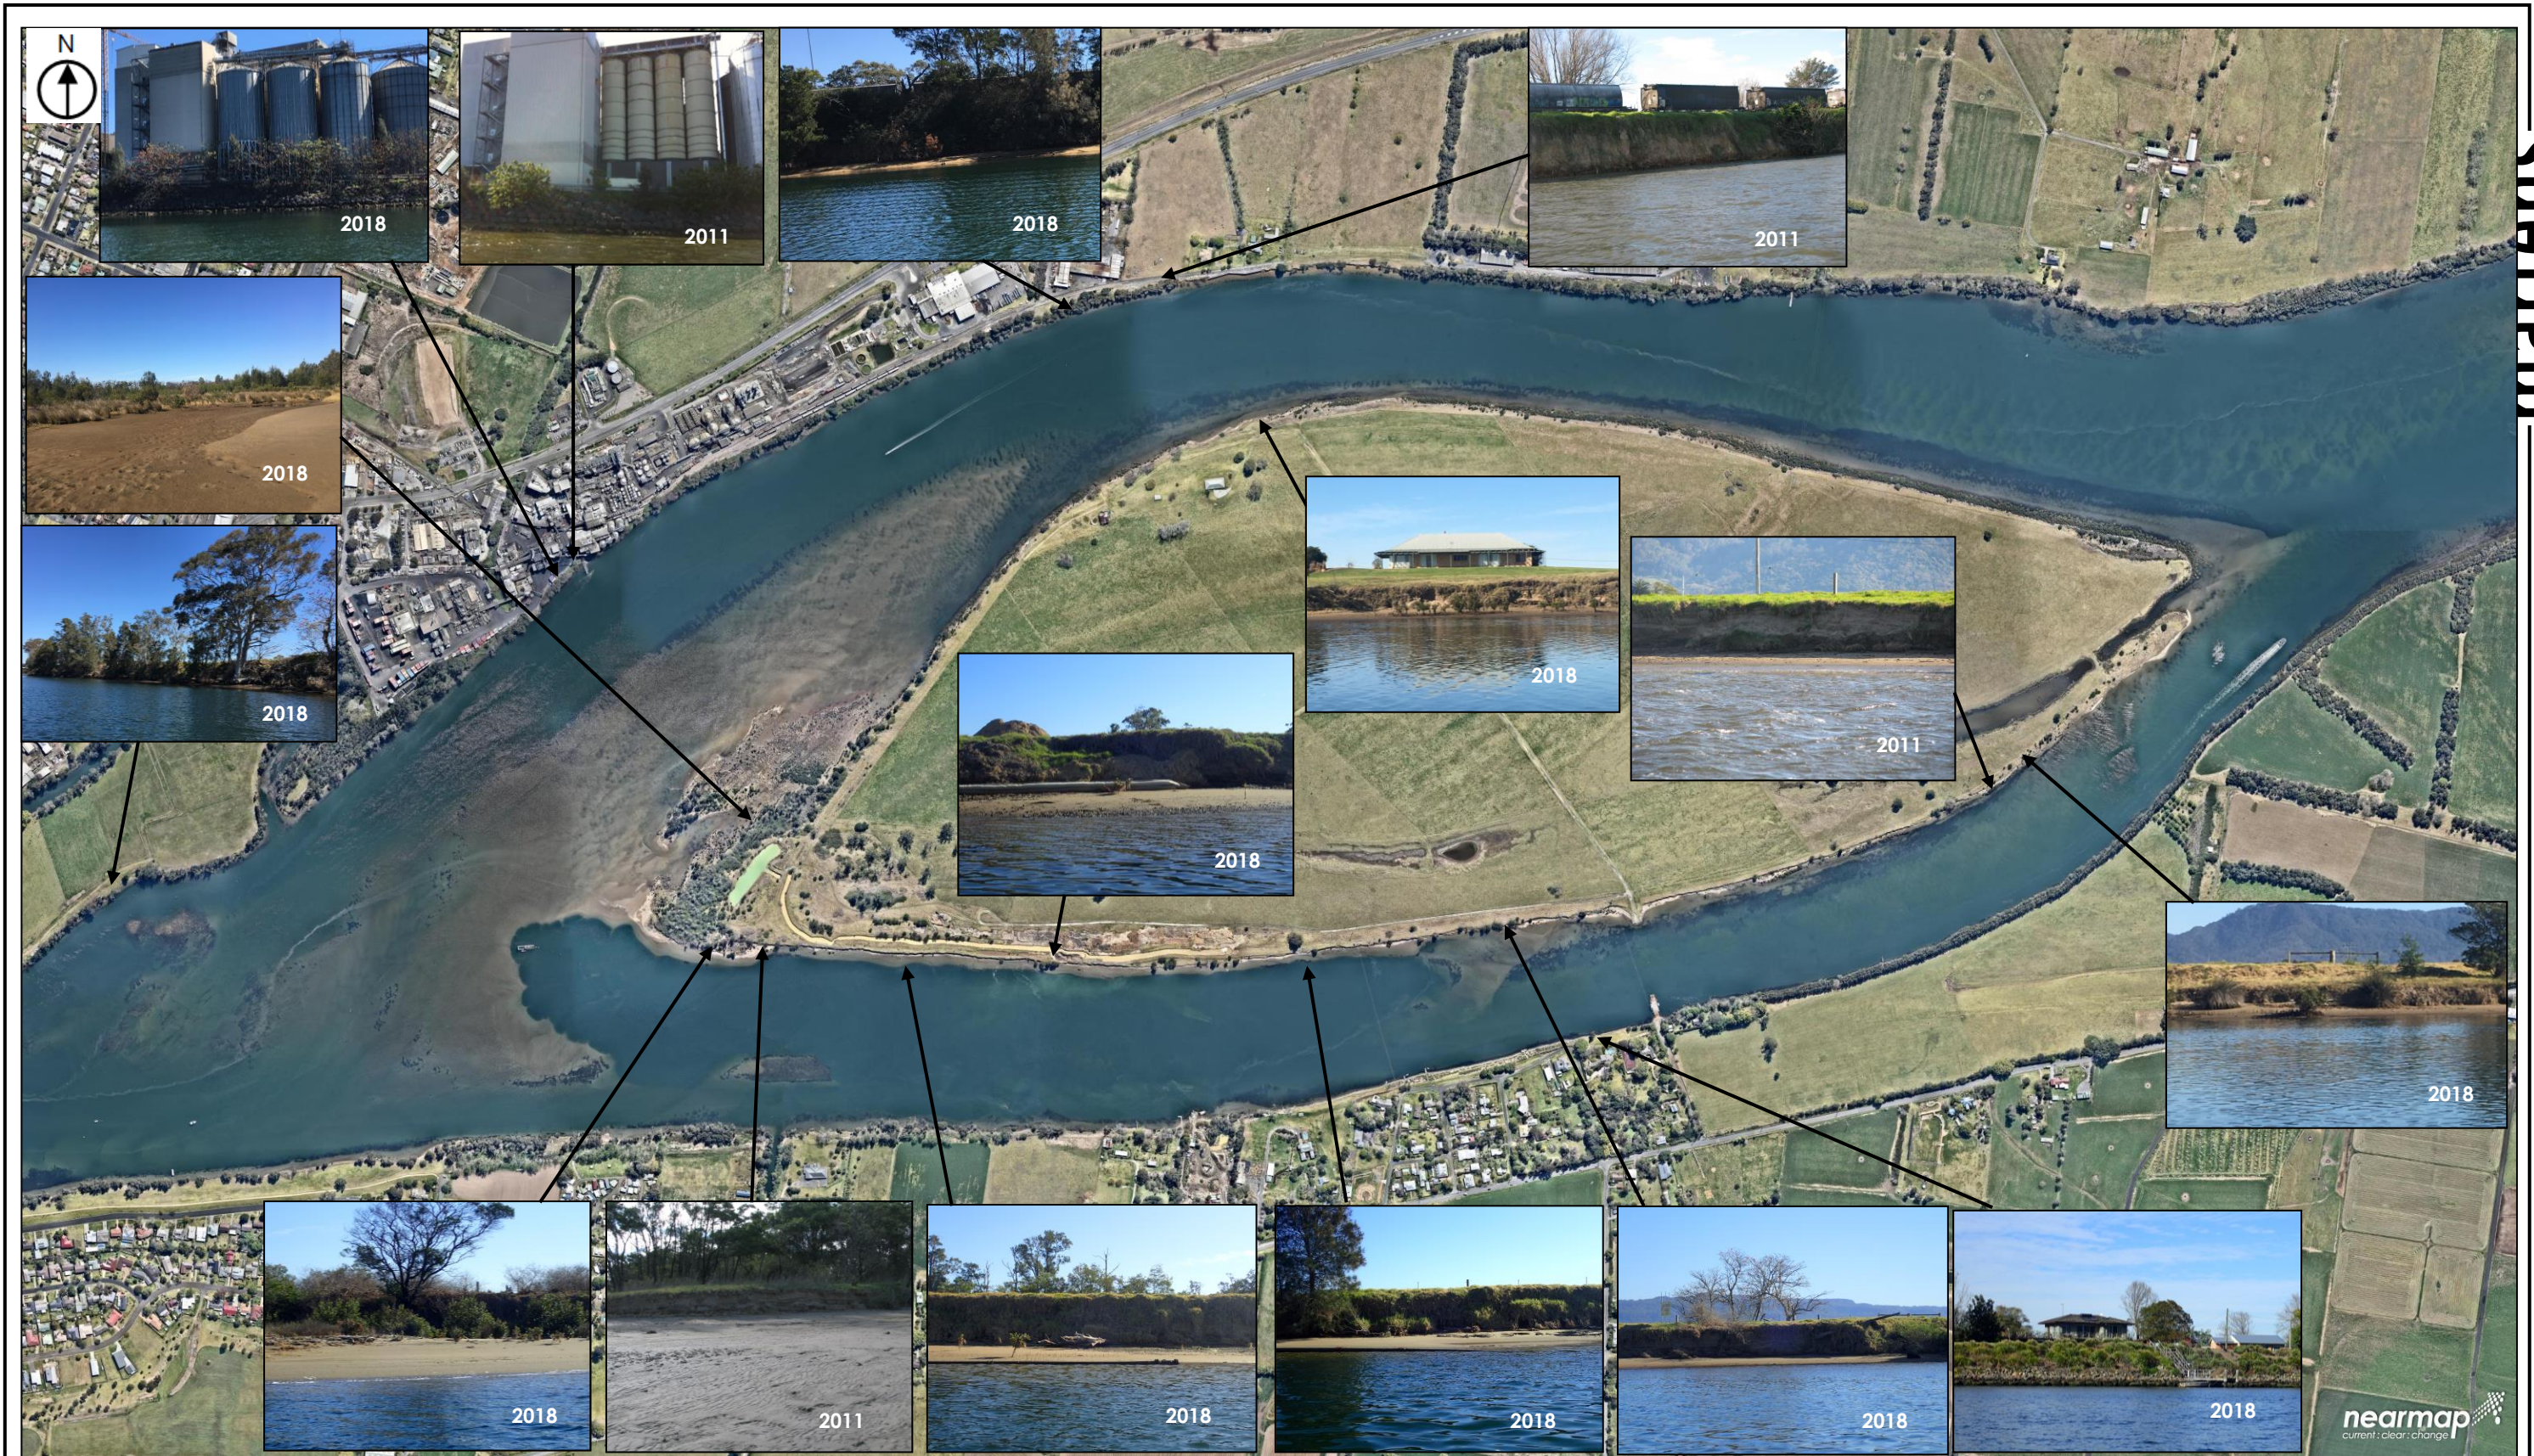
A river bank photographic survey was undertaken of Pig Island. Bank features such as evidence of erosion, slumping and bank failure, existing protection works, riparian vegetation and depositional features were photographed and noted (refer to Figures 4 and 5, Attachment A). The survey is summarised in Table 3.

Reach Extent ¹	Mainland - Bank Conditions 2011	Mainland - Bank Conditions 2018	Pig Island - Bank Conditions 2011	Pig Island – Bank Conditions 2018
Reach 1 (adjacent to existing extraction area)	<p>Localised rock protection along the bank. Bank generally 2 to 4 m high. Evidence of undercutting observed near Bomaderry Creek. Rock gabions adjacent to Shoalhaven Starches ethanol plant.</p> <p>Bank vegetation – trees, shrubs, grasses. Some fallen and dead trees observed on bank slopes and on the river's edge.</p>	Little change from 2011 conditions.	<p>Bank 1- 2 m high. Some undercutting of bank.</p> <p>Bank vegetation – grasses.</p>	<p>Bank 1 – 2 m high, stable and well vegetated. Mangroves and salt marsh areas in good condition.</p> <p>Bank vegetation – grasses, scattered trees and shrubs. Mangroves and salt marshes.</p>
Reach 2	<p>Bank generally 2 to 4 m high. Evidence of slumping and bank instability.</p> <p>Bank vegetation – trees, shrubs, grasses. Fallen and dead trees observed on bank slopes and on the river's edge.</p>	Little change from 2011 conditions.	<p>Bank appeared stable and well vegetated. Some undercutting of bank.</p> <p>Bank vegetation – grasses, scattered trees.</p>	<p>Bank 1 to 2 m generally appeared stable and well vegetated. Localised undercutting.</p> <p>Bank vegetation – grasses, trees and shrubs.</p>

Reach 3	<p>Bank generally 1 to 3 m high. Localised evidence of slumping.</p> <p>Bank vegetation – trees, shrubs, grasses, and mangroves. Some fallen and dead trees observed on bank slopes and on the river's edge.</p>	Little change from 2011 conditions.	<p>Bank appeared stable and well vegetated. Some undercutting of bank.</p> <p>Bank vegetation – grasses, scattered trees.</p>	<p>Bank generally appeared stable and well vegetated. Localised bank undercutting. Mangroves in good condition.</p> <p>Bank vegetation – grasses, trees and shrubs, and mangroves.</p>

Reach Extent ¹	Mainland - Bank Conditions 2011	Mainland - Bank Conditions 2018	Pig Island - Bank Conditions 2011	Pig Island – Bank Conditions 2018
Reach 4	<p>Levee and localised rock wall protection works implemented along reach.</p> <p>Bank well vegetated with grasses, shrubs, trees, and mangrove areas.</p>	Little change from 2011 conditions.	<p>1 m high bank. Some undercutting and slumping.</p> <p>Bank vegetation – grasses.</p>	<p>Bank 1 to 3 m high. Slumping in some areas, other areas stable and well vegetated. Banks more stable and well vegetated further downstream.</p> <p>Bank vegetation – grasses, scattered trees and shrubs.</p>
Reach 5	<p>Levee and localised rock wall protection works implemented along reach.</p> <p>Bank well vegetated with grasses, shrubs, trees, and mangrove areas.</p>	Little change from 2011 conditions.	<p>1 – 2 m high bank. Some undercutting and slumping.</p> <p>Bank vegetation – grasses, shrubs and scattered trees.</p>	<p>Bank 1 to 3 m high. Some slumping and bank instability. Portions of the bank stable and vegetated.</p> <p>Bank vegetation – grasses, scattered trees and shrubs.</p>

Reach 6	<p>Levee and localised rock wall protection works implemented along reach.</p> <p>Bank well vegetated with grasses, shrubs, trees, and mangrove areas.</p>	Little change from 2011 conditions.	<p>1 – 2 m high bank. Some undercutting.</p> <p>Bank vegetation – grasses.</p>	<p>Bank 1 to 2 m high. Slumping in some areas.</p> <p>Bank vegetation – grasses, scattered trees and shrubs.</p>
Reach 7 (adjacent to existing extraction area)	<p>Levee and localised rock wall protection works implemented along reach.</p> <p>Bank well vegetated with grasses, shrubs, trees, and mangrove areas.</p>	Little change from 2011 conditions.	<p>Bank relatively well vegetated. Bank 1 – 2 m high. Some undercutting.</p> <p>Bank vegetation – grasses.</p>	<p>Bank well vegetated. Mangroves and salt marsh areas in good condition. Bank 1 m high in some areas. Localised slumping.</p> <p>Bank vegetation – grasses, scattered trees and shrubs. Mangroves and salt marshes.</p>

1. Whilst there is some evidence of bank instability, this has not changed between 2010 and 2018.
2. Banks are largely stable as demonstrated by their historical stable position.
3. Recent dredging operations do not appear to have had any material effect on bank stability.

Martens & Associates Pty Ltd ABN 85 070 240 890		Environment Water Wastewater Geotechnical Civil Management	
Drawn:	CS	River Bank Condition Photos (2018 and 2011) Lower Shoalhaven River and Pig Island, NSW Image Source: Nearmap (2018) and MA	Drawing No:
Approved:	JF		Figure 4
Date:	March 2019		
Scale:	Not to Scale		Job No: P1806743

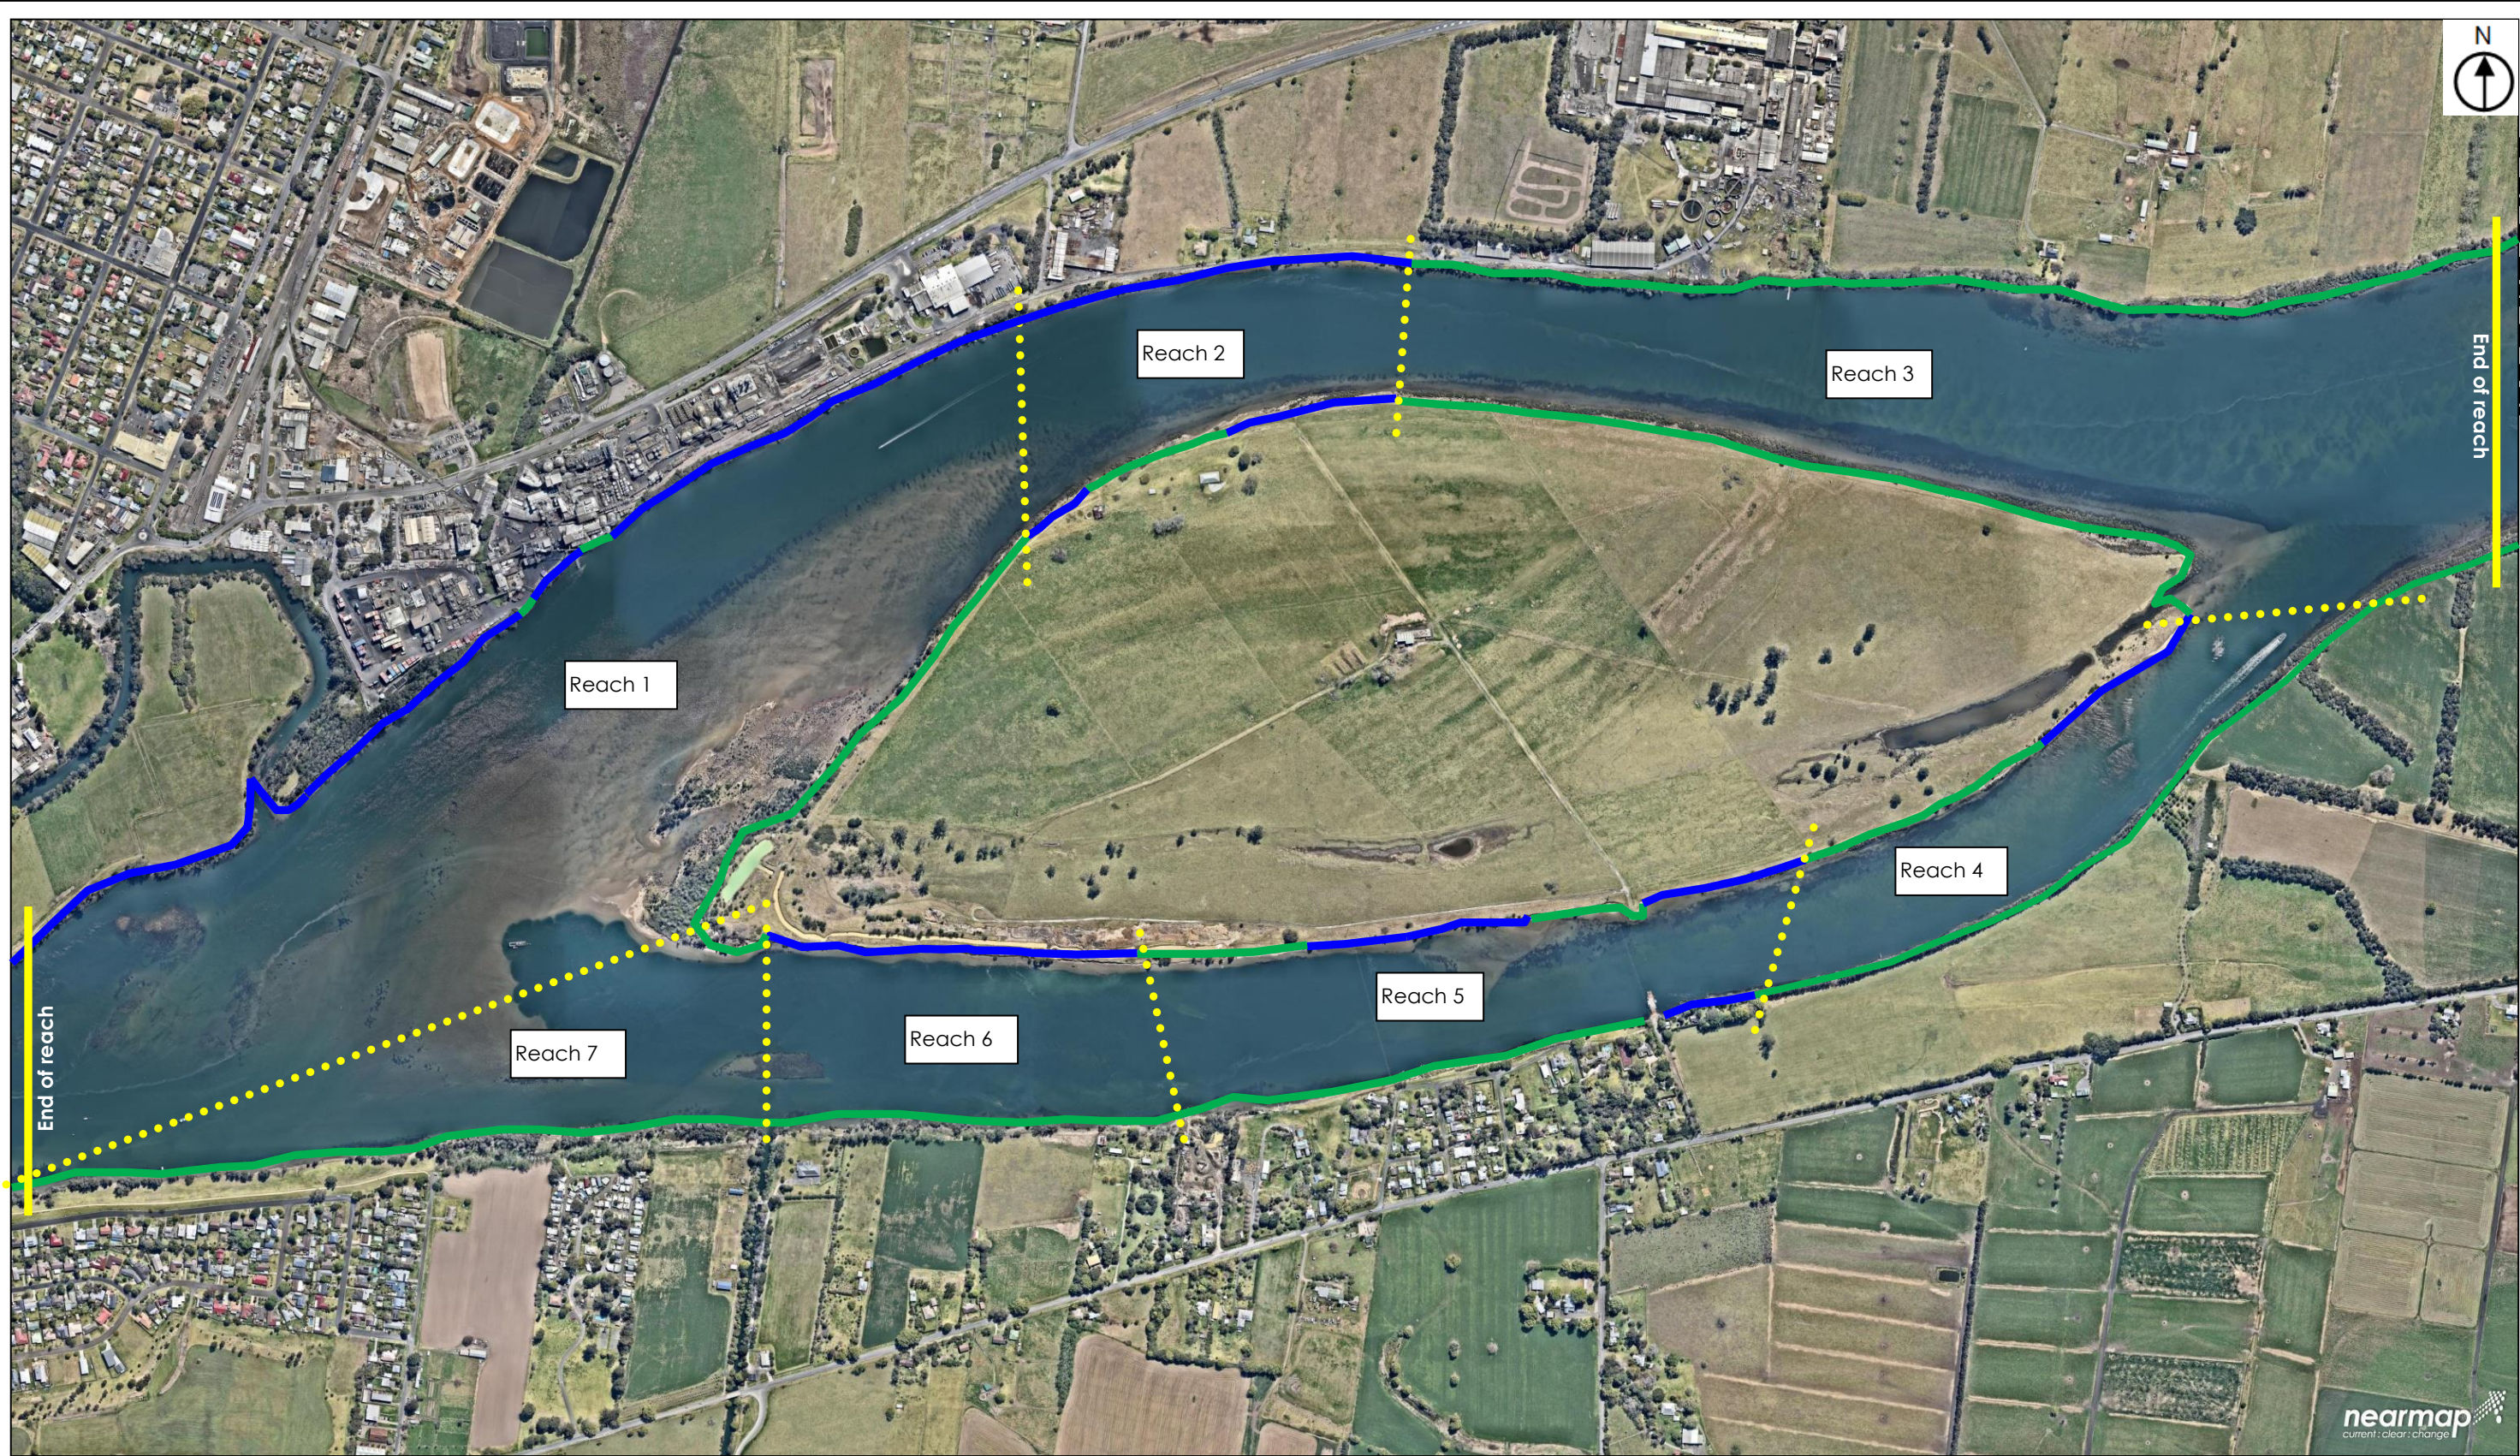
¹ Refer to Attachment A, Figure 5 for reach extents, and Figure 4 for bank condition photos.

KEY	
—	Oversteepened / some undercutting
—	Generally stable / vegetated / protection works

Environment Water Wastewater Geotechnical Civil Management	
River Bank Condition Lower Shoalhaven River and Pig Island, NSW Image Source: Nearmap (2018)	
Drawing No:	Figure 5
Job No: P1806743
