Arboriculture Addendum

10- 16 Pacific Drive Port Macquarie NSW

The Tree MD Pty Ltd

**Site Assessment conducted by and
report prepared by: Geoffrey Ashton – Arboriculture AQF 5**

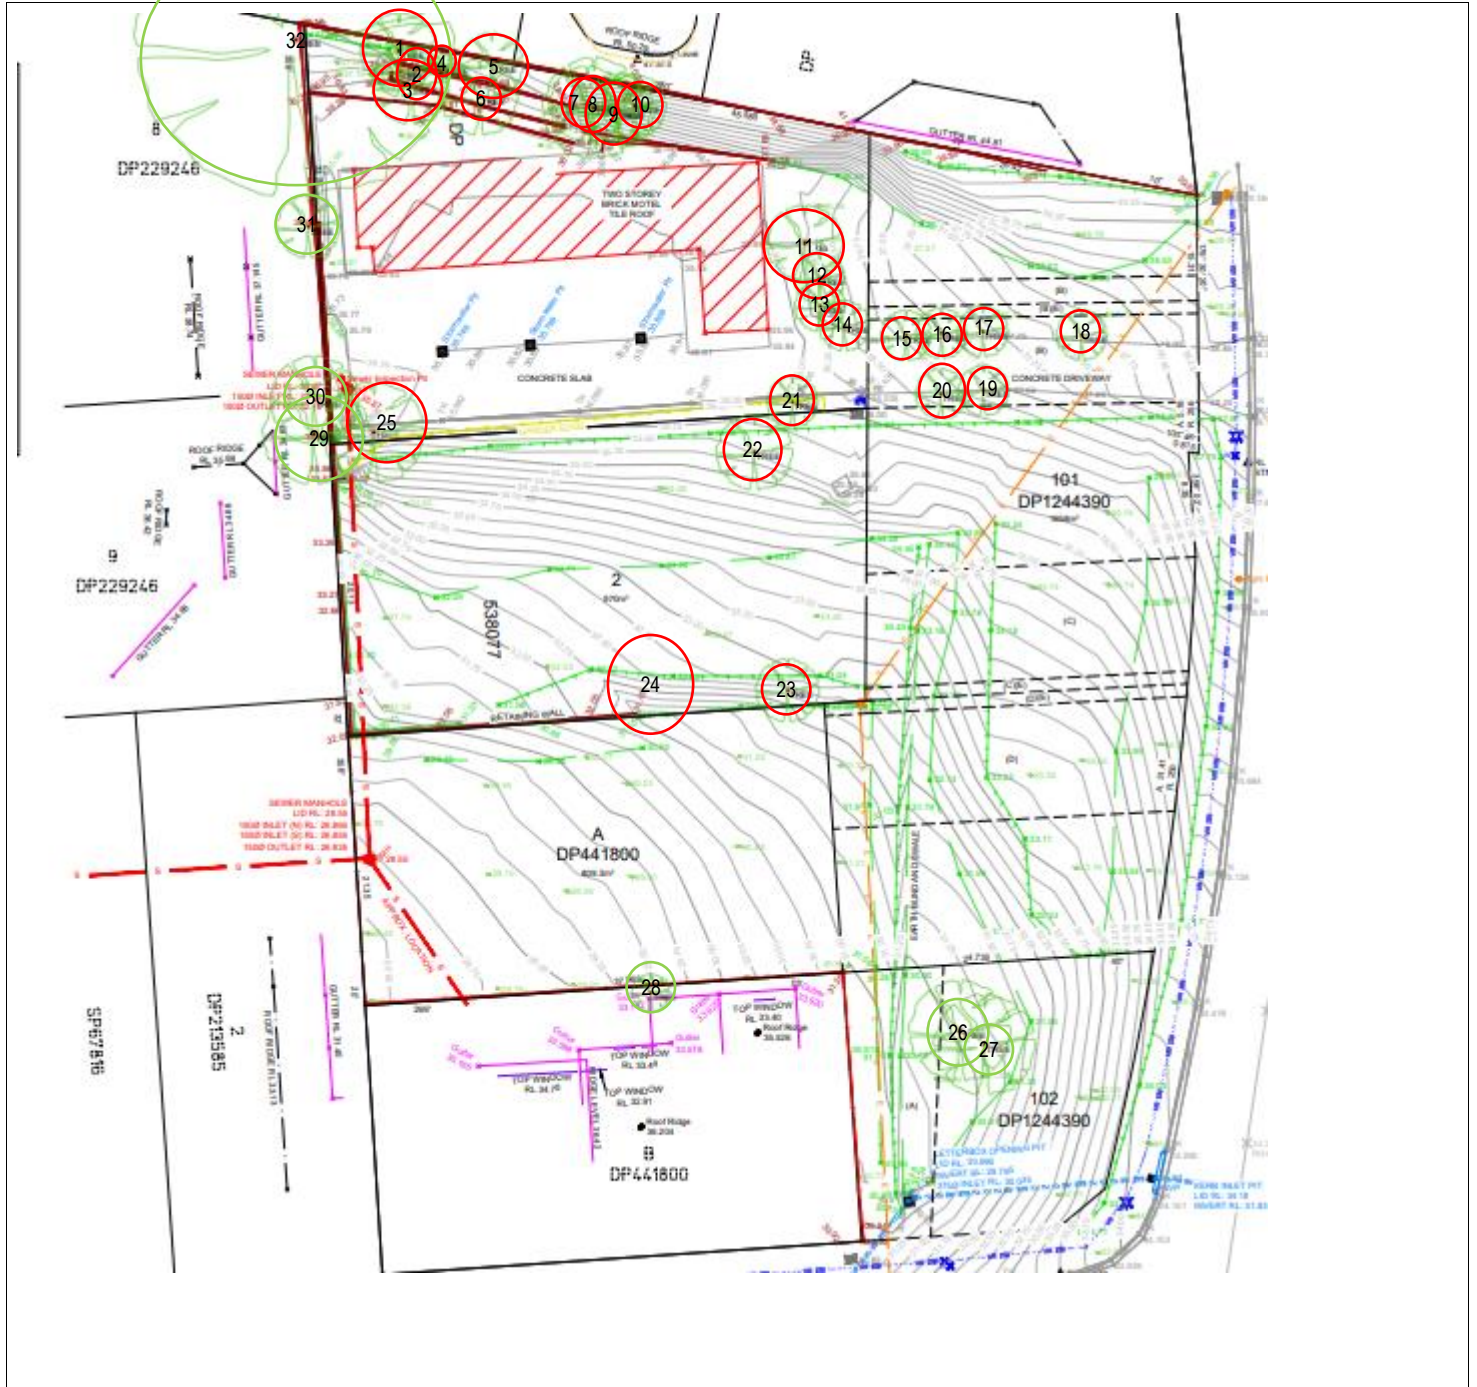
9 Appendix A Tree Protection Plan Diagram

An overlay of the trees and their numbers onto the existing plan building footprint is provided within the Tree Protection Plan Site Diagram. This plan in conjunction with the measurements supplied within the Tree Profile Table will allow for a measured analysis of the trees canopy and root systems as well as the associated impacts. Where plans are not measured, or access is not achieved an estimated distance is utilised.

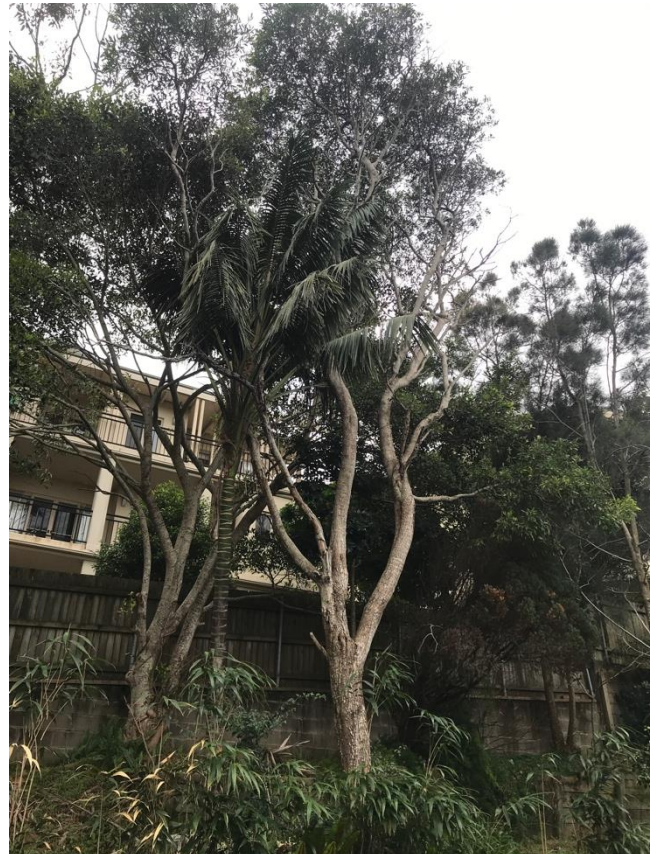
3	Wattle <i>Acacia spp.</i>	Low The tree is in poor condition and average vigour, The tree is only partly visible from surrounding properties as obstructed by other vegetation. The tree provides a minor contribution to the local area.	3 short <1-15 Years	Poor	Average	M	10 to 15	6	6	1	5	100	2.37	4.08	0.45	0.34	0.00	0.00	0.00	Located in that garden bed possibly self-seeded. Poor specimen declining branches to south	Remove and replace

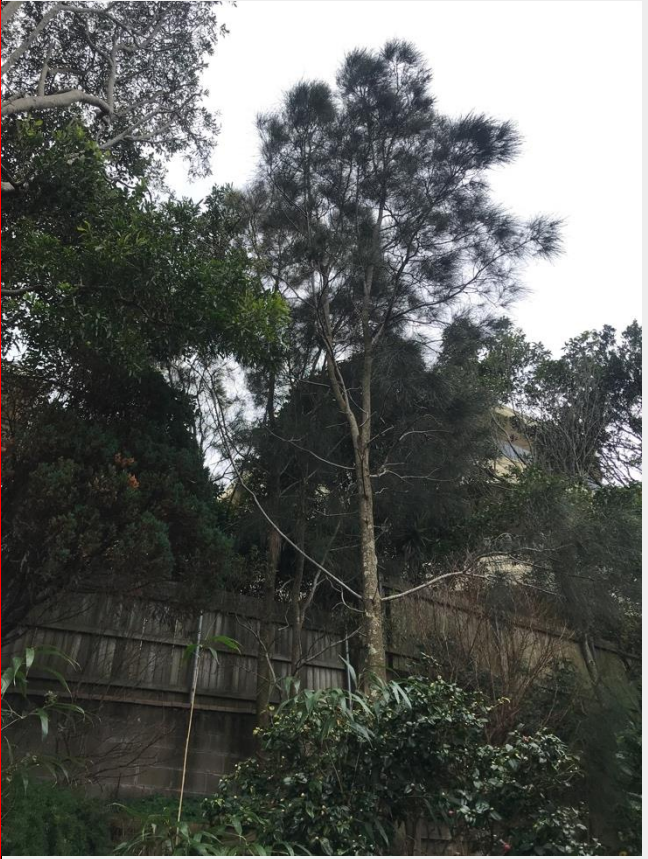
6	She Oak <i>Casuarina spp</i>	Low The tree is a young specimen and readily replaceable The tree is only partly visible from surrounding properties as obstructed by other vegetation. The tree provides a minor contribution to the local area	2 Medium 15-40 years	Good	Good	I	5 to 10	2	2	2	2	100	1.85	2.64	0.25	0.22	0.00	0.00	0.00	Located in centre of garden bed questionable retaining wall stability reduced life expectancy unless allowances are made. Within footprint of landscape plan	Remove and replace

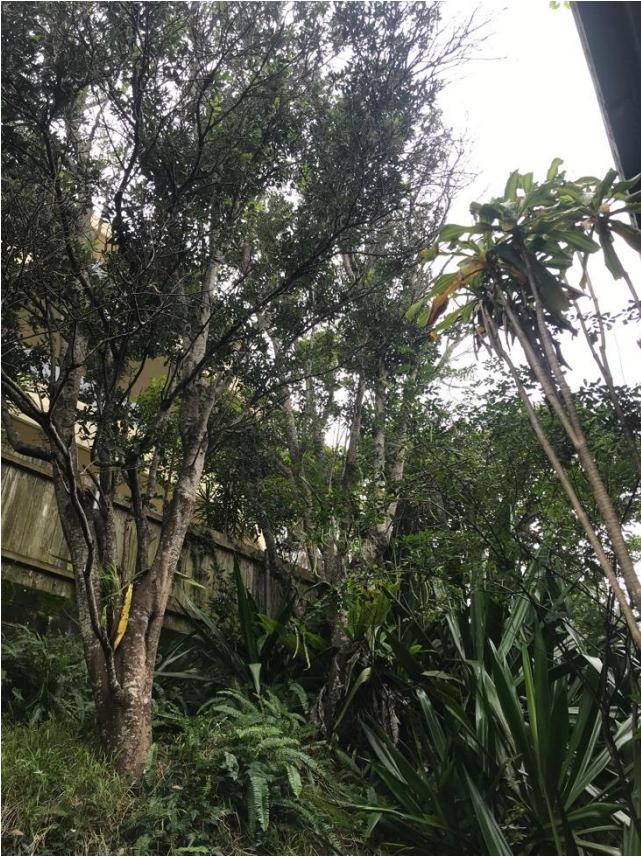
9	Guioa <i>Guioa semiglauc</i>	Low The tree is in fair condition and average vigour, The tree is only partly visible from surrounding properties as obstructed by other vegetation. The tree provides a minor contribution to the local area	3 short <1-15 Years	Average	Average	M	5 to 10	4	2	2	2	100	1.97	3.12	0.29	0.16	0.12	0.12	0.10	Limited soil media and water penetration due t concrete Result in poor vitality decline of branches to south. Landscape plan to remove and remediate area	Remove and replace

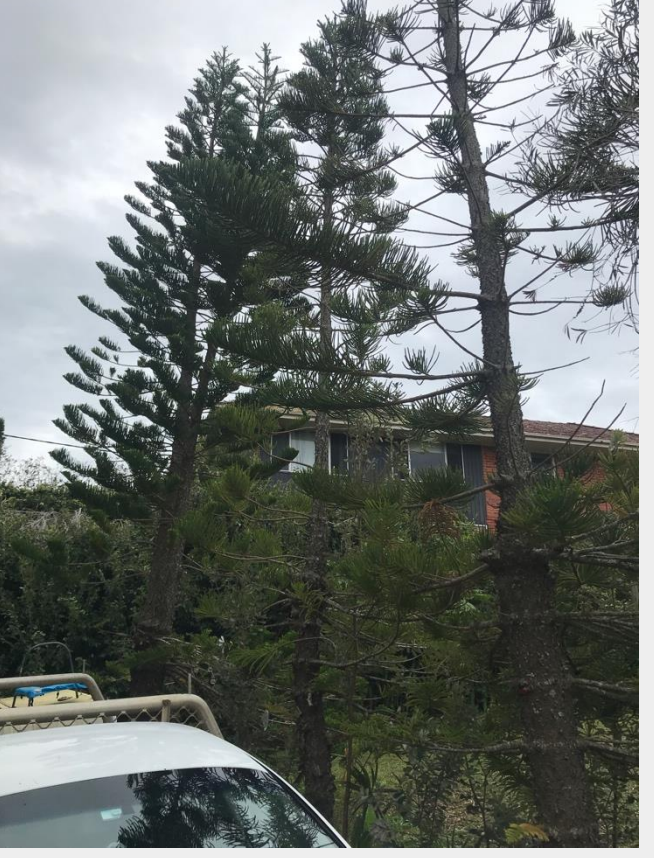
1
2

12	Norfolk Island Pine <i>Araucaria heterophylla</i>	Low The tree is in poor condition and average vigour, The tree is a young specimen that is easily replaceable. The tree provides a minor contribution to the local area	3 short <1-15 Years	Poor	Average	I	5 to 10	2	2	2	2	100	1.85	2.40	0.25	0.20	0.00	0.00	0.00	Previously main stem failure at 2m	Remove and replace
13	Norfolk Island Pine <i>Araucaria heterophylla</i>	Low The tree is in poor condition and average vigour, The tree is a young specimen that is easily replaceable. The tree provides a minor contribution to the local area	3 short <1-15 Years	Average	Average	I	10 to 15	2	2	2	2	100	2.00	2.76	0.30	0.23	0.00	0.00	0.00	Limited room for future stem and root development	Remove and replace

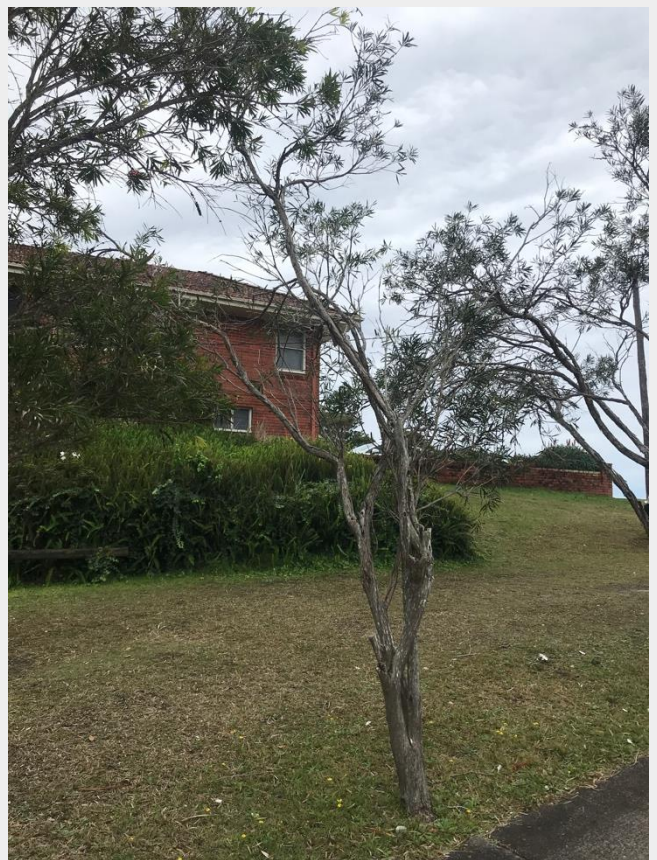
1
6

16	Bottle Brush <i>Callistemon viminalis</i>	Low The tree is in poor condition and poor vigour, The tree is a young specimen that is easily replaceable. The tree provides a minor contribution to the local area	3 short <1-15 Years	Poor	Poor	M	0 to 5	3	1	0	1	100	1.15	1.08	0.08	0.06	0.06	0.00	0.00		Remove and replace
17	Bottle Brush <i>Callistemon viminalis</i>	Low The tree is in poor condition and average vigour, The tree is a young specimen that is easily replaceable. The tree provides a minor contribution to the local area	3 short <1-15 Years	Poor	Average	M	0 to 5	3	2	1	2	100	1.68	1.68	0.20	0.07	0.05	0.06	0.08		Remove and replace

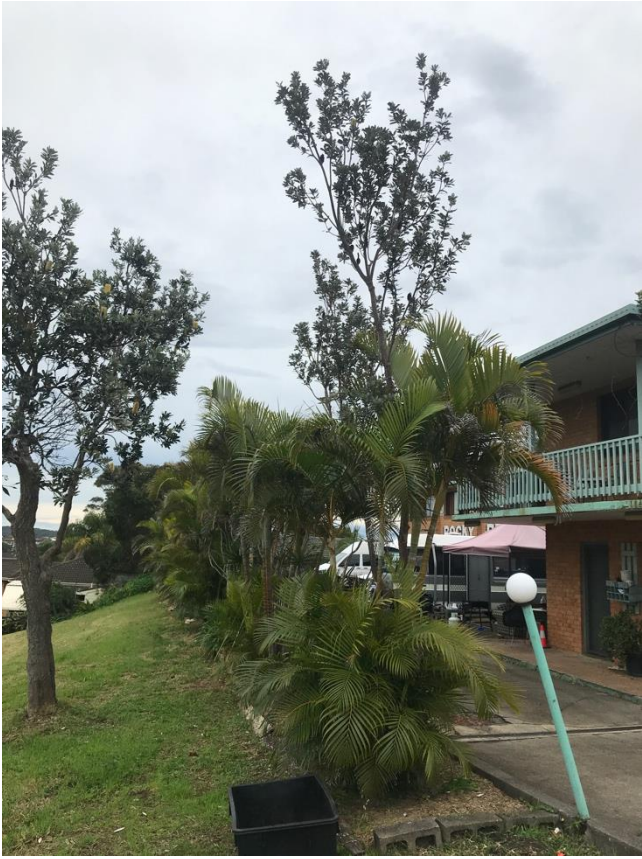
2
1

21	Coastal Banksia <i>Banksia integrifolia</i>	Low The tree is in poor condition and good vigour, The tree is a young specimen that is easily replaceable. The tree provides a minor contribution to the local area	3 short <1-15 Years	Average	Good	M	5 to 10	1	1	1	1	100	1.68	1.56	0.20	0.10	0.07	0.00	0.00	Located 20 cm from curb young specimen Readily replaceable	Remove and replace

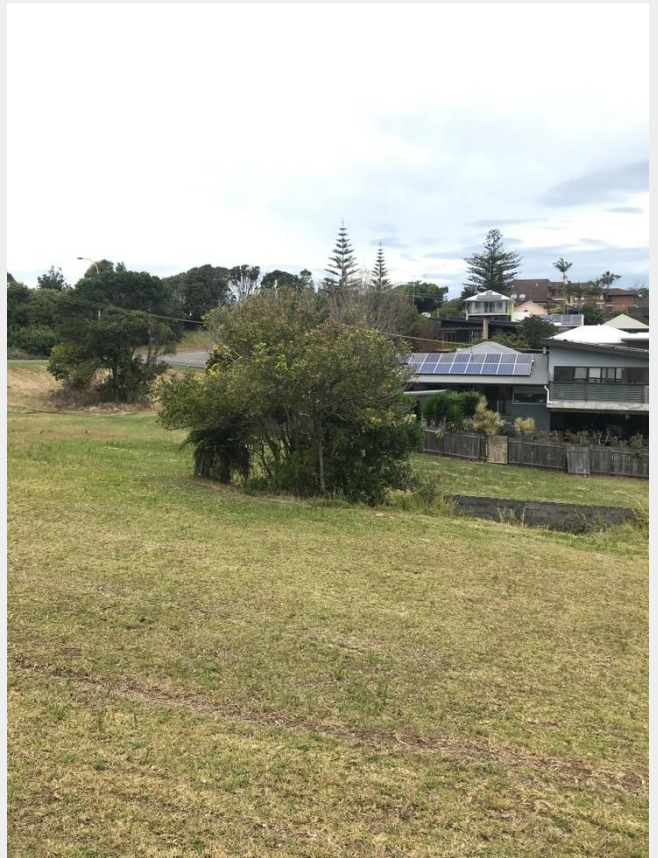
2
4

24	Cheese tree <i>Glochidion ferdinandi</i> x4 Guioa <i>Guioa semiglauca</i> x3	Low The tree is in average condition and good vigour, The tree is a young specimen that is easily replaceable. The tree provides a minor contribution to the local area	2 Medium 15-40 years	Average	Average	M	0 to 5	5	5	5	5	100	1.85	2.40	0.25	0.20	0.00	0.00	0.00	clump of trees multiple species stemming from one location	Remove and replace
25	Cheese tree <i>Glochidion ferdinandi</i> x2	Low The tree is in poor condition and good vigour, The tree has a defect that may become structurally unsound. The tree provides a minor contribution to the local area	3 short <1-15 Years	Poor	Poor	M	5 to 10	5	5	0	5	100	2.67	5.16	0.60	0.30	0.20	0.18	0.12	Significant decline leans to north Small tree growing near base. Previous poor pruning and restricted growth under carpark	Remove and replace

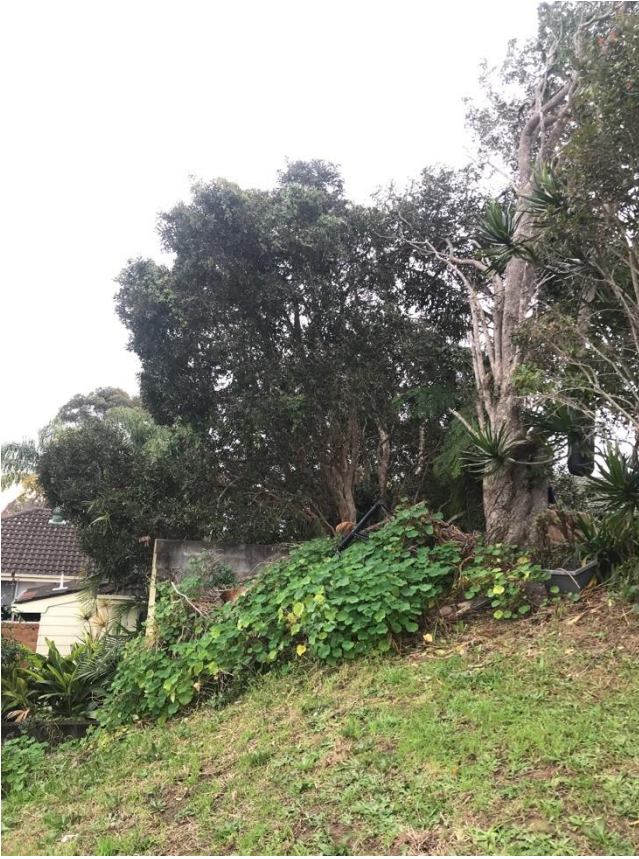
2
9

Tree 29 is situated in the neighbouring property approximately 3m below the ground level of the subject site. Due to the retaining wall between the properties and the significant amount of soil media reducing conditions for optimal root development, there is unlikely to be any root system within the development footprint as the subject tree would have optimised to the path of least resistance with root development occurring in soil that provides gaseous exchange. If the root system of Tree 29 was not asymmetric the proposed encroachment would still be outside of the formulated Structural Root Zone and still remain a minor encroachment of 9.2%, it is also well established this is a species that can tolerate substantial encroachments on its root system.

29	Broad Leaved Paper Bark <i>Melaleuca quinquenervia</i>	Medium The tree is in good condition and good vigour, the tree is locally indigenous, the trees growth is moderately restricted	3 short <1-15 Years	Good	Good	M	5 to 10	6	3	5	6	0	2.67	6.00	0.60	0.50	0.00	0.00	0.00	Approximately 1 m from fenceline estimated measurements canopy overhangs fenceline by 2 m the fenceline so is the supporting wall drops down approximately 3 to 4 m	Retain and protect

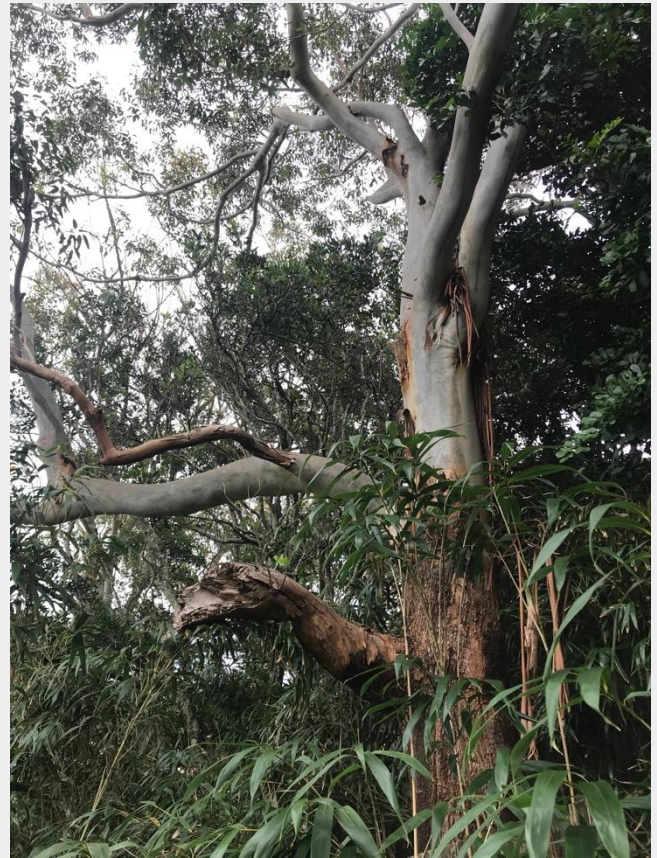
3
2

Tree 32 is assessed as a minor encroachment from the proposed plans. Updated Level 01 and 02 Plans Drawing No. A-1204 issue C plans show a reduced encroachment on the formulated Tree Protection Zone of 2.2%. This encroachment is well outside the formulated Structural Root Zone and unlikely to adversely impact the tree. Additional measures are provided within The Tree MD Pty Ltd report dated 25th June 2021 to minimise encroachments from proposed plantings within the Tree Protection Zone.

Recommendation to assess the canopy of Tree 32 were provided in The Tree MD Pty Ltd report dated 25th June 2021 to allow for the best management of the subject tree however an aerial inspection is not required to carry out the proposed works as the proposed works will have no bearing on the outcome of the aerial inspection, and the inspection will have no bearing on the proposed works. At the most extreme outcome a significant defect would be observed, and the subject tree would be removed which would reduce the requirement of tree protection in this area. The subject tree has had previous failures and with the limited assessment from over the fenceline it is identified the tree has a less desirable structural formation. There is no imminent danger evident with the limited view from ground level within 10-16 Pacific Drive Port Macquarie NSW.

32	Blue Gum <i>Eucalyptus saligna</i>	Medium The tree is in average condition and good vigour, the tree is locally indigenous, the trees growth is moderately restricted.	2 Medium 15-40 years	Average	Good	M	10 to 15	8	8	8	8	10	2.85	7.20	0.70	0.60	0.00	0.00	0.00	Located against fence line previous failure at 2 m to South previous failure at 4 m to south questionable branch attachment and rubbing branch at 7 m. Retaining walls assessed as a minor encroachment, plantings will need to be flexible in their final location to avoid significant root systems	Retain and protect, contact owner to have trees assessed
