SITE PLAN
SCALE 1:500

building & infrastructure services Suite 203, 18 Aquatic Drive, Frenchs Forest NSW 2086 T: 02 9451 7555 F: 02 9451 8555 E: info@mgp.com.au		SERVICE PROTECTION REPORT 2 THE CIRCLE NARRAWEENA 2099		Design By	MG	Scale	1:500	
				Approved	MG	Sheet	1 OF 1	
				Job.No. 2022-0373				
				Dwg.No. SPR1			Issue	1

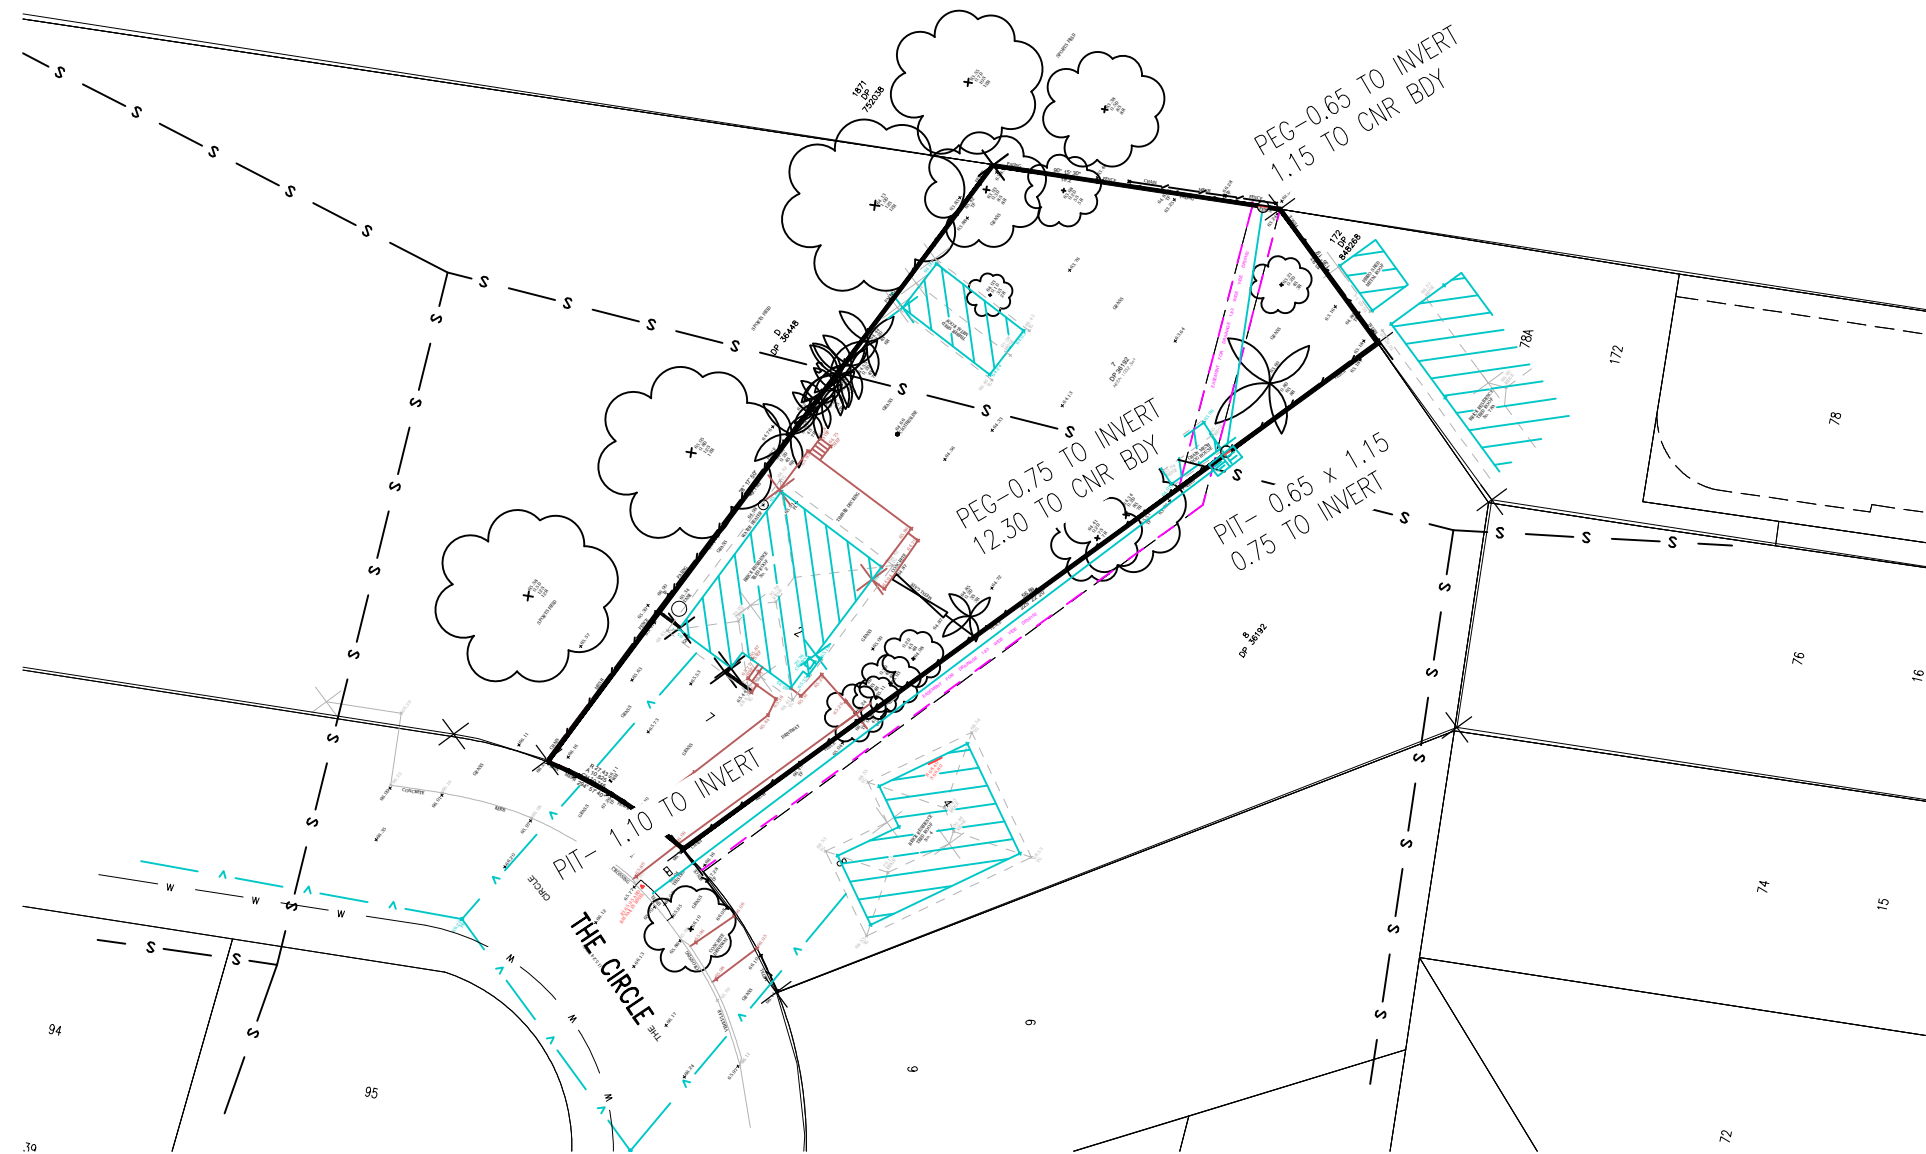
13. STRATA: ROCK/SOIL
PIPE SIZE: DN375
PIPE TYPE: CONC
