Pavement Investigation & Design

East Seaham Road, East Seaham

Report Ref: G0558-R-001-Rev0

Client: Port Stephens Shire Council

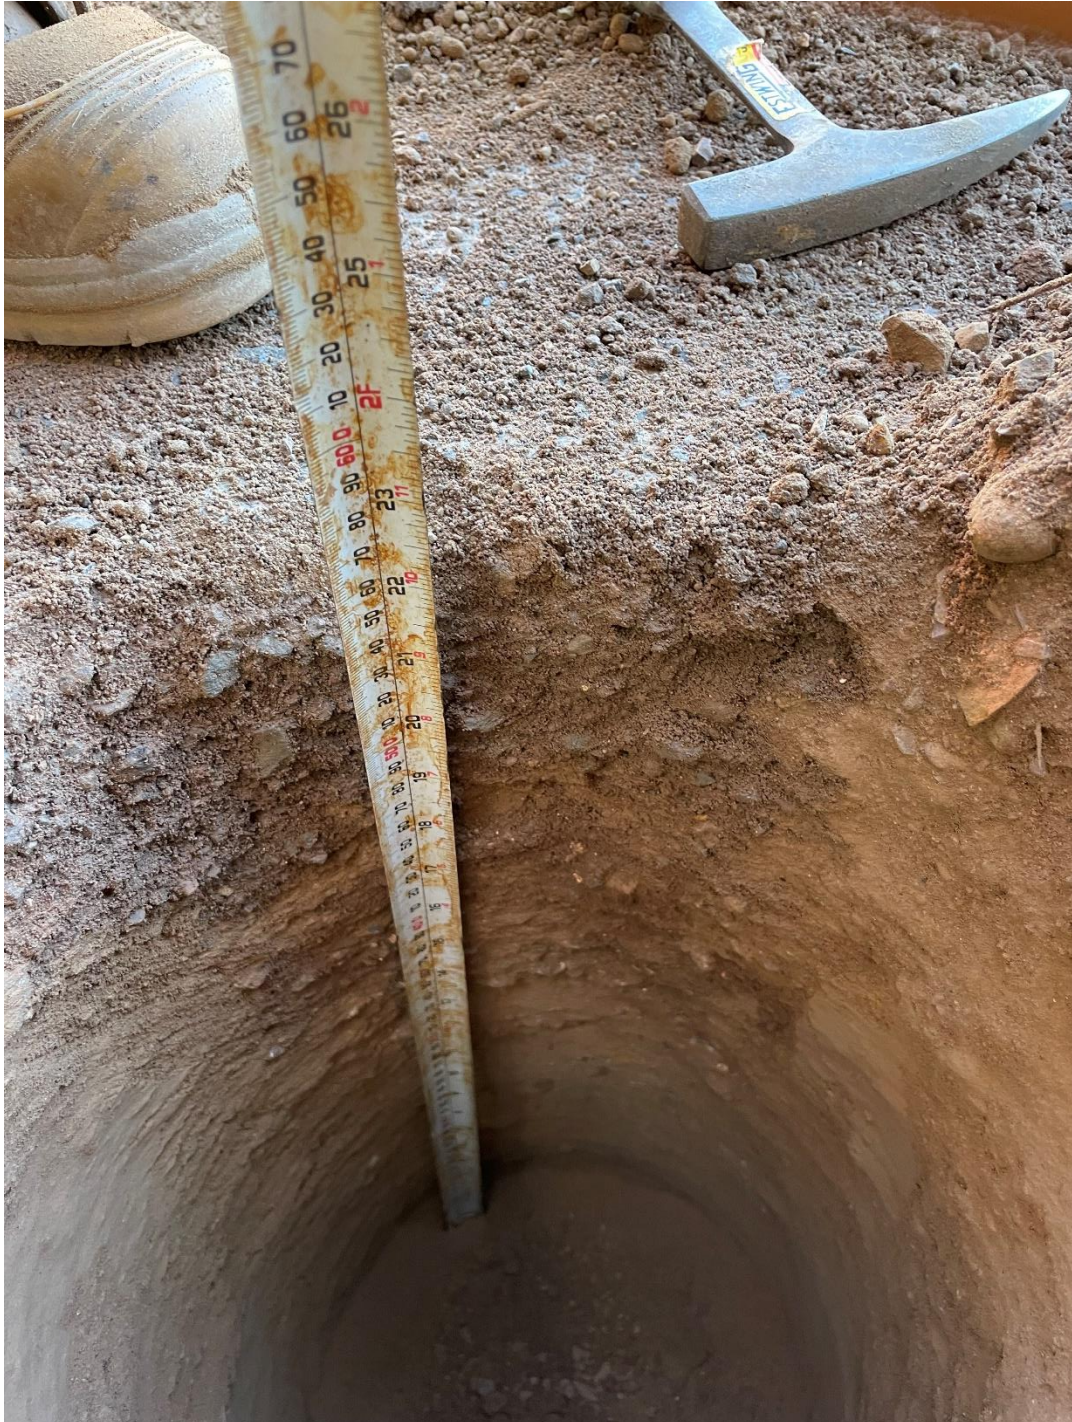
Figure 1 – Showing Borehole 1

Water	DCP graph	PSP	Testing	Samples	Depth (m)	Graphic Log	Classification Code	Material Description	Moisture	Consistency/Density	Soil Origin	Remarks
				Bulk								
					0.1		GM	FILL: Silty to sandy GRAVEL, fine to coarse sized, fine to coarse grained sand, grey.	M-D		Fill	
					0.3		GM	FILL: Silty to sandy GRAVEL, fine to coarse sized, fine to coarse grained sand, brown.	D		Fill	
				2 bulk	0.8		GM	FILL: Silty to sandy GRAVEL, fine to coarse sized, fine to coarse grained sand, with low plasticity clay, brown, trace cobbles .			Fill	
	3						CL-CI	Silty to sandy CLAY, low to medium plasticity, brown / orange, fine grained sand, trace fine sized gravel.	w > PL	St-VSt	Residual	
	4											
	3			2 bulk	1							
	5											
	6							BH1 Terminated at 1.2m				
	9											
	T

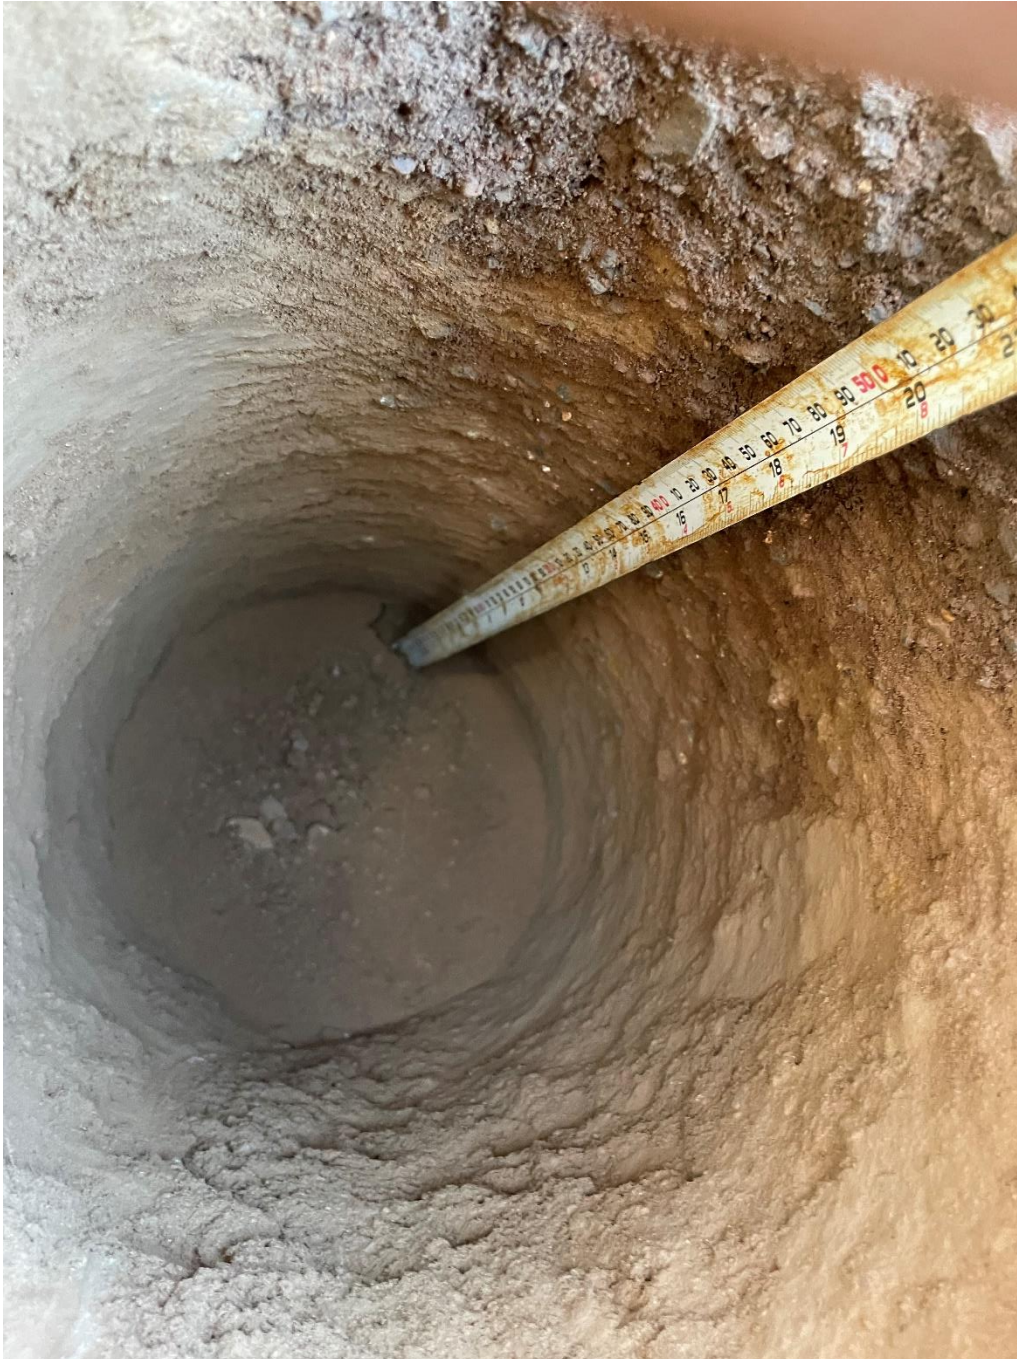
Figure 3 – Showing Borehole 7

Drilling Method	Water	DCP graph	Samples	Depth (m)	Graphic Log	Classification Code	Material Description	Moisture	Consistency/Density	Soil Origin	Remarks
			Bulk								
				0.1		GM	FILL: Silty to sandy GRAVEL, fine to coarse sized, fine to coarse grained sand, grey.	D		Fill	
				0.3		GM	FILL: Silty to sandy GRAVEL, fine to coarse sized, fine to coarse grained sand, brown.			Fill	
						GM	FILL: Silty to sandy GRAVEL, fine to medium sized, fine to coarse grained sand, brown.	M-D		Fill	
		9									
		10									
		12									
		T									
			2 bulk (CBR)								
							BH7 refusal at 1m (Refused sandstone/ possible sandstone fill boulder)

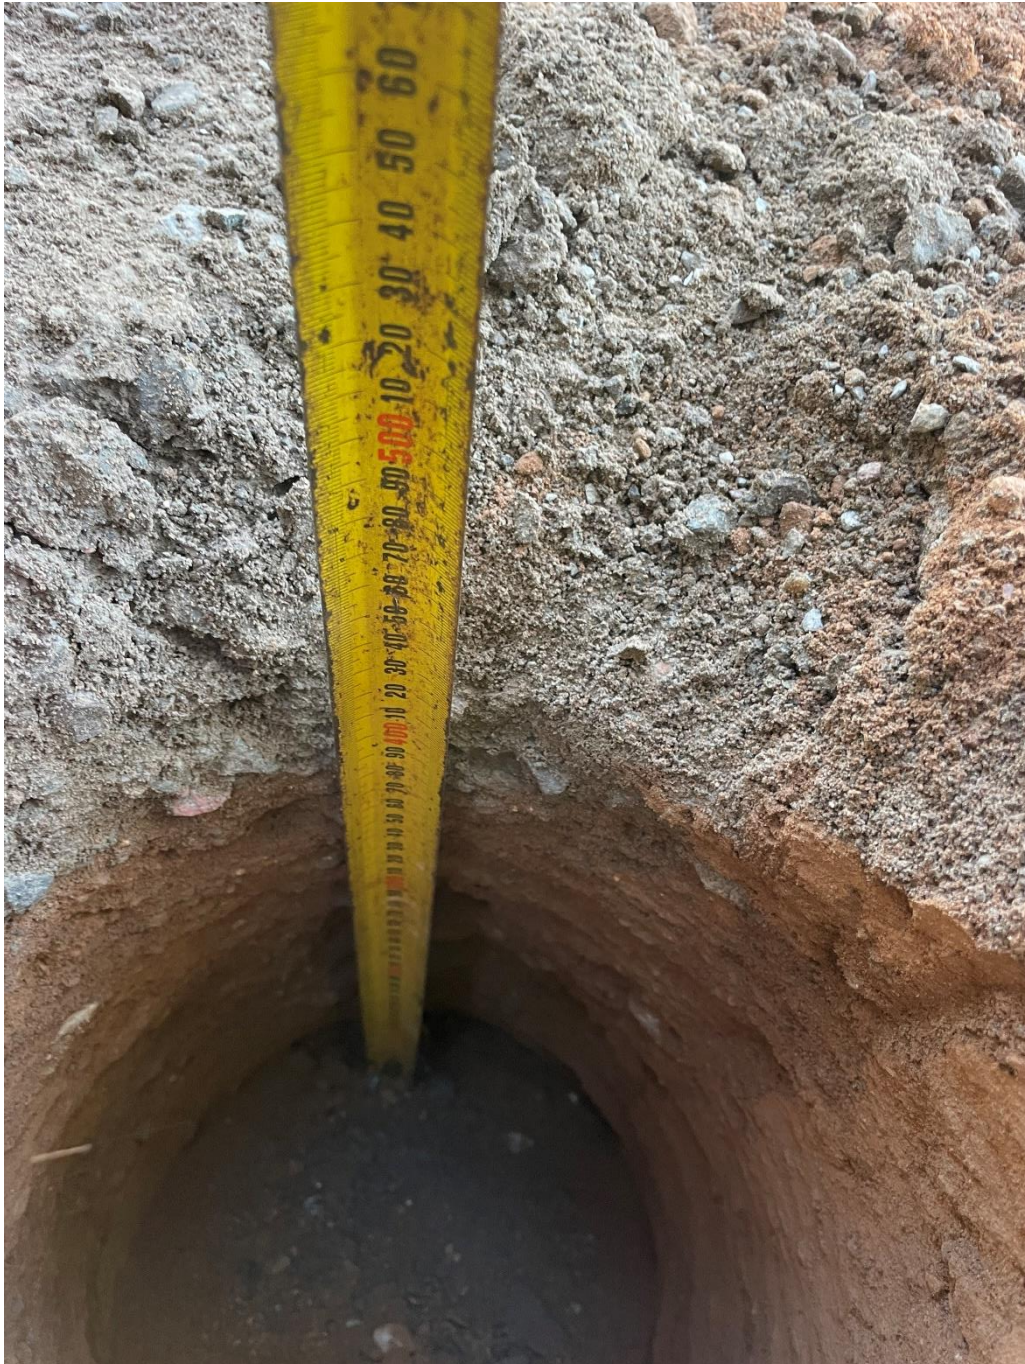
Figure 4 – Showing Borehole 9

Drilling Method	Water	DCP graph	Samples	Depth (m)	Graphic Log	Classification Code	Material Description	Moisture	Consistency/Density	Soil Origin	Remarks
			Bulk								
						GM	FILL: Silty to sandy GRAVEL, fine to coarse sized, fine to coarse grained sand, grey.	D		Fill	
		2		0.1		GM	FILL: Silty to sandy GRAVEL, fine to coarse sized, fine to coarse grained sand, brown.			Fill	
		9	1 bulk	0.3		SC	Clayey SAND, fine to coarse grained, grey / brown, low plasticity clay.	M-D	MD	Residual	
		19		0.4		SC	As above, but increased clay content, with fine to medium round / sub-rounded gravel			Residual	
		T									
			2 bulk								
				1							
							BH9 refusal at 1.1m

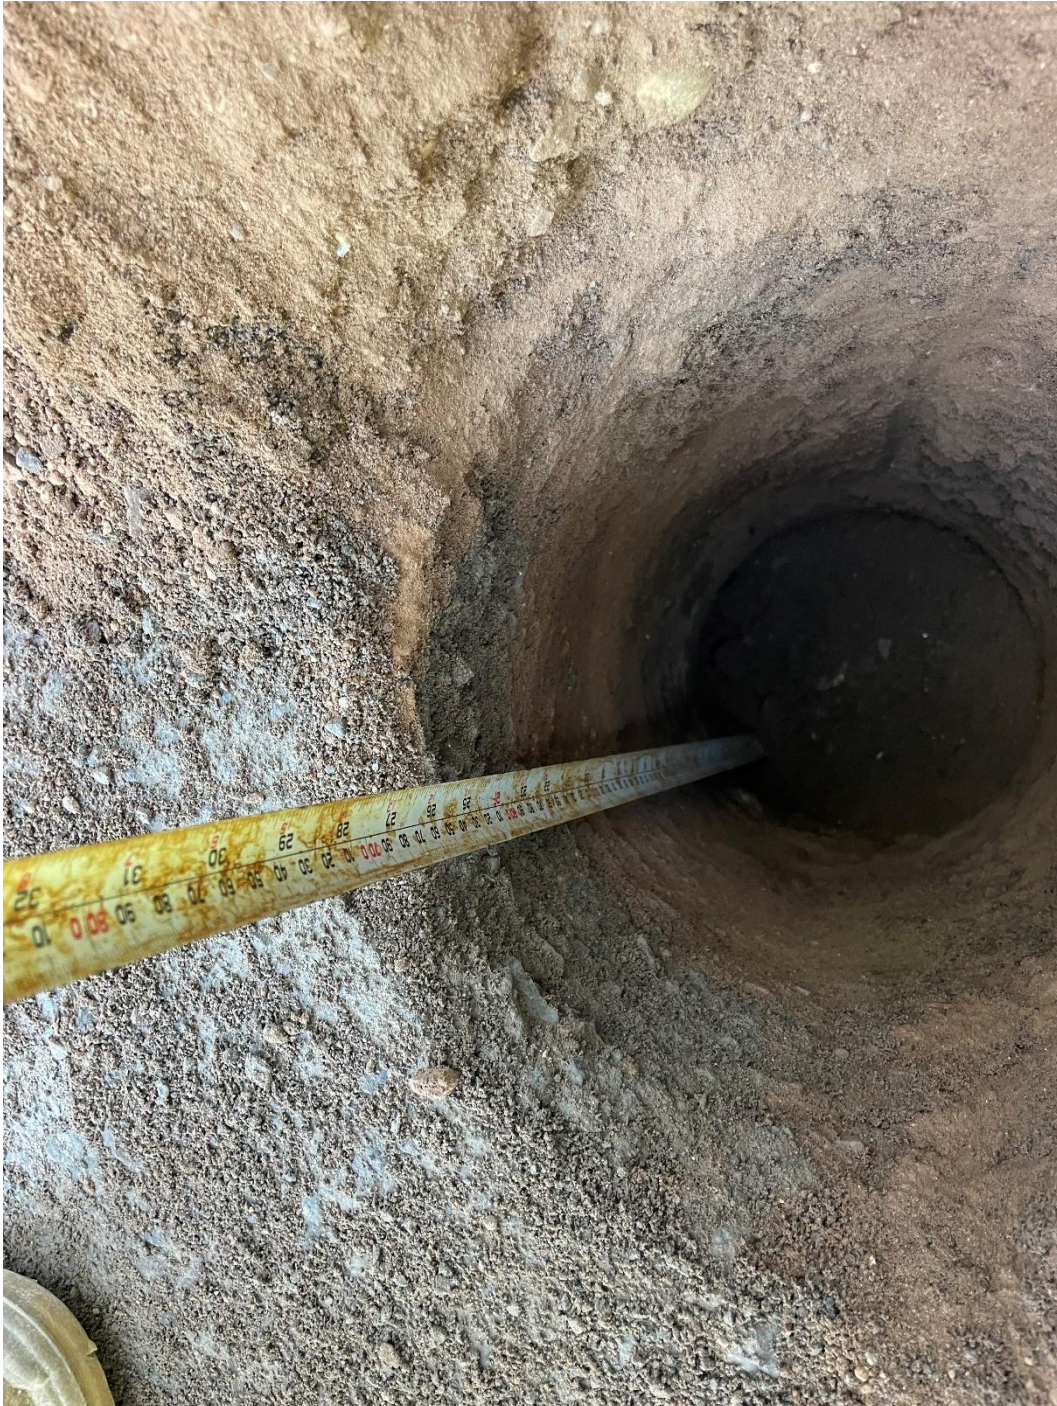
Figure 5 – Showing Borehole 12

Drilling Method	Water	DCP graph	Samples	Depth (m)	Graphic Log	Classification Code	Material Description	Moisture	Consistency/Density	Soil Origin	Remarks
			Bulk								
				0.1		GM	FILL: Silty to sandy GRAVEL, fine to coarse sized, fine to coarse grained sand, grey.	D		Fill	
			2 bulk			GM	FILL: Silty to sandy GRAVEL, fine to coarse sized, fine to coarse grained sand, brown.			Fill	
				0.6		GM	FILL: Silty to sandy GRAVEL, fine to coarse sized, fine to coarse grained sand, with low plasticity clay, brown / pale brown, trace cobbles.	SLM		Fill	
			3								
			4	1		SC	Clayey to silty to gravelly SAND, fine to coarse grained, fine to medium sized gravel, brown, low plasticity clay.	D	MD-D	Residual	
			5								
		T					BH12 Terminated at 1.2m

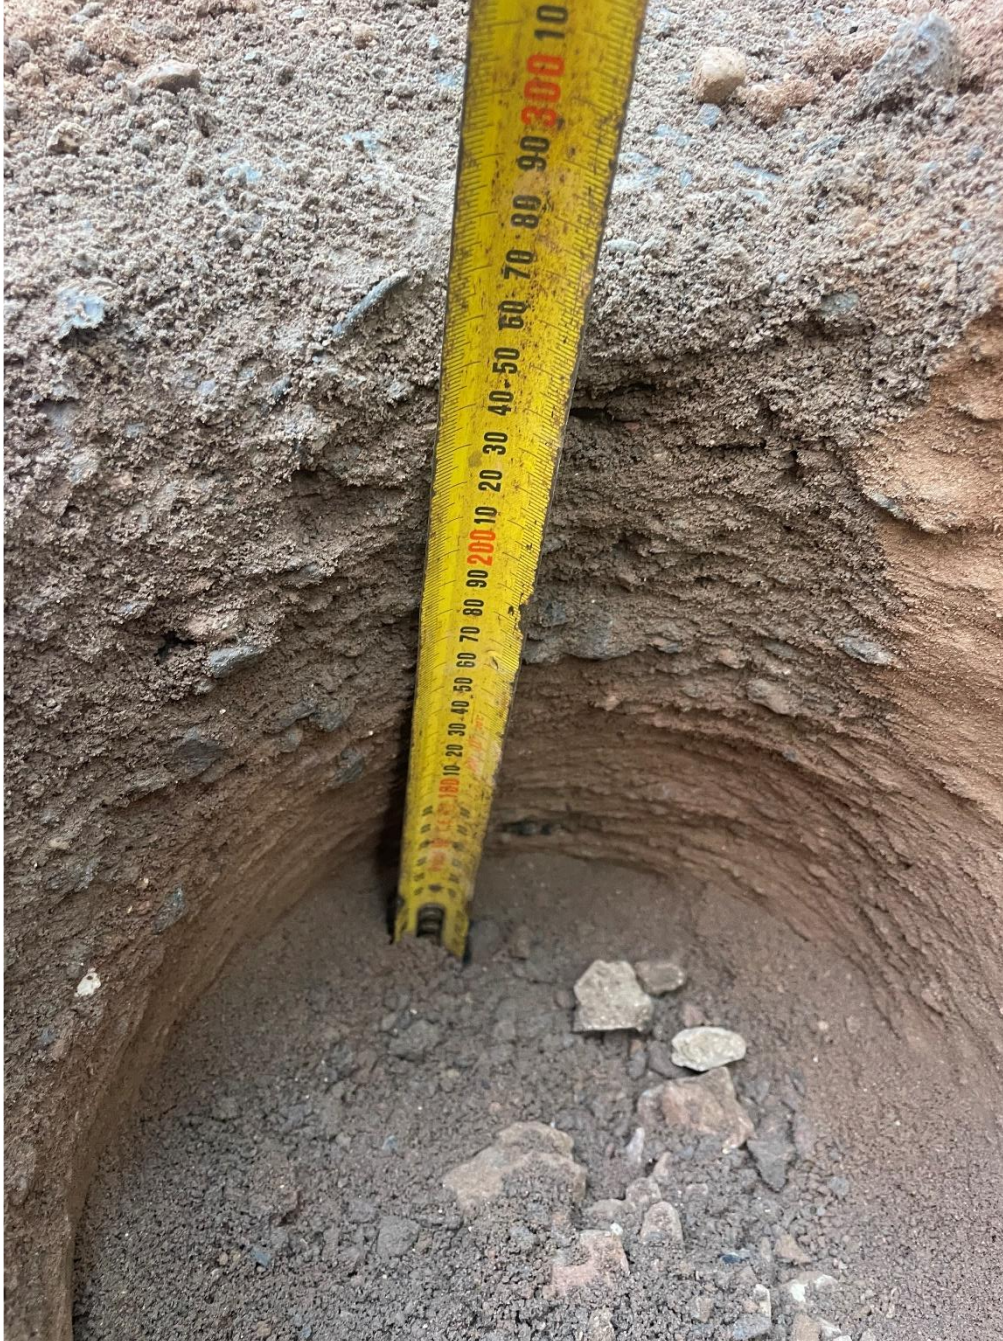
Figure 6 – Showing Borehole 15

Drilling Method	Water	DCP graph	Samples	Depth (m)	Graphic Log	Classification Code	Material Description	Moisture	Consistency/Density	Soil Origin	Remarks
			Bulk								
				0.1		GM	FILL: Silty to sandy GRAVEL, fine to coarse sized, fine to coarse grained sand, grey.	D		Fill	
				0.2		GM	FILL: Silty to sandy GRAVEL, fine to coarse sized, fine to coarse grained sand, brown.			Fill	
			1 bulk			CL-CI	Silty to sandy CLAY, low to medium plasticity, brown / grey, fine grained sand, trace fine sized gravel.	w > PL	St	Residual	
			2bulk								
		2									
		4									
		5									
		5									
		8									
		T									
							BH15 Terminated at 1.2m

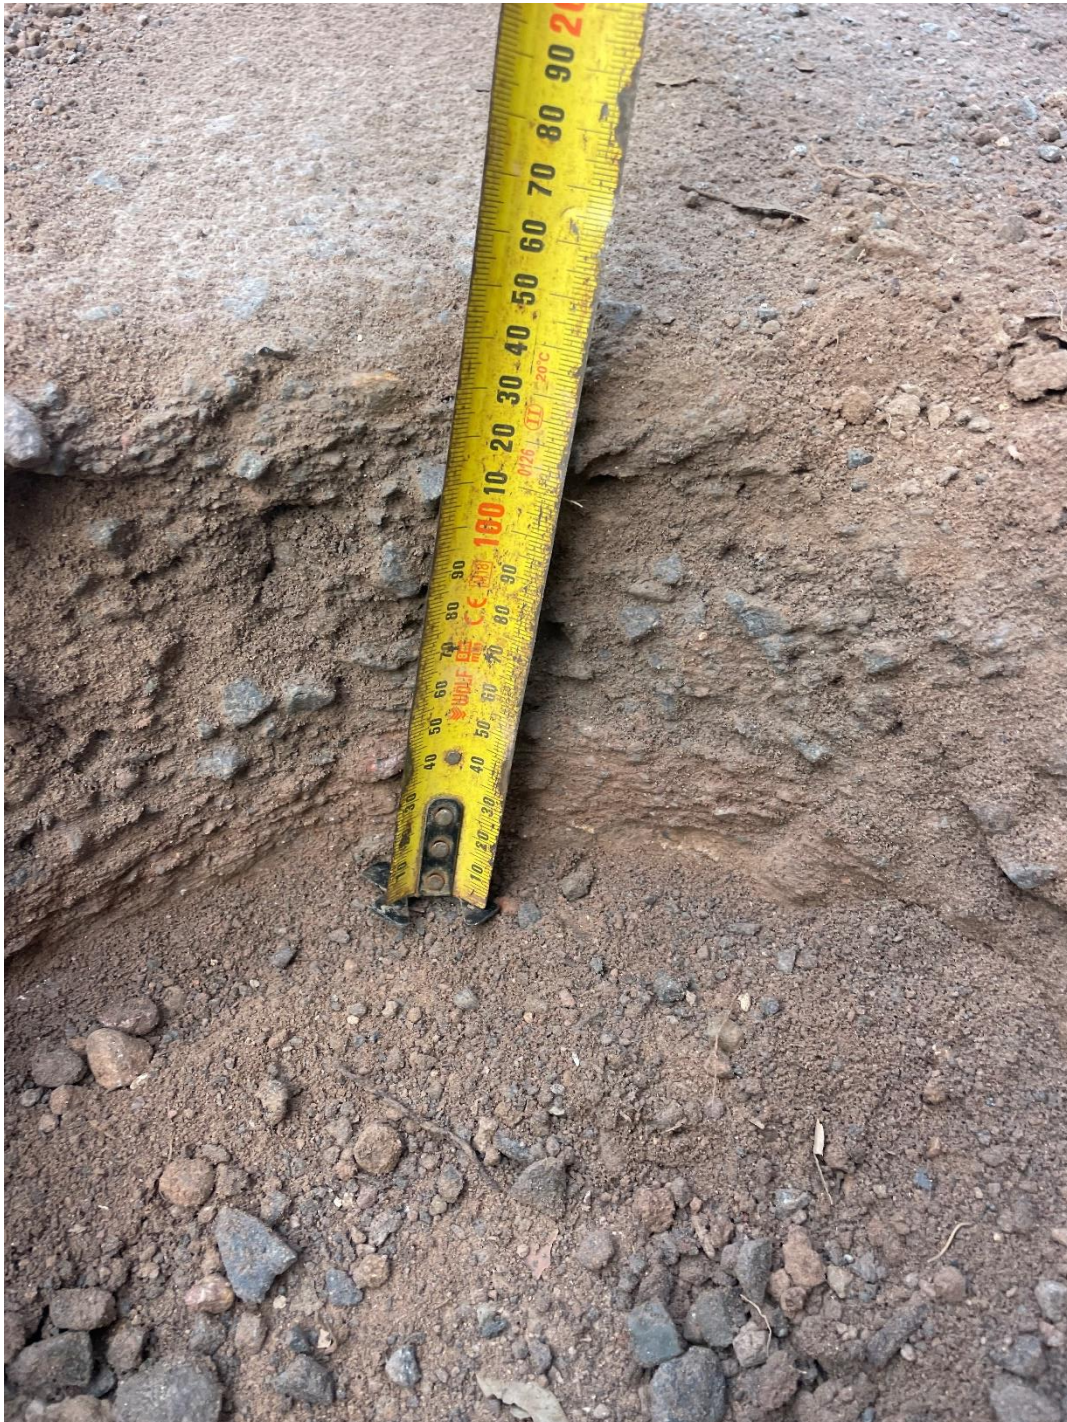
Figure 7 – Showing Borehole 18

Drilling Method	Water	DCP graph	Samples	Depth (m)	Graphic Log	Classification Code	Material Description	Moisture	Consistency/Density	Soil Origin	Remarks
			Bulk								
				0.1		GM	FILL: Silty to sandy GRAVEL, fine to coarse sized, fine to coarse grained sand, grey.	D		Fill	
				0.2		GM	FILL: Silty to sandy GRAVEL, fine to coarse sized, fine to coarse grained sand, brown.			Fill	
		R	1 bulk			SST	Highly weathered SANDSTONE, fine to medium grained, brown orange, indistinct, very low to low strength.		VLS-LS	Rock	
							BH18 refusal at 0.3m

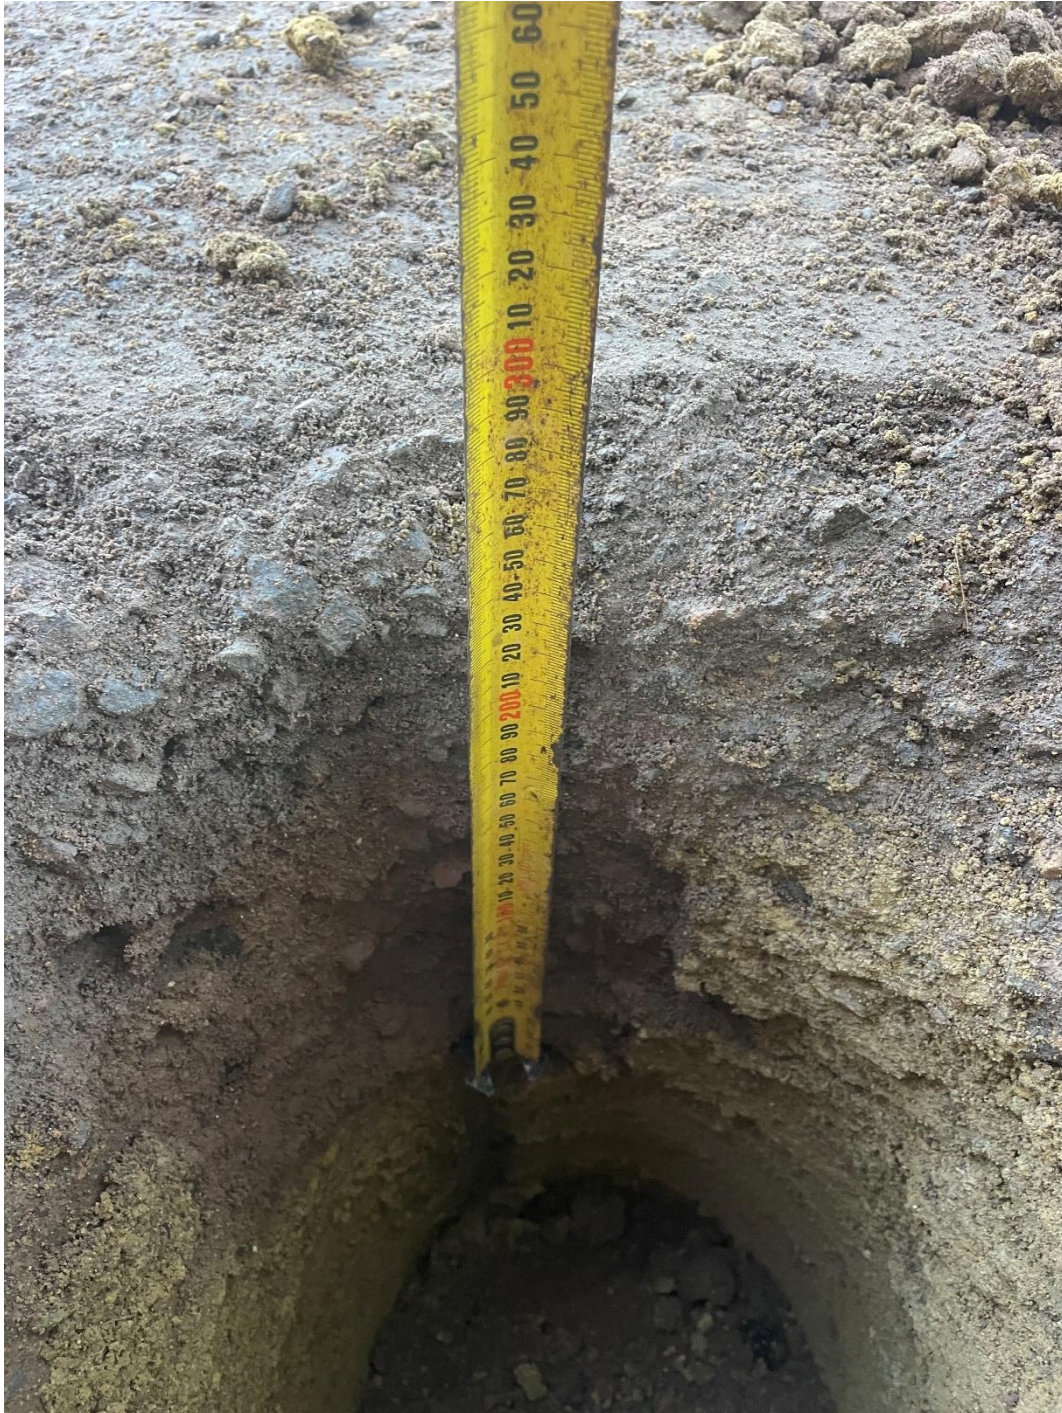
Figure 9 – Showing Borehole 21

Drilling Method	Water	DCP graph	Samples	Depth (m)	Graphic Log	Classification Code	Material Description	Moisture	Consistency/Density	Soil Origin	Remarks
			Bulk								
				0.1		GM	FILL: Silty to sandy GRAVEL, fine to coarse sized, fine to coarse grained sand, grey.	M-D		Fill	
			2 bulk			GM	FILL: Silty to sandy GRAVEL, fine to coarse sized, fine to coarse grained sand, brown.	D		Fill	
		4		0.3		CI-CH	Silty to sandy to gravelly CLAY, medium to high plasticity, grey, fine sized gravel, fine to medium grained sand, with roots.	w > PL	F-St	Residual	
		6									
		6	2 bulk								
		6									
		6									
		9									
		T									
				1		CL	Sandy to gravelly CLAY, low plasticity, brown, fine to medium sized gravel, fine to coarse grained sand.	w ≈ PL	St-Vst	Residual	
							BH21 Terminated at 1.2m

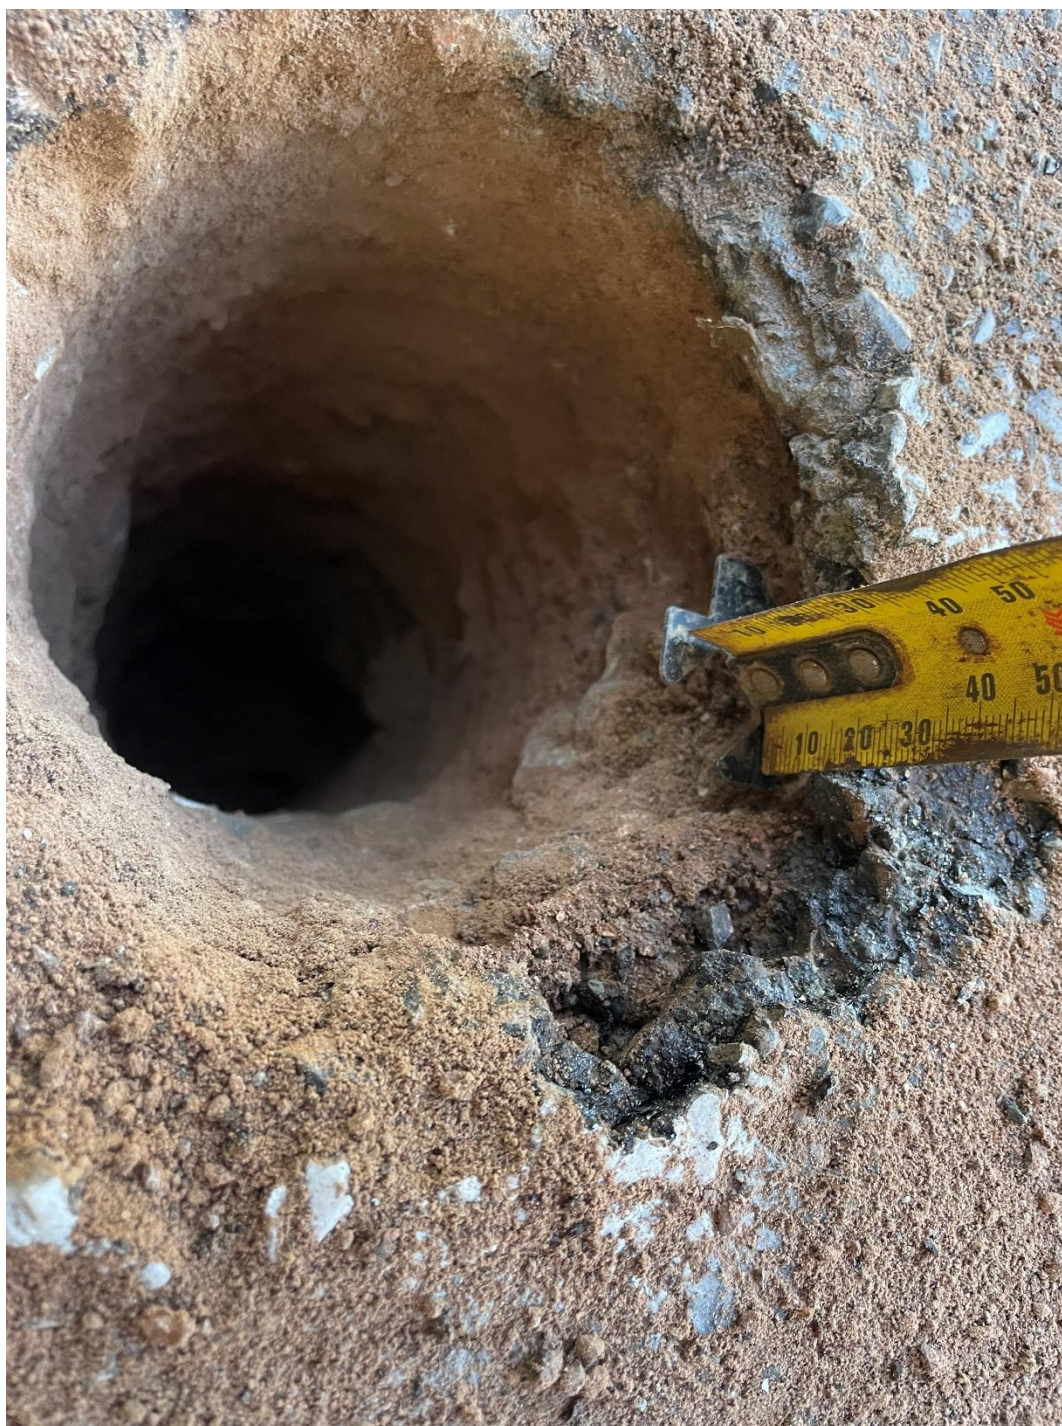
Figure 10 – Showing Borehole 23

CI-CH	Silty to sandy CLAY, medium to high plasticity, grey / brown, fine grained sand.	w > PL	F-St	Alluvial	
		3									
		4									
		4									
		6									
		6		1							
		T									
							BH23 Terminated at 1.2m
