## DETAILED CONTAMINATION SITE INVESTIGATION REPORT

### 1036 Richmond Road, Marsden Park

REPORT No: NE083

DATE: 17 January 2017

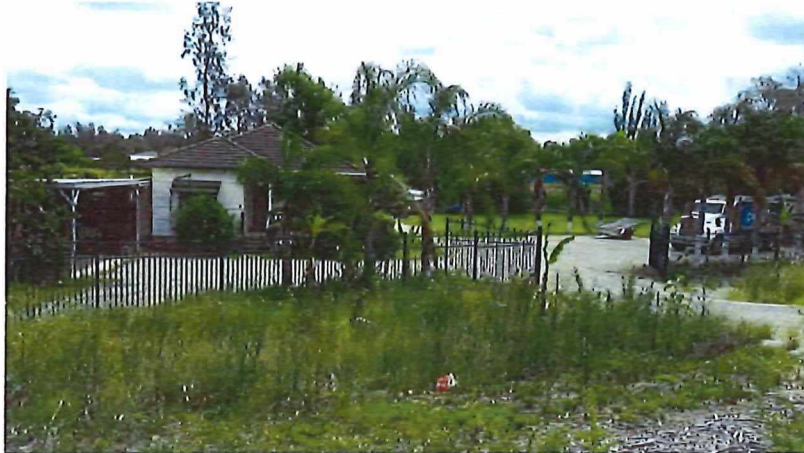
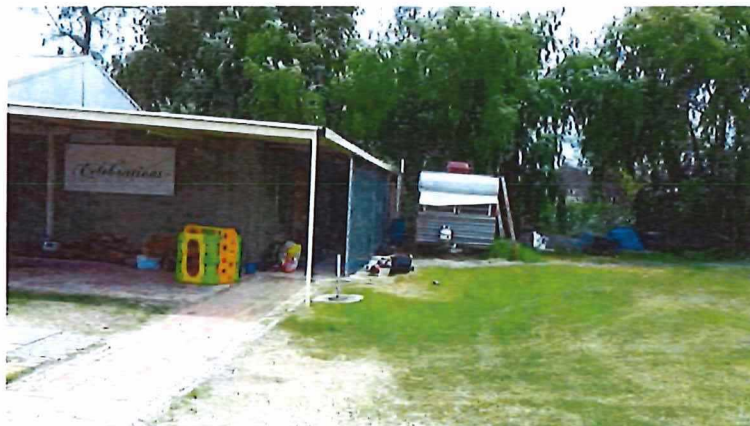
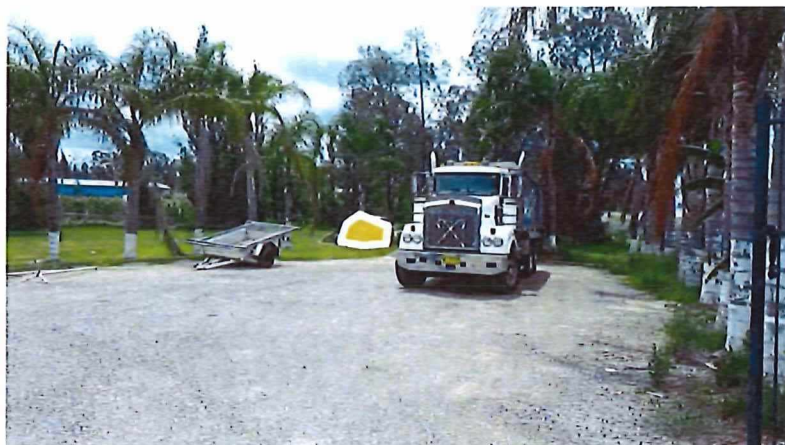
Figure 1: Dwellings, sheds and stockpiles in the site

During the detailed investigation, three sheds and a one storey dwelling were observed onsite. This was identified in the preliminary site investigation as well. There is also some limited stockpiling on the south west boundary of the site neighbouring site 1032 and in the

middle of site. The sampling of these materials will be carried out after the demolition of the buildings and sheds and removal of the stockpiling for validating the site.

- Based on the scope of works undertaken in this investigation, the site is considered suitable for the proposed land use for residential development.
- As described in Section 7.3, additional sampling is required after demolition of the existing building and sheds and removal of the limited stockpiles observed in the site.
