## DETAILED CONTAMINATION SITE INVESTIGATION REPORT

**1032 Richmond Road, Marsden Park**

REPORT No: NE083

DATE: 27 January 2017

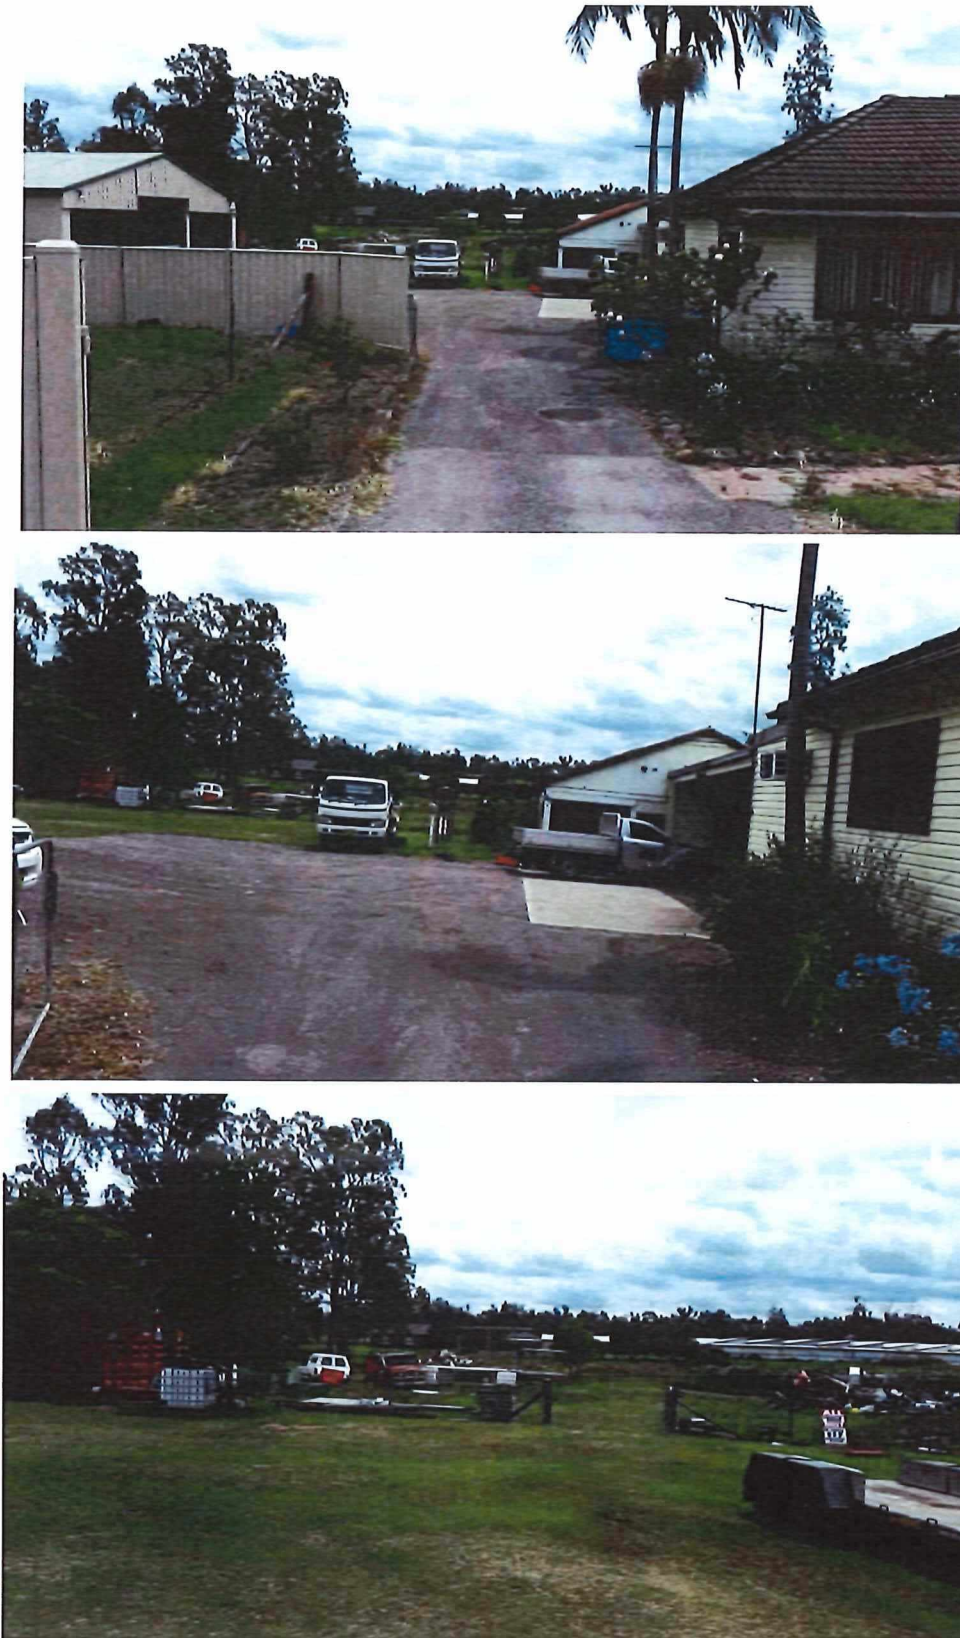
During the detailed investigation, a one storey building, several sheds/chicken sheds, stockpiles, old vehicles and site fillings were observed onsite. This was identified in the preliminary site investigation as well. The sampling of these materials will be carried out

after the demolition of the buildings and sheds and removal of the stockpiling for validating the site.

Figure 1: Dwellings, sheds, stockpiles, old vehicles, and site fillings in the site

- Based on the scope of works undertaken in this investigation, the site is considered suitable for the proposed land use for residential development.
- As described in Section 7.3, additional sampling is required after demolition of the existing building, sheds and removal of the stockpiles, old vehicles and site fillings observed in the site.
