THOMPSON HEALTH HORNSBY

**PROPOSED AGED CARE FACILITY
DEVELOPMENT PROPOSAL**

**ARBORICULTURAL IMPACT
ASSESSMENT REPORT**

Report Ref No- RTC-1520

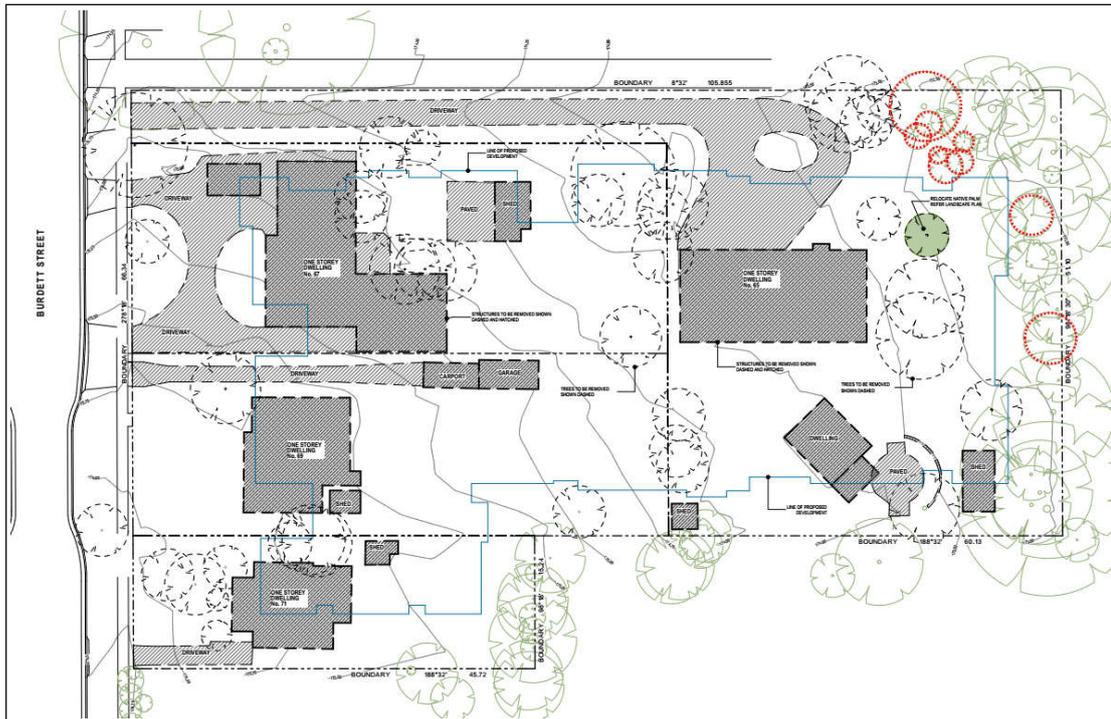
Figure 1, showing proposed demolition & tree removal plan

1.2.1 In summary, the following thirty three (33) prescribed trees require or are recommended for removal to accommodate design.

- T1, 2, 9.1, 10, 11, 12, 14, 16, 17, 18, 19, 20, 21, 57, 58, 59, 60, 60.1, 61, 62, 63, 66, 67, 68, 71, 78, 82, 83, 84, 85, 88, 91 & 98

- Trees which fall within proposed building and road infrastructure footprints, or receive high level SRZ impacts by the designed footprint are identified as trees 1, 9.1, 10, 11, 12, 14, 16, 19, 20, 21, 82, 83, 84, 85, 91 & 98.

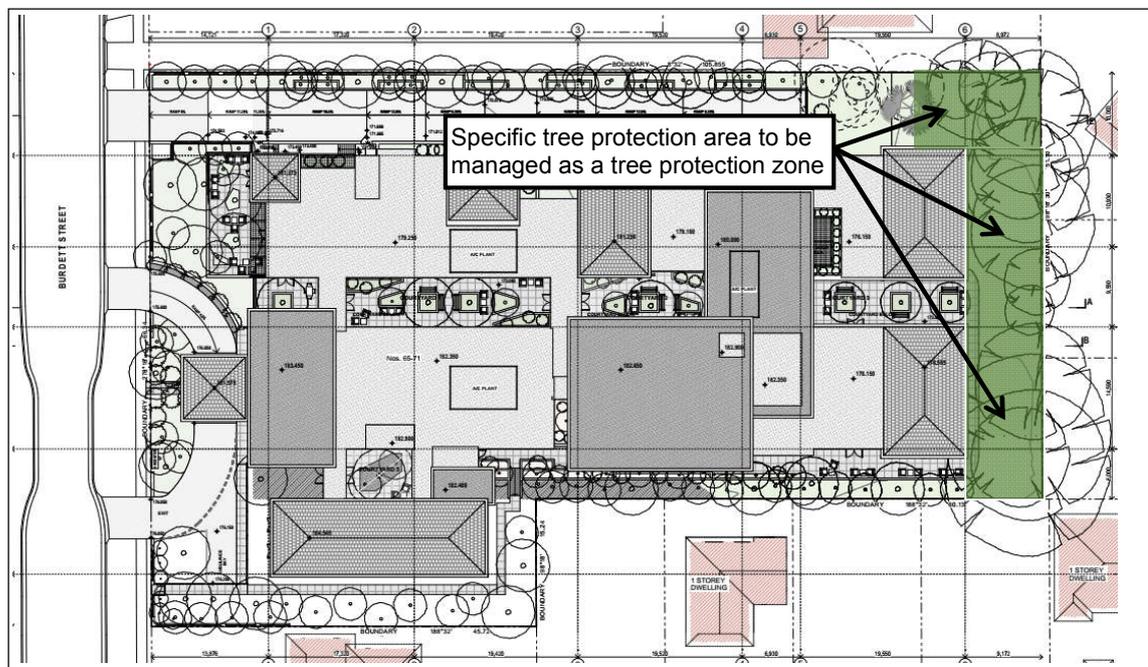
Figure 2, showing development footprint & specific tree protection area

1.3.4 A specific tree protection and management area has been provided for trees located along the northern boundary where an 8m building setback is proposed. The 8m setback is to be considered a tree protection area (TPA) where direct project arborist advice including site supervision for tree protection, fence & ground management (irrigation & mulching) is to be installed and certified prior to demolition and basement excavation.

1.3.5 Those trees identified as having low level impacts where the 8m building setback is located outside of tree protection zones are identified as trees 64, 69, 70, 71, 72, 73, 74, 75, 76, 78.1, 80, 81, 86, 87, 89, 92.1, 92.2 & 95. Of these trees T71 is recommended for removal as exposure by loss of adjacent trees and degrading (dead & decaying) anchoring root zone will eventually result in collapse of the dead tree.

Excluding minor above ground pathways and infrastructure trees receiving Minor and manageable (10% to <15%) building encroachment within TPZ's are identified trees 77, 79, 92, 90, 93, 94 & 95.

Tree 96 encounters the highest TPZ disturbance which includes coverage by minor pathway infrastructure. The overall TPZ disturbance is still considered somewhat minor and manageable (<10%) as an existing garage is located within the trees 12m TPZ. The hard surface and garage foundations may have restricted radial root development towards the building footprint having the ability to minimise the overall TPZ disturbance.

- Within the fenced tree protection area irrigation and mulching of the entire protection zone shown in Figure 2 is recommended.
 - The fenced tree protection area is to be considered a development exclusion zone where no site access or modification of site conditions are to occur without prior arborist advice.
