6 October 2021

WRL Ref: WRL2021082 JTC LR20211006

## **Coastal Engineer's input/advice regarding cliff erosion, 22c Burran Street, Mosman**

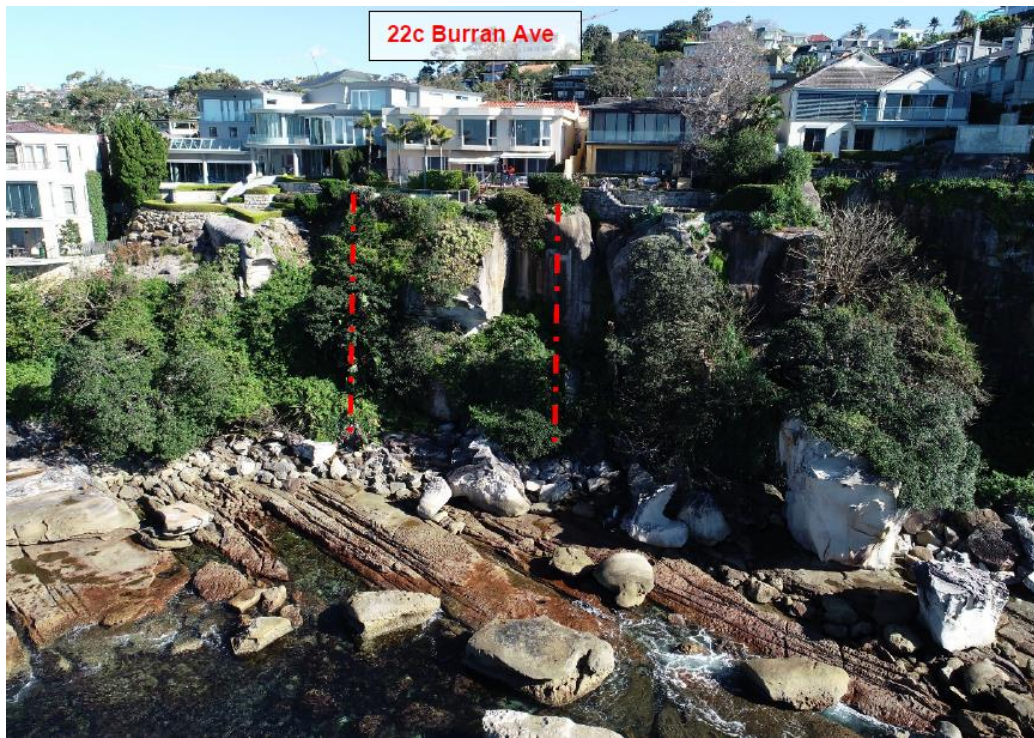
3. The cliff face at the subject property is predominantly sandstone and is fronted by a wave cut platform (Figure 3, Figure 4). The surface of this platform is approximately 20 m in width. The landward portion of the platform is predominantly armoured with rock boulders from previous cliff face collapses (Figure 4, Figure 5, Figure 6). The rock boulders are highly variable in size, ranging from 0.5 m in places, but typically 1 m, with blocks of more than 3 m in places. The rock boulder apron provides a degree of protection to the base of the cliff from further wave attack over planning periods of 50 to 100 years.

**Figure 4: Oblique aerial view (GHD, 2020)**

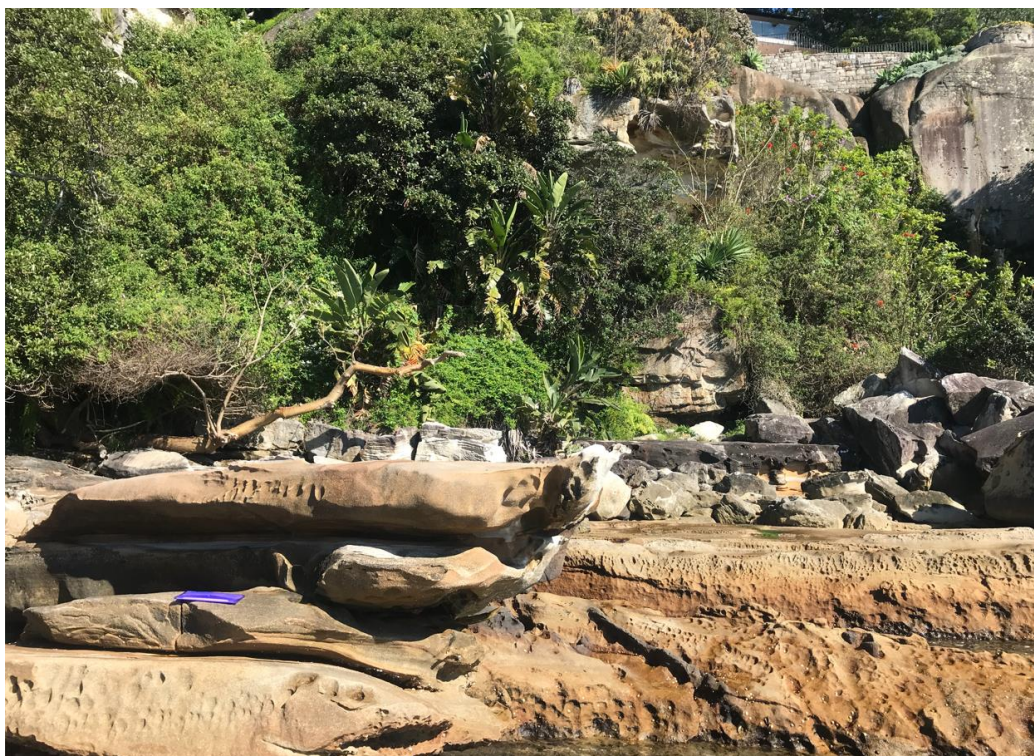
20. Wave runup from ocean swell may occasionally impact the siltstone band, causing increased erosion. Further detailed modelling and calculations are possible to quantify this. As per Figure 5, the existing vegetation extends below the siltstone band, indicating that substantial wave runup to the siltstone band is infrequent, possibly less than approximately once per year. Wave runup events reaching the siltstone band would only persist for a short duration (1 to 2 hours) around the peak of high tide.

**Figure 5: Vegetation line and armour**

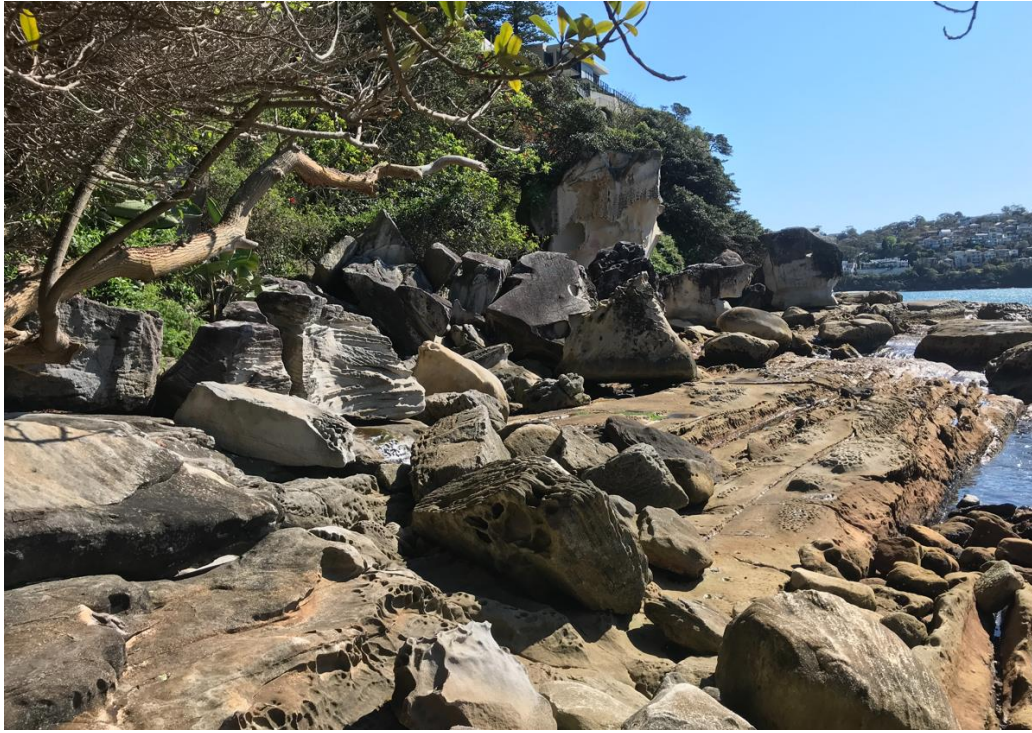
**Figure 6: Armour at base of cliff**

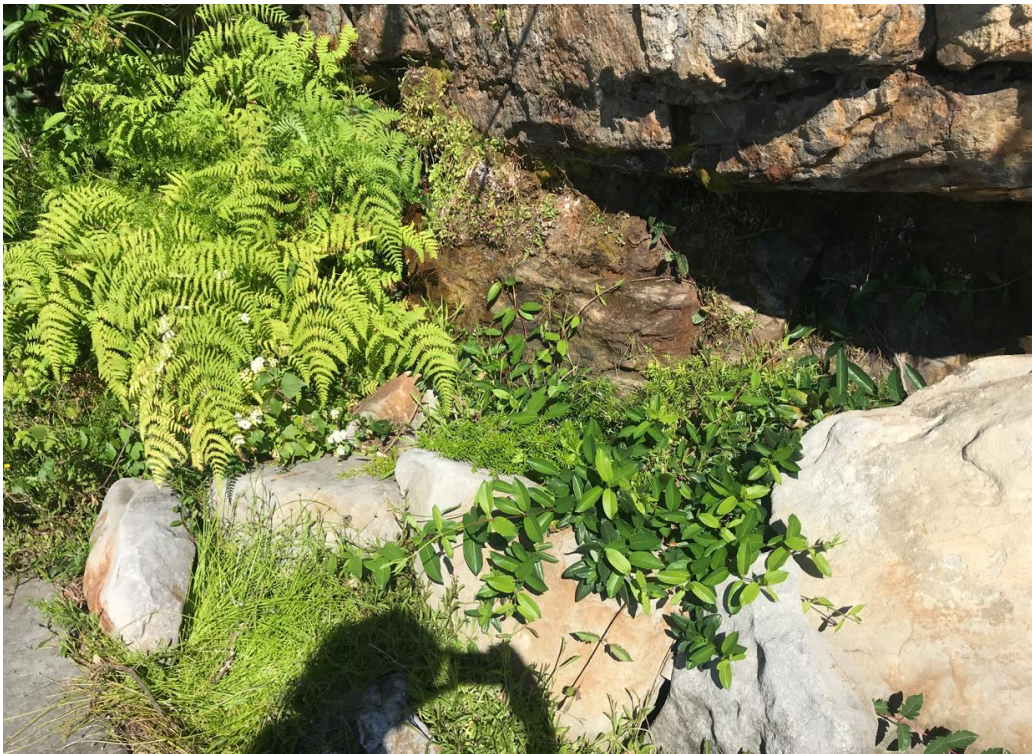
4. Approximately 2.8 m AHD (Australian Height Datum, which is approximately mean sea level), there is a band of siltstone within the sandstone (Figure 7, Figure 8). This siltstone band extends vertically approximately 0.5 to 1 m. The siltstone band is broadly flush with the sandstone cliff face at the northern and southern extremities of the subject site, however, there is an overhang with a small cave in the centre of the subject property's cliff frontage (Figure 7).
5. The presence of vegetation to below the level of the siltstone band indicates that waves reach this band with any force on an infrequent basis – less than once per year.

**Figure 7: Overhang of siltstone band in middle of site**

23. Due to the small spatial extent (0.5 to 1 m vertical extent) of the siltstone band, if increased undercutting is observed in the future, structural hardening would be relatively straightforward subject to geotechnical input. It is recommended that ongoing inspections and monitoring of the cliff face and the siltstone band be undertaken at 5 to 10 year intervals.

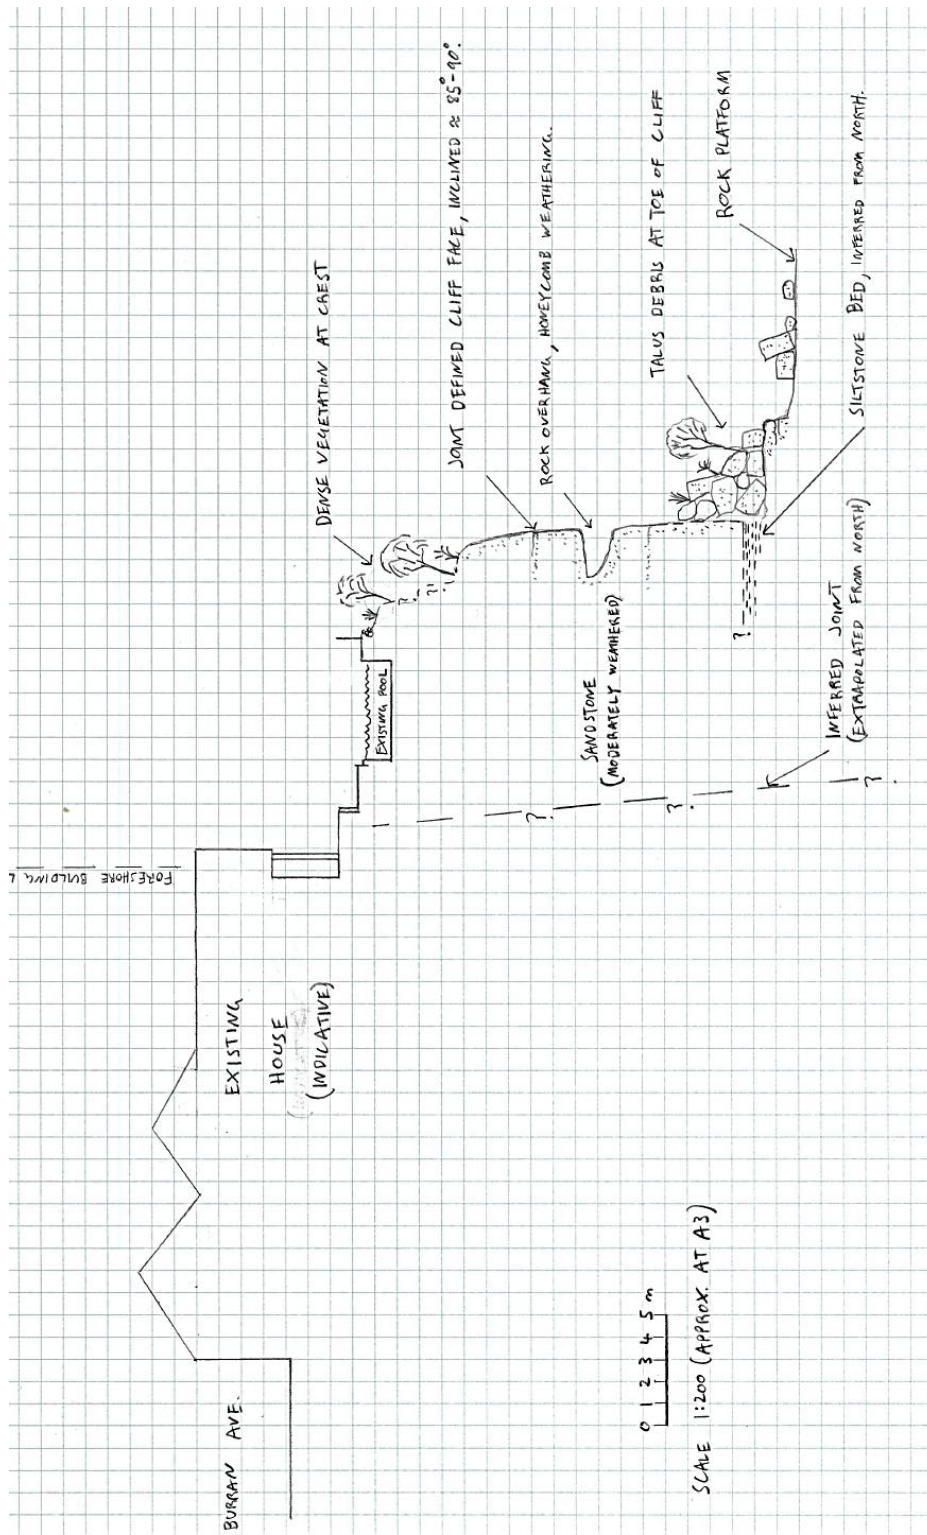
Figure 8: Sketch of cross section (GHD, 2020)

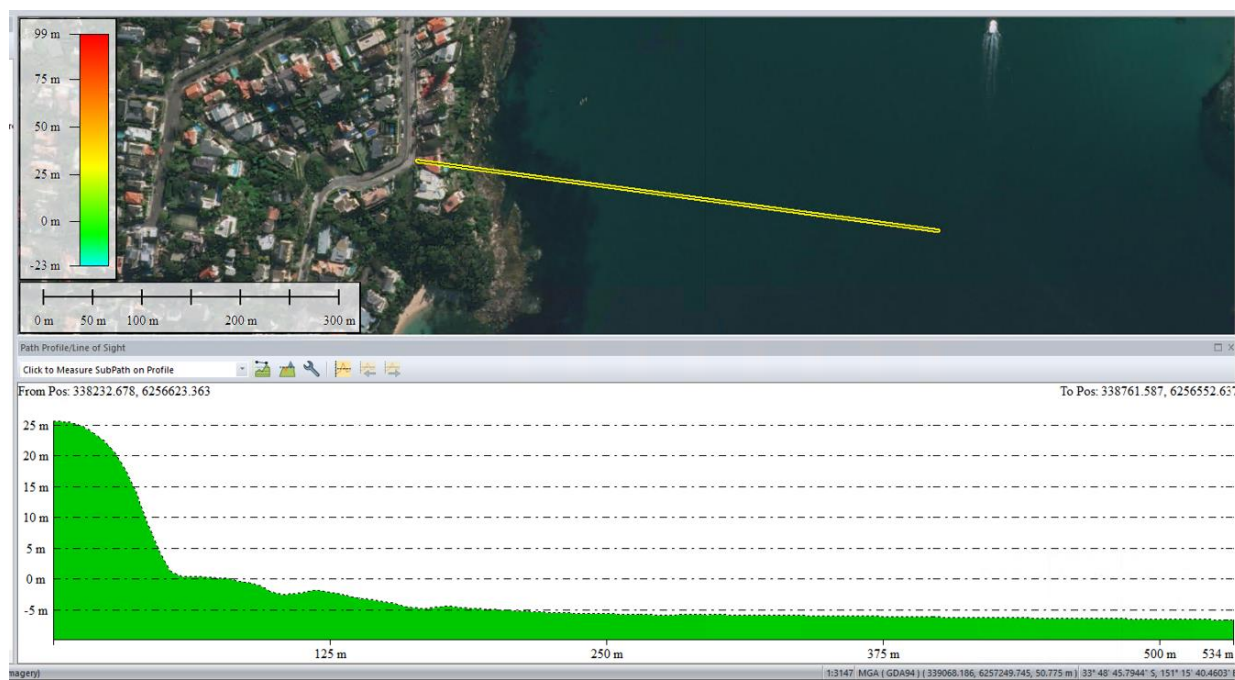
21. A profile offshore from the site from the NSW Government's 5 m bathymetric LiDAR survey is shown in Figure 10. This shows that the seabed offshore from the subject property is shallow and gently sloping. It does not drop into deep water. The combination of a shallow and gently sloping seabed with the 20 m wide platform limits the ability of large waves to directly impact the cliff face.

**Figure 10: Bathymetric profile offshore from site**
