## **Preliminary Site Investigation Environmental Site History**

**Lots A DP 150057, B 150057, 1 DP 516621, 33  
DP 1138201**

148 Rouse Street, Tenterfield, NSW, 2372

**Prepared for Jack Thomas, Nutrien  
Harcourts**

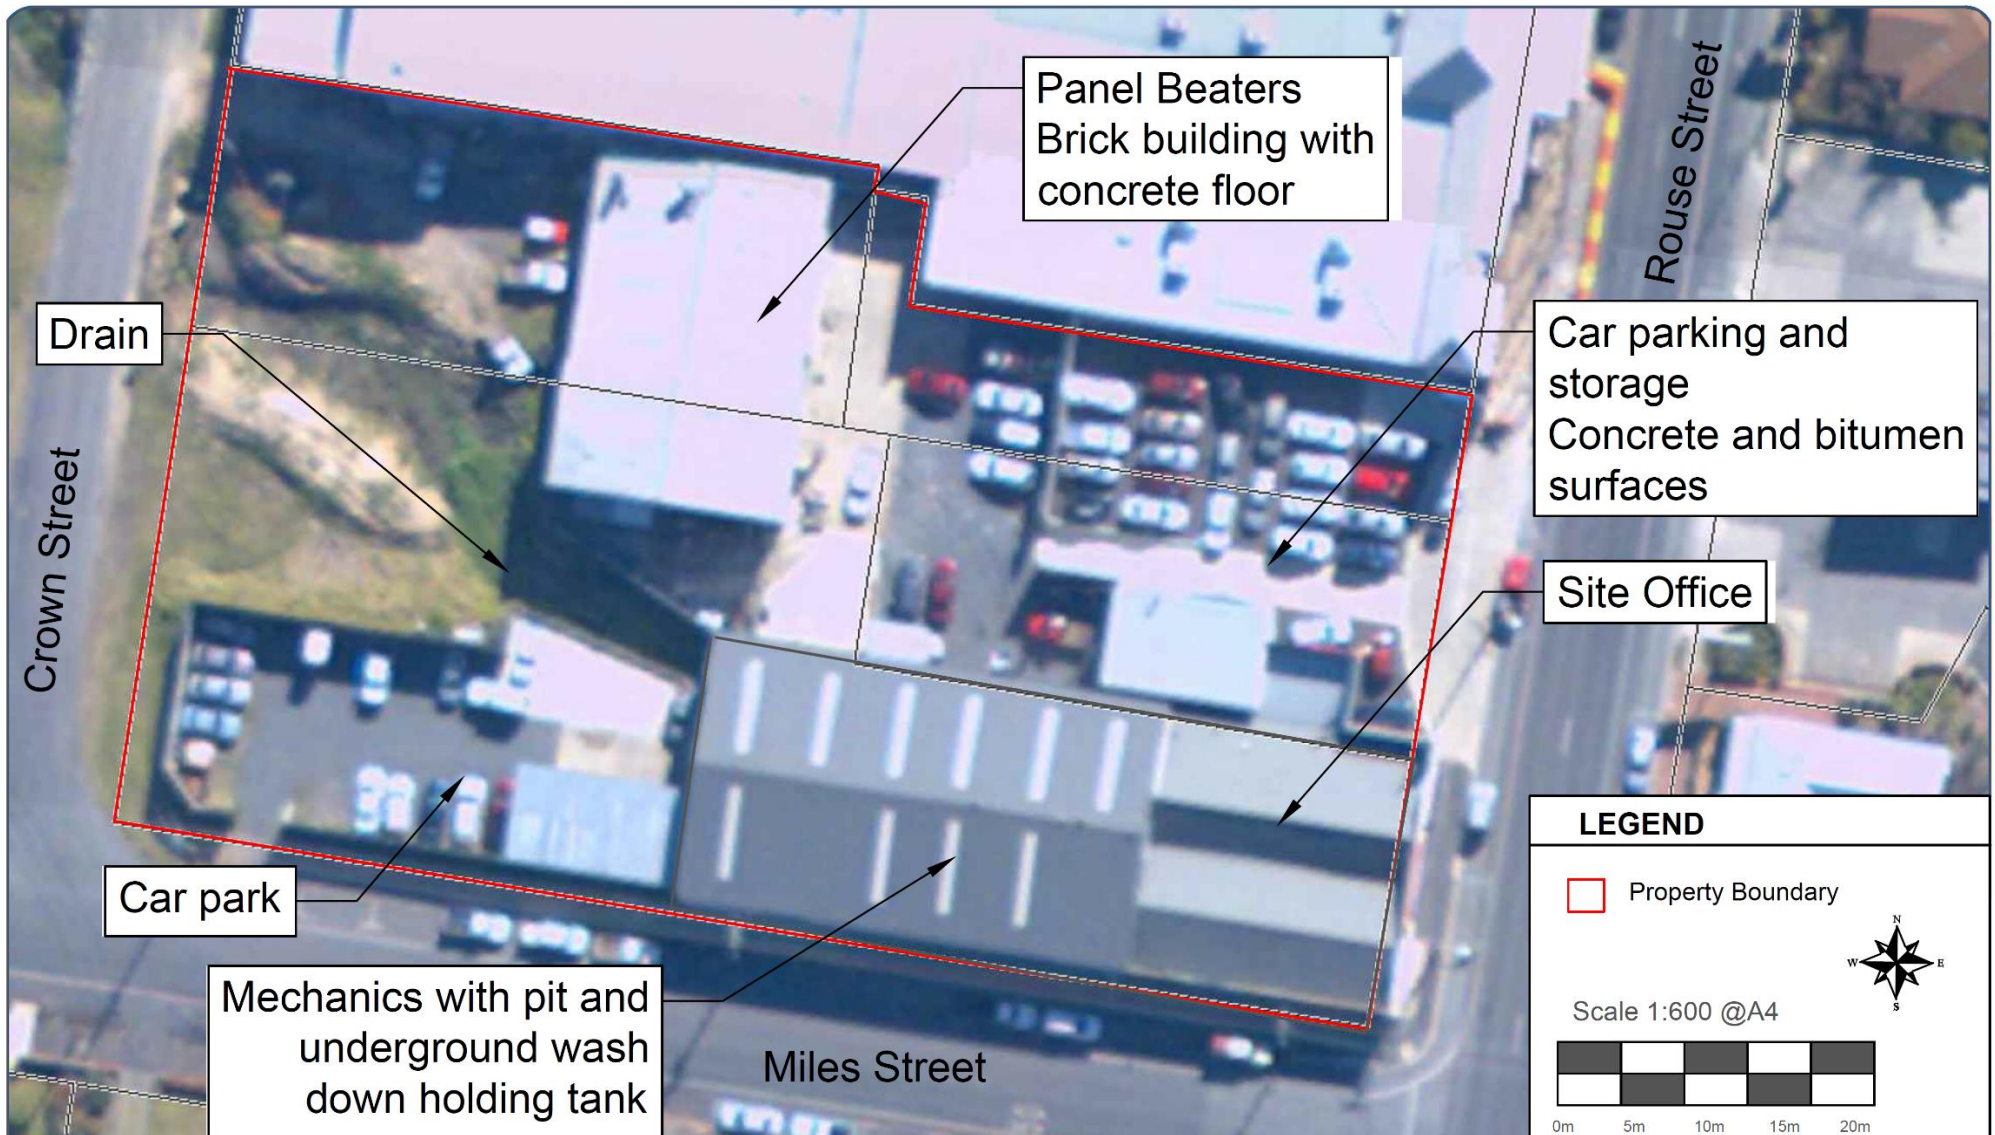
Contaminating Infrastructure has been identified on the site map in **Appendix A**.

- Mechanic Pit (4.3m x 1.2 m x 1.8 m deep)
- Wash down treatment pit (location unknown)
- Internal wash down drains
- Car parking area

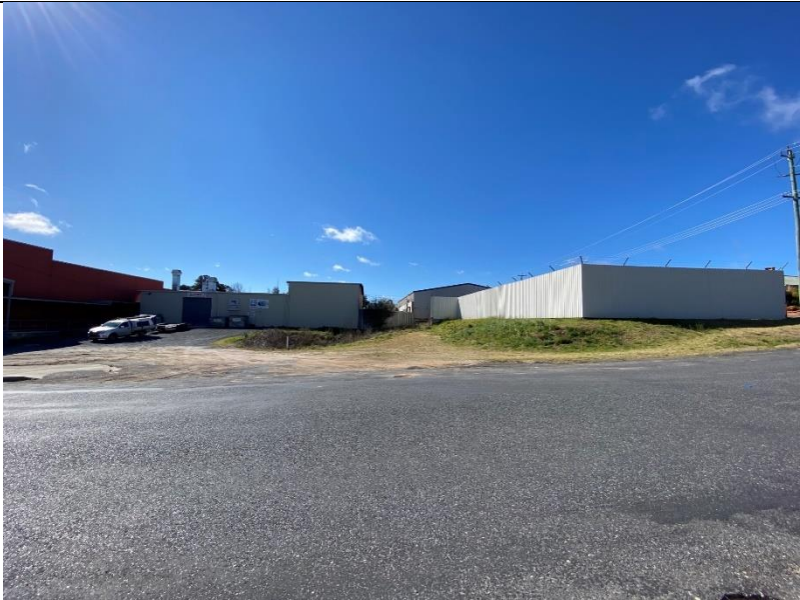
| | <p><b>Plate A- 24/08/2021</b><br/>Wester Workshop (Panel beaters). View Northern western corner of the site looking east.</p> |

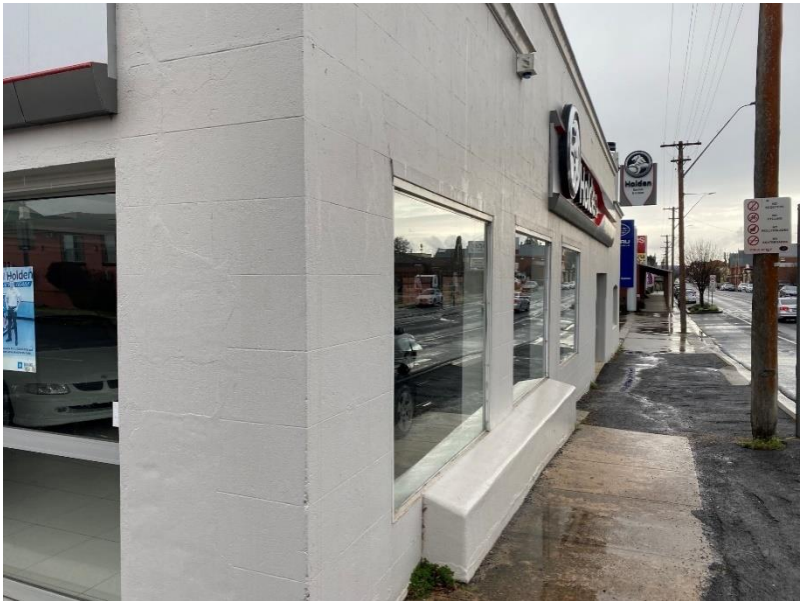
| | <p><b>Plate B- 24/08/2021</b><br/>Sexton and Green building. South-eastern corner. Looking north.</p> |

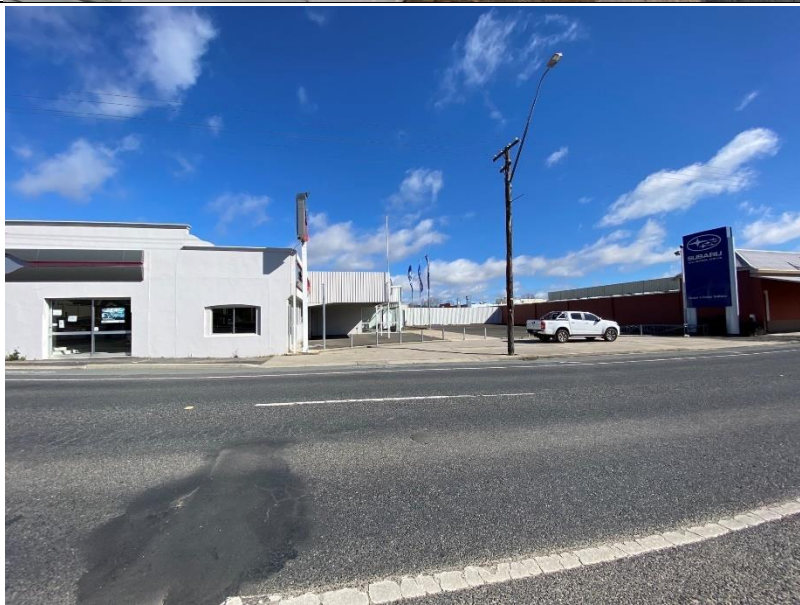
| | <p><b>Plate C- 24/08/2021</b><br/>Sexton and Green building and north-eastern car park. Looking west</p> |

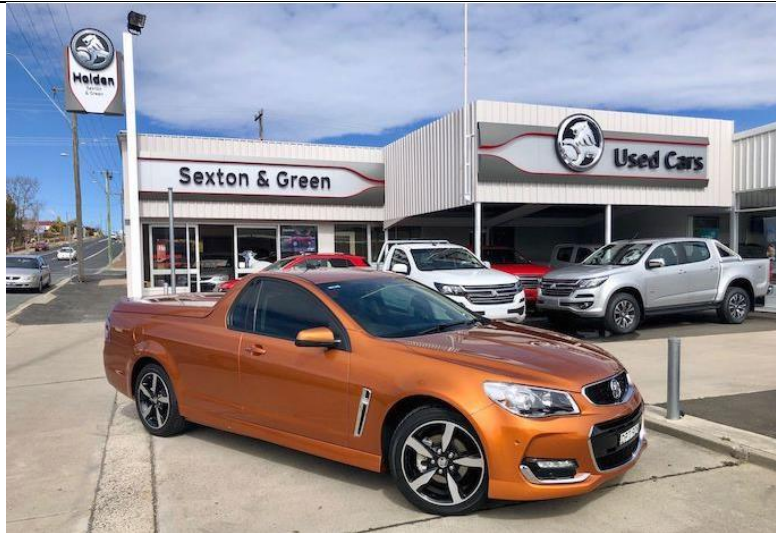
**Plate D- 24/08/2021**  
Sexton and Green building and north-eastern car park. Looking south.

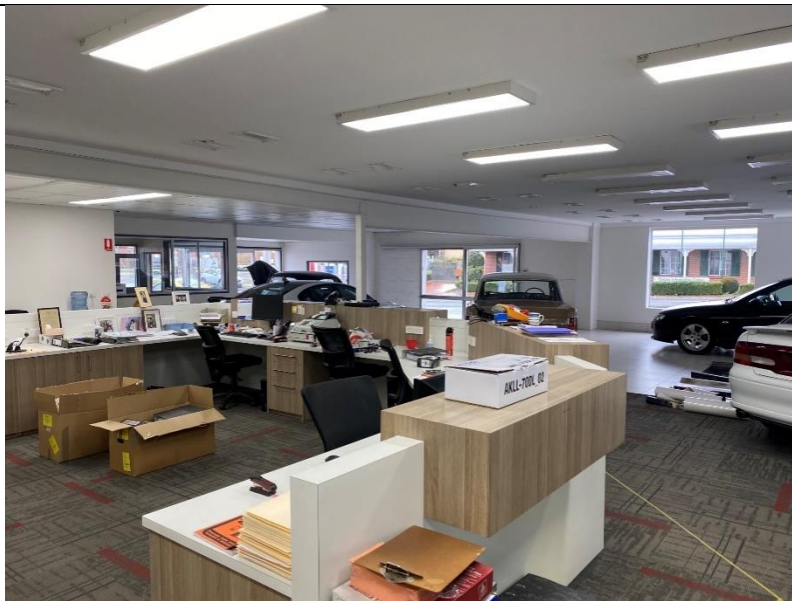
**Plate E- 24/08/2021**  
Sexton and Green building-offices/show room.

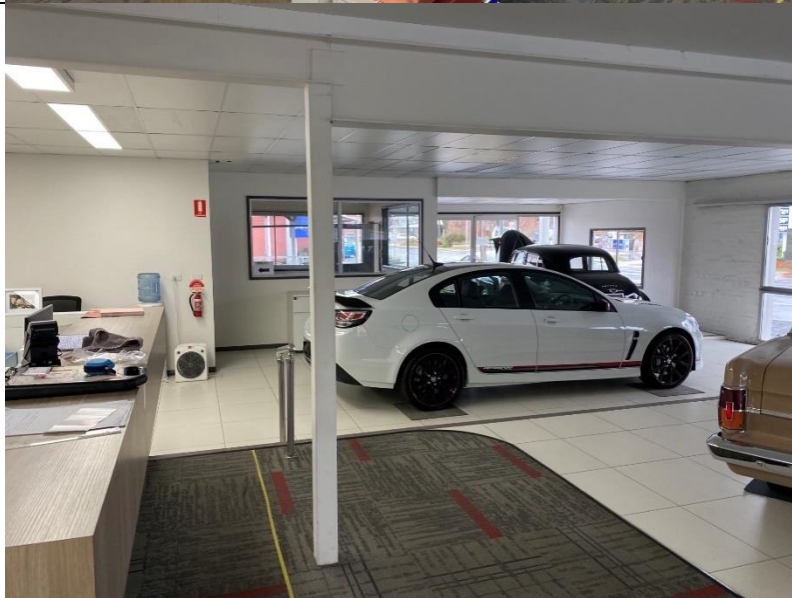
**Plate F- 24/08/2021**  
Sexton and Green building-offices/show room.

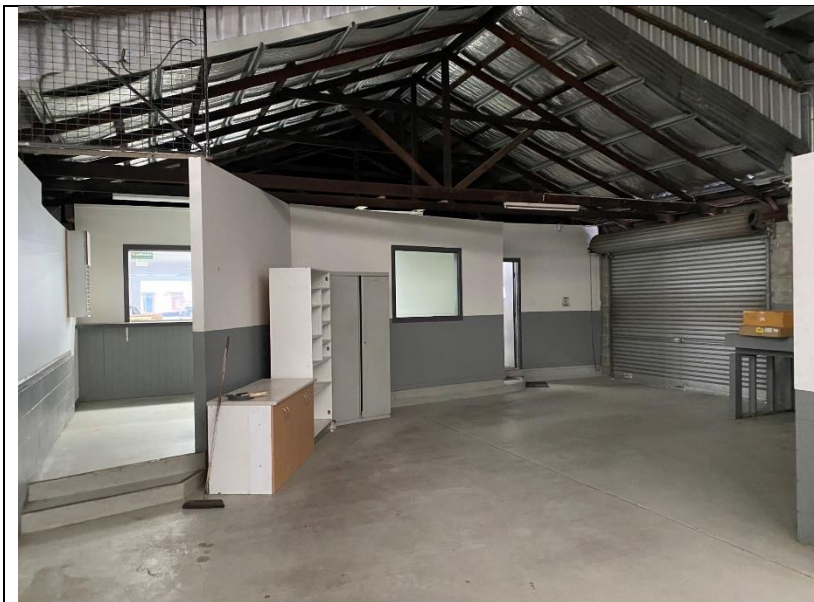
**Plate J- 24/08/2021**  
Sexton and Green building.  
Mechanics. Office space.
