REPORT TO
SIT FAMILY PTY LTD

ON
GEOTECHNICAL ASSESSMENT

FOR
PROPOSED RESIDENTIAL DEVELOPMENT

AT
22C BURRAN AVENUE, MOSMAN, NSW

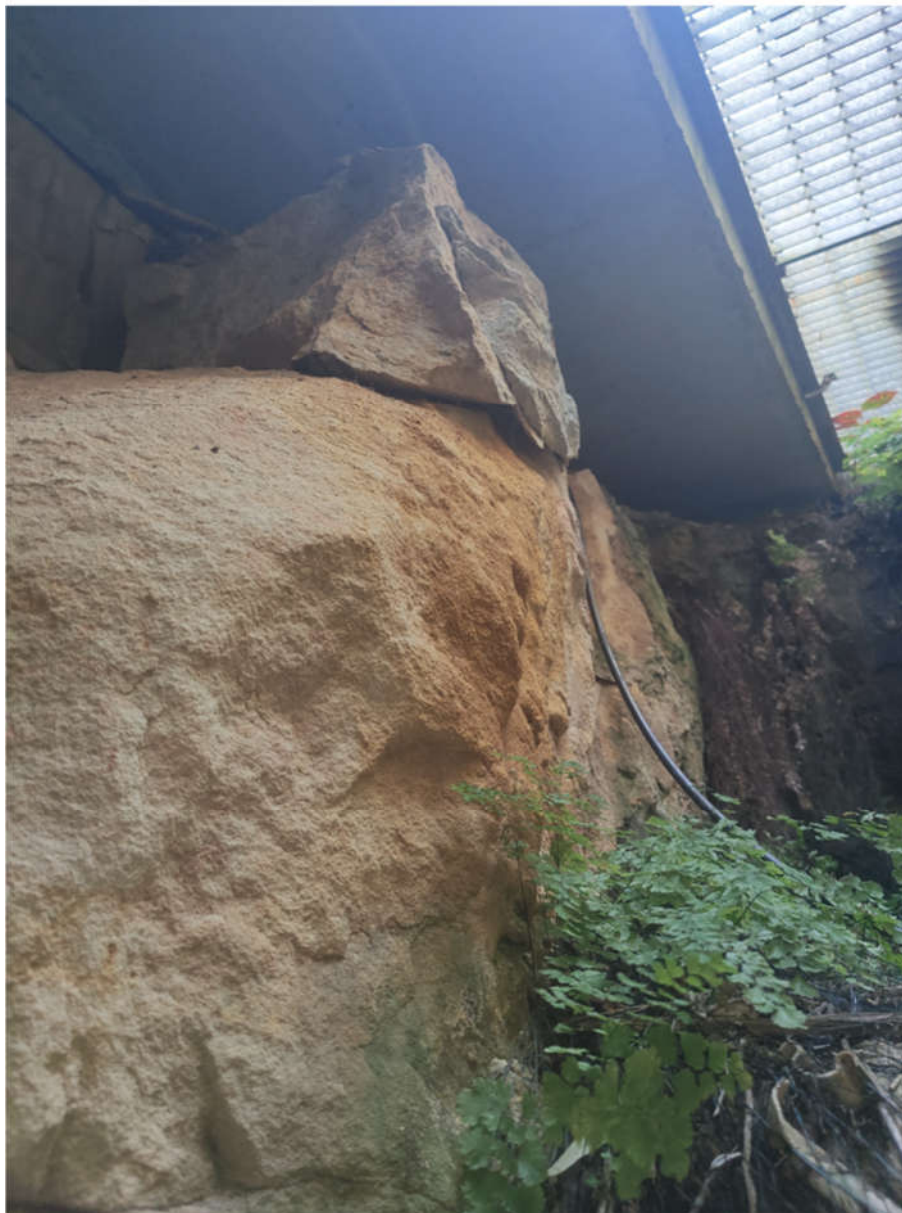
The house has been cut into the hillside. As a consequence of this there is a sandstone cutting runs across the site in a north-west to south-east direction between CH. 12m and CH.15m and ranges in height from about 2m to 3m. The cut also extends to the east and rear of the site along the northern and southern boundaries between CH. 12m and CH.20m and CH. 15m and CH. 18m, respectively. The materials exposed in the face of the sandstone cutting were assessed to be slightly weathered and of medium strength. We observed 4 bedding partings, generally horizontal, with exception to one which was between about 10° and 20°. A loose boulder was observed above the crest of the cut at Ch. 15m.

Plate 1a - Block of Rock (Boulder size) at Crest of Sandstone Cutting (Southern Boundary)

In the early stages of construction, we recommend that any loosened blocks of rock at the crest of the existing cut near the southern boundary be removed and that test pits be excavated along the boundaries to confirm the footing details of the existing boundary walls and retaining walls. Where these are not founded on sandstone bedrock of at least low strength, underpins may be required. The structural engineer should detail

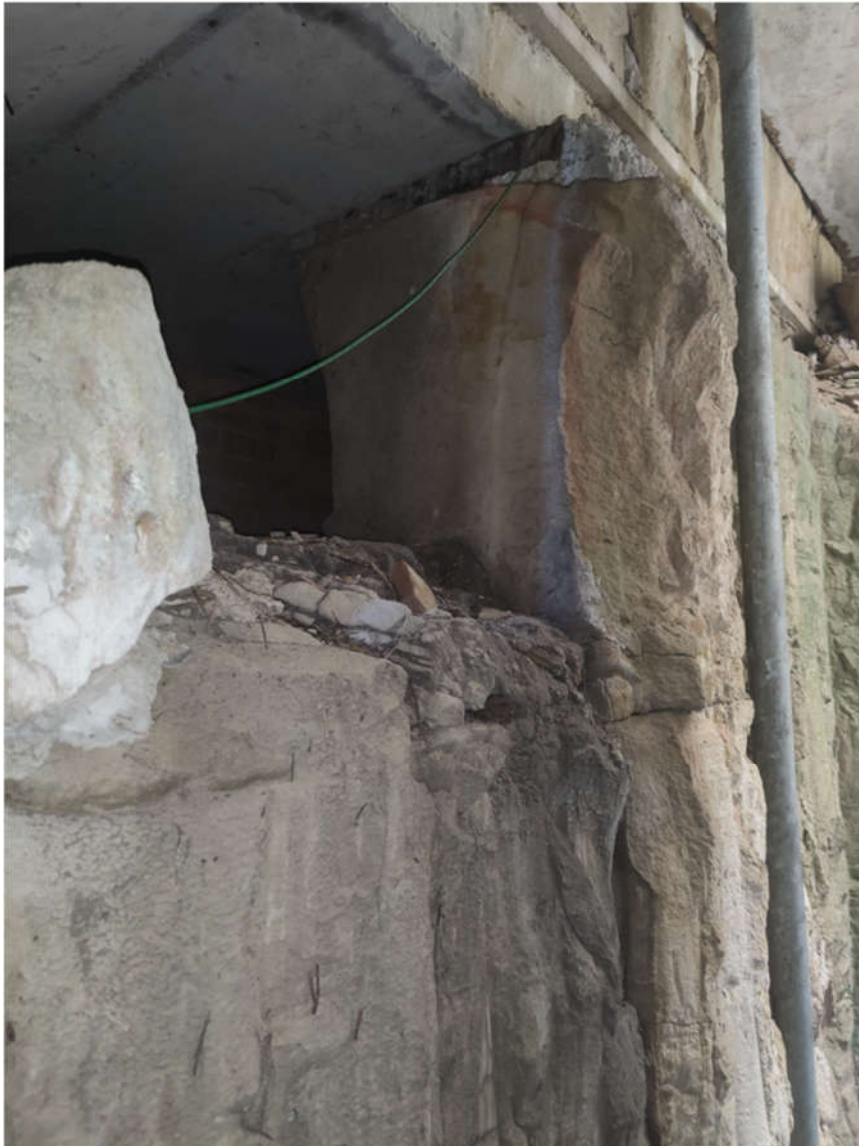
Plate 1b – Plinth of Rock along Sandstone Cutting (Southern Boundary)

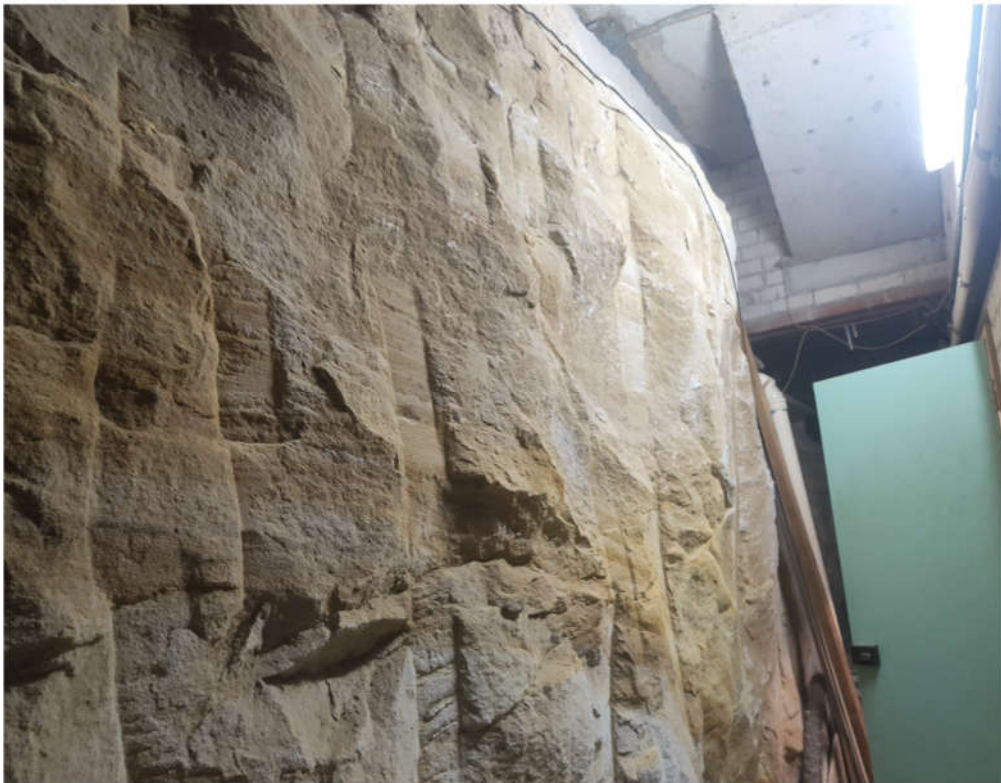
Plate 1c –Sandstone Cutting (Central)

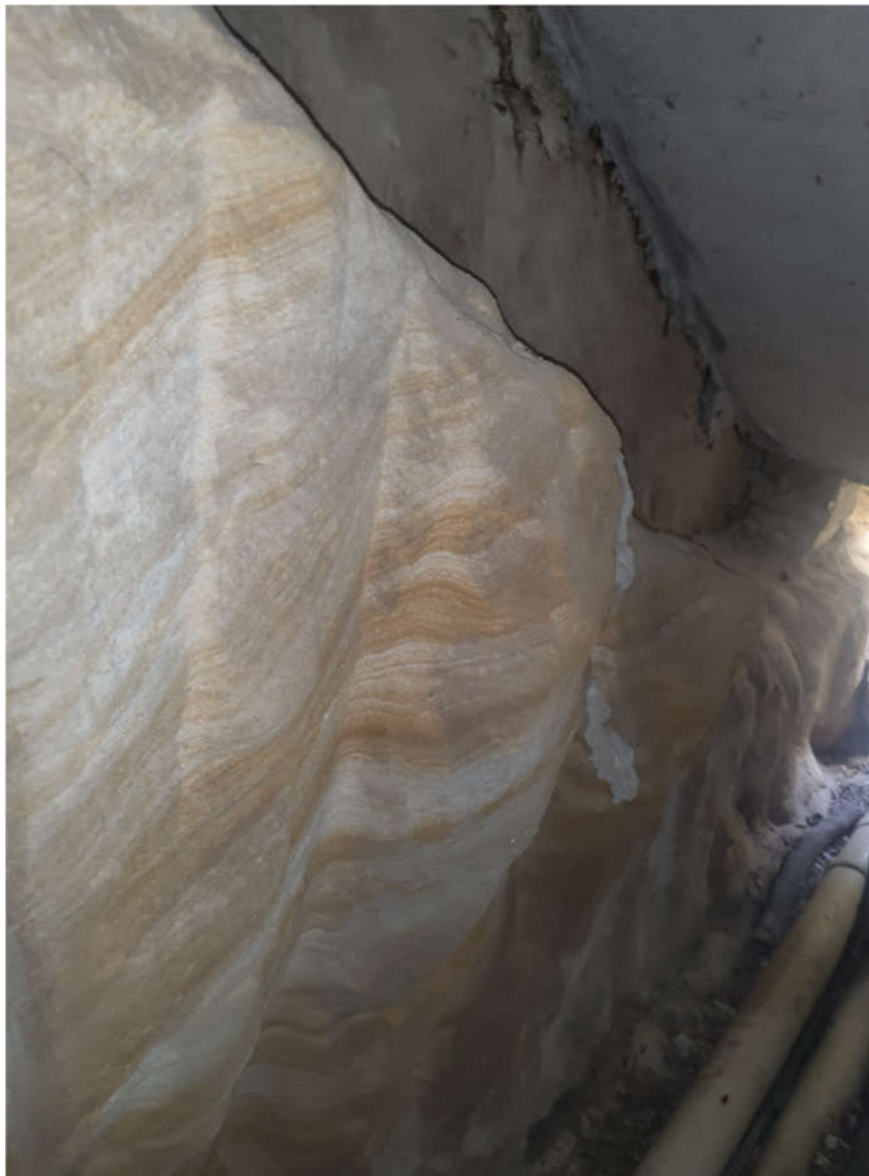
- CH. 12.5m to CH. 15.5m: Above the cut a 0.6m to 1.1m high brick and concrete retaining wall has been constructed and supports the property to the north. The concrete wall appears to be propped by the suspended stairway and appears in good condition.

Plate 1d –Sandstone Cutting and Retaining Wall Above (Northern Boundary)

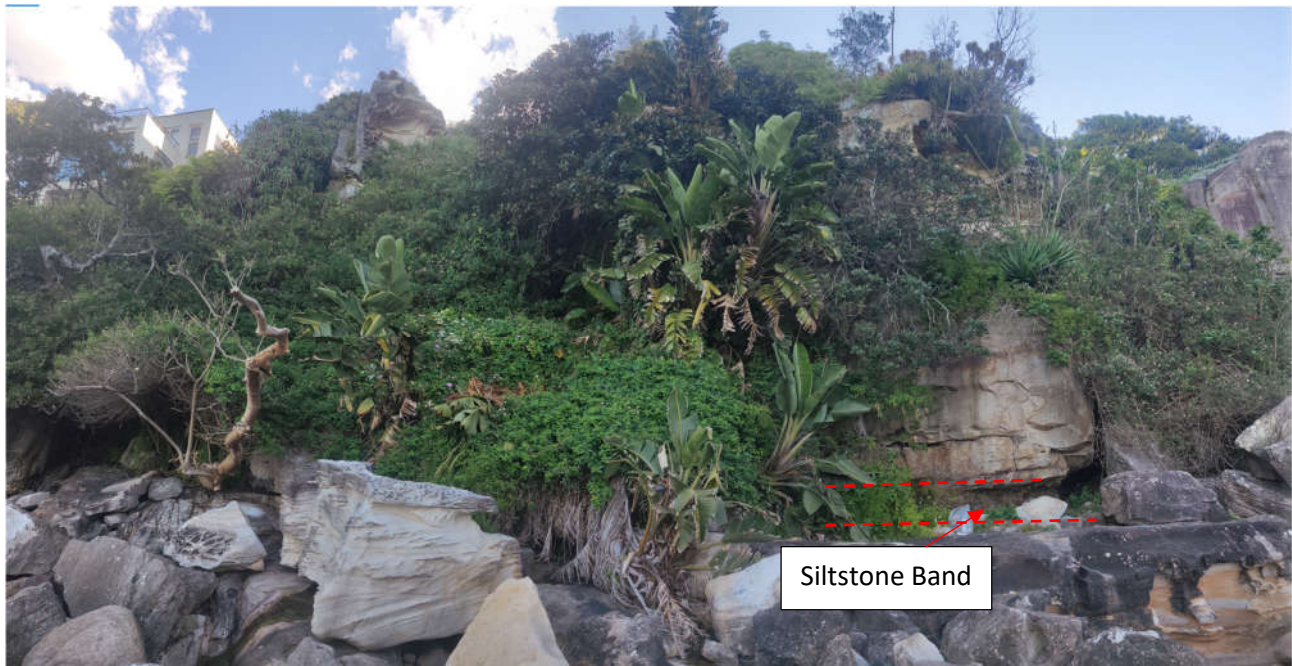
Plate 2: Siltstone Band at Base of Cliff-Line

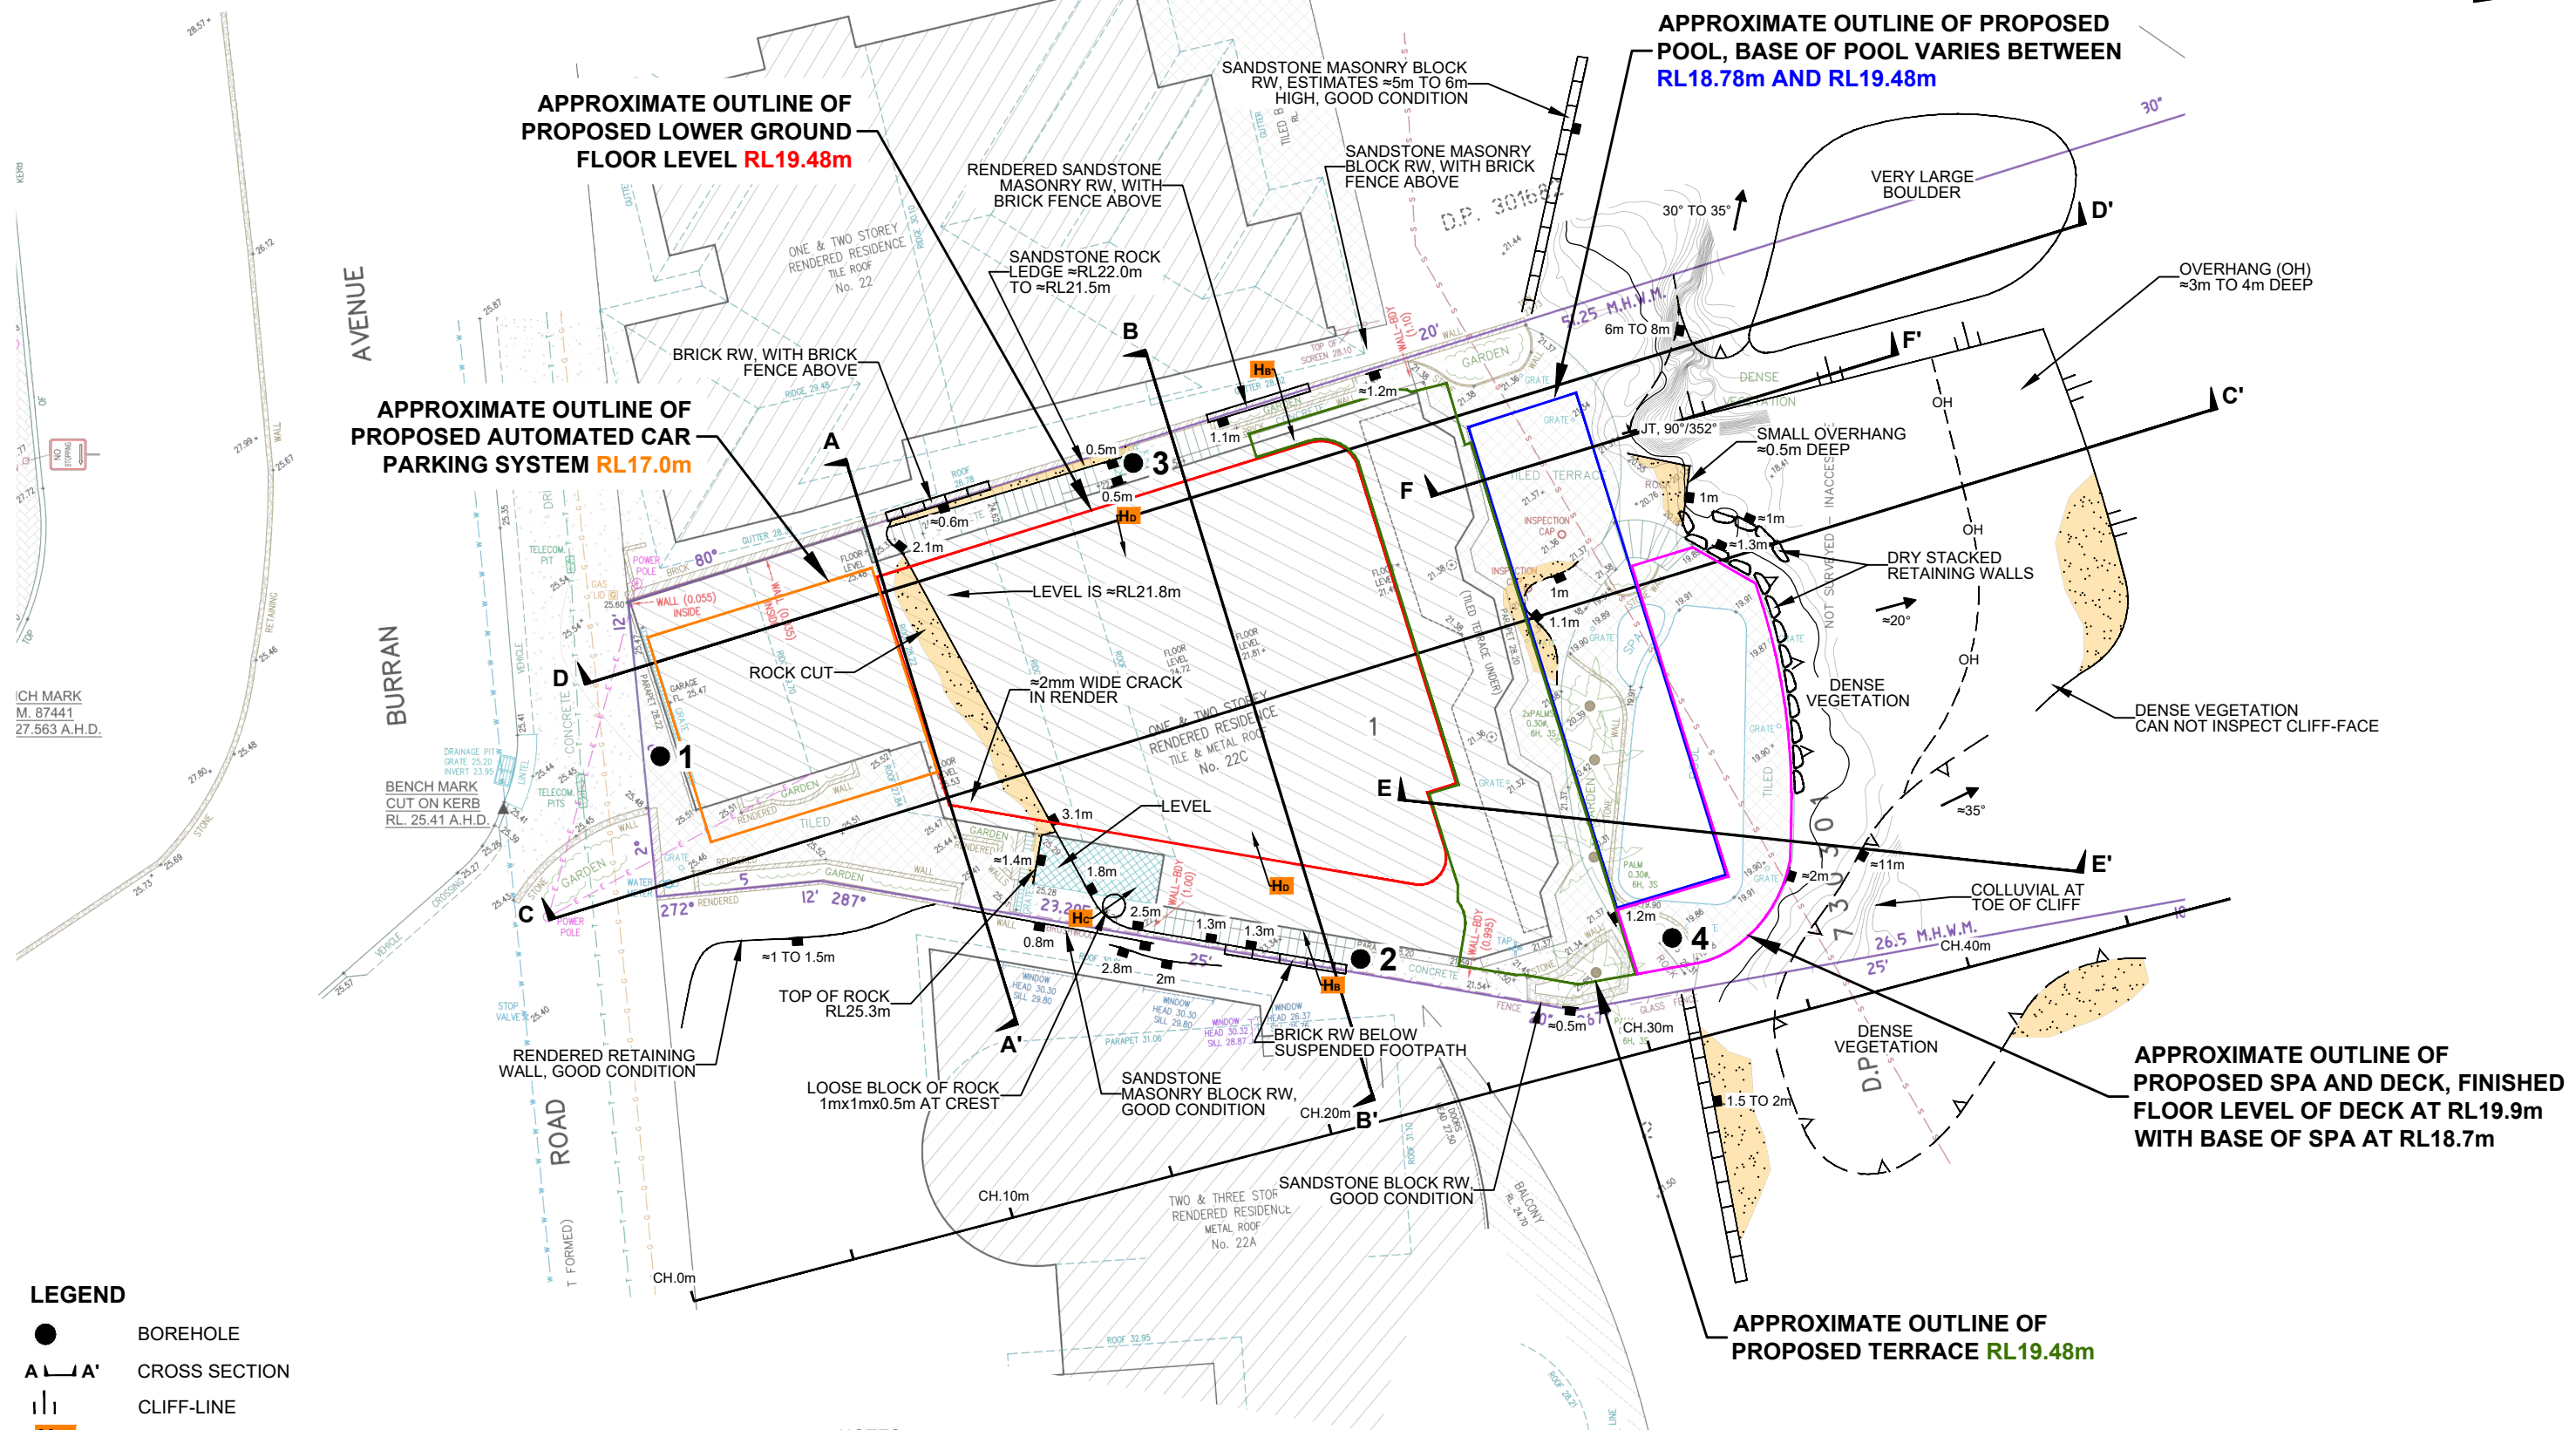
Title: PLAN OF NOTABLE GEOTECHNICAL FEATURES AND HAZARDS	
Location: 22C BURRAN AVENUE, MOSMAN, NSW	
Report No: 34431YJ	Figure No: 3
JKGeotechnics

Reference should be made to the attached Figures 3, 4 and 5, which indicate the approximate location of the potential hazards posed by this site to the adjoining properties. These hazards are described below:

- **Hazard A** – Stability of sandstone bedrock cut,
- **Hazard B** – Stability of existing retaining walls greater than 0.5m high,
- **Hazard C** – Stability of loose block of rock in plenum, and,

- **Hazard D** – Stability of new engineered walls/permanent sandstone cuts.
