# arboricultural impact assessment – 21 & 22 burnham close, thornton

8<sup>th</sup> December 2021  
prepared by Melanie Howden - Ass. Dip. Hort. (Haw. Ag. C.), SoA. Arb. MAIH, MIACA

This report has been prepared to assess the condition and significance of a number of trees on and adjacent the properties known as 21 & 22 Burnham Close, Thornton and to assess the potential impact of the proposed development on the identified trees.

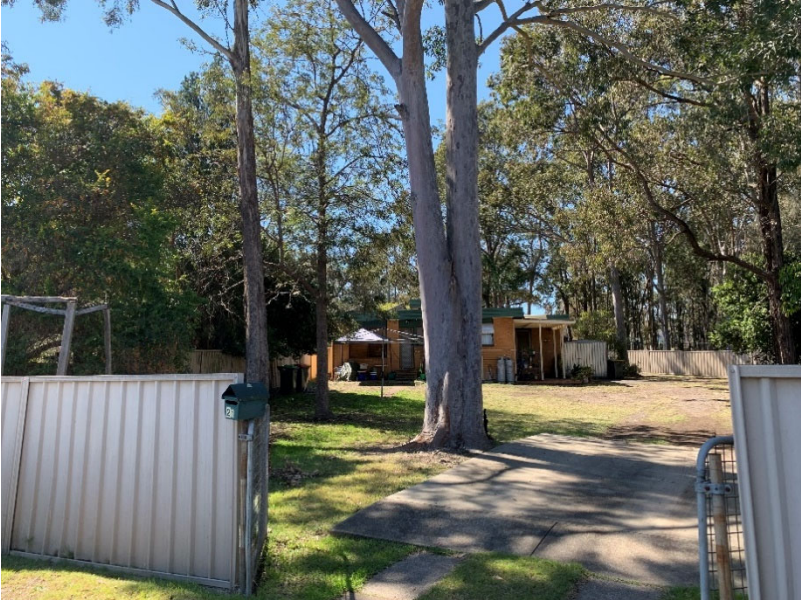
Figure 7.1 - View of the frontage of 21 Burnham Close showing Tree No's 1 (centre) and Tree No. 2 (left).

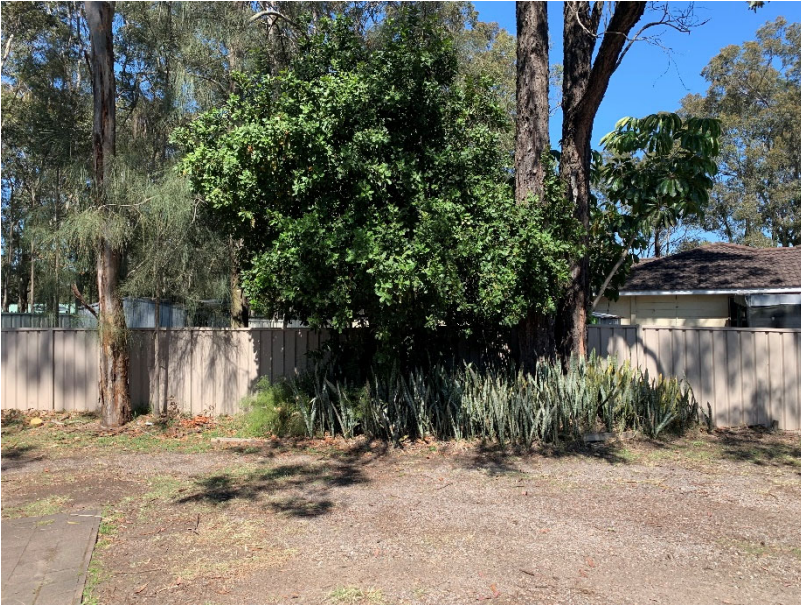
4	<i>Eucalyptus fibrosa</i>	480, 510	1100	1	Very High L/scape Sig.	8.40	5.9	3.4	The external parking bay spatially conflicts with the location of the tree with existing levels being excavated.	Not applicable	To be Removed	On site
5	<i>Corymbia maculata</i>	370	440	1	High L/scape Sig.	4.40	3.1	2.3	The proposed building footprint spatially conflicts with the location of the tree.	Not applicable	To be Removed	On site
6	<i>Corymbia maculata</i>	590	690	1	High L/scape Sig.	7.10	5	2.8	The proposed building footprint spatially conflicts with the location of the tree.	Not applicable	To be Removed	On site
7	<i>Syagrus romanzoffianum</i>	250	340	2	Low L/scape Sig.	1.40	1	1	The proposed building footprint spatially conflicts with the location of the tree.	Not applicable	To be Removed	On site
8	<i>Syagrus romanzoffianum</i>	240	330	2	Low L/scape Sig.	1.50	1	1	The proposed basement carpark is within 1.9m (west) of the tree.	No significant impact however, retention of the tree conflicts with the landscape plan.	To be Removed	On site

Figure 7.2 - Looking south across the site with Tree No's 5, 23 & 4 (left to right)

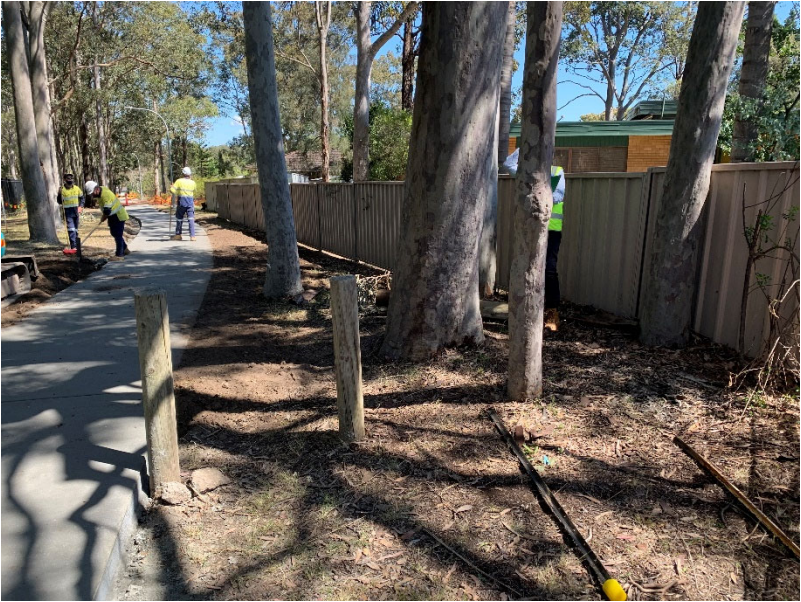
Figure 7.3 - View of the public pathway adjacent the eastern boundary of the site looking south from Taylor Avenue.
