Comments on Updates to Plans

J2578. 10th September, 2020. Page 1.

GEOTECHNICAL INVESTIGATION:

New House and driveway at 13 Pacific Road, Palm Beach

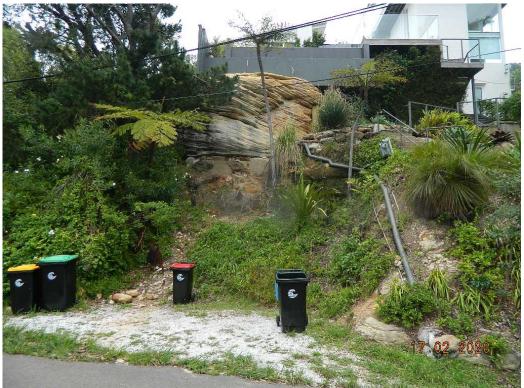
Photo 1

- 2.3 Sandstone bedrock outcrops uphill of Pacific Road (Photo 1). At the road frontage a concrete driveway runs to a carport at the SW corner of the house (Photos 2 & 3). A stable ~0.7m high concrete block retaining wall supports the driveway fill. Sandstone bedrock outcrops downhill of the retaining wall (Photo 4). The single storey brick house is supported on brick walls, brick piers and a concrete slab (Photos 5 & 6). The concrete slab is in good condition and the supporting walls and piers stand vertical and show no significant signs of movement (Photos 7 & 8). Sandstone bedrock outcrops underneath and downhill of the house (Photos 9 & 10). A timber balcony at the downhill side of the house is supported by timber posts and

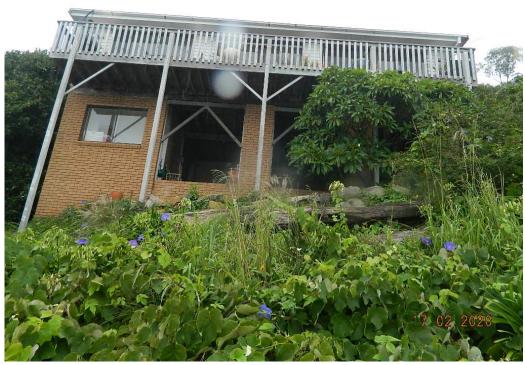
Photo 6

is in good condition (Photo 6). The steep slope below the property is thickly vegetated (Photos 11 & 12). No signs of slope instability were observed on the property.
