Tuesday 17<sup>th</sup> May 2016

DL3701\_S004533

**Re: Review of Site History and Site Inspection – Altrove Stages 2-6, Lot 4 DP1191977, Schofields, NSW, 2762.**

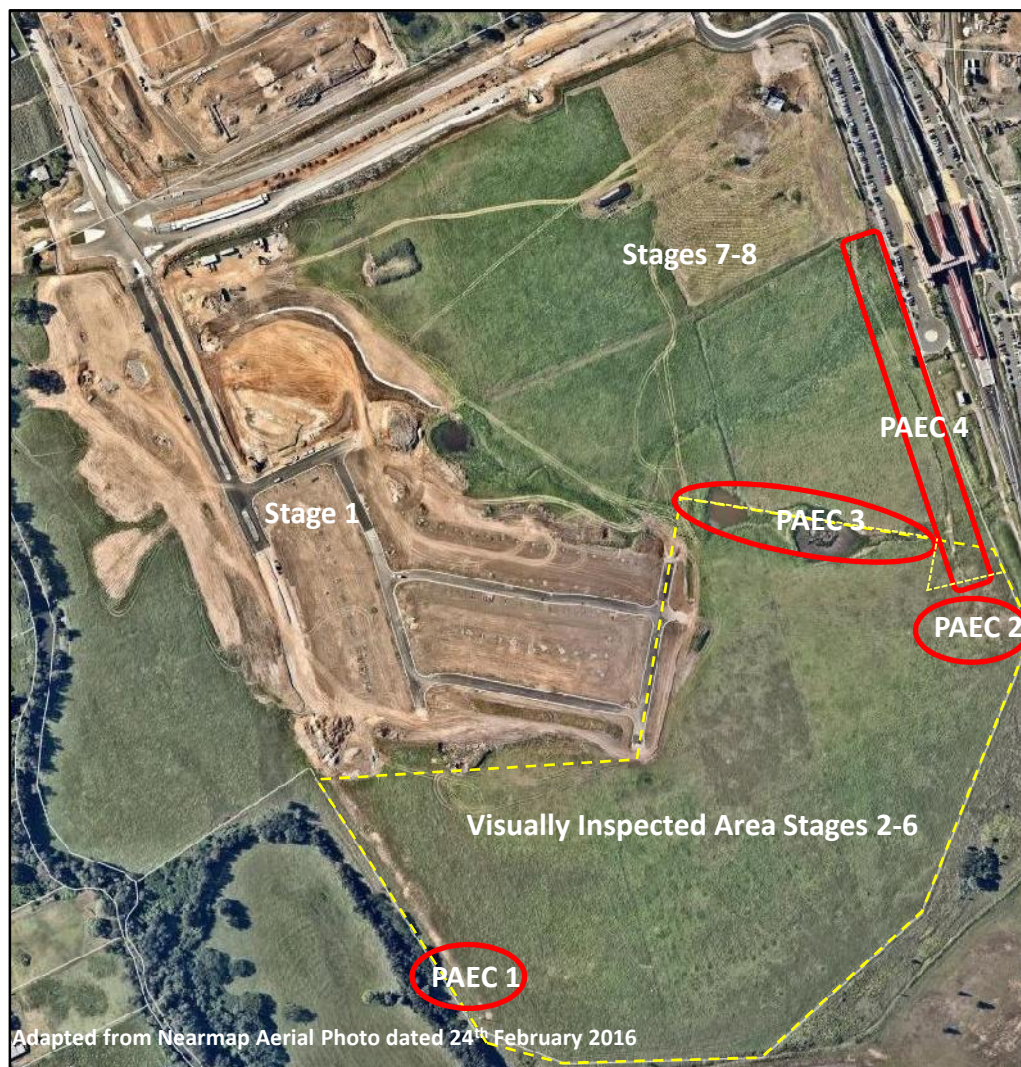
**FIGURE 2 – POTENTIAL AREAS OF ENVIRONMENTAL CONCERN**

- o PAEC 1 included a rusty vehicle within the Site and a recently abandoned vehicle in Eastern Creek adjoining the south-west corner of the Site.
- o PAEC 2 was a former construction compound associated with sewer installation in July 2014 located in the south east corner of the Site.
- o PAEC 3 included the existing drainage line and dams which may contain fill materials, although only concrete blocks were observed near the dam walls.
- o PAEC 4 includes a small part of Stages 2-6 and extends into Stages 7 & 8. This area consists of a former construction road which has been filled and contains traces of brick, concrete and tiles at the surface. The road extended from the north east of the Site to the sewer construction yard identified at PAEC 2.

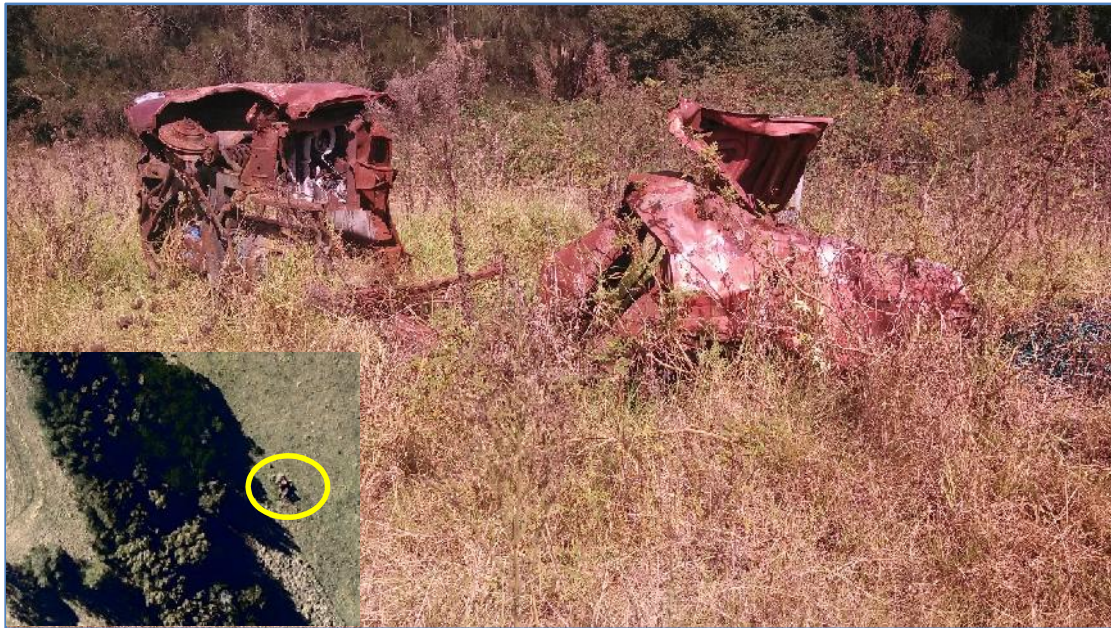
**Print 001**

PAEC 1 - South west corner car body

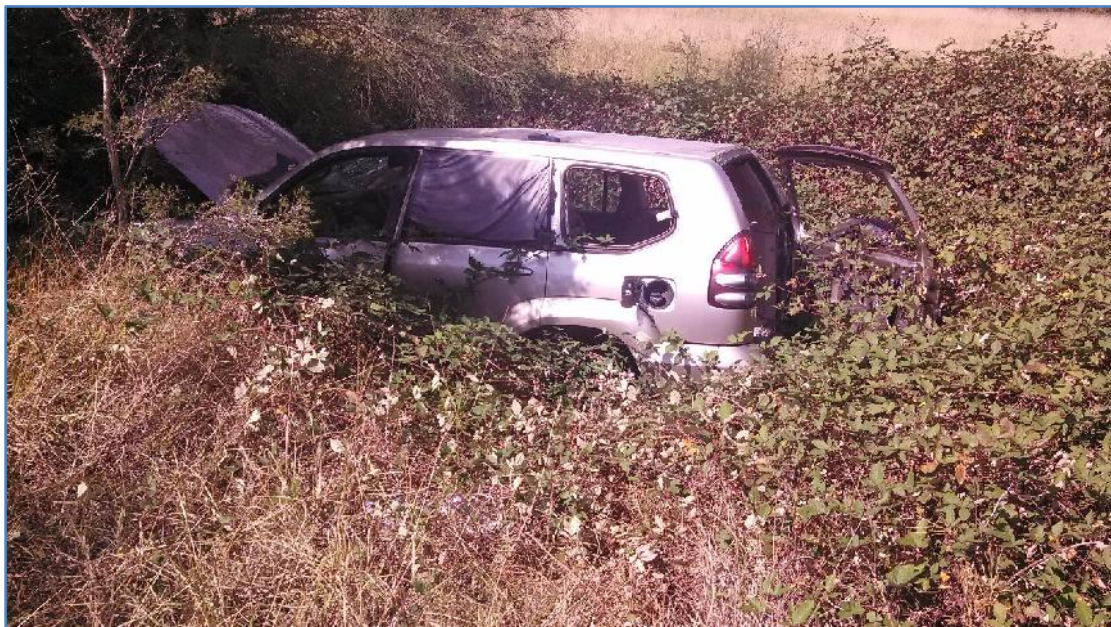
**Print 002**

PAEC 1 - South west corner abandoned car body in creek.

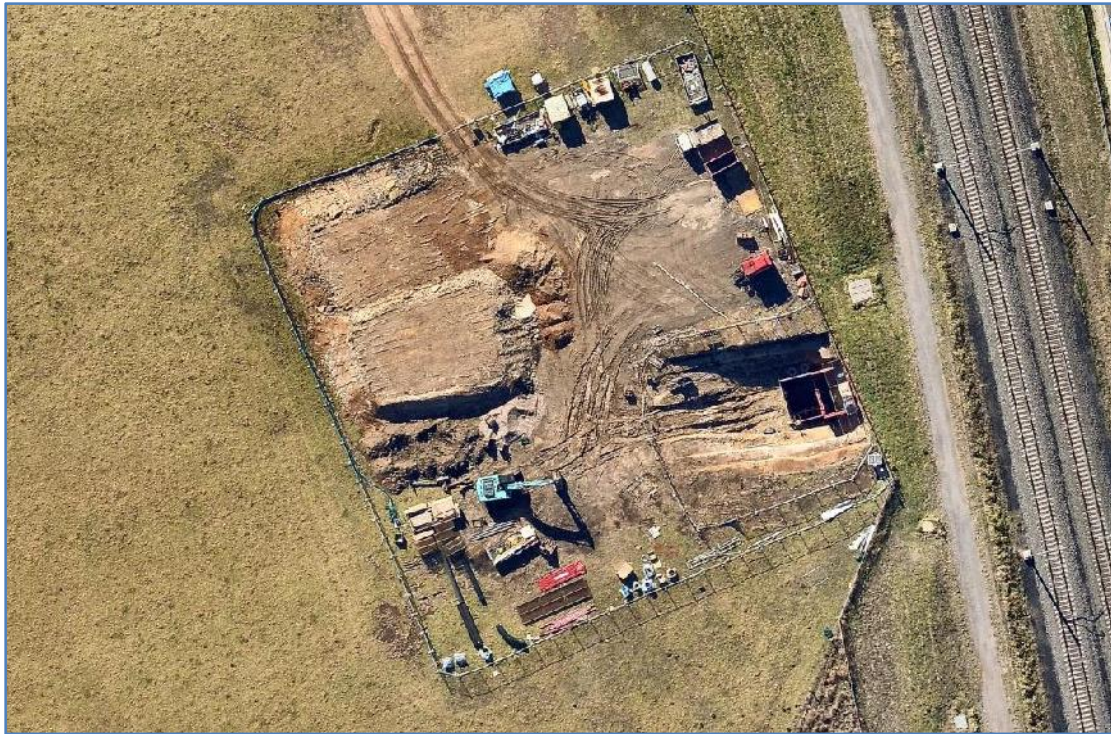
**Print 003**

PAEC 2 - South east corner former construction yard (July 2014)

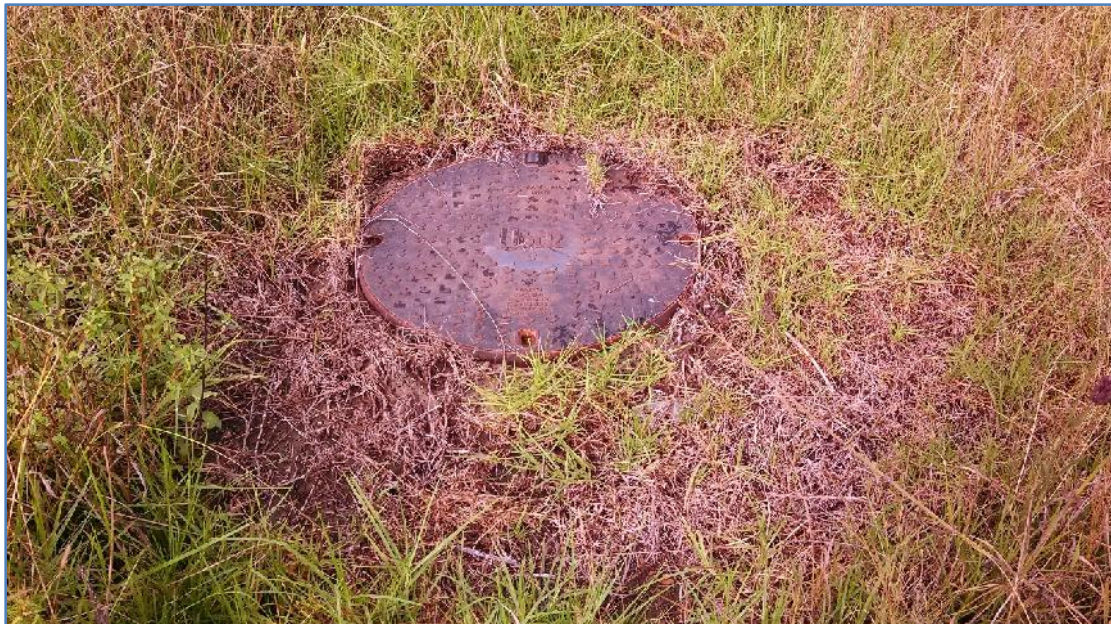
**Print 004**

PAEC 2 - Sewer manhole cover.

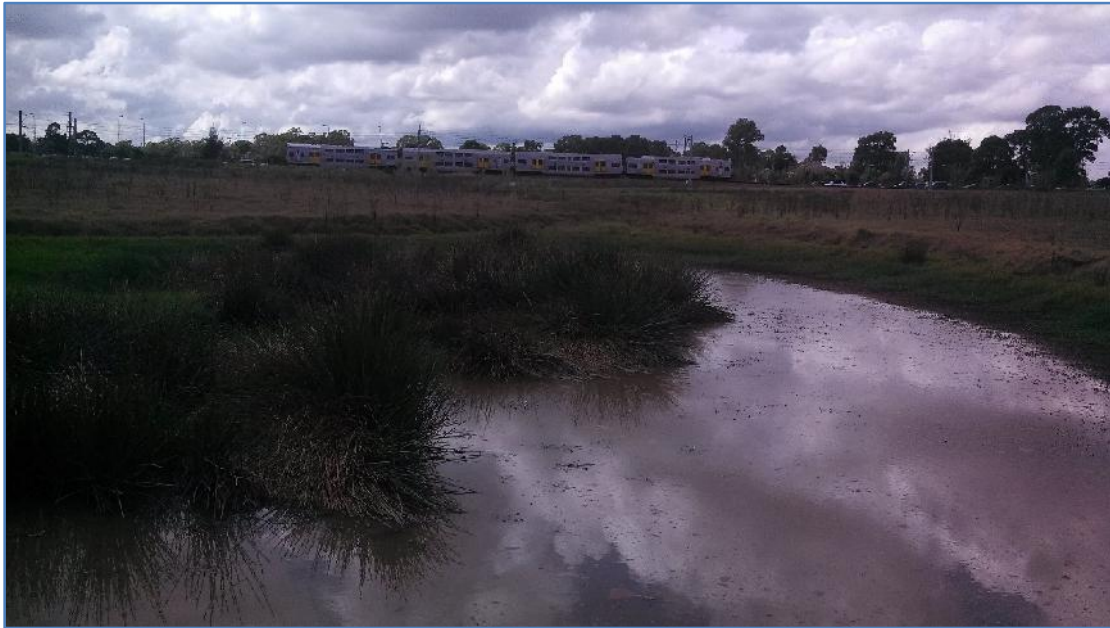
**Print 005**

PAEC 3 – Dam Area potential fill area.

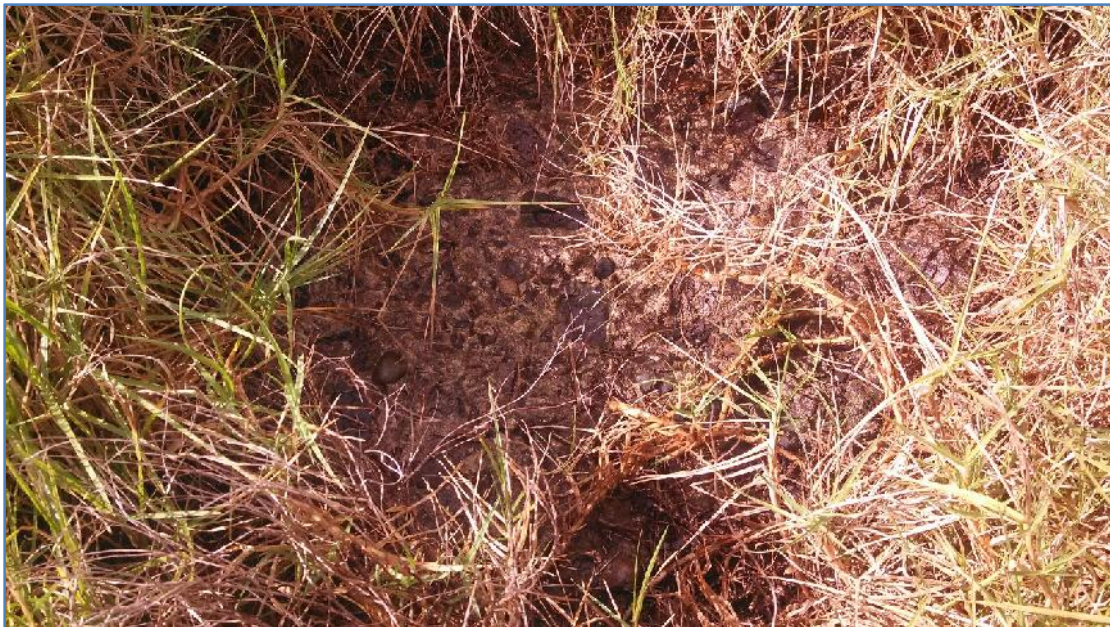
**Print 006**

PAEC 3 – Dam Area – Concrete blocks at surface behind dam wall.

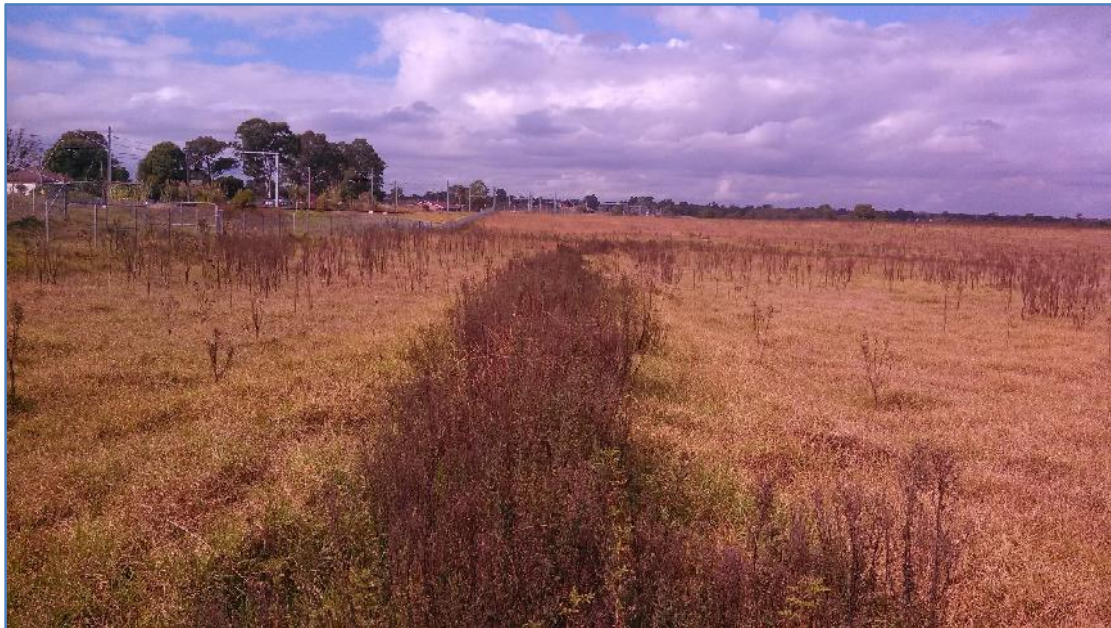
**Print 007**

PAEC 4 – Former construction road potential fill area.

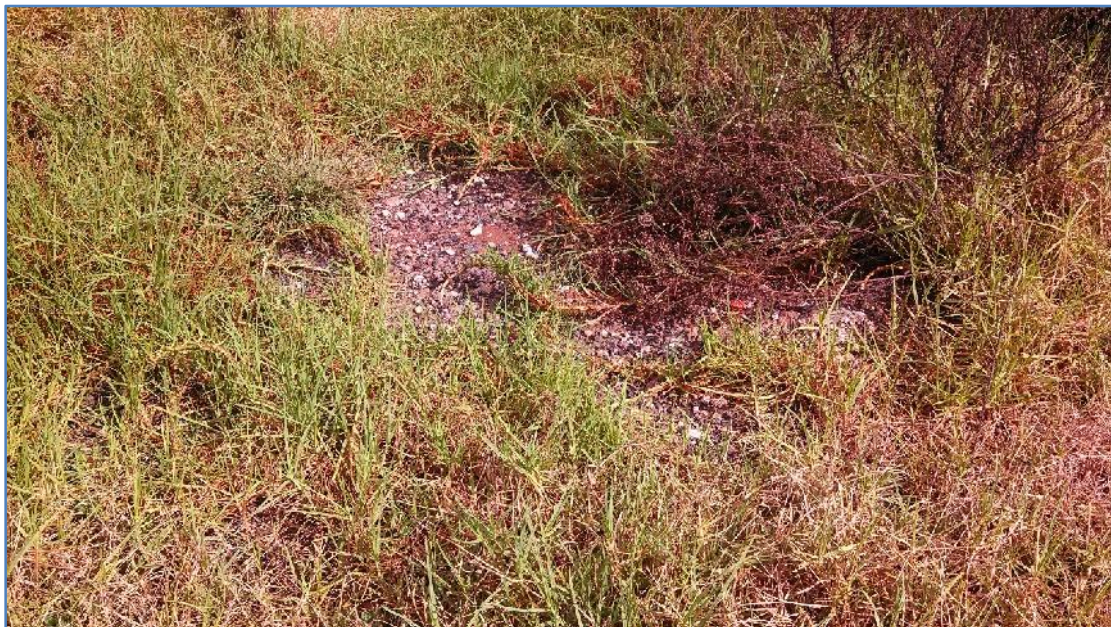
**Print 008**

PAEC 4 – Former construction road – traces of brick and tile.
