AC:ds  
Project 34161  
6 February 2004

**REPORT ON GEOTECHNICAL INVESTIGATION  
PROPOSED SITE CLEARING  
LOT 5 DP 261728 WARRADALE ROAD  
SILVERDALE**

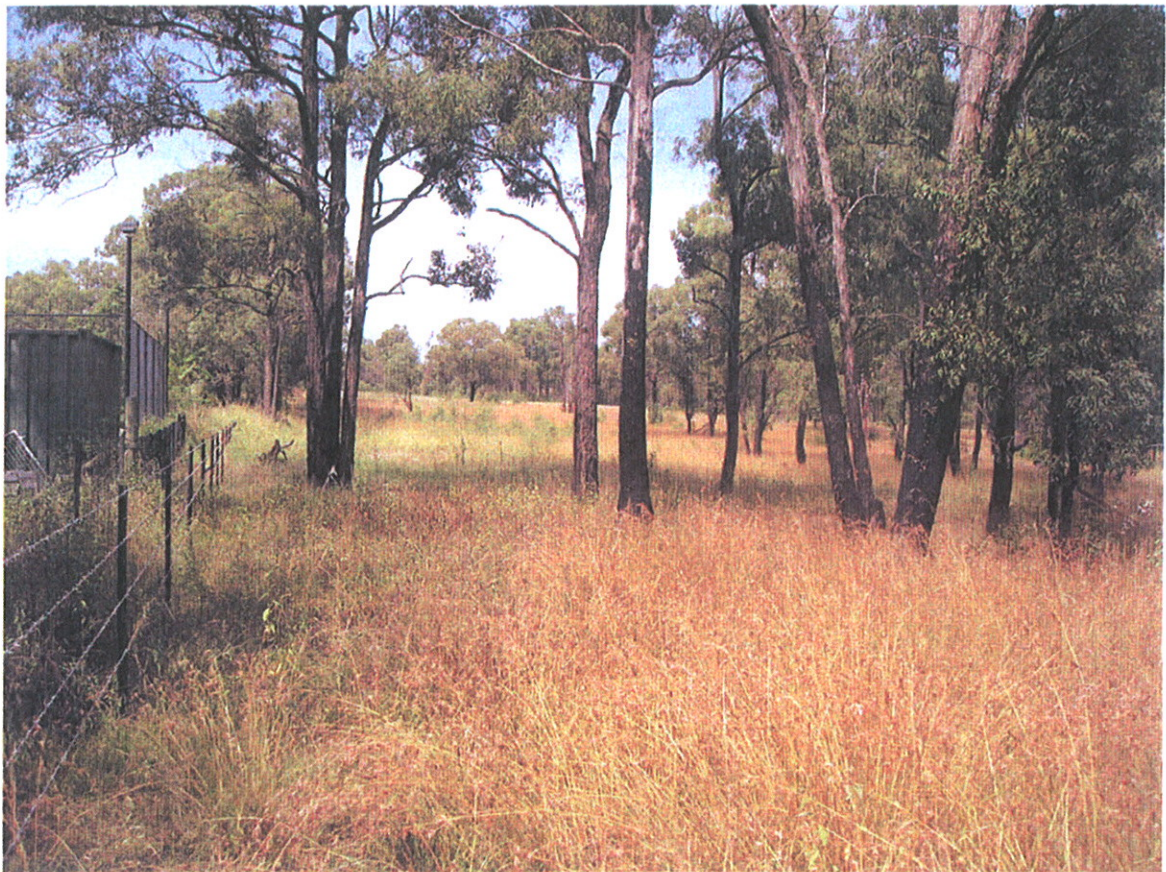
**PLATE**  
**1**

View from north-eastern corner of the site  
towards cleared section

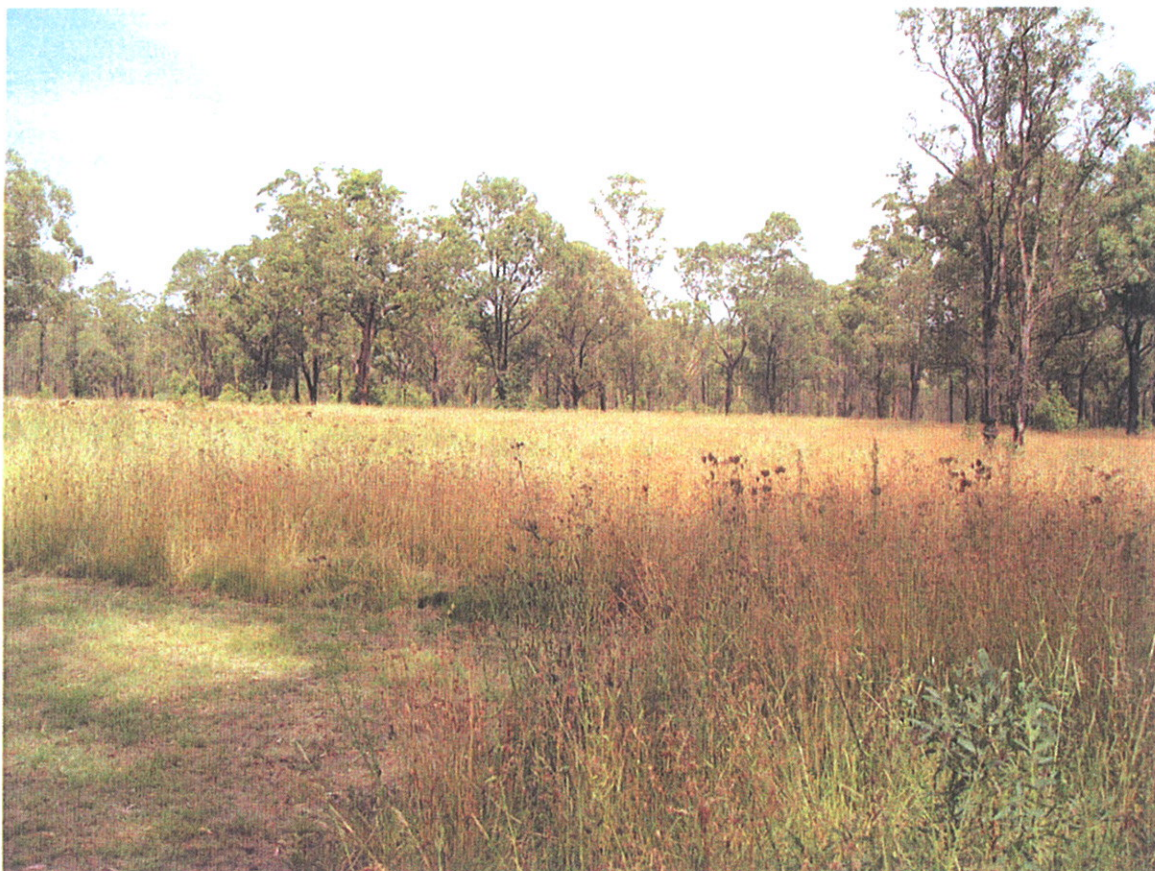
PLATE  
2

View to the west from the eastern boundary

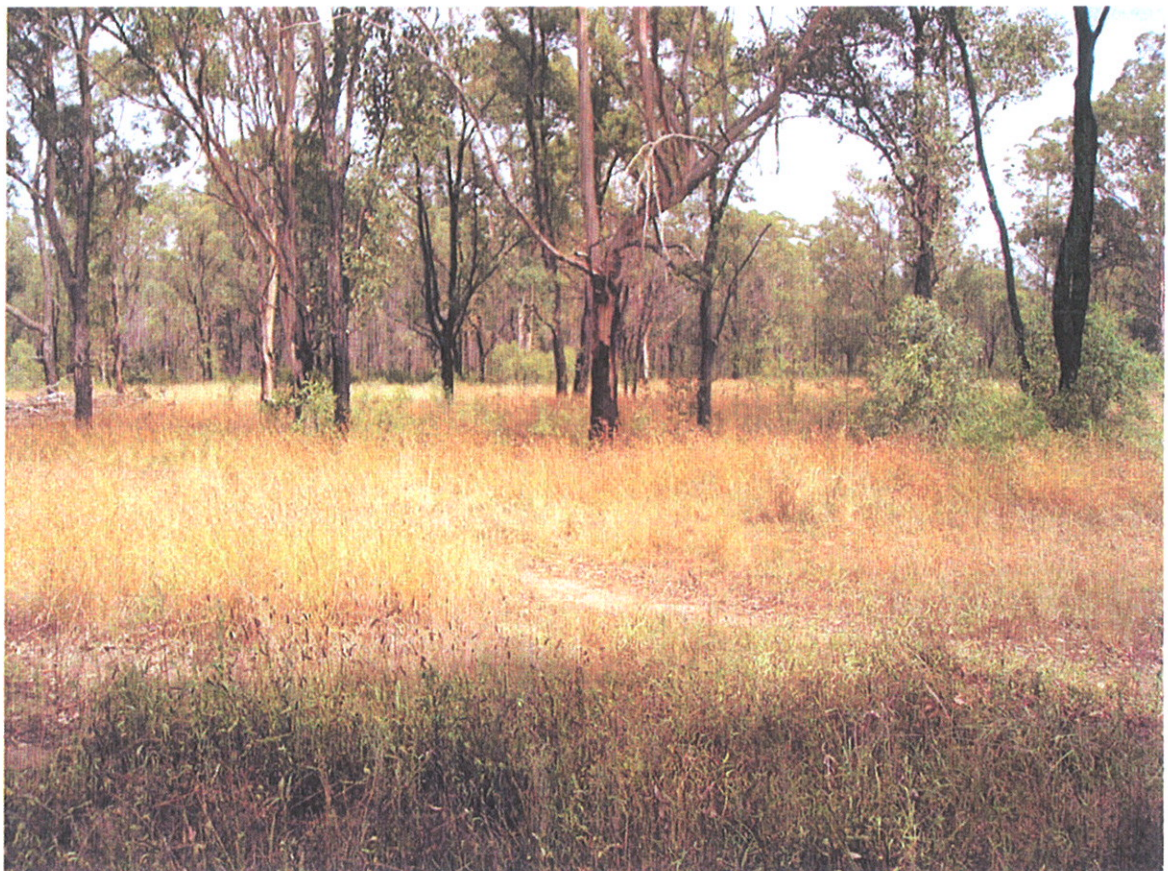
**PLATE**  
**3**

View to north-west from near the south-eastern corner of the site

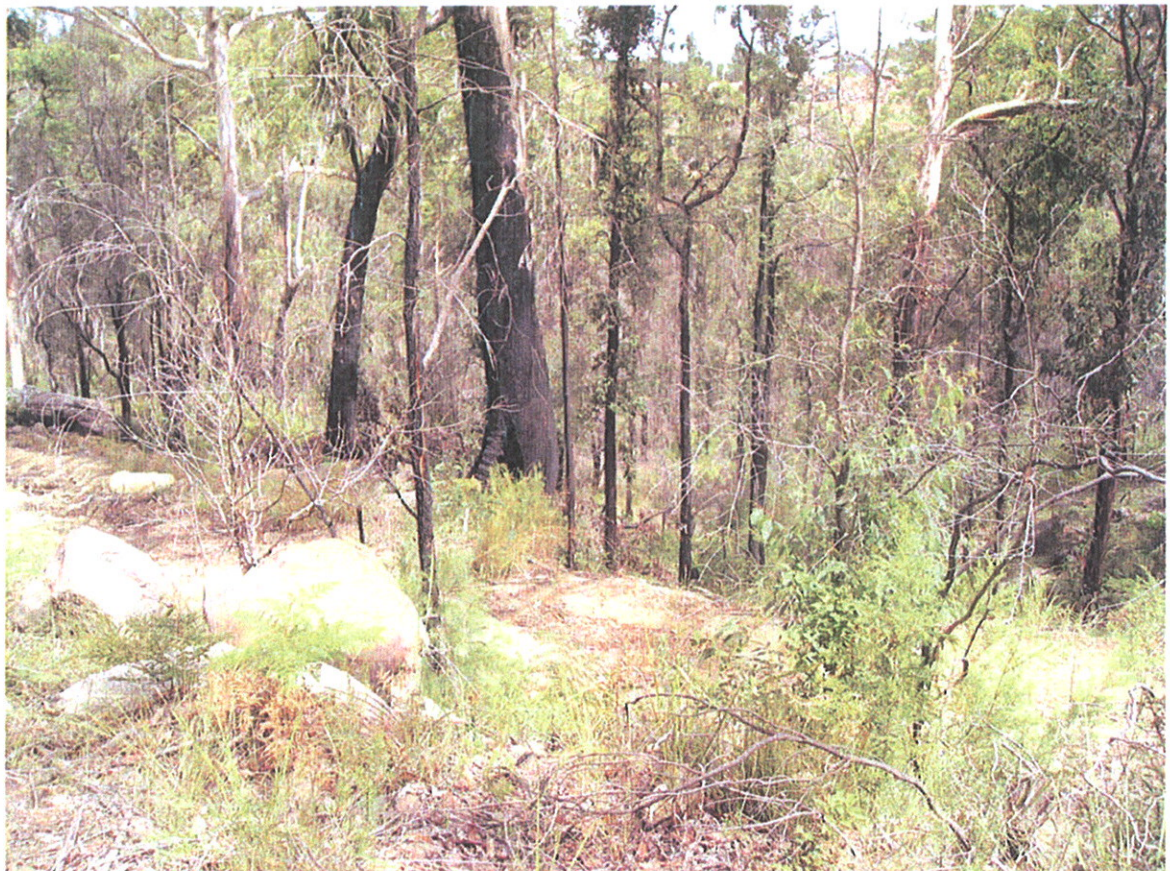
**PLATE**  
**4**

View from top of cliffline toward Megarittys Creek

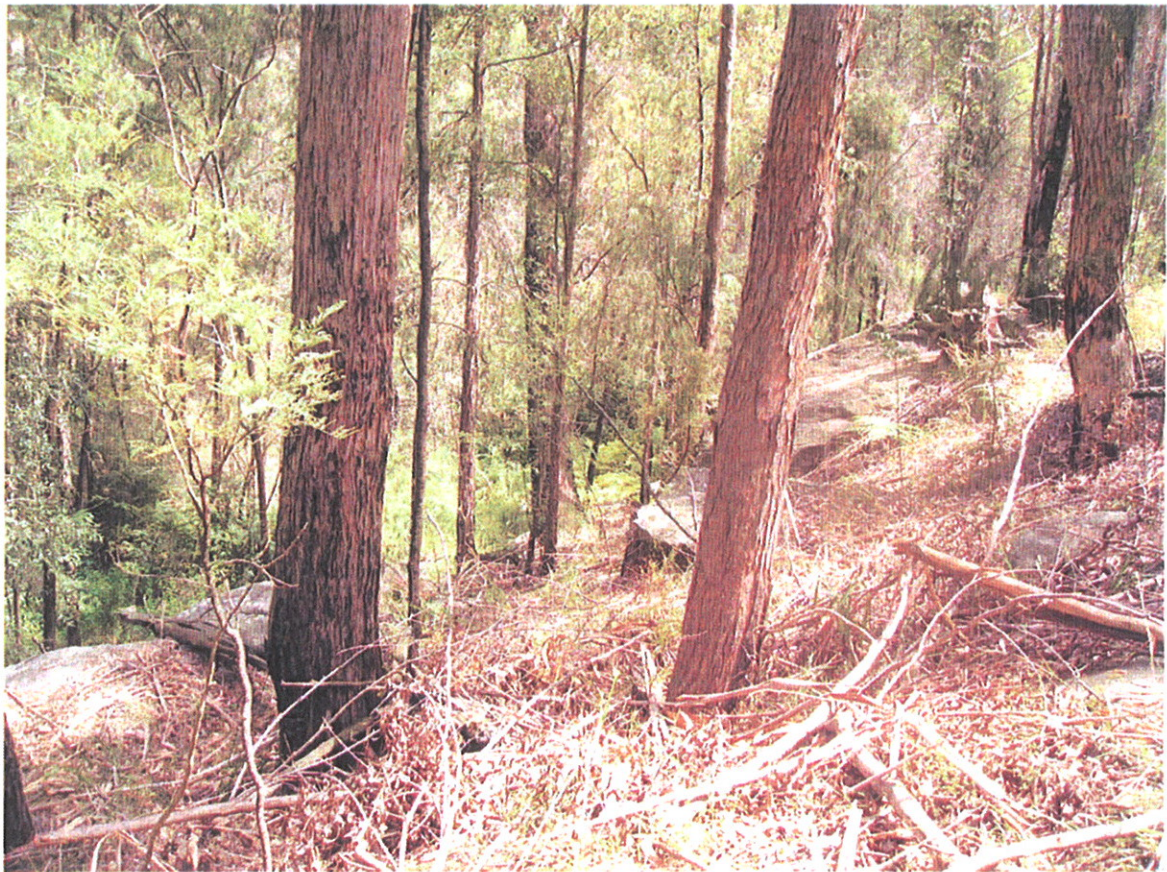
**PLATE  
5**

View from cliffline towards Megarittys Creek near southern boundary

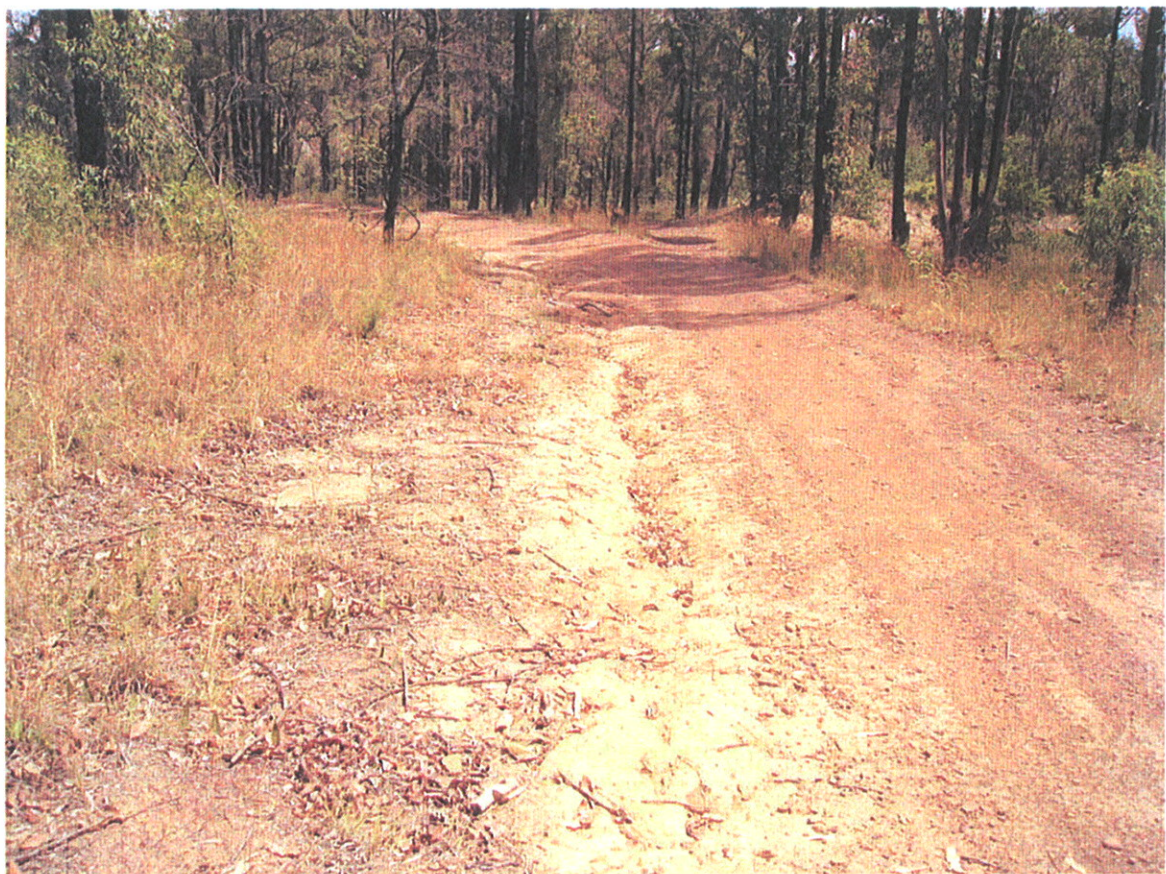
**PLATE  
6**

Minor rilling adjacent to track in north-east of the site

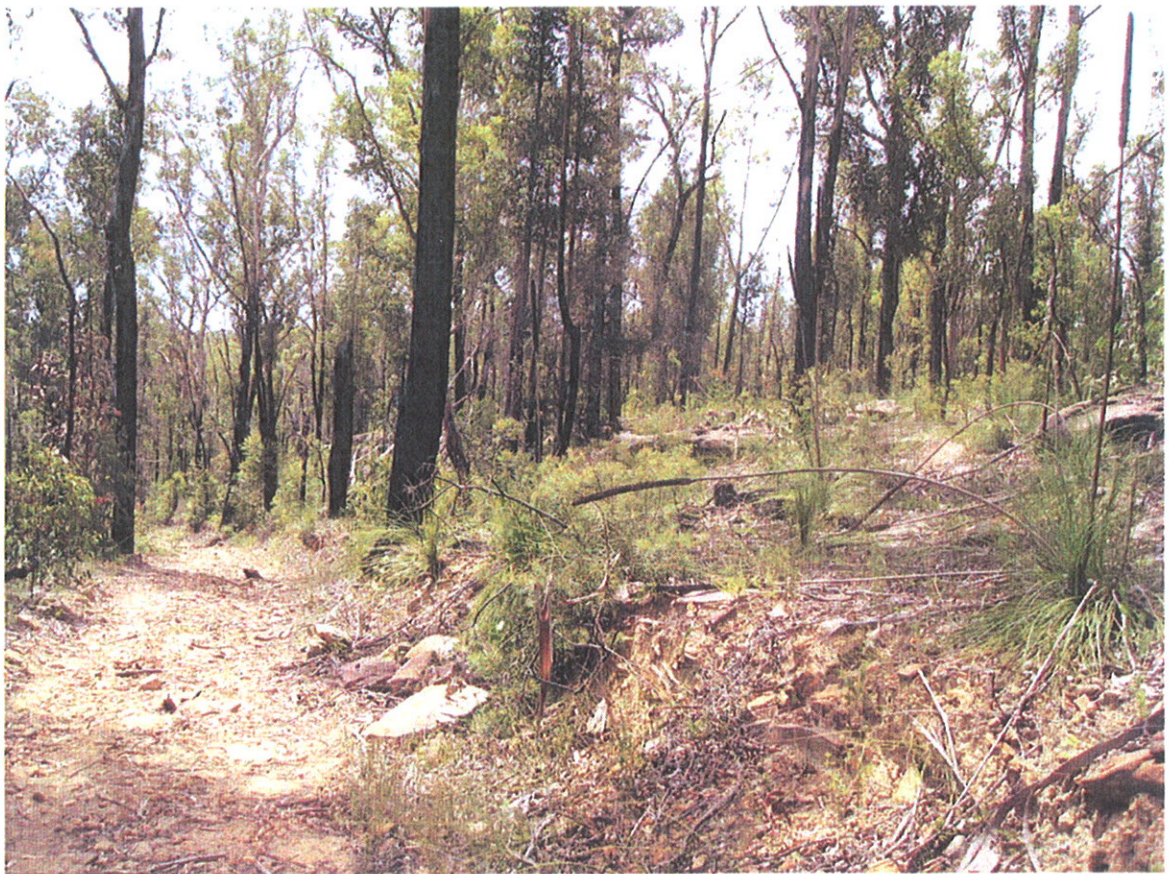
**PLATE  
7**

View to the east from the western side of Megarittys Creek

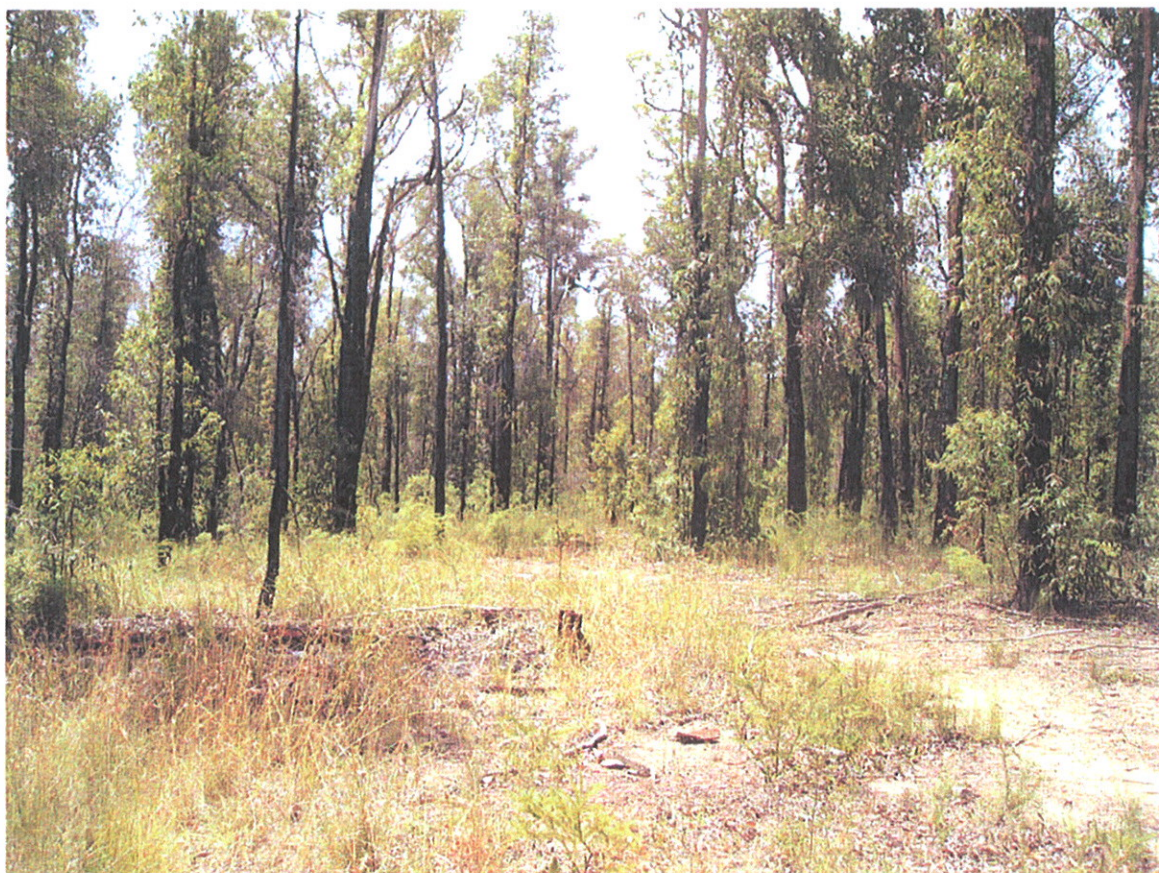
**PLATE  
8**

View east from powerline easement (western boundary)

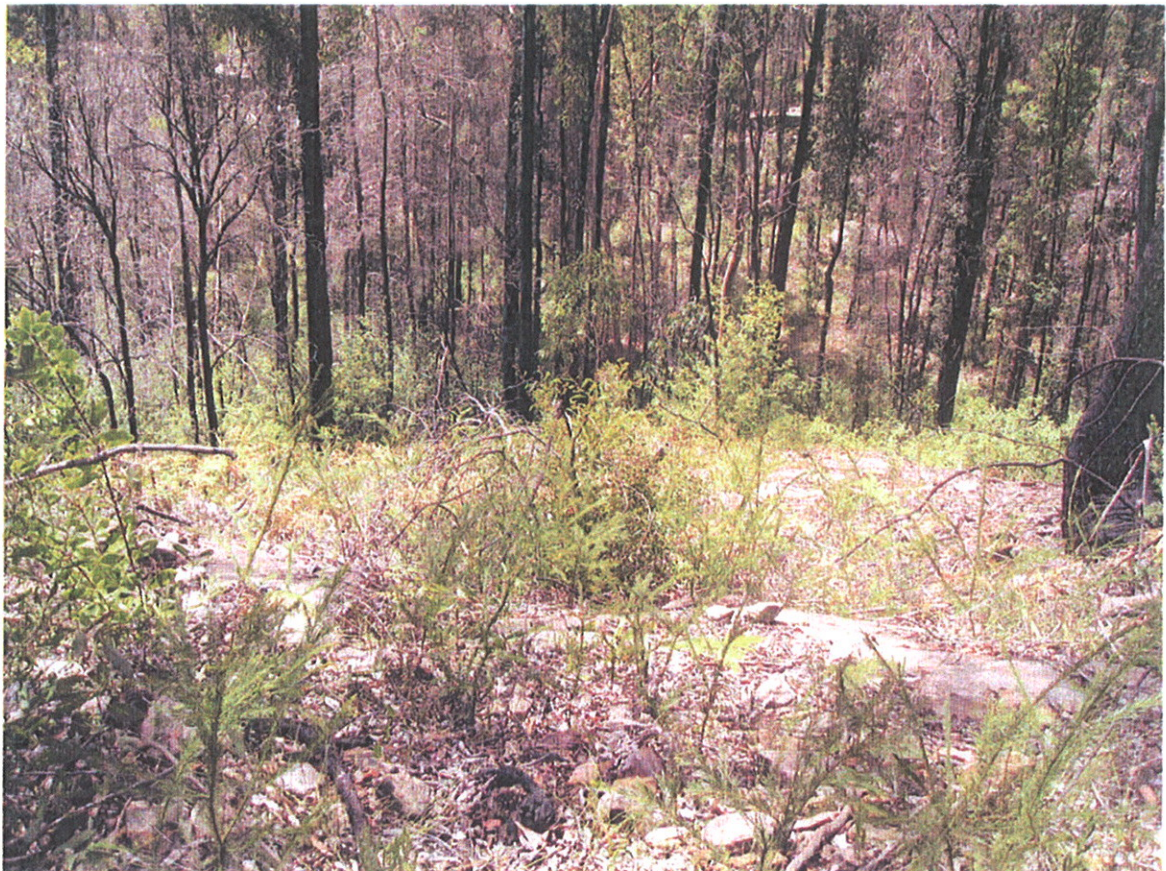
**PLATE  
9**

**Sandstone outcrops leading to Megarittys Creek (looking east)**

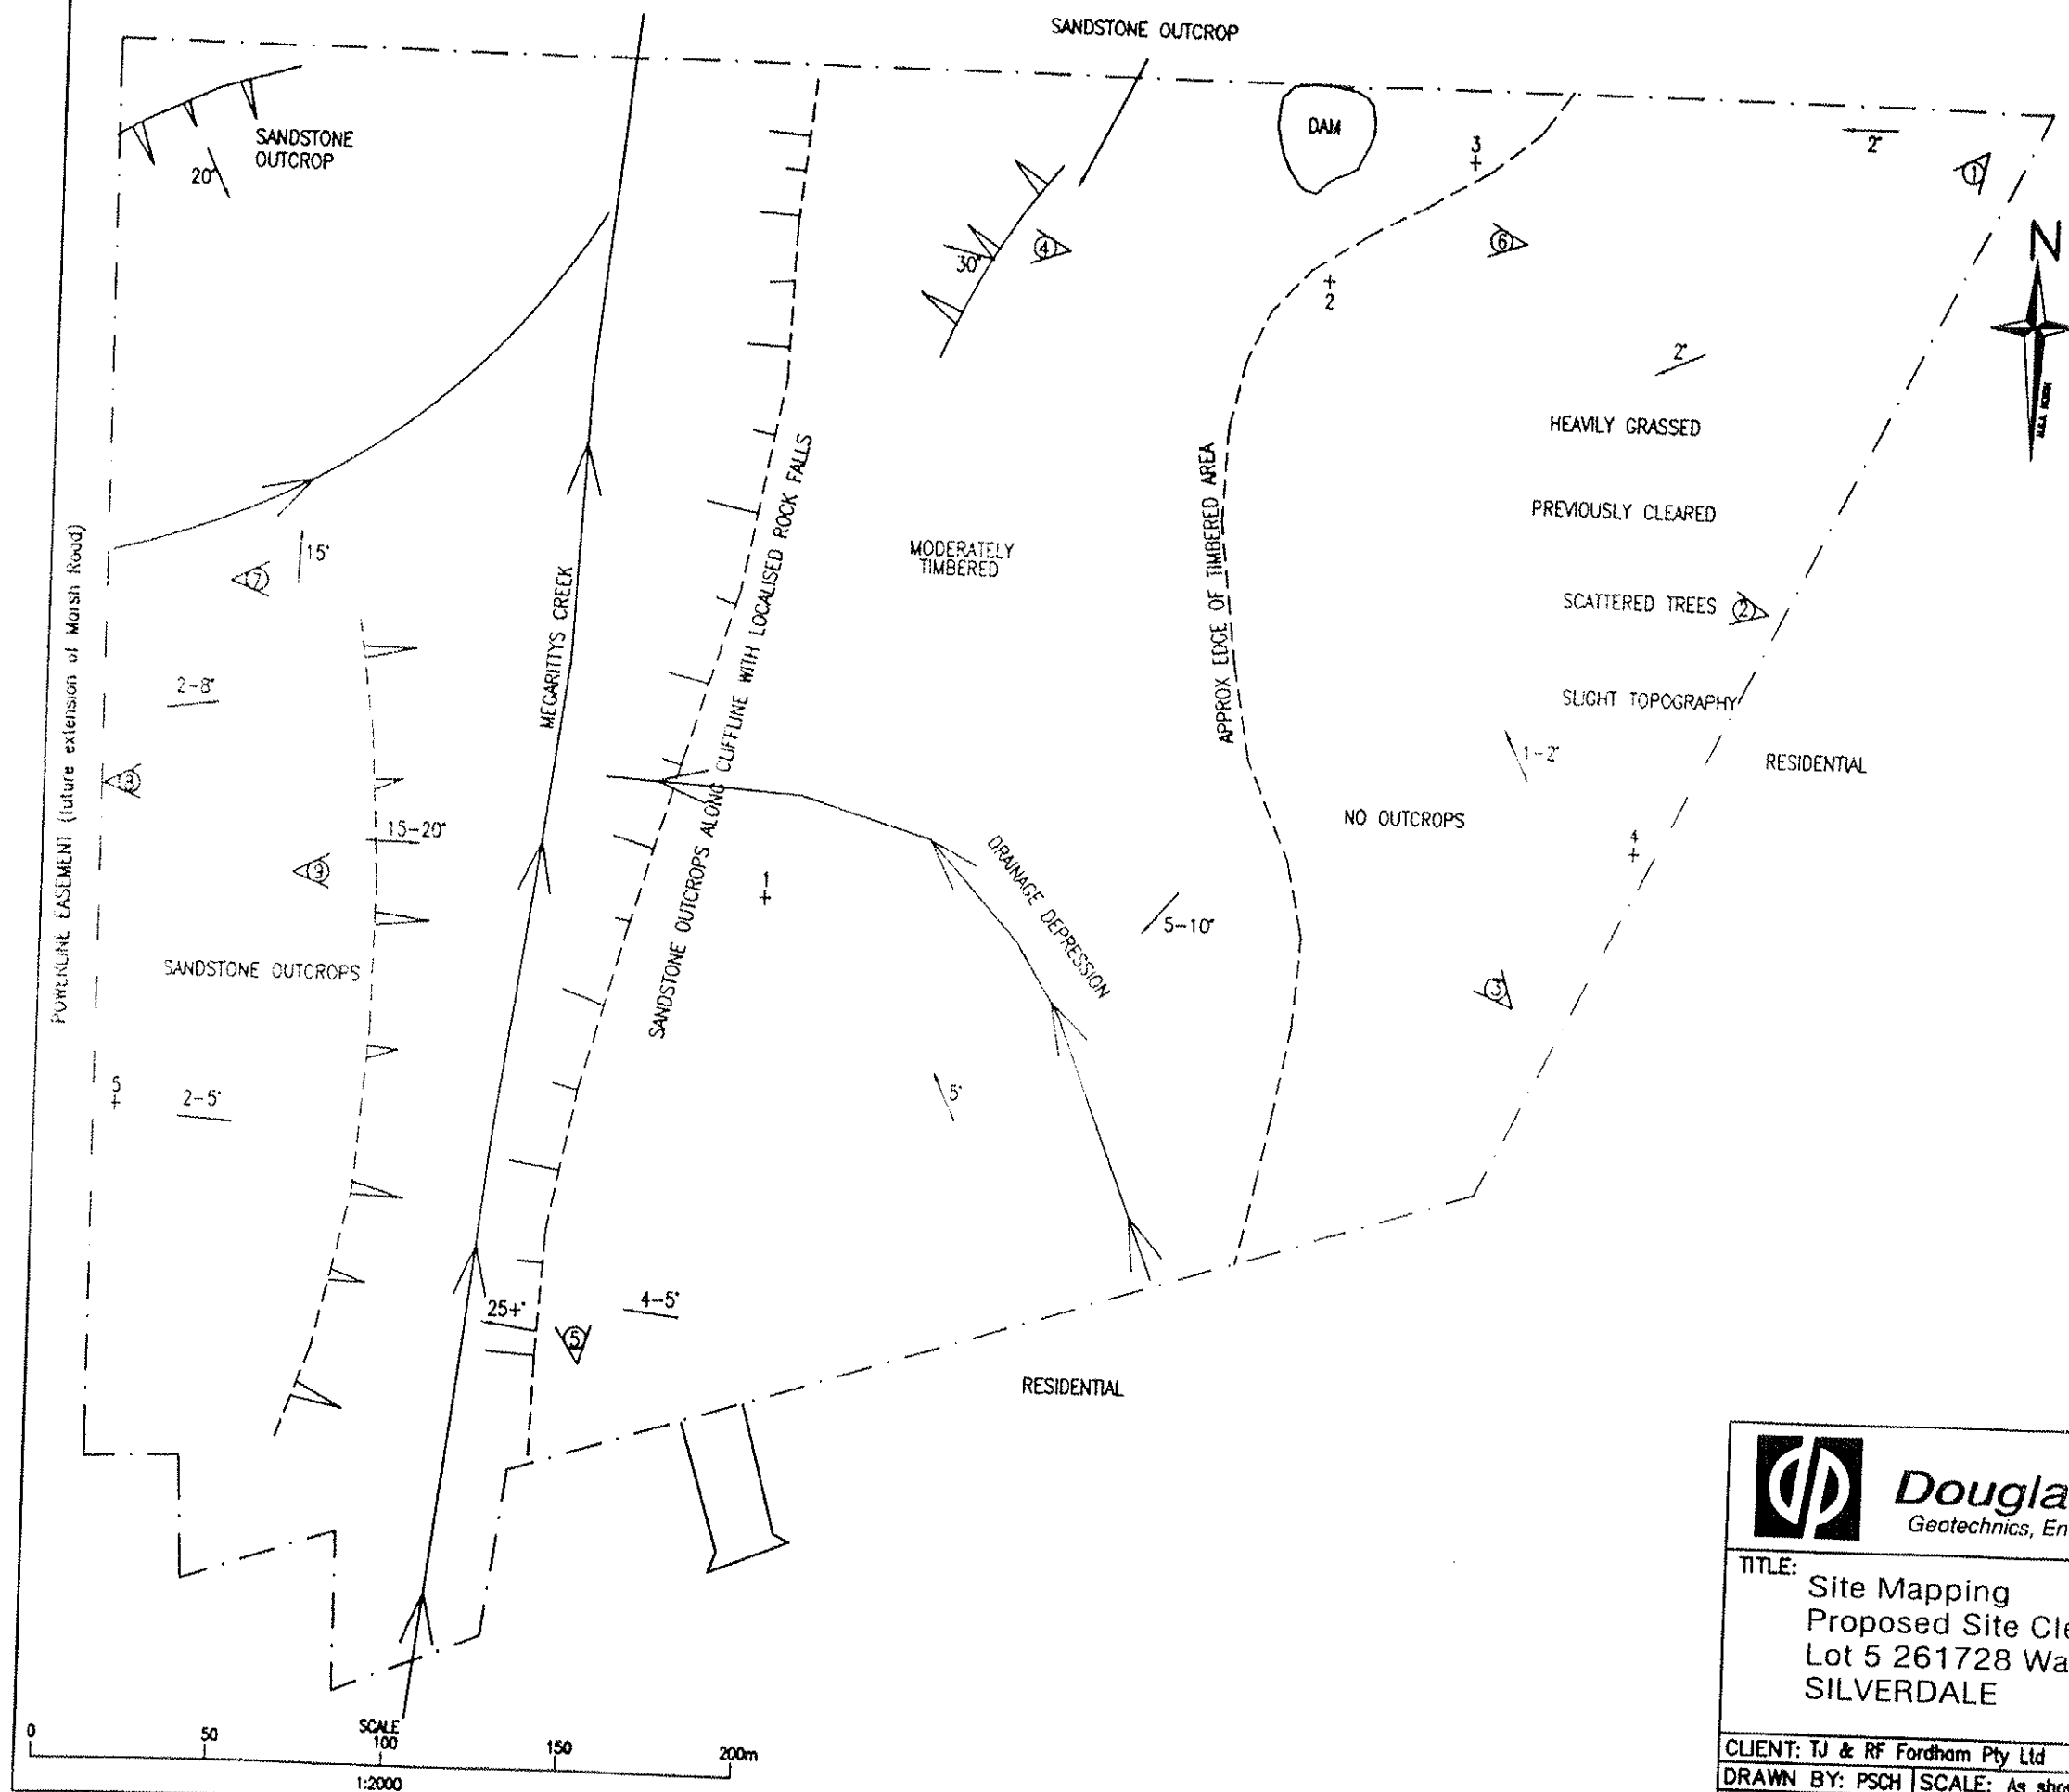
DRAWING No: 1

Site levels generally fall towards a northerly trending creek (Megarittys Creek) at slopes of 2 – 5° (but locally steeper to 10°) increasing to slopes of 15 – 30° at cliff lines which flank the creek (see Drawing 1).

The field work comprised a site inspection by an experienced geotechnical engineer and the collection of five near-surface soil samples (Samples X1 – X5). The approximate sampling locations are shown on Drawing 1 attached, together with pertinent features noted during the site walkover.
