**New Brighton Golf Club**  
**Report for Rezoning of New Brighton Golf Course**  
**- Residential Area**  
**Stage One Contamination Assessment**

June 2011

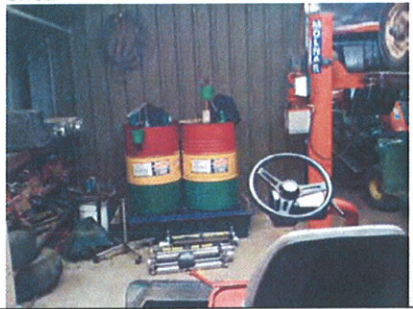
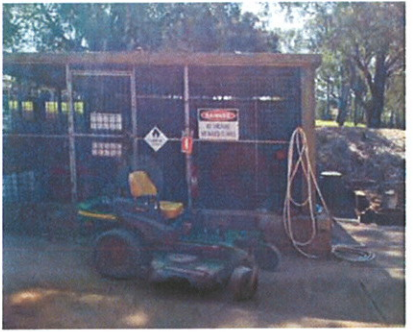
| Site observations | Photographs |
|---|---|
| <p><i>Current Golf Course</i></p> <p>A single storey clubhouse is located in the south west corner of the Site. The clubhouse is bordered on the west and south by a bitumen sealed car park. A two storey brick Pro Shop is located to south east of the clubhouse. Fibre cement sheeting was noted in the clubhouse and pro shop and owing to the age of the buildings, there is the potential for asbestos to be present.</p> <p>A maintenance shed is located in the north west portion of the Site that houses plant, equipment and chemicals used to maintain the golf course. In general, good housekeeping was noted in and around the maintenance shed. Several 44 gallon drums containing hydraulic oil were noted within the shed (Photo 1) while three above ground storage tanks (AST) were located in a secured concrete bunded area (Photo 2). Two of the ASTs contained unleaded fuel and the third contained diesel. All pipework was above ground. On a whole, the ground surface surrounding the storage area did not show signs of impact (i.e. stains, odours). No underground storage tanks were observed on site.</p> <p>Adjacent to the fuel storage area is a wash</p> | <p>Photo 1 – Oil Drums in Maintenance Shed</p> <p>Photo 2 – Three Above Ground Fuel Storage Tanks</p> |

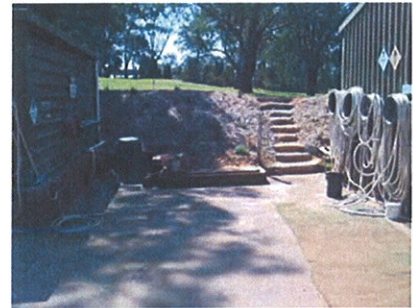
Photo 3 – Plant / Equipment Wash Down Area

bay for plant and equipment (Photo 3). The wash bay is typically used for hosing down golf course mowing equipment. The area has a drain that captures the water and directs it to a separator before discharging to the large dam to the east of the shed.

- ▶ GHD recommends that limited soil sampling be undertaken on the site, targeting any areas subject to uncontrolled filling, stockpiles and the maintenance shed.

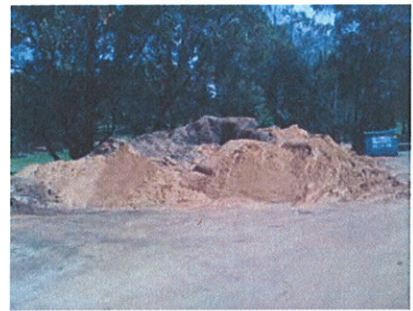
Photo 4 – Stockpiles of Sand and Mulched Timber

Approximately 20m to the east of the maintenance shed there were stockpiles of sand and mulched timber (Photo 4). The golf course superintendent, Norm Foord, indicated that the sand stockpiles were used for the dressing of greens and tee boxes and were sourced from landscape supply companies. The mulched timber was from wood collected onsite after it had fallen from trees following storms and high wind periods.

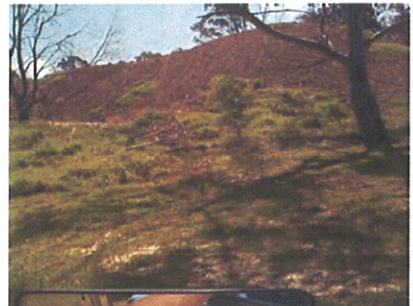
Photo 5 – Stockpiled Material Excavated for Construction of a Dam

A large stockpile of soil was noted near the current 8<sup>th</sup> hole (Photo 5). It was indicated the stockpile was excavated from alongside the 7<sup>th</sup> green to create a new dam.

- ▶ The site inspection identified that widespread cut and fill and some uncontrolled infilling has historically occurred at the site. The potential for that imported materials may have been contaminated cannot be completely discounted as the materials were not accompanied by the appropriate documentation.
