GHD Pty Ltd (GHD) was commissioned by Architectus Sydney Pty Ltd, on behalf of Holsworthy Shopping Centre Pty Ltd, to carry out a preliminary site investigation (PSI) for potential contamination at Lot 5 in DP 825745 located at 2 MacArthur Drive, Holsworthy, NSW 2173 (the 'site').

Holsworthy Shopping Centre Pty Ltd Preliminary Site Investigation 2 Macarthur Drive, Holsworthy, NSW, 2173 Job Number | 21-26038 Revision 0 Date 07 Dec 2016

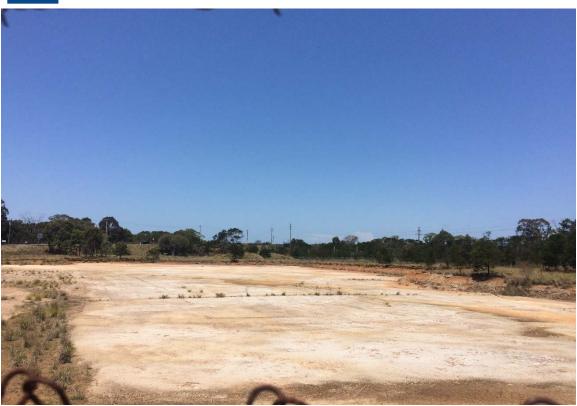
Photograph 1 – Excavated and compacted gravel on the midsection of the site (Eastern view).

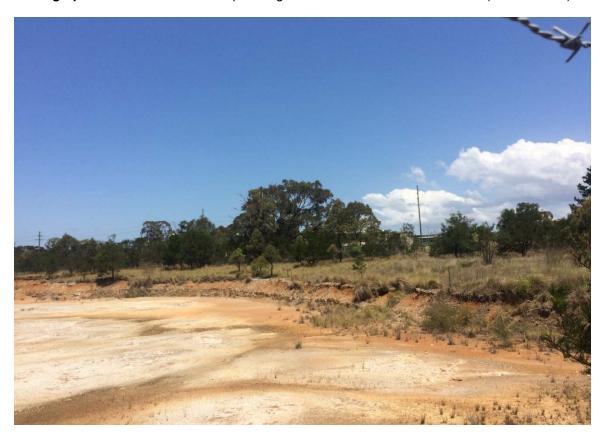
Photograph 2 – Excavated and compacted gravel on the midsection of the site (Southern view).

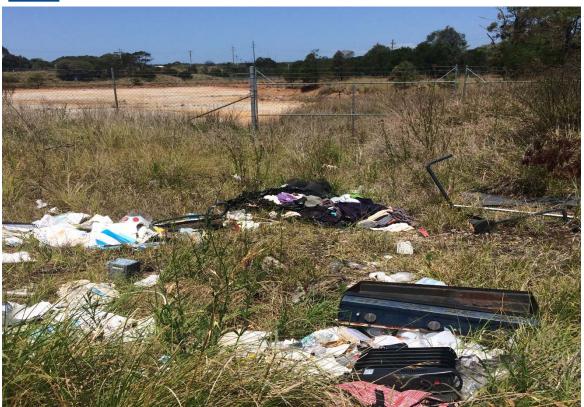
- A site inspection by GHD on 13 December 2016 did not identify any obvious indication of significant contamination at the site, although minor illegal dumping of rubbish was noted in places. Parts of the site were inaccessible for inspection due to dense vegetation cover.

Photograph 3 – Western boundary of the site scrap materials.

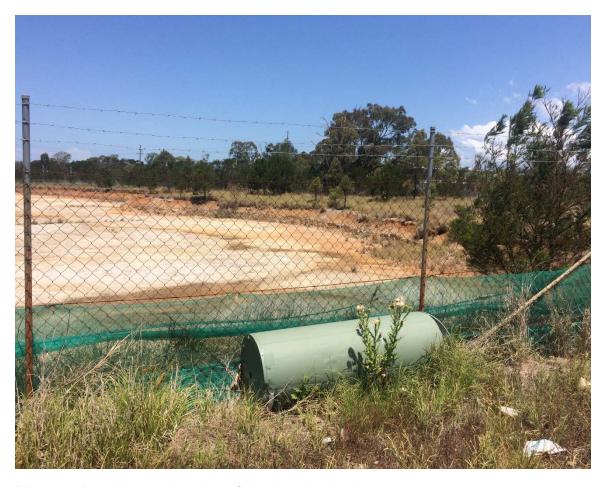
Photograph 4 – Western boundary of the site redundant hot water system.

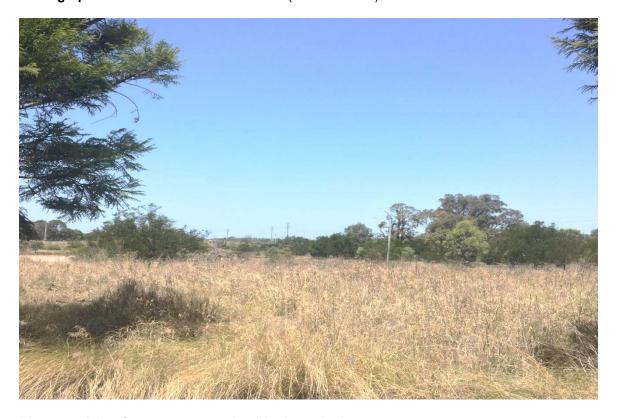
Photograph 6 – Overgrown vegetation (Northern view).
