# 189 Macquarie Street PARRAMATTA

# TREE REPORT and ARBORICULTURAL IMPACT ASSESSMENT

**12 February 2013**

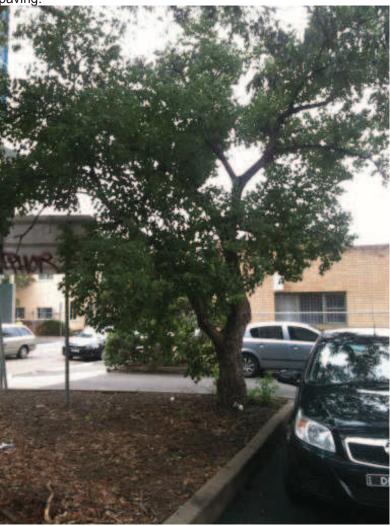
This tree is a mature *Pyrus calleryana* and is approximately 7.5m tall with canopy spread of 8m. The tree is in good health and condition with minimal deadwood or epicormic growth. This tree has a single trunk with a diameter at breast height of 385mm. This tree is in a small planter bed and is approximately 1m from the car park kerb and sealed paving.

Figure 1 - Tree 3 showing proximity to kerb

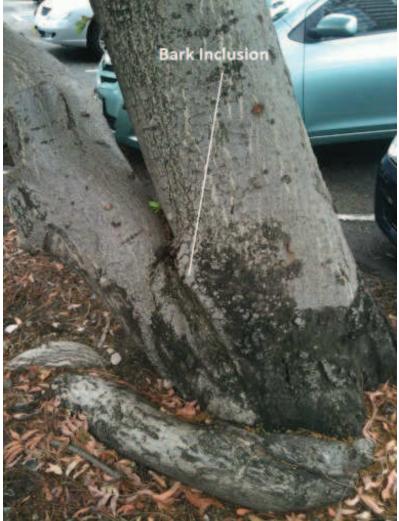
This tree is a mature *Castenospermum australe* and is approximately 10.4m tall with canopy spread of 14m. The tree is in good health and condition with minimal deadwood or epicormic growth. This tree has a single trunk with a diameter at breast height of 530mm. This tree has a bark inclusion at the base of a leaning trunk and has a canopy almost entirely made up of elite epicormic shoots. Recommend removal of this tree.

Figure 2 - Tree 4 showing bark inclusion in main junction

Tree 4 is recommended for removal regardless of the development due to structural defects present in a leaning trunk and the high amount of elite epicormic branches in the upper canopy. This places this tree at an elevated risk of failure in an area of high pedestrian and vehicular traffic.

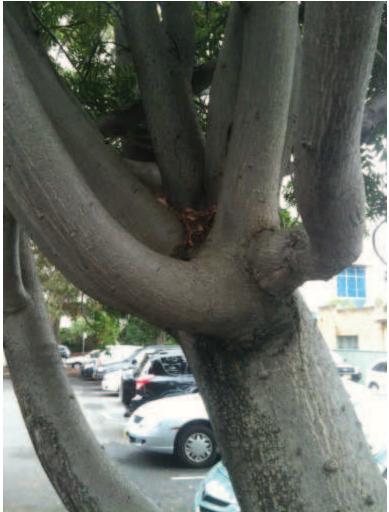
Figure 3 - Elite epicormic branches in tree 4

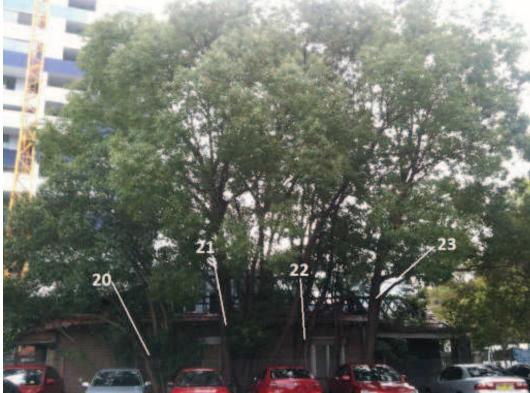
Figure 4 Trees 20 to 23

This tree is a mature Broad leaf Privet and is approximately 10m tall with canopy spread of 8m. The tree is in good health and condition with minimal deadwood or epicormic growth. This tree has multiple co dominant trunks from the base with an approximate aggregate diameter at breast height of 500mm. This tree is exempt from Parramatta City Council Tree Preservation Order. This tree is immediately over the boundary on a neighbouring property and is less than 2m from a vacant fire damaged building.

Council Tree Preservation Order. This tree is immediately over the boundary on a neighbouring property and is less than 2m from a vacant fire damaged building.

This tree is a mature Camphor laurel and is approximately 10m tall with canopy spread of 18m. The tree is in good health and condition with minimal deadwood or epicormic growth. This tree has multiple co dominant trunks from the base with an approximate aggregate diameter at breast height of 500mm. This tree is exempt from Parramatta City Council Tree Preservation Order. This tree is immediately over the boundary on a neighbouring property and is less than 2m from a vacant fire damaged building.

Trees 5, 20, 21, 22 and 23 are on neighbouring properties and therefore are required to be retained and protected, however trees 20, 21, 22, 23 are in close proximity to a vacant, fire damaged house and are also immediately adjacent to the boundary. It is recommended that this opportunity is taken to seek approval for the removal of these trees during the construction process.
