## **Pacific Brands Limited**

**Report for 190 Dunmore Street  
Wentworthville NSW**

**Phase 2 Environmental Site  
Assessment**

**May 2011**

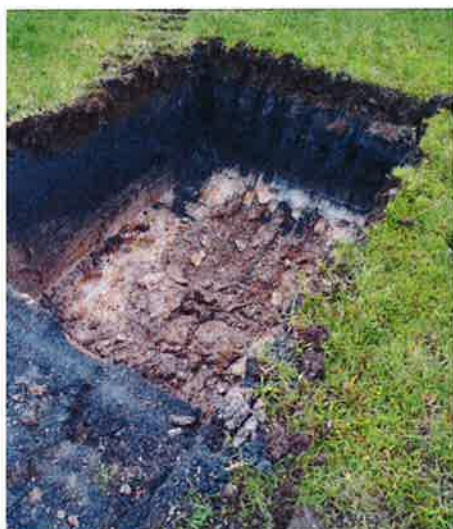
- A horizon of black impacted soil and ash approximately 800 mm thick was identified in the south western corner of the site (TP9) and is believed to be waste material from the former incinerator at this location. The area of this impacted soil was approximately 10 x 10 m. Analytical results were below the adopted criteria however this may represent an aesthetic issue.

**Photo 1 – Black Horizon at TP09**

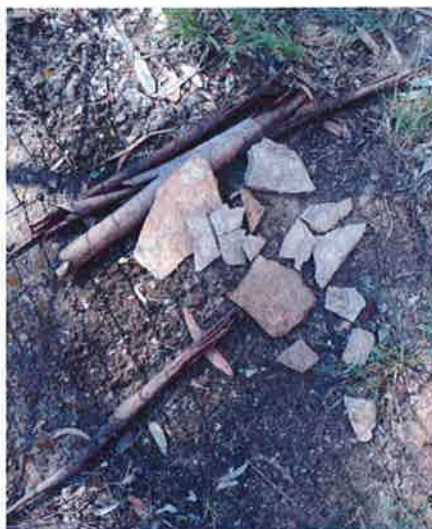
- Fragments of asbestos cement (AC) were identified in fill material (mostly reworked natural clay and rock) along the eastern portion of the site.

**Photo 2 – Asbestos Cement Fragments at TP30**

- Management or removal of AC fragments in fill material along the eastern portion of the site and within the central car park area;
- Further assessment of PCBs in surface soils in the vicinity of former transformer stations, such as identified at WS6;

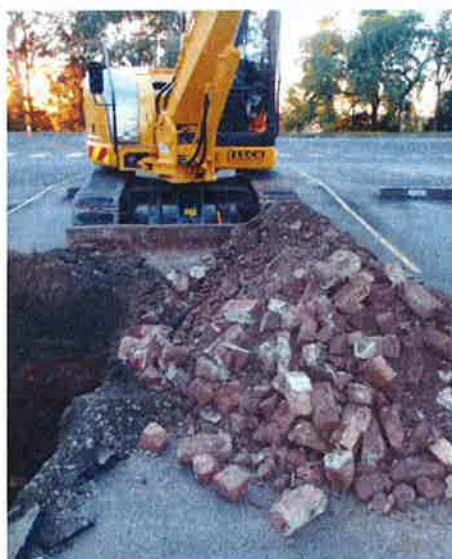
- Rubble including brick material and AC fragments was identified in fill material within the central staff car park. This is understood to be waste material from demolition of the old boiler house and was used to fill a depression (former creek) in this area. Analytical results were generally below adopted criteria in the fill material. The geotechnical characteristics of the fill material and the management of identified AC fragments will require consideration prior to site development.

**Photo 3 – Rubble at TP40**

- Management or removal of any near surface soils containing elevated heavy metals concentrations including crushed rock and road/slab base material;
- Management or removal of any material that may represent an aesthetic issue for site redevelopment, such as the black impacted soil and ash identified at test pit TP9 or the fill material within the central car park (rubble from demolition of old boiler house); and
